AN ARCHAEOLOGICAL INVESTIGATION OF STRUCTURAL FEATURES AT WATERHOF, HOF STREET: CAPE TOWN

Trevor Thorold Architects

December 1998

Archaeology Contracts Office

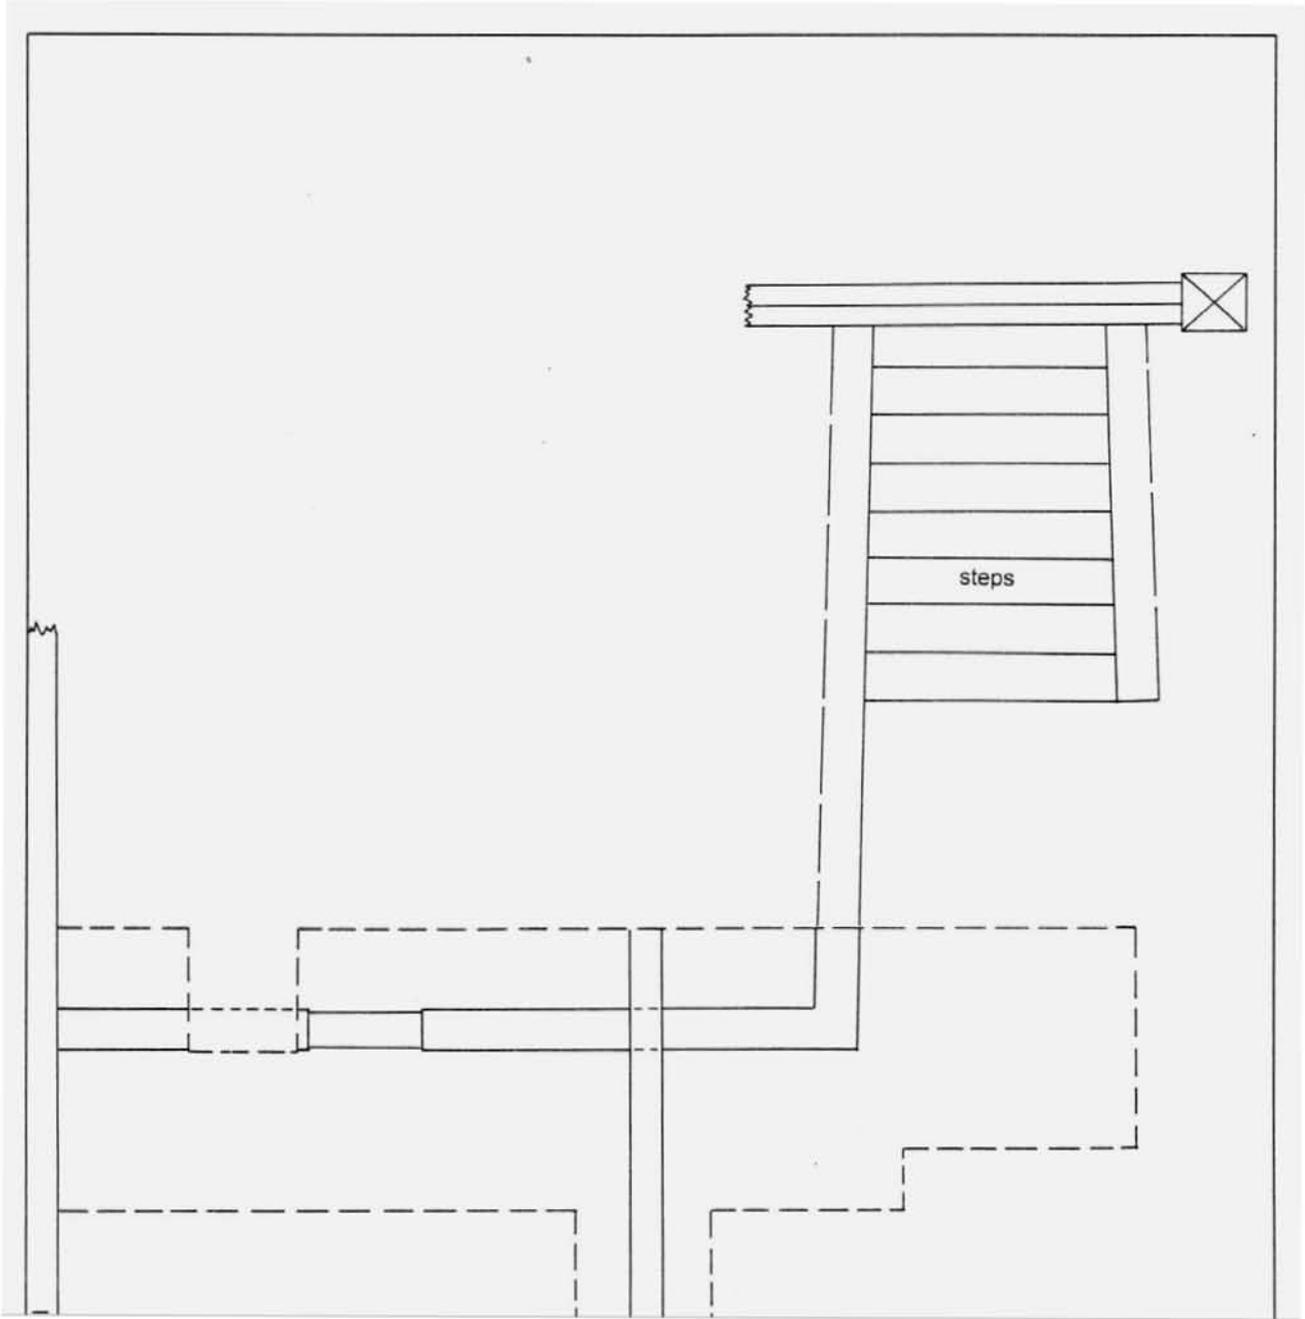
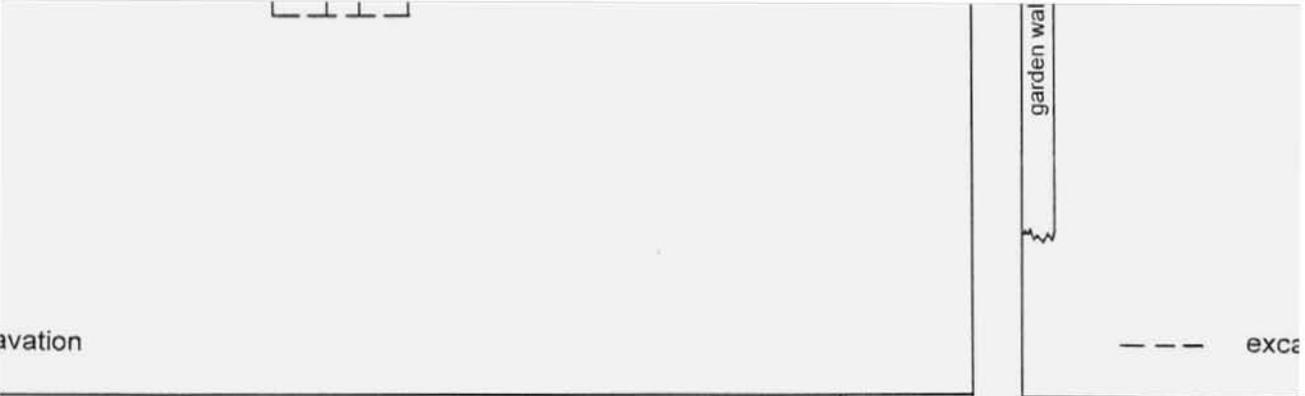
avation
 ings exposed in area 17
 Scale 1:50
 garden wal
 --- exc
7 Wall foot

No visible surface evidence of the feature was detected and a series of trenches was dug in the area to determine whether we could uncover any traces of structural remains. Figure 7 shows a plan view of the walls that have been exposed.

At about 500mm below the surface we uncovered a stone wall footing. This depth approximates the height of the original surface identified in the previous phase of excavations. Extending the excavation laterally revealed further stone footings as well as exposing part of the wall which ACO previously described as the northern wall adjacent to the steps. A corner is present at the end of this wall from where it runs toward and up to the garden wall at the northern edge of the excavation. It appears that the “garden” or at least a part of it, formed part of the old outbuilding and suggests that the steps ran down against the outbuilding toward the adjacent property.

Another stone footing of an apparently more substantial wall cuts through a section of the outbuilding foundation and suggests that at some stage, after the demolition of the outbuilding, there might have been an original boundary wall at this point.

At the same depth as the top of the stone wall foundations and in many places lying against the stone features we found a brick and lime plaster layer. We suggest that this layer resulted from the demolition of the outbuilding. The presence of so much brick suggests that although the foundations of the outbuilding were stone, the walls were constructed of brick. Additionally, the presence of lime based plaster mixed in with the bricks covering the stone footings suggests that at least the brick part of the walls was plastered.

1. The trenches excavated at location 17 have been left open at the request of the architect. These should eventually be backfilled preferably with building sand or at least a layer of this with garden soil on top. This would alert anyone digging here in the future to the presence of the structural features and would make them easier to expose if this was required in future.

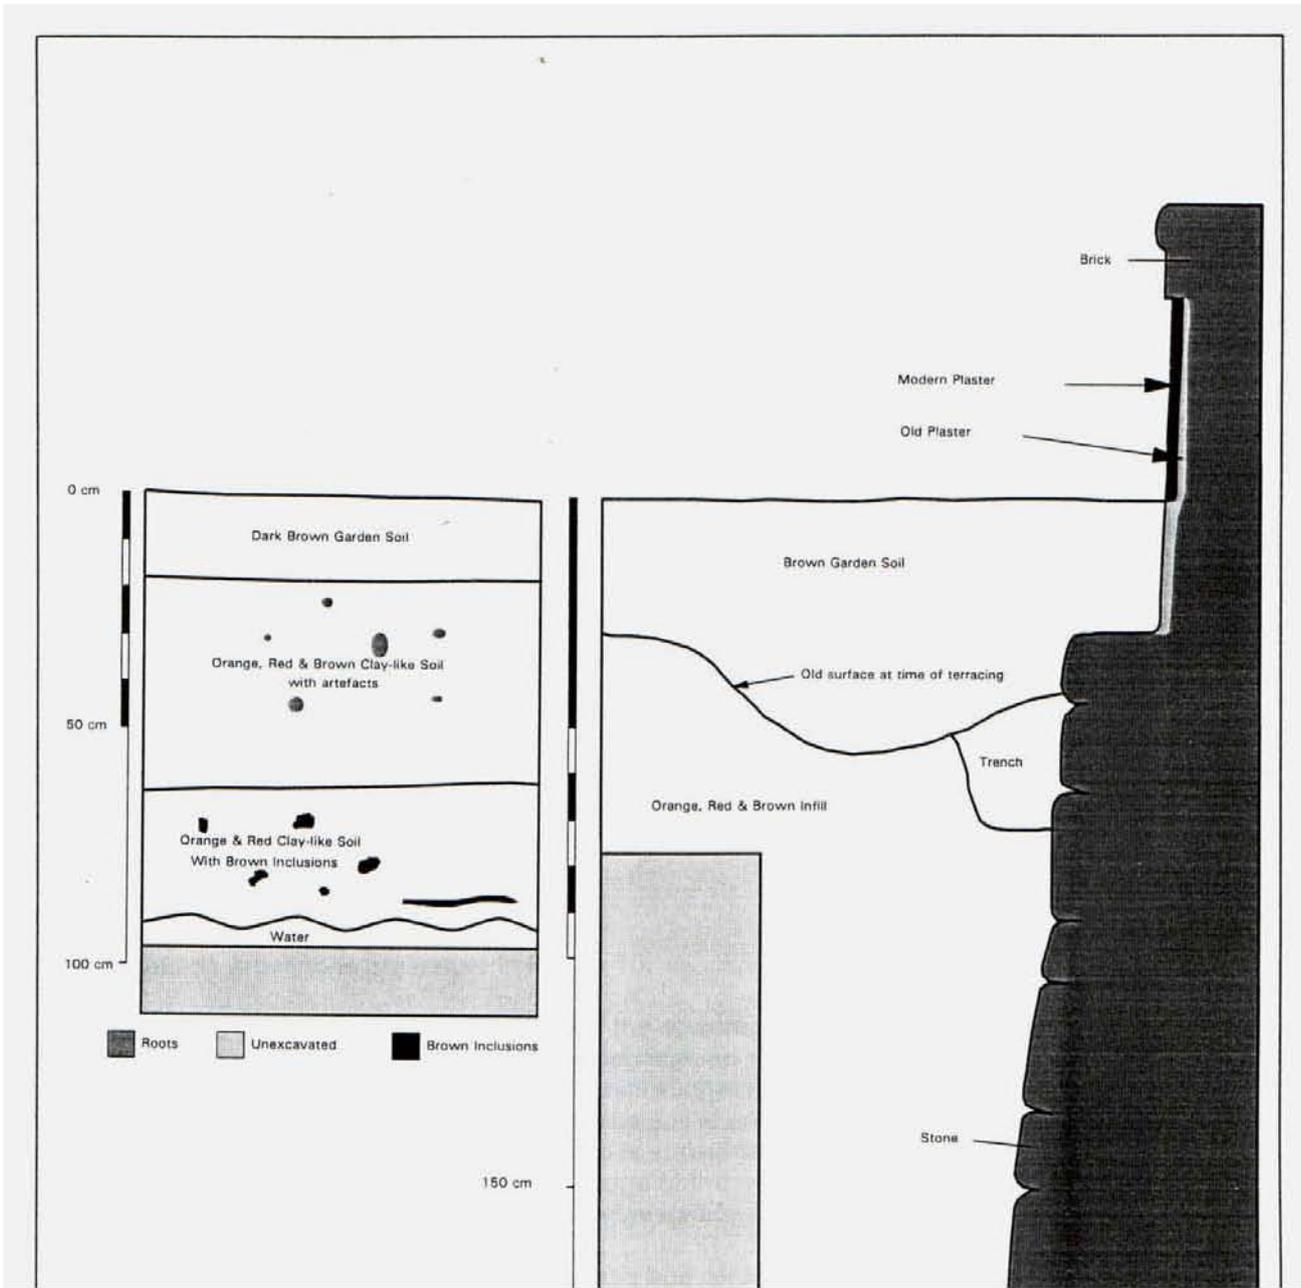
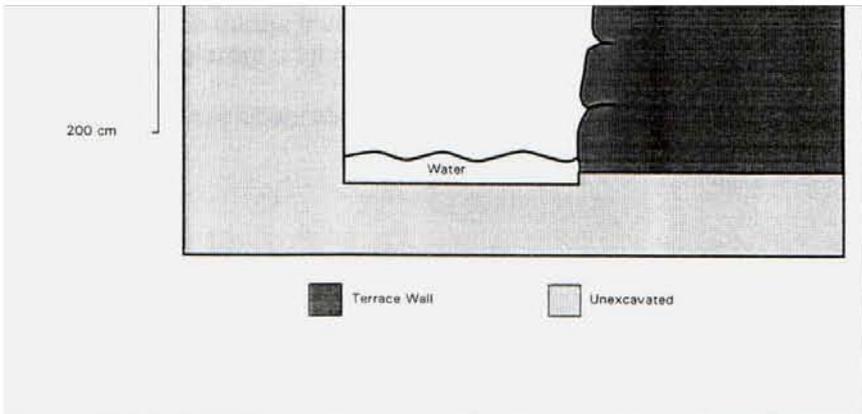
9

The excavation showed that since no trench was dug to build the wall, and since the deposit against the wall is not *in situ*, that the wall must have been built to retain soil after a levelling process took place. Since the soil against the wall is not *in situ*, we can discount the possibility that the retaining wall was built flush against the section of cutting. It would appear rather that the wall was first built on the original slope running down from the house, after which the area between the original ground surface and the new wall was filled and levelled with material removed from up slope (and other areas) as terracing progressed. While the lower part of the wall up to where it narrows is of Table Mountain Sandstone (TMS), the upper part is of brick.

Old lime plaster is present down to the top of the TMS base and is covered down to the present ground surface on the southern side by modern plaster. The irregular face of the northern side of the wall, when compared to the straight northern face of the wall on the eastern side of the garden path, indicates that at some point the wall collapsed and was rebuilt.

The top layer consists of humic dark brown garden soil. Below this is a thick layer of orange, red and brown clay-like soil which contains artefactual material such as glass, ceramic and bone. Below this is a thick orange and red clay-like soil with a few inclusions of brown soil that appear to be *in situ*. We did not excavate deeply into this layer due to water table being encountered at 900mm below surface.

The excavation showed that the stratigraphy from this trench and the one excavated at location 8 is similar, but that the thickness of the layers varies. The fill in area 18 is some 460mm thick while the fill in area 8 is at least 1500mm. This indicates that a great deal of fill was used to bring the northern part of the second terrace to the same level as the southern part.

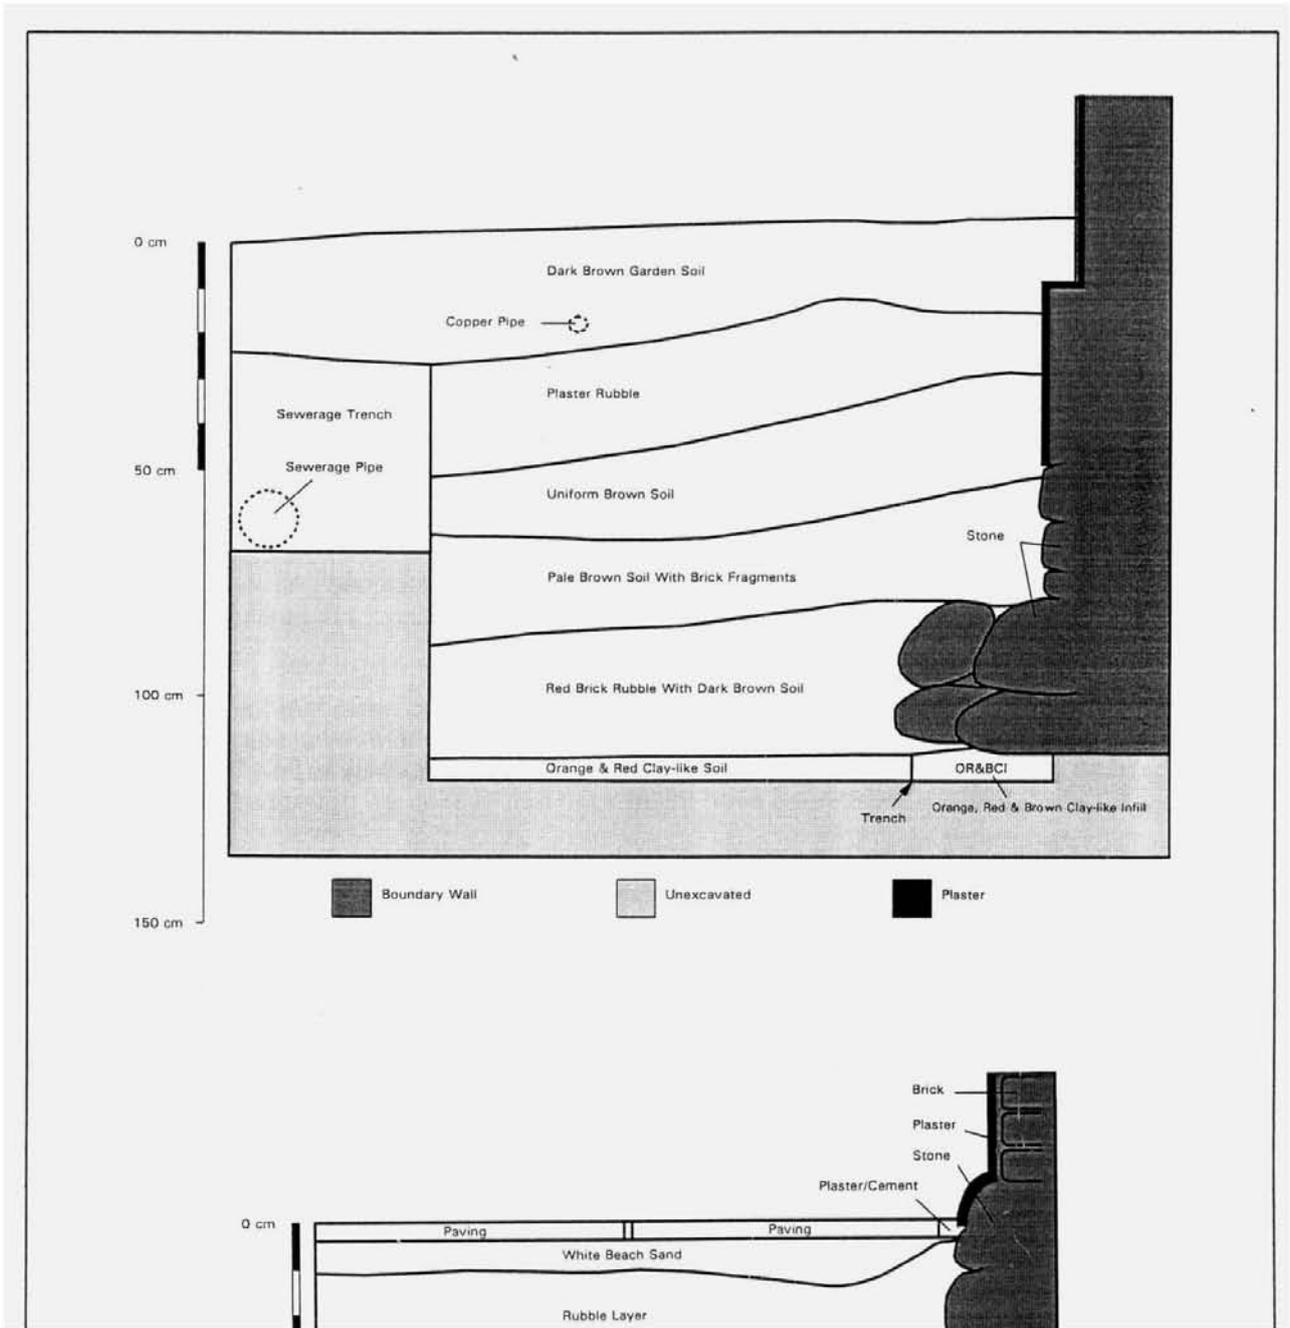
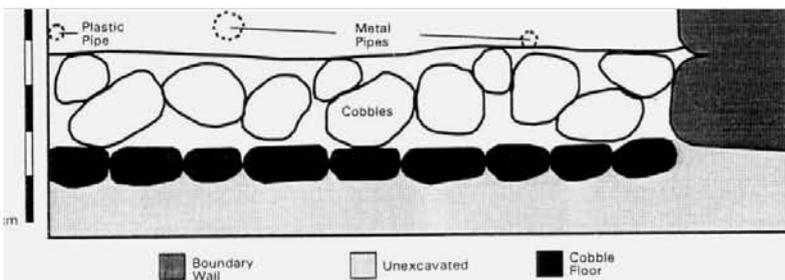
Section drawings: Areas 6 and 14

Below the garden soil and to the west of the sewerage trench is a layer consisting almost entirely of plaster and probably indicates an episode of re-plastering. All the stratigraphic layers lie flush against the wall suggesting that they were deposited after the wall was built. Orange and red clay-like soil is encountered at approximately 1100mm below surface where the water table is encountered. At about 1200mm below the surface and directly below the eastern edge of the wall footing is a faint but visible soil change indicating the trench that was excavated for construction of the wall foundation.

According to the architect, plaster stripping and renovation of the Waterhof house occurred during the 1920's. The red brick rubble layer may be consistent with that episode. The level of the bottom of the plaster on the wall indicates an old level.

No traces of the water furrow or canal were observed.

A layer of rubble containing brick, plaster and cobbles also produced a considerable amount of artefactual material including glass, ceramic, bone, metal and marine shell. A layer of cobbles lies below the rubble and on top of a formal cobble surface at a depth of 540mm below surface. The cobbled surface is shown in Plate 6. It appears that the formal cobbled

surface runs beneath the wall footing, but without disrupting the surface this is difficult to confirm. The layers above the cobbles were introduced after the wall was constructed as there is no sign of any foundation trench.

The level of the cobble surface is similar to the level of that uncovered during excavations in June 1998 in the courtyard and may indicate that cobbling such as this was quite extensively used around the house. No water features were uncovered in this area suggesting that either the plans are inaccurate or these structures have been demolished or covered.

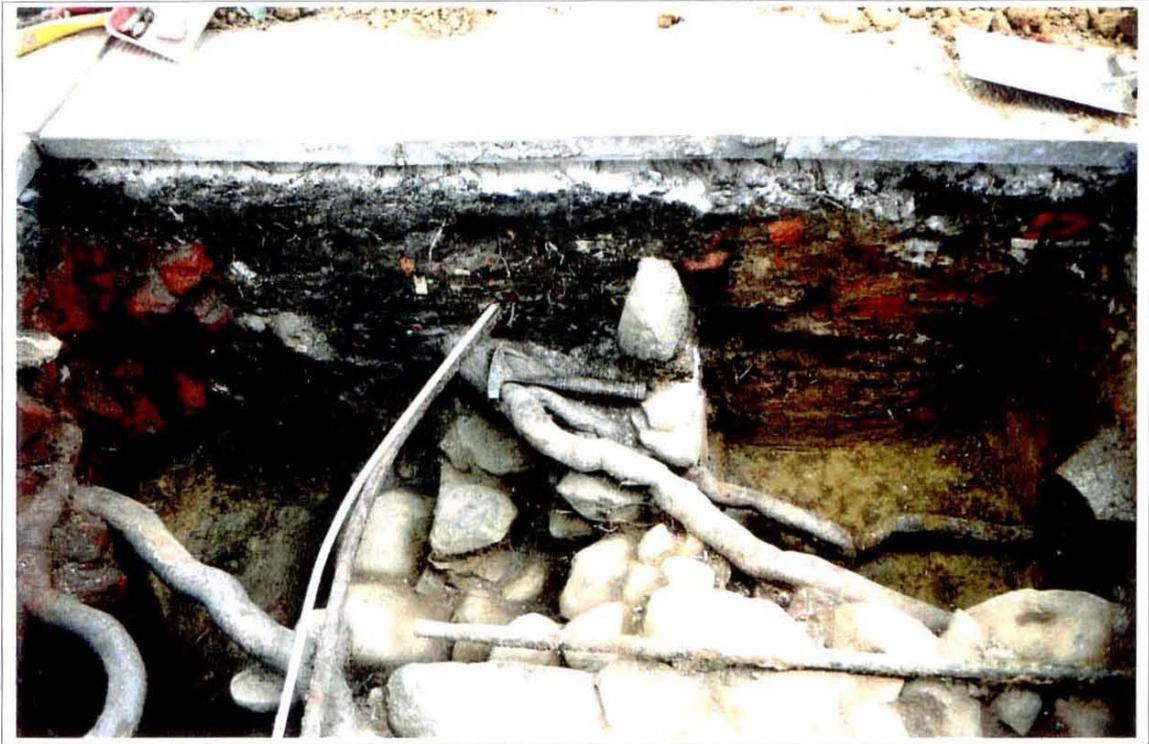
Stone wall footings are found at 590mm below surface. Excavation proceeded to a depth of 1000mm on both sides of the wall footing. To the south of the wall footing the deposit is an orange and red clay while on the northern side of the wall footing the deposit is a pale orange and yellow clay-like soil. Deposits of ash and coal are found on the northern side of the footings and indicate dumping of cleanings from domestic heating fires prior and subsequent to the demolition. The lack of artefactual material within these deposits suggests that they were from heating rather than kitchen hearths. Due to time and cost constraints we could not extend the excavation but a metal probe was hammered to a depth of 950mm below the base of the excavation to see if any trace of cobbled surfaces could be identified. No hard surfaces were encountered and indeed no surfaces were detected close to the wall footings.

PLATE 1: The east section of the excavation in area 15 showing the old wall footings in the foreground.

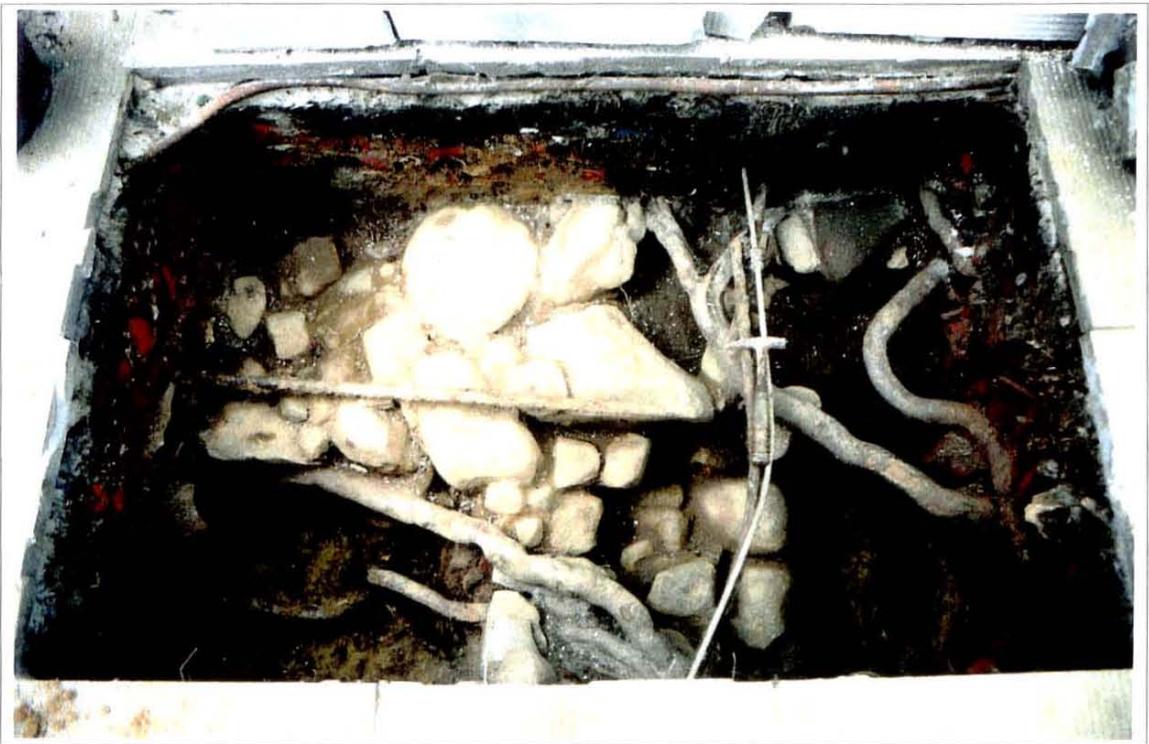
PLATE 2: The west section of the excavation in area 15 showing the old wall footings in the foreground.

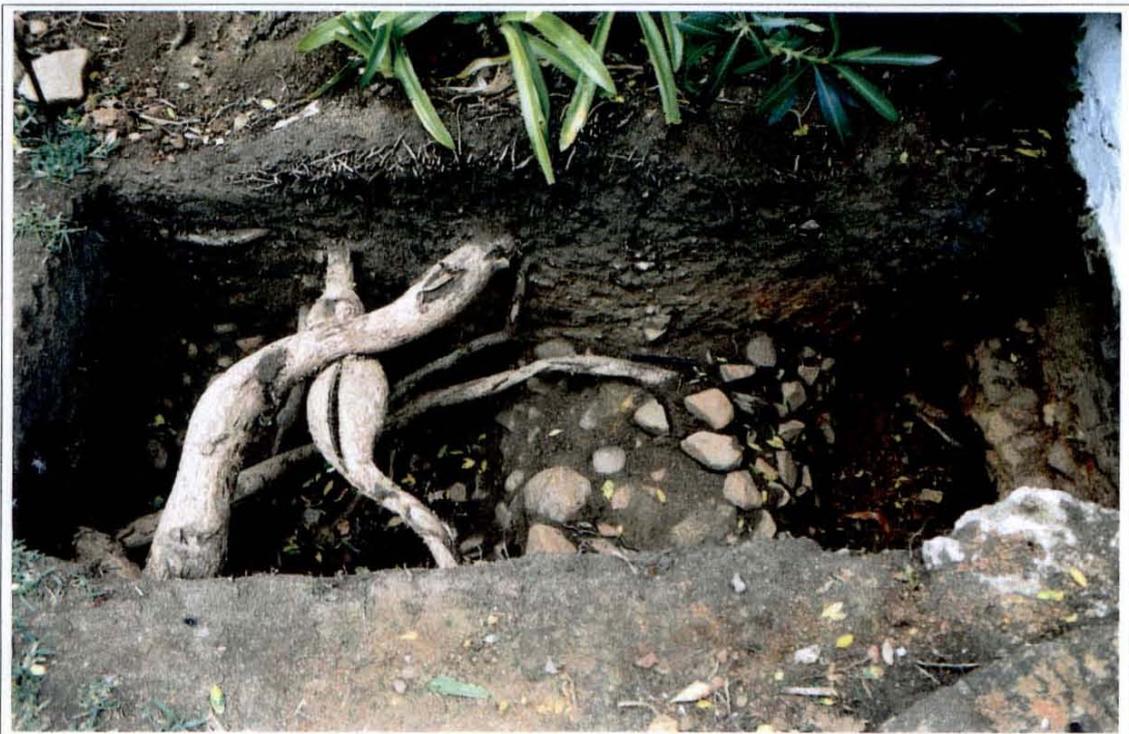
At 550mm below the present surface and a short distance to the west of the pathway wall is what appears to be a stone "feature" made from cobbles. From the section drawing it can be seen that the cobbles appear to form a channel. The presence of many large tree roots has made it difficult to fully explore the feature. This apparent channel may represent a modification of a natural feature (i.e. similar material to the cobble layer/stream bed found in area 17) into the form of a channel. Plate 3 shows the southern section shows the feature with the roots lying above it. At the same depth as the top of the cobble "feature" the pathway wall bottoms out and lies on top of a mixture of brown sand and red and orange clay-like soil. There is no clear foundation trench for the garden wall. The colour and nature of the stratigraphy in this excavation is quite different to the other holes on the western terraces. There is less of the orange clayey soil that is so common elsewhere.

A much more extensive excavation would be needed before we can say more about this feature.

PLATE 3: The southern section of the excavation in area 10B. The cobble “feature” is visible below the roots at left while the base of the pathway wall is seen at right.

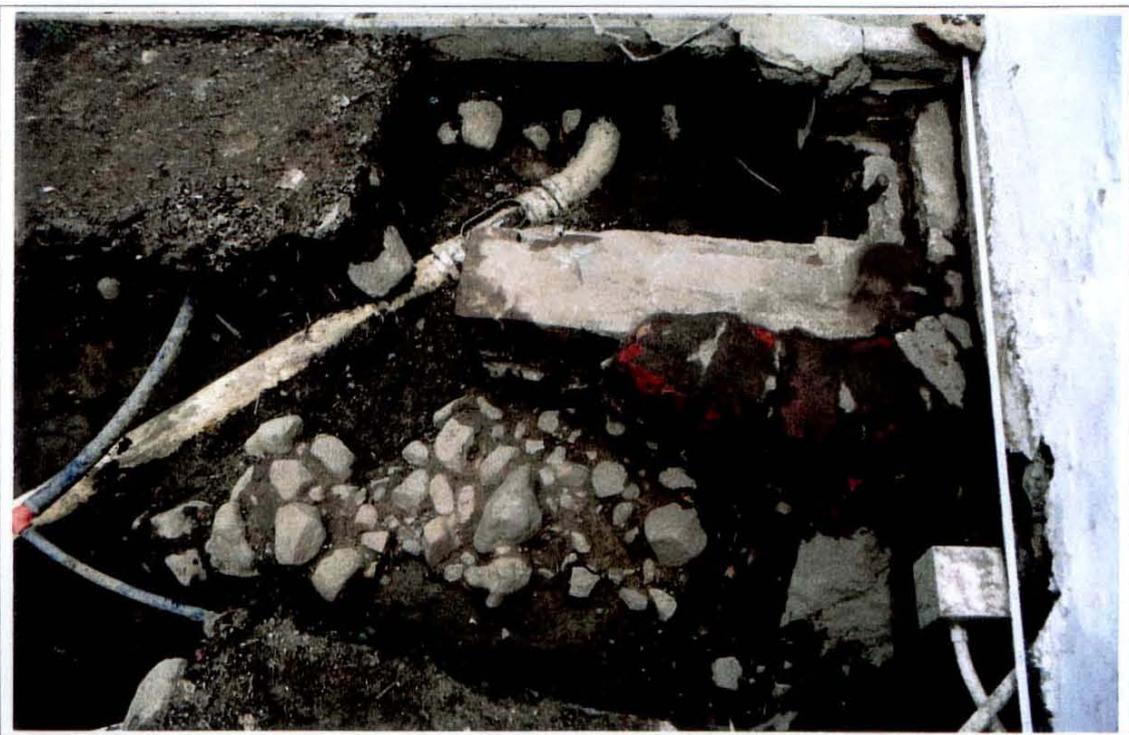
This area has been significantly disturbed by laying of modern services. Despite the disturbance, at 400mm below the present ground surface there are traces of cobbles. The presence of a cobbled surface in the alley (area 14) may suggest that the cobbles here are part of a more extensive cobbled surface around the house. Against the southern side of the alley wall (next to the gate) are traces of an old partially demolished square brick feature which probably functioned as a manhole. The top of this feature is about 150mm below the present ground level. On the western side of this feature and partially incorporated into it, are the remains of what must have been a circular brick and plaster feature which must have been present before the manhole was built. This construction is reminiscent of a well shaft but given that we know that there is supposed to have been some form of water storage facility in this vicinity, it is entirely possible that this is either that feature or another one (as the storage "cask" shown on the early plans is clearly not in this location).

PLATE 4: A view of the fragment of circular brick feature in area 7, partially covered by the wall and more recent manhole.

As numerous services run through this area, it will not be possible to fully explore this feature without diverting of some of them.

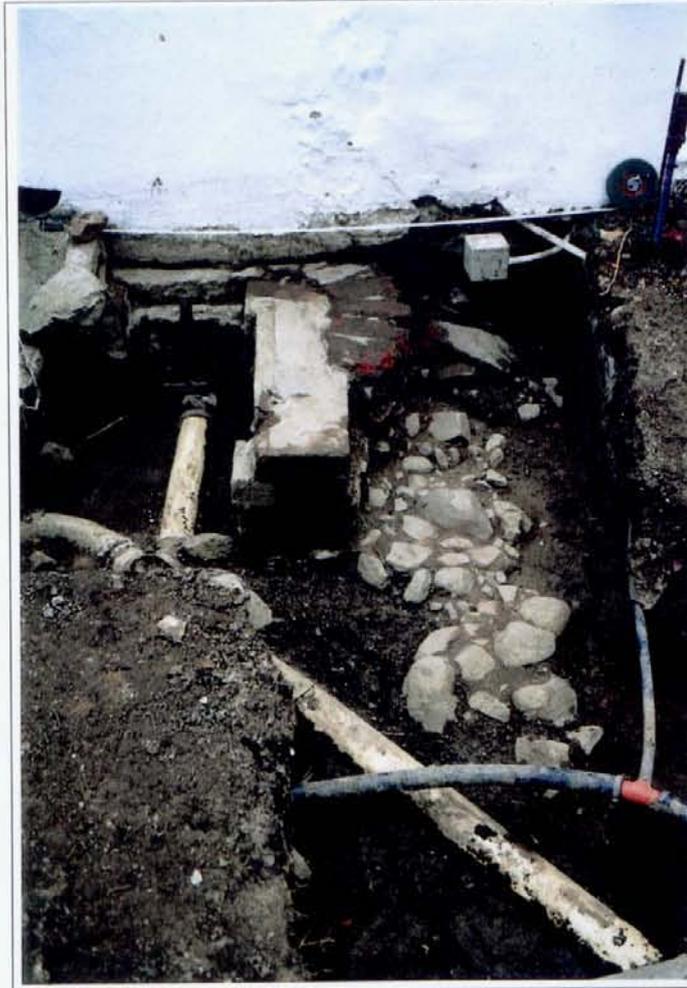
PLATE 5: A view of the features in area 7

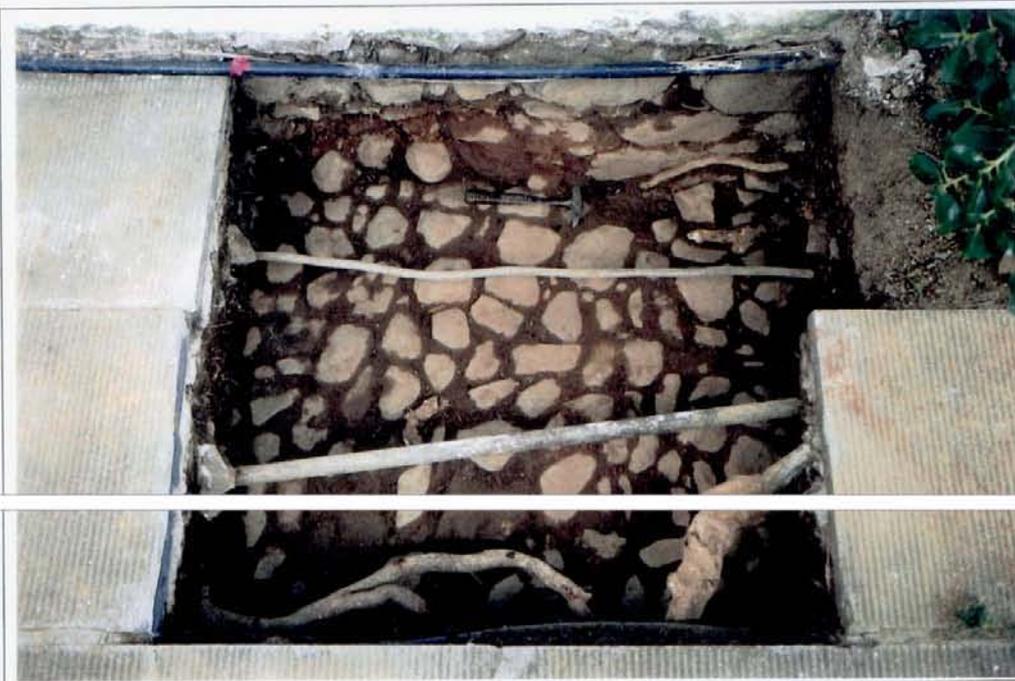
PLATE 6: The cobbled surface in area 14
