PHASE 1 ARCHAEOLOGICAL INVESTIGATION OF TWO AREAS OF THE CASTLE MOAT

Prepared for

Gabriel Fagan Architects

August 1996

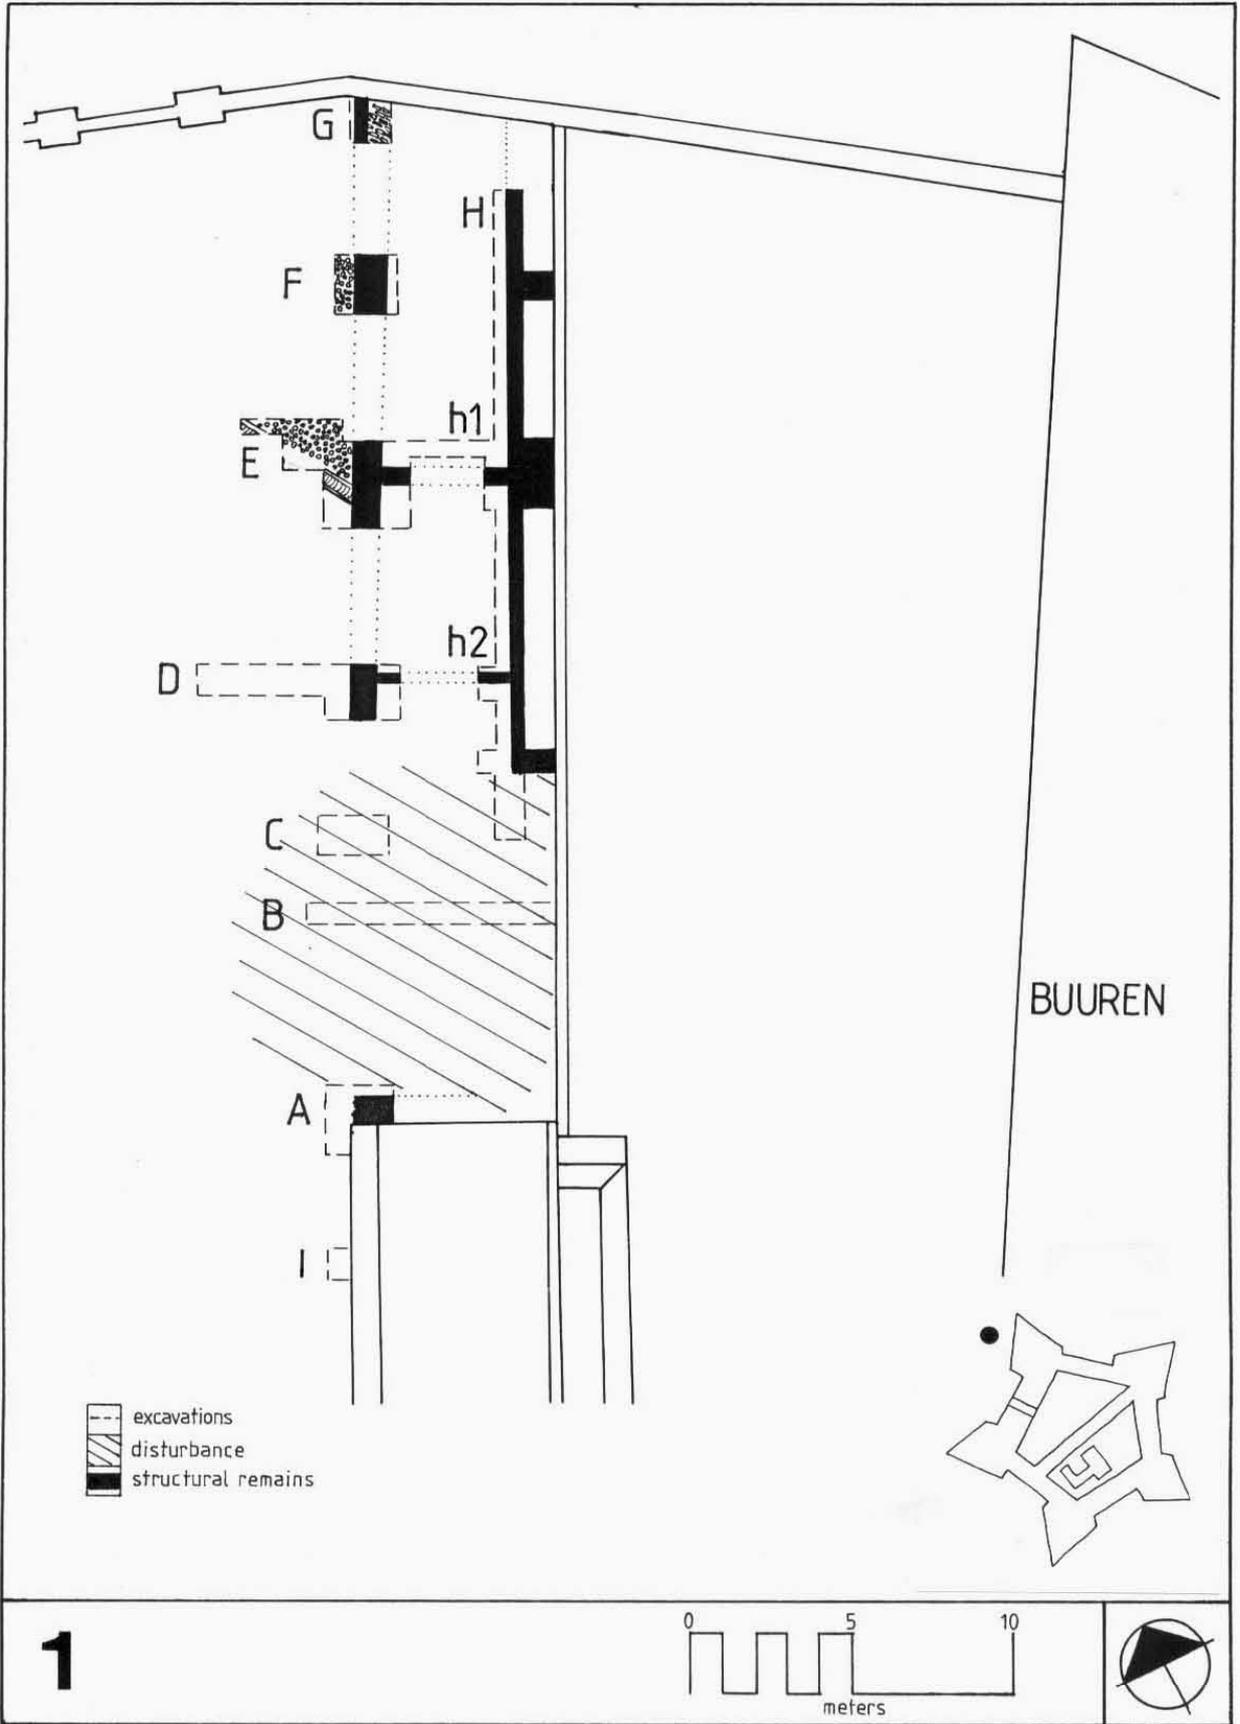
As this project represents a preliminary investigation of the structure, it has been the intention to establish through a series of strategically placed trial excavations rather than full scale excavation, if any part of the old structure remained, and if so, to make sure that it corresponded with archival information interpreted on the architects plan. A drawing of the area showing the location of trial holes is presented in Figure 1.

Prior to beginning the excavations it was necessary to remove an earth ramp built at the time when the area was used for a construction camp during the restoration of the castle interior. The use of the area for the stockpiling and subsequent removal of soil has resulted in destruction of the old structure where it was not covered by the earth ramp. The approximate area of disturbance is also indicated on Figure 1.

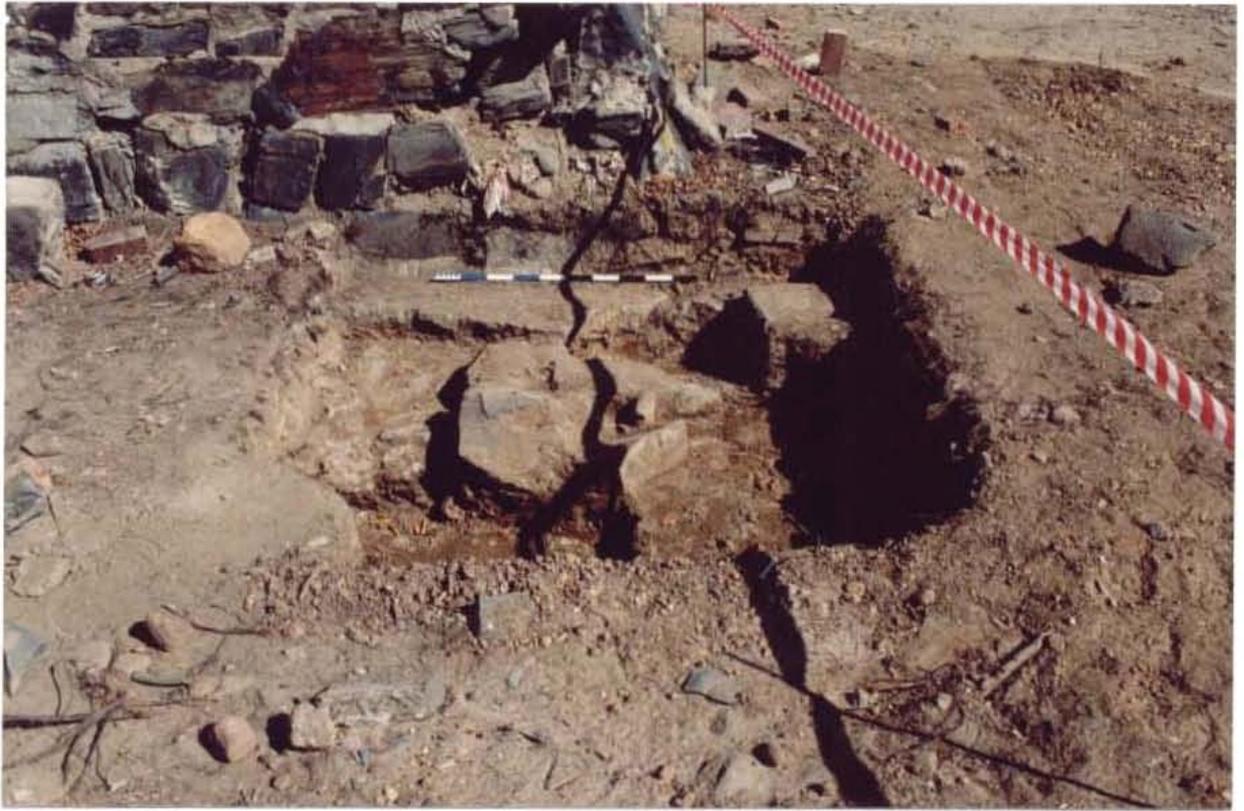
1

Portions of a substantial stone foundation consistent with those in test holes abutting the moat wall were exposed. The foundation is approximately one meter in width and is constructed with shale blocks. A modern cement lip some 130mm in width is cast on top of the stone foundation abutting the embankment wall (see plate 1).

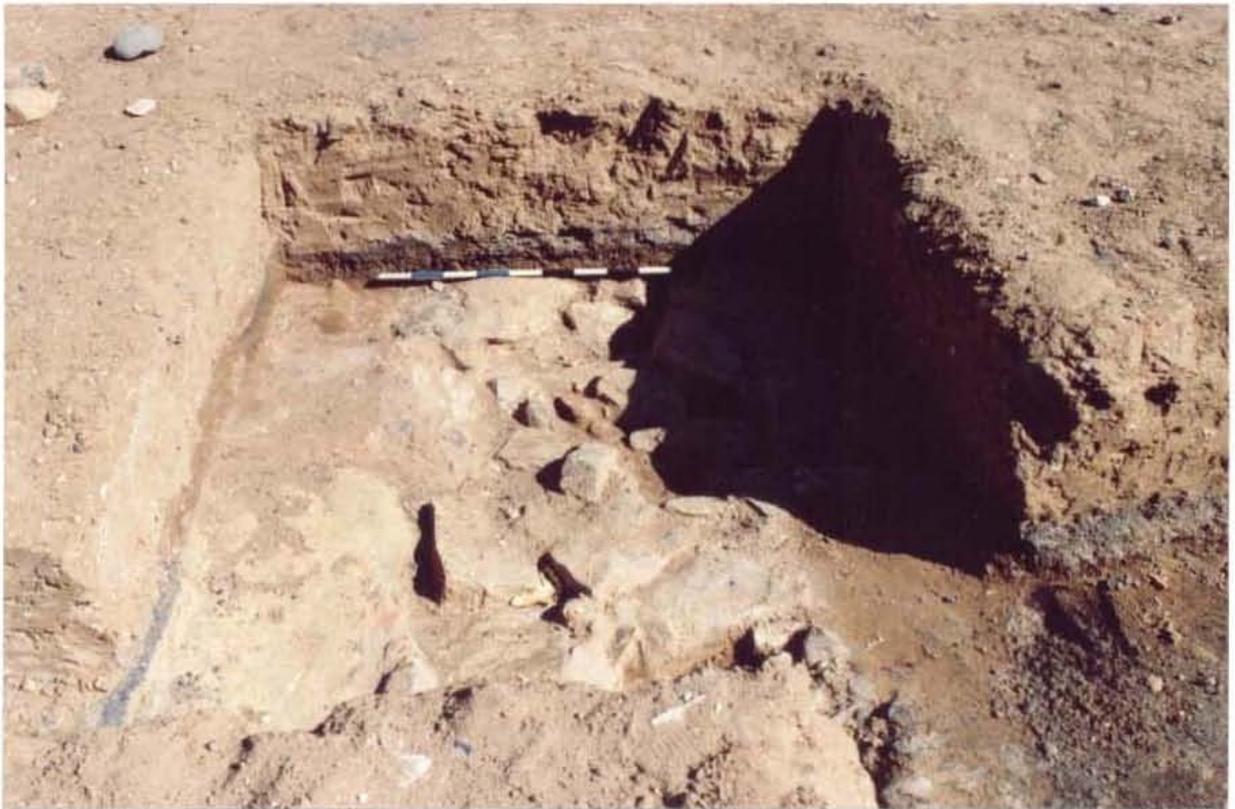
2

This excavation was sited on the line of the wall that had been found in test hole D and opposite the brick wall corner that was located in hole h1. The stone foundation existed here and again was approximately 900mm in width. A brick wall approximately 360mm in width was found to adjoin the wall and ran towards the opposite foundation where it was again exposed in hole h1. In addition to foundation, cobbles were found abutting the foundation on the west. These were partially disturbed by the addition of a cement channel, the positioning of which indicates that the structure was probably in use until fairly recently (c1940/50). The foundation can be seen in Plate 2.

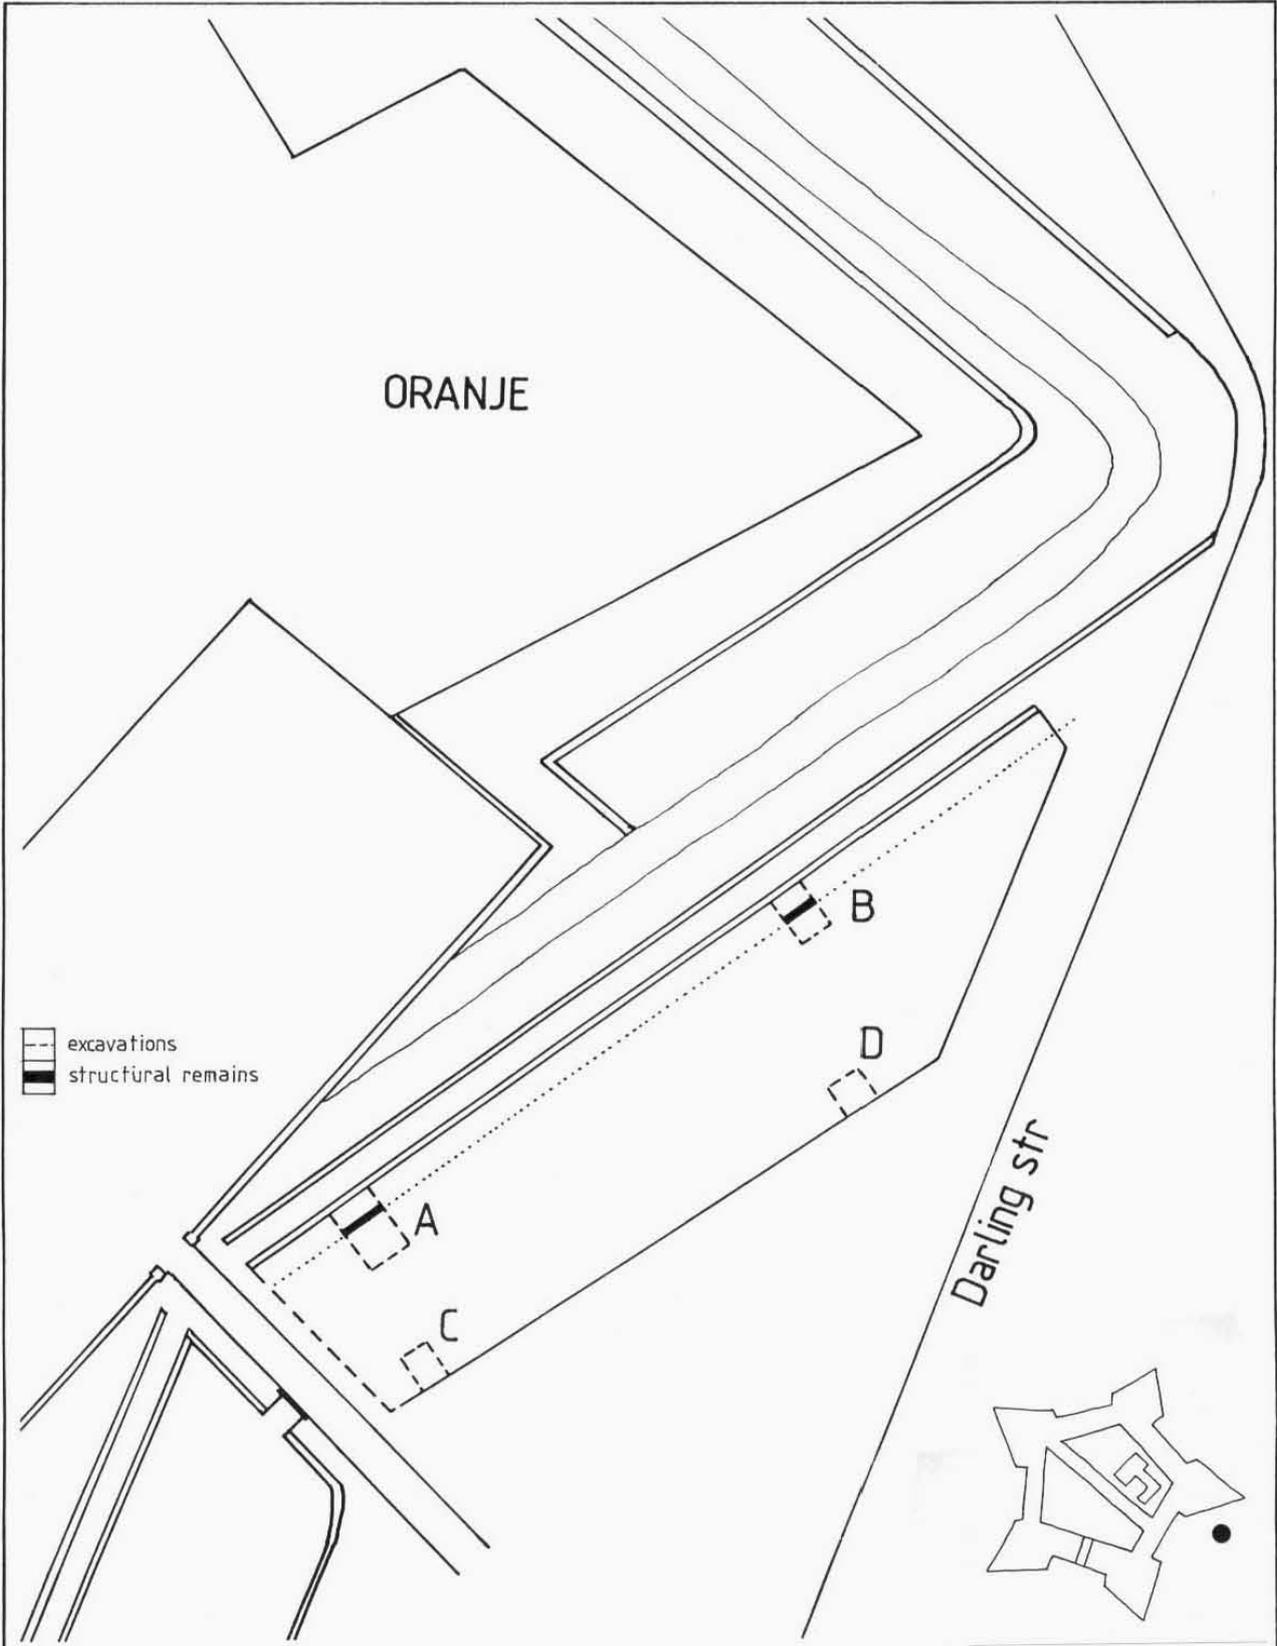
2

The location of the area under discussion here is shown in Figure 2. As the configuration of the moat walls had previously been established, this latest phase of excavation has been undertaken to ascertain that this pattern persists as well as to determine the depth of foundations. In addition, excavations would show if any rich artefact deposits were located in this area. A mechanical excavator was used to dig the initial large holes to a point short of the foundation. From here on digging was done by hand to avoid any damage to the structure.

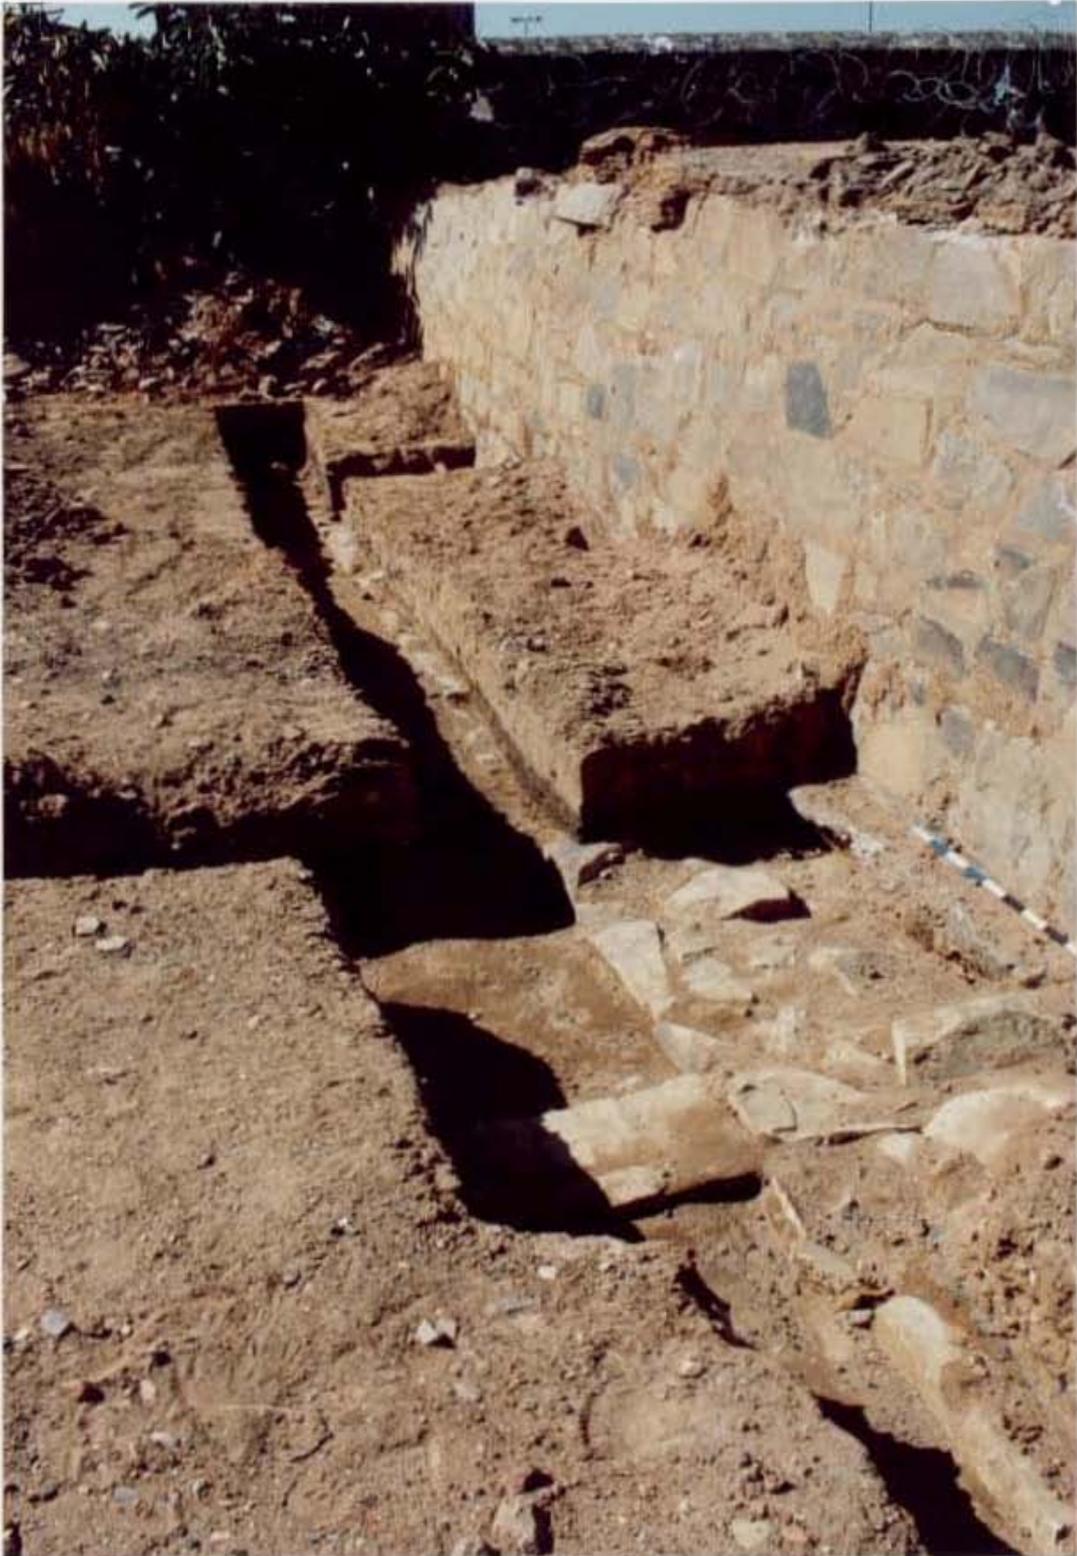
3

Nevertheless we would assume that this foundation will continue right the way through. To the south it was found that the platform had been removed by disturbance. We have similarly not been able to get into the southern corner because of a tree but have picked up the stone again in hole A. Two brick walls were found at positions h1 and h2 as described. A portion of the brick wall where it joins the foundation in h1 is shown in Plate 3.

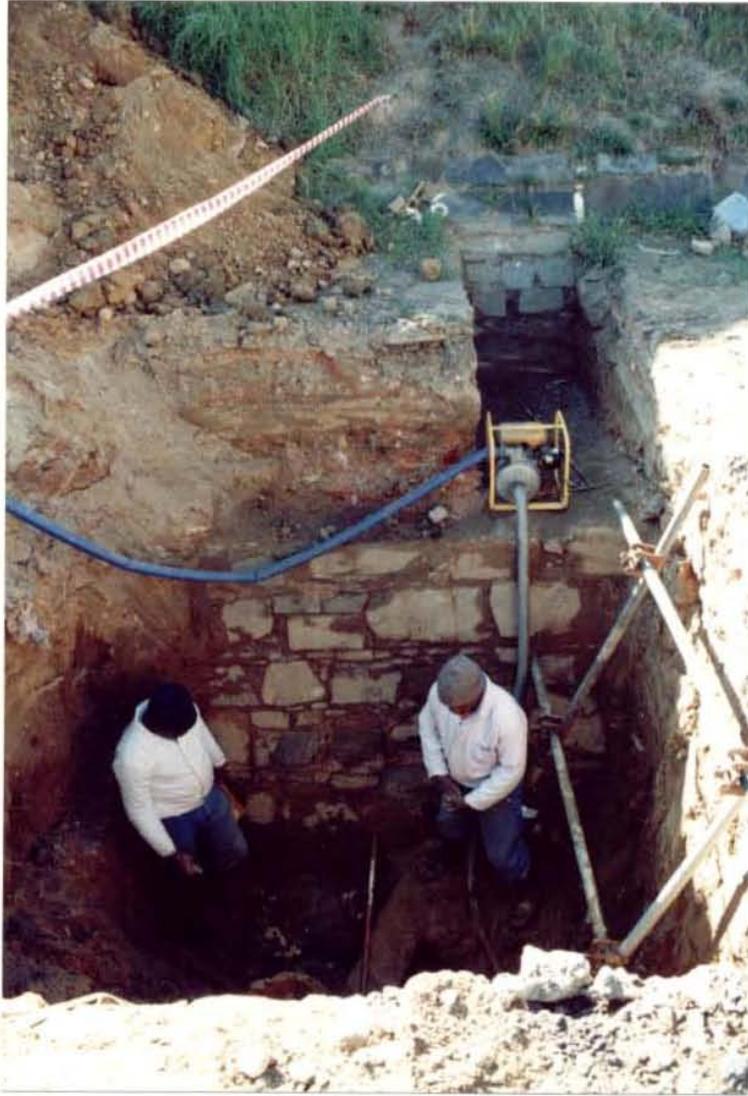
4

As we were expecting to find a platform running parallel to the exposed moat wall, a small trench was initially dug by hand to establish that this was indeed present. The platform was located and the width approximated previous observations (Plate 4). Foundations, consisting of rounded Table Mountain Sandstone boulders support the structure (Plate 5). The soil stratigraphy is straightforward with the uppermost material consisting of fairly recent introduced fills of great variability, the middle deposits are fairly uniform clayey sands containing a moderate amount of artefactual material dating to the 19th century (mostly sherds of refined earthenware with transfer print patterns). The lowermost deposits consist of a band of yellow clay seeming to cap the foundation and was probably used to seal the bed of the moat. Lying immediately above the yellow clay is a layer containing rounded pebbles and cobbles in a granular sandy matrix which probably marks the original base of the moat. Minimal artefactual material was noticed here. The yellow clay eventually grades into a more grey variety. This clay was not penetrated other than to confirm the width of the foundation. The various features are shown in Figure 3.

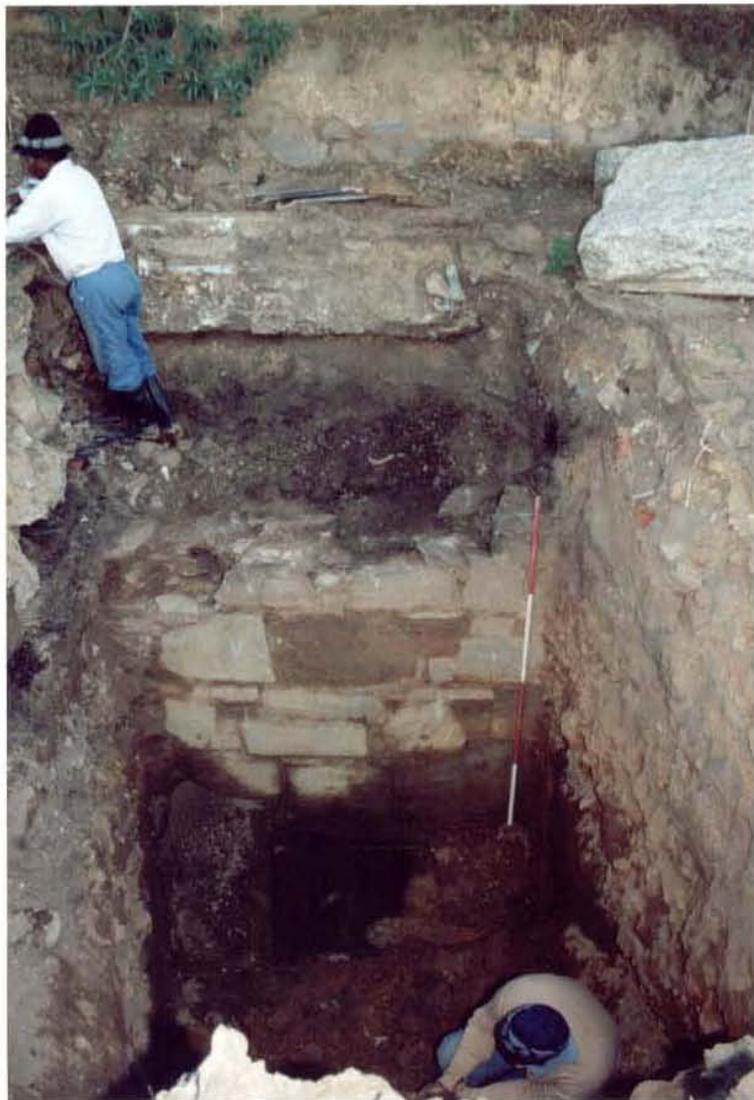
7

easily restored. The damaged section of wall can be seen in Plate 7. The wall below this is undamaged and the foundation is intact. Structural details are presented in Figure 3.

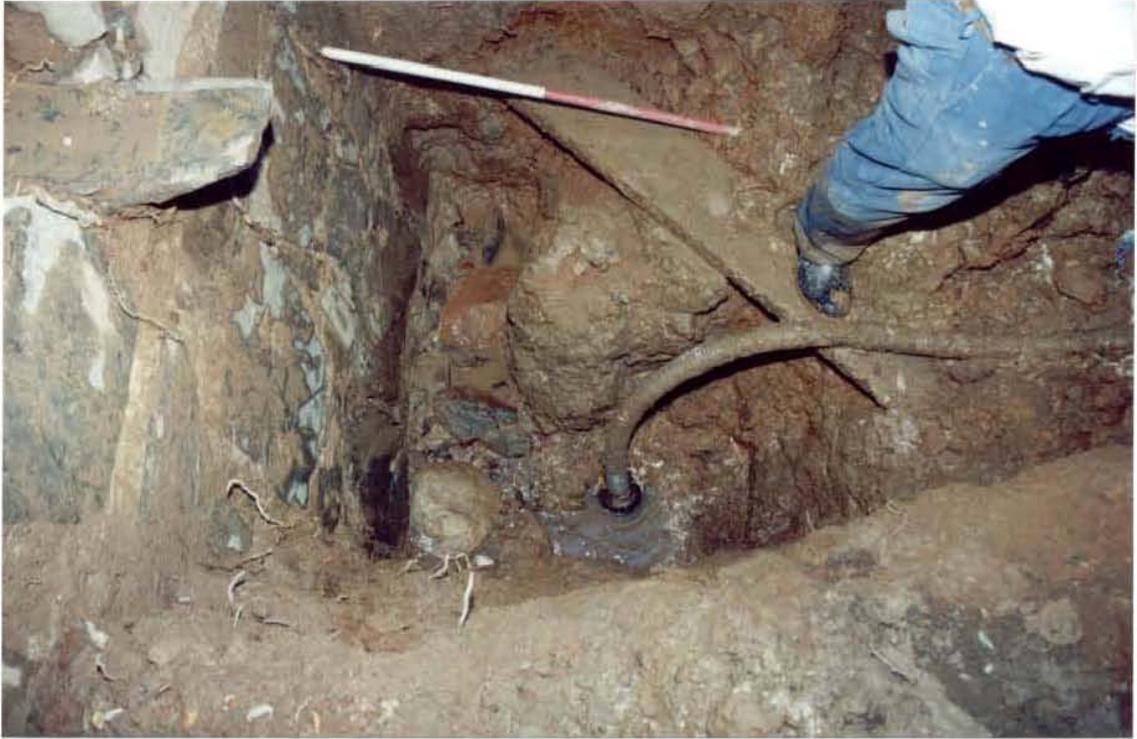
8

This is one of two holes which tested the west moat wall. Previous observations indicated that the configuration of this wall differs from the eastern one in that no additional embankment wall is present. Excavation followed the wall down to the foundation which turned out to be relatively narrow (Plate 8). One feature of note is a small water outlet with a lip set in the lower portion of the wall which probably drained Darling Street at some stage. Once the wall in the excavation had been cleaned it became obvious that the upper portion of the wall is a later addition. Although dressed shale has been utilised, the style of laying and shape are different to the original (Plate 9). The later addition to the top of the west moat wall was noted in other sections of the moat as well. These features can be seen in Figure 3. The stratigraphy is uniformly similar to the middle layers of Test Hole A, i.e. a clayey sand. Artefactual material is present in moderate quantities throughout this soil body but no obvious layering is present. This would be consistent with a fill of the 19th C. The level around the foundation is marked by a change to whitish clay. Some silty material is noted above the clay.

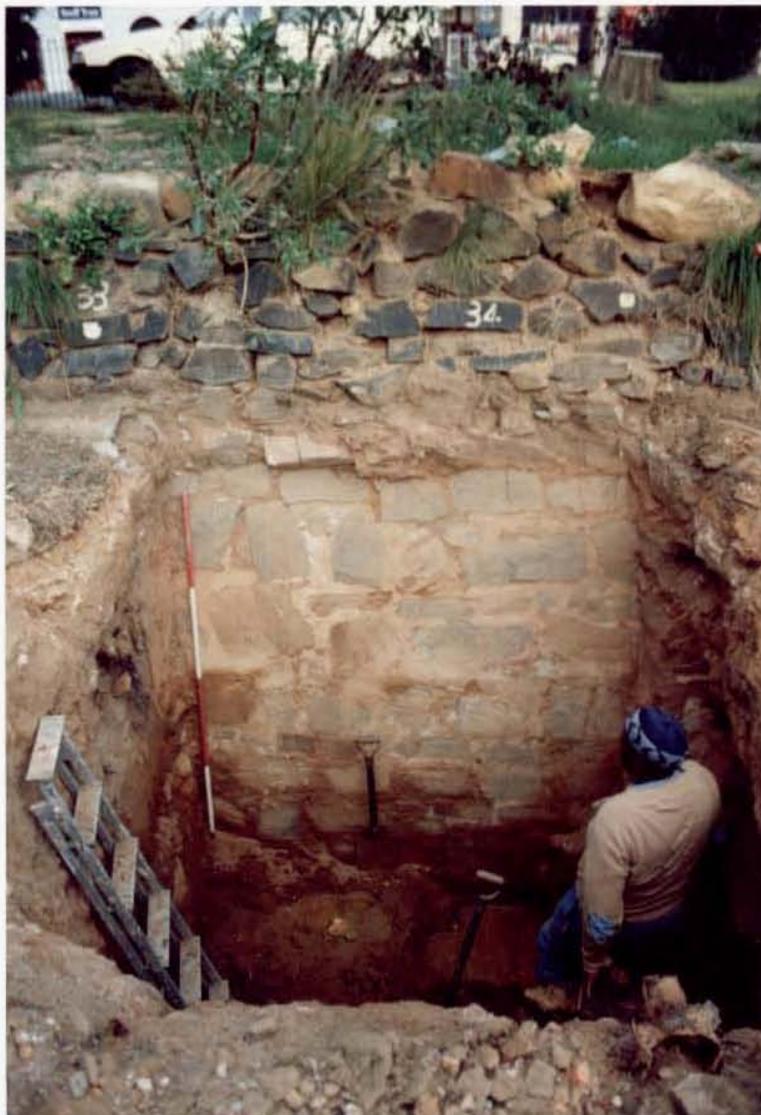
11

Also located along the west wall excavation followed a featureless wall down to a point just above the foundation. It was not possible to fully expose the foundations in this particular hole due to the fragile nature of the sections particularly the northern one. The central portion of the deposit contained a large mass of old sheet iron and drain pipe (Plate 10) which had probably been dumped in a pit. A smaller hole was dug into the lower deposits and an iron probe was hammered in at points parallel to the wall to establish the width of the foundation. We assume that the structure and material used will be the same as in other holes. Additional courses of stone were evident here too and these are clearly visible in Plate 11.
