# **AN ARCHAEOLOGICAL INVESTIGATION OF THE KAT BALCONY: THE CASTLE**

Prepared for

**Gabriël Fagan Architects**

September 1999

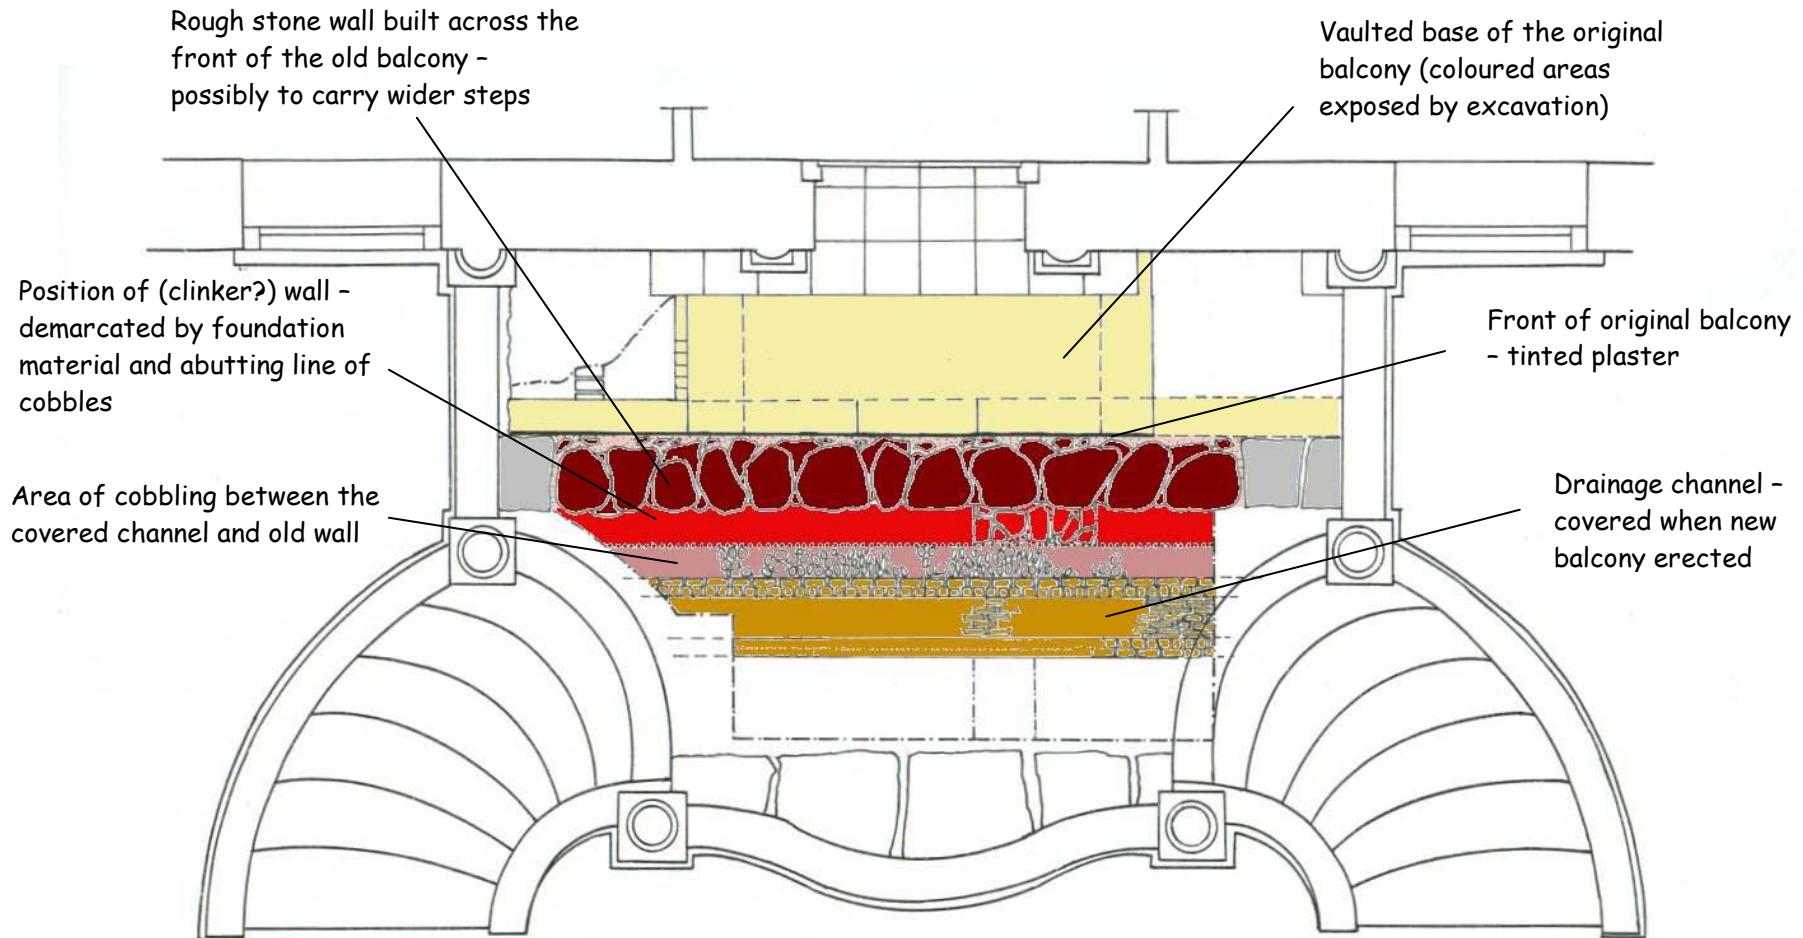
**3 KAT BALCONY: PLAN OF STRUCTURAL FEATURES**

A plan of the site (Figure 3) shows the various features which have been uncovered during the excavations. Side and front views of the features are superimposed on drawings of the extant balcony for comparison (Figure 4). Each of the features will be discussed below in the order in which the archaeological evidence suggests that they occurred. Briefly summarised these events are as follows:

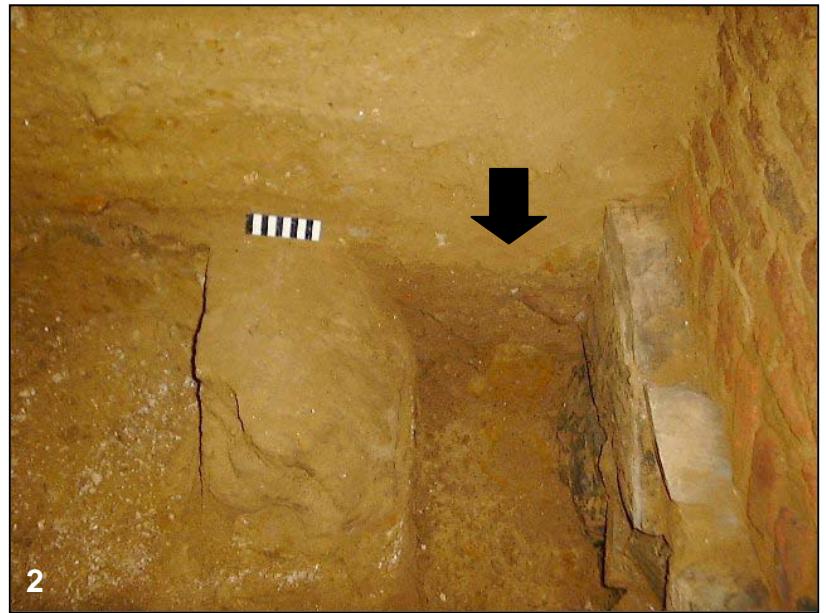
The foundation trench of the accommodation adjacent to the Kat wall.

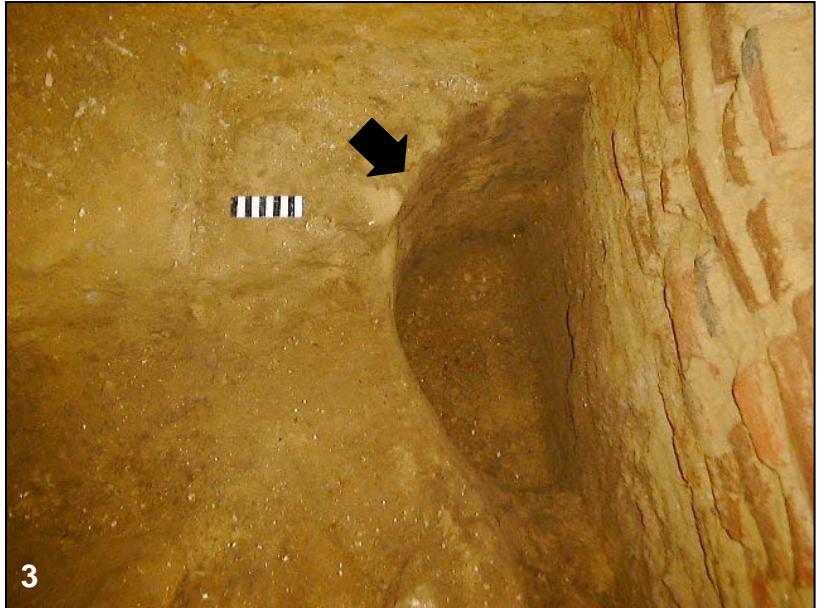
A large pit over which the front wall of the vault had been constructed.

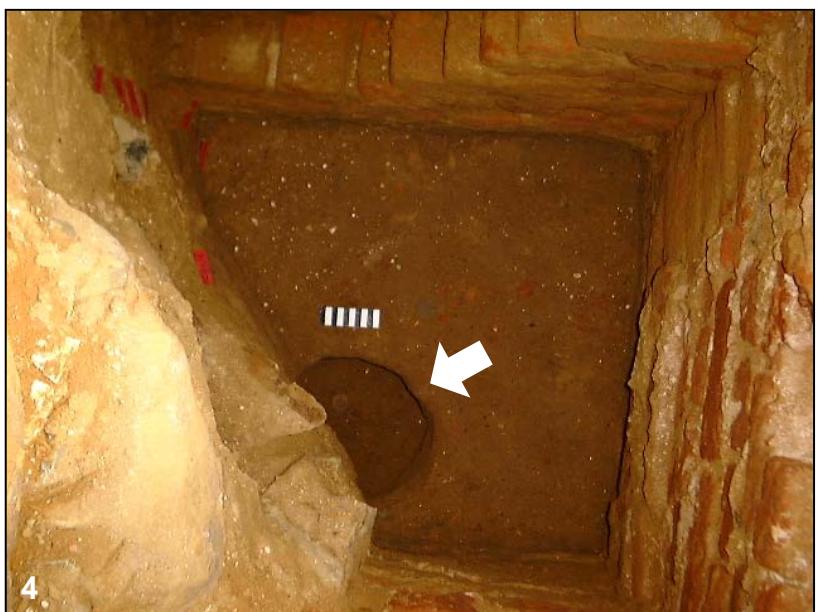
Two pits cut into lower deposits were obviously dug before the balcony was erected. The levels from which these pits were dug also gives some idea of the original ground levels during these early years. Similar pits have been observed in D Block and are believed to represent holes that supported scaffolding used in the early construction process (Plates 3,4). The pit below the opening in the old balcony was much larger than would be necessary for scaffold. Because of its awkward location we were unable to fully excavate its content and therefore do not know its depth and cannot comment on its use. The pit had been cut through a compacted surface covered by a lens of

A smaller pit dug into what must have been an original surface. This type of pit has been observed elsewhere in the Castle and probably once held building scaffolding in place.

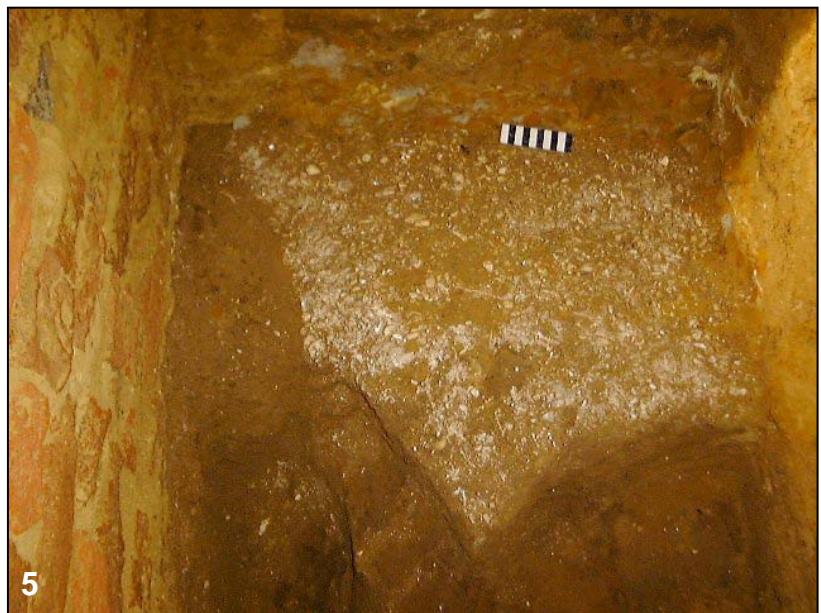
crushed marine shell. This compacted brown deposit covered by shell was also found in a test pit outside the vault and indicated an earlier surface but not necessarily man-made (Plate 5).

A surface covered by crushed marine shell. This is a natural layer which pre-dates the building of the Castle.

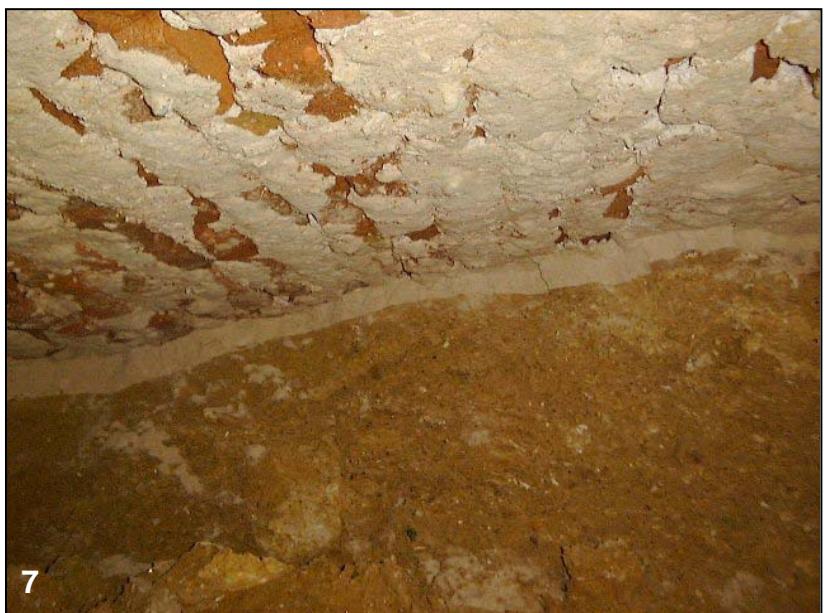
Edge of the opening to the vault clearly seen after tinted plaster removed.

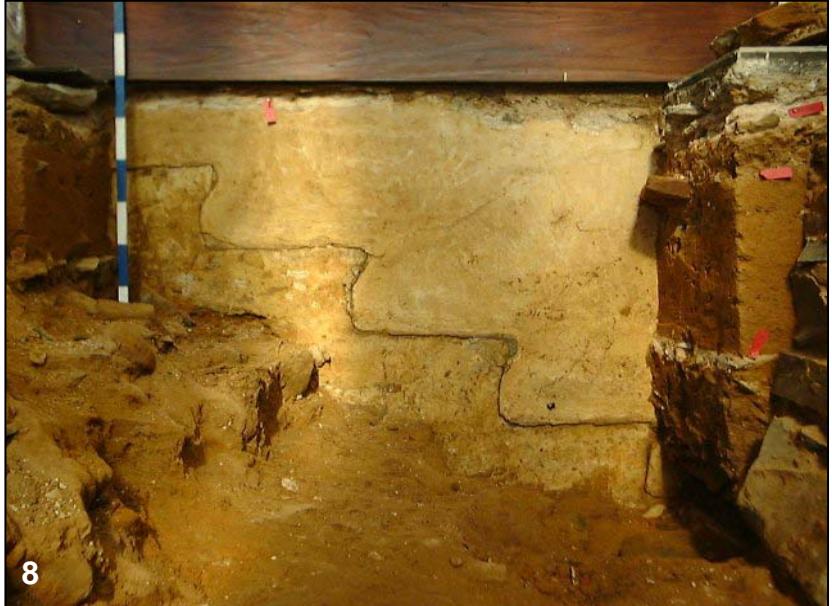
A layer of white sand was found immediately below the vault roof. This was in place before the vault was built and the sand probably supported the brick during construction.

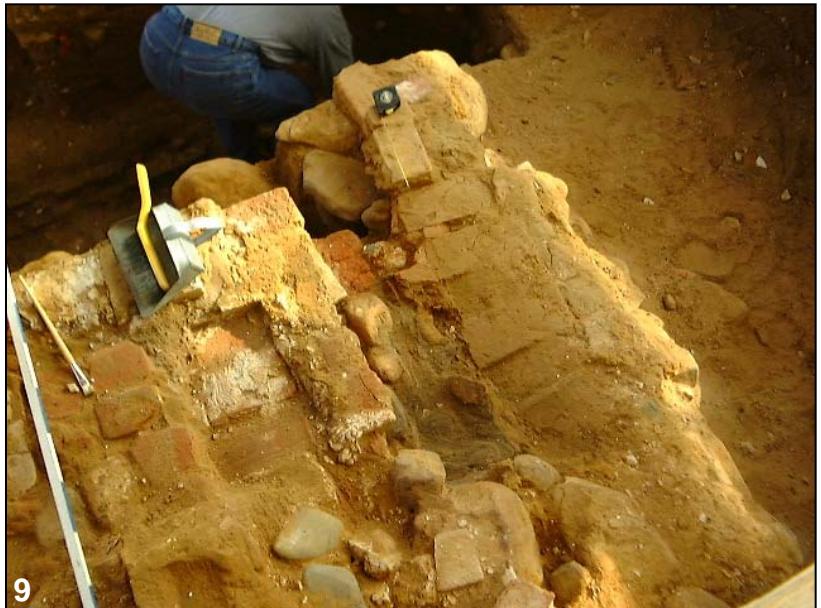
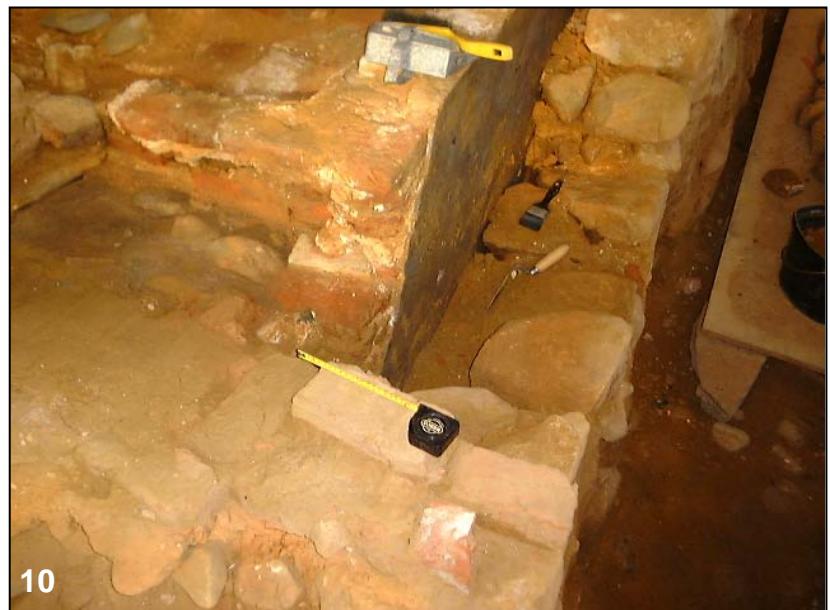
Traces of the second phase of steps which extended onto the rough stone wall shown here looking from above, and below from the front.

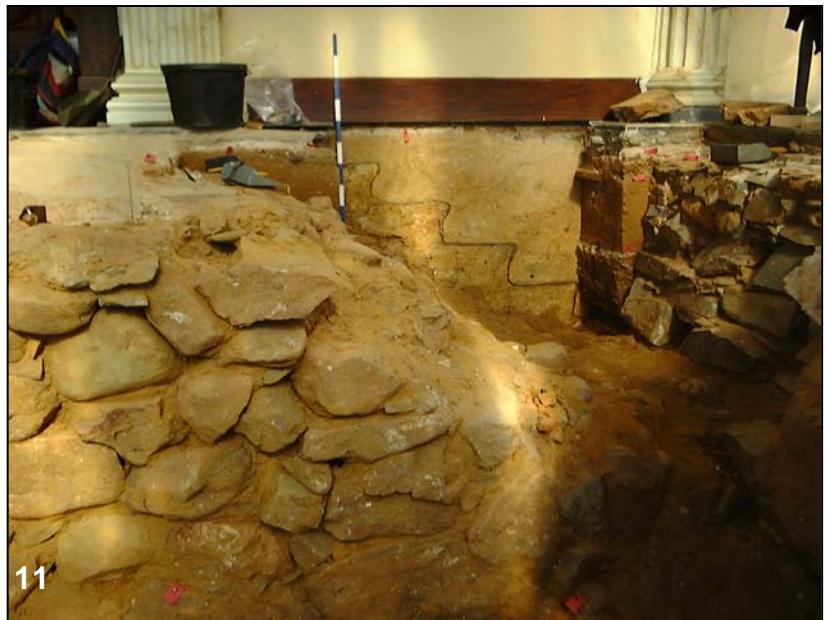
The rough stone wall angled down following the slope of the second phase steps. No finishes have been preserved however.

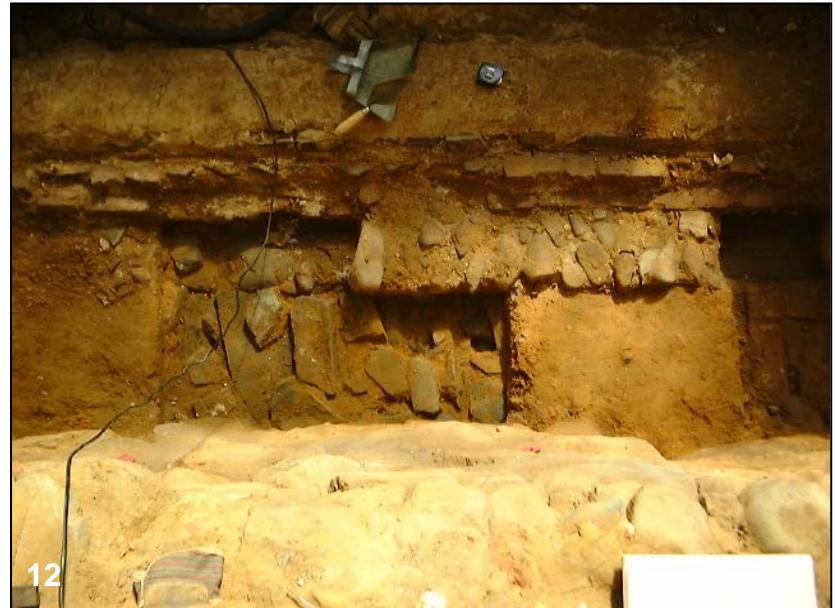
Foundation material was found immediately in front of the rough stone wall. This supported a facing wall probably made from yellow clinker bricks. A line of cobblestones originally was laid against the outer face of the clinker wall.

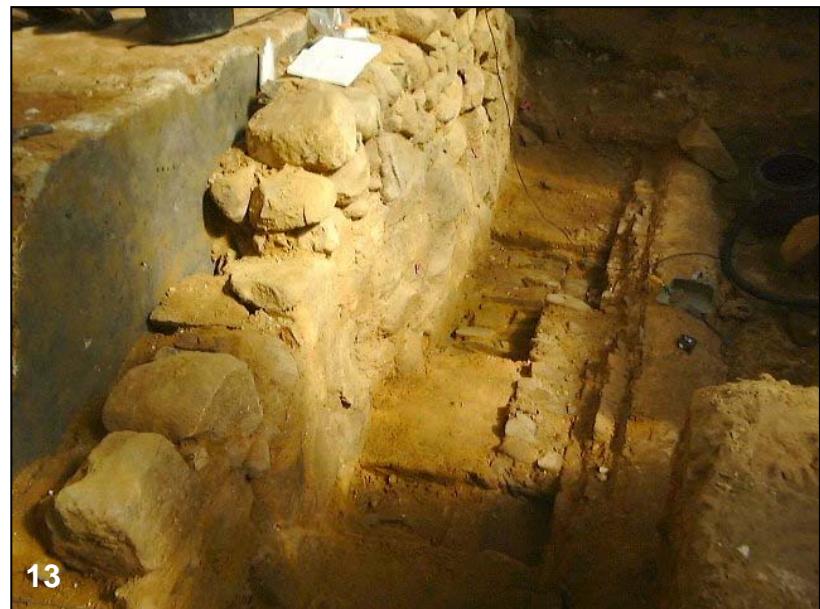
Line of cobblestones originally laid against the outer face of the clinker wall seen from the side. The plastered front of the original balcony, the rough stone wall of the second phase and the covered drainage channel can also be seen in this view.

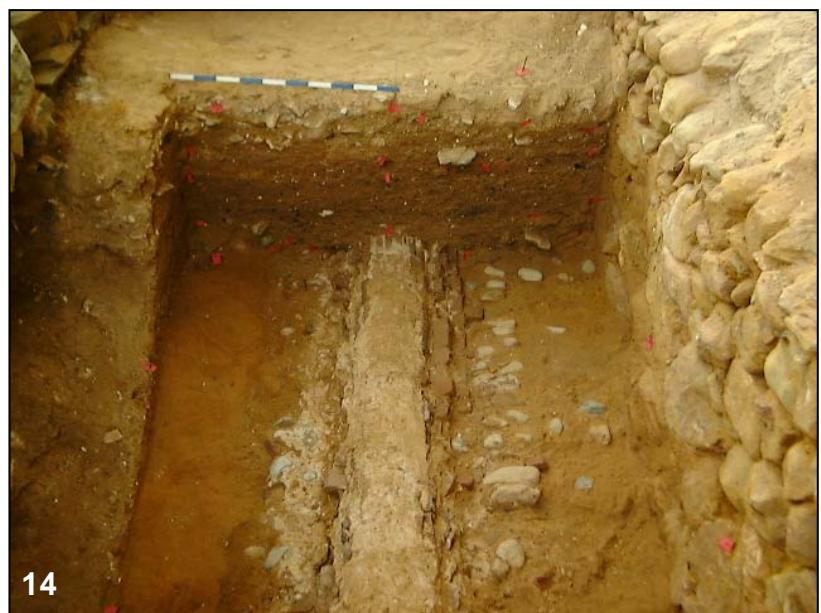
The covered drainage channel showing some of the fill added when the elaborate Kat balcony was constructed.
