# REPORT ON A STUDY OF A BUILDING, CNR OF HOUT AND BUITENGRACHT STREETS, CAPE TOWN

**Cape Town Heritage Trust**

December 1997

**Archaeology Contracts Office**  
Department of Archaeology  
University of Cape Town  
Private Bag Rondebosch  
7700

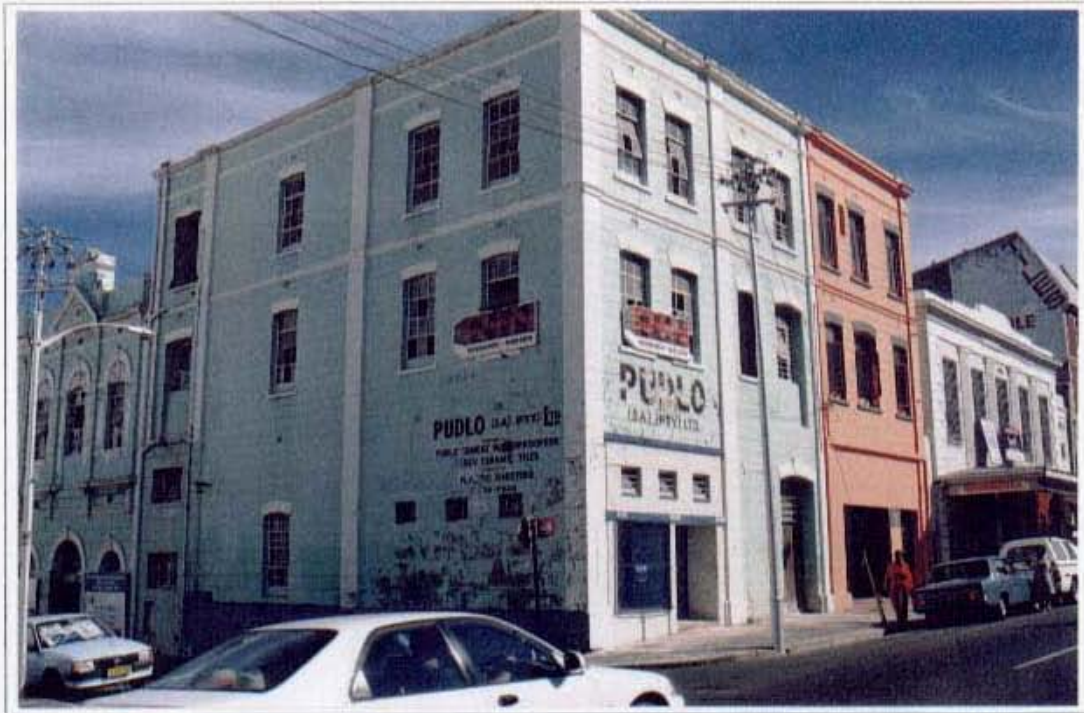
**PLATE 1:** Exterior view of building, corner of Hout and Buitentengracht Streets

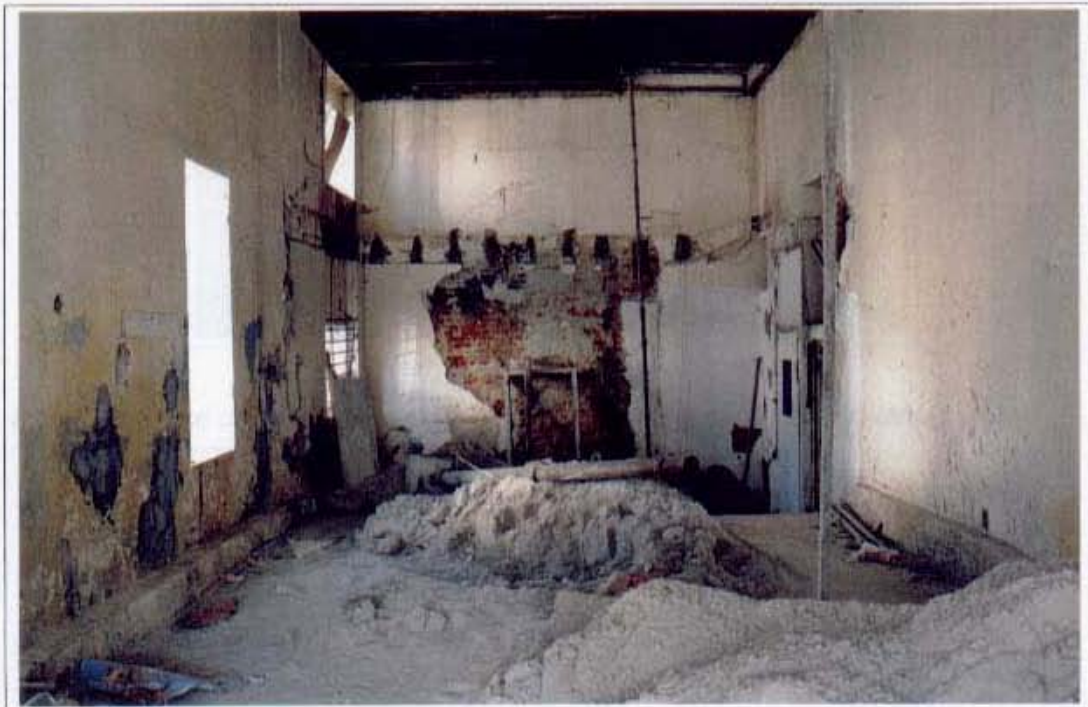
Plaster has not been stripped on this side but enough fabric is visible to determine that much of the left-hand room is 18th century (Plate 2). The rear wall shows evidence of a kitchen fire or hearth, furthermore the room is stepped down (with the fall of the land) and the resulting saving in head space used to create an *opkamer* above the kitchen. Beam slots are visible. The right hand room (left wall rear) shows evidence of 3 openings (Plate 3) with relieving arches - probably one of the original walls of the *gaandery*. In general the central core of the house has been demolished (pre 1862) to create two properties. The right hand wall of the right hand room is not original but nevertheless mid-19th century. Openings in this wall are

**PLATE 2:** Interior view (Hout Street side) showing soot blackened 18th century fabric, and beam slots (possible *opkamer* above).

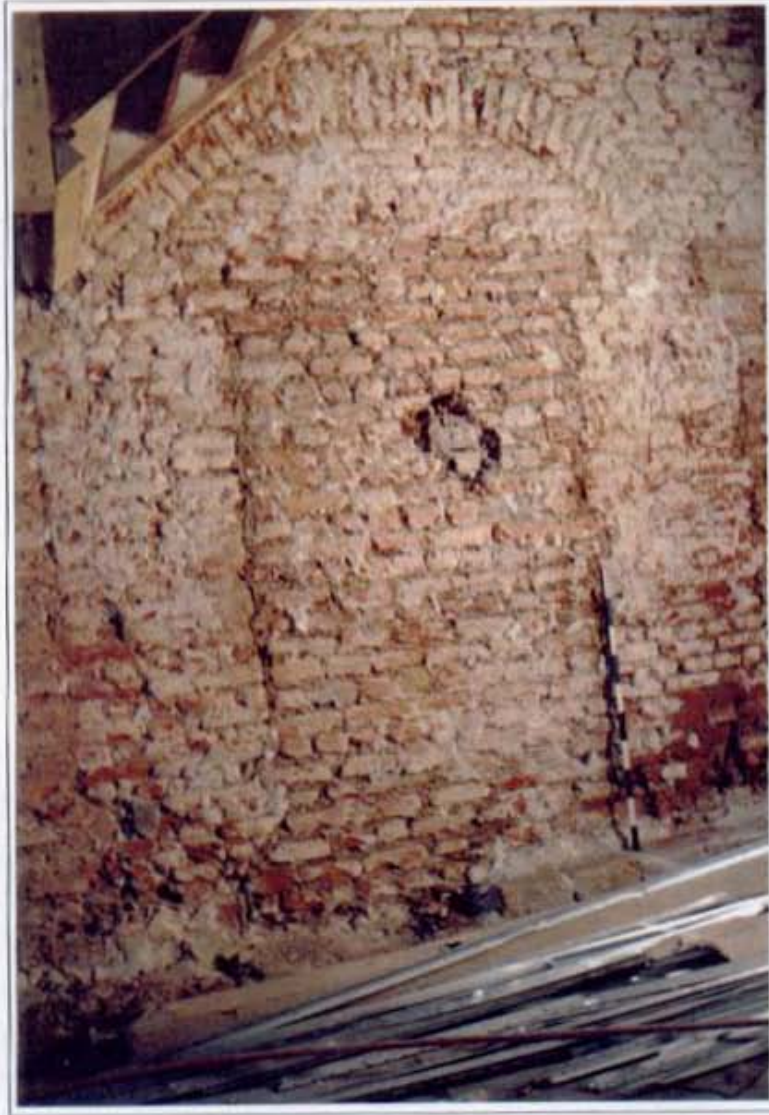
**PLATE 3:** One of three bricked up 18th century openings with relieving arches.

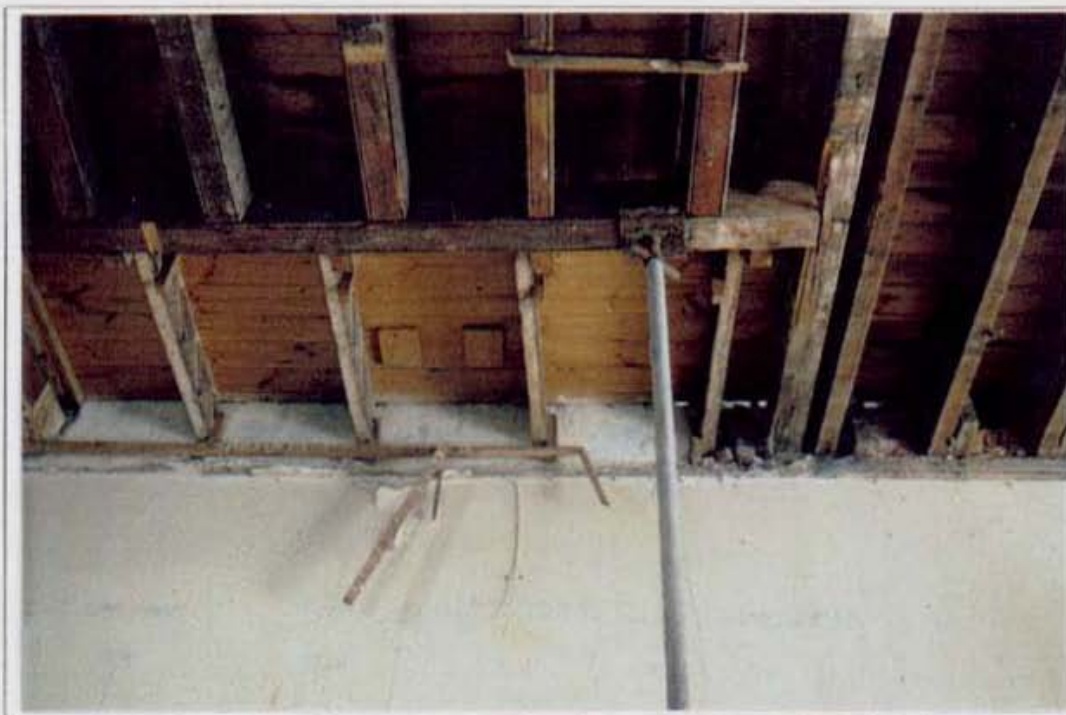
rudimentary with no use of relieving arches. Cosay who was evidently a jerry builder recycled a number of 18th century beams which are visible in the left hand room (Plate 4).

**PLATE 4:** 18th Century beams (Hout Street side) reused along with 19th-early 20th century pine.

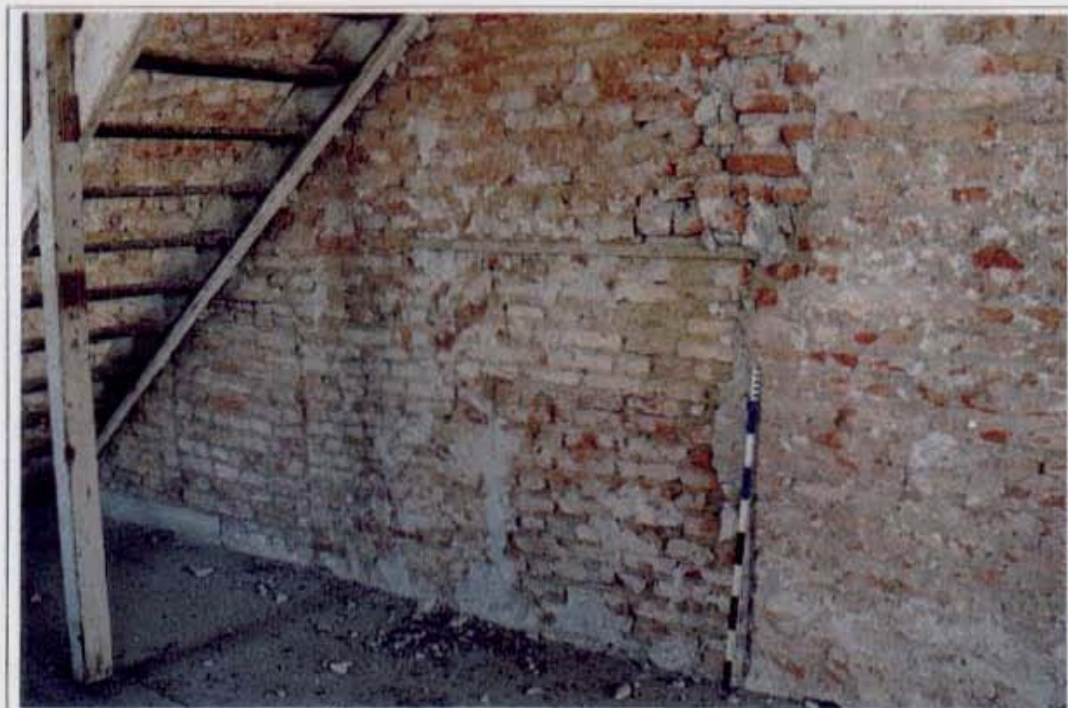
One of the major alterations Cosay undertook was raising the floor level of the first floor by 920 mm. This is evident by beam slots (bricked up) on the ground floor walls. There are also openings with lintels that extend across both levels which are evidence of previous floor arrangements (Plate 5). The right hand room shows clear evidence of a scar marking the position of the original internal dividing wall (Plate 6). This however, extends to only half the height of the first floor showing that the second floor has also been raised by at least 1000mm with recycled bricks. Several bricked up beam slots are also evident.

**PLATE 5:** Interior view, (Hout Street side) first floor showing early openings projecting through present (1902) floor levels.

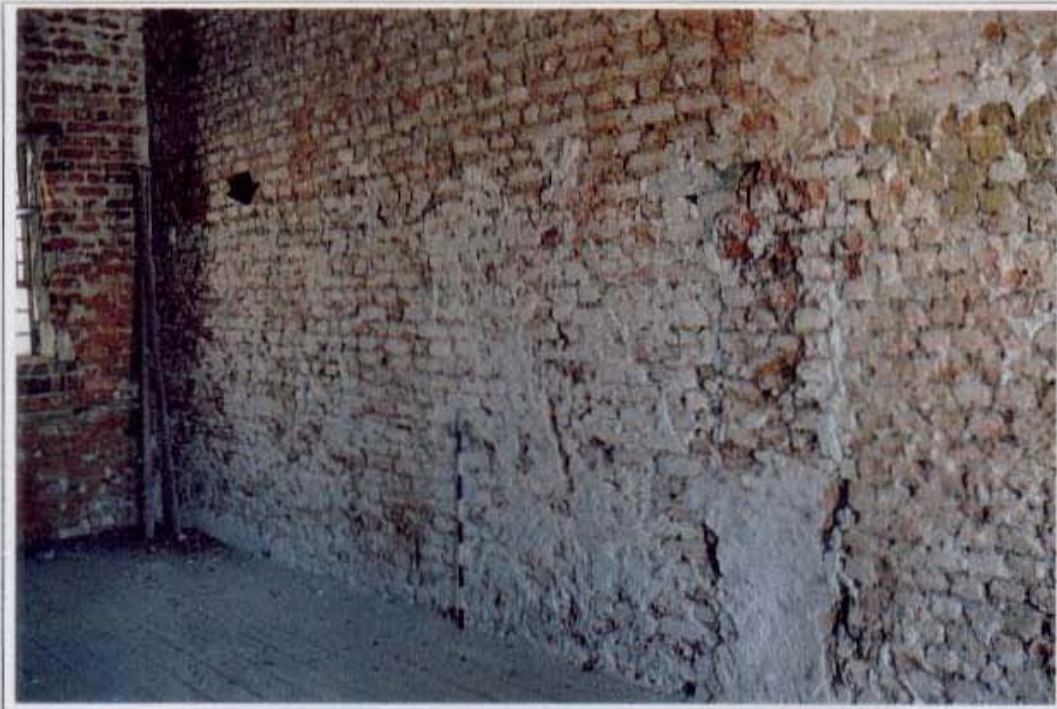
**PLATE 6:** First floor: the remains of the internal dividing wall is visible as a scar (right), while the change in brick work texture indicating a height raising event (1902) is indicated by an arrow.

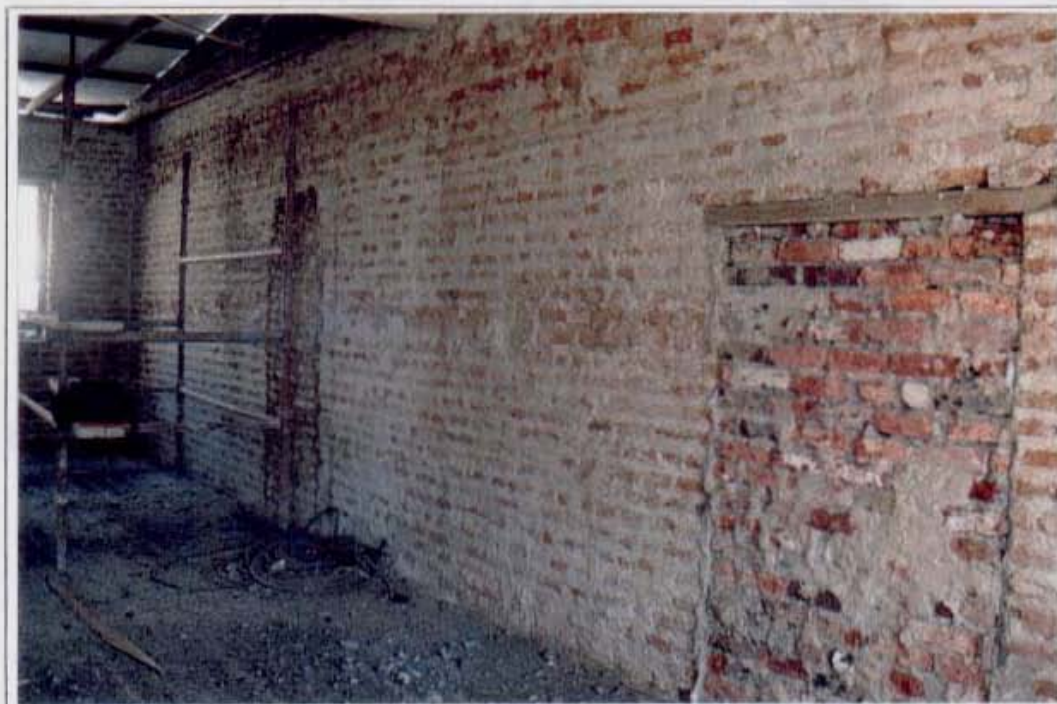
The second floors in both rooms have been added with non-standard bricks (recycled) but with cement based mortar (Plate 7). Some 18th century beams have been recycled to support parts of the roof as well as lifting hitches. The most interesting aspect of the second floor is the hand-operated 19th century lift. This is a unique artefact worthy of conservation (Plates 8 and 9).

**PLATE 7:** All of the brickwork on the second floor post-dates the turn of the century although extensive use has been made of recycled 18th and 19th century fabric.

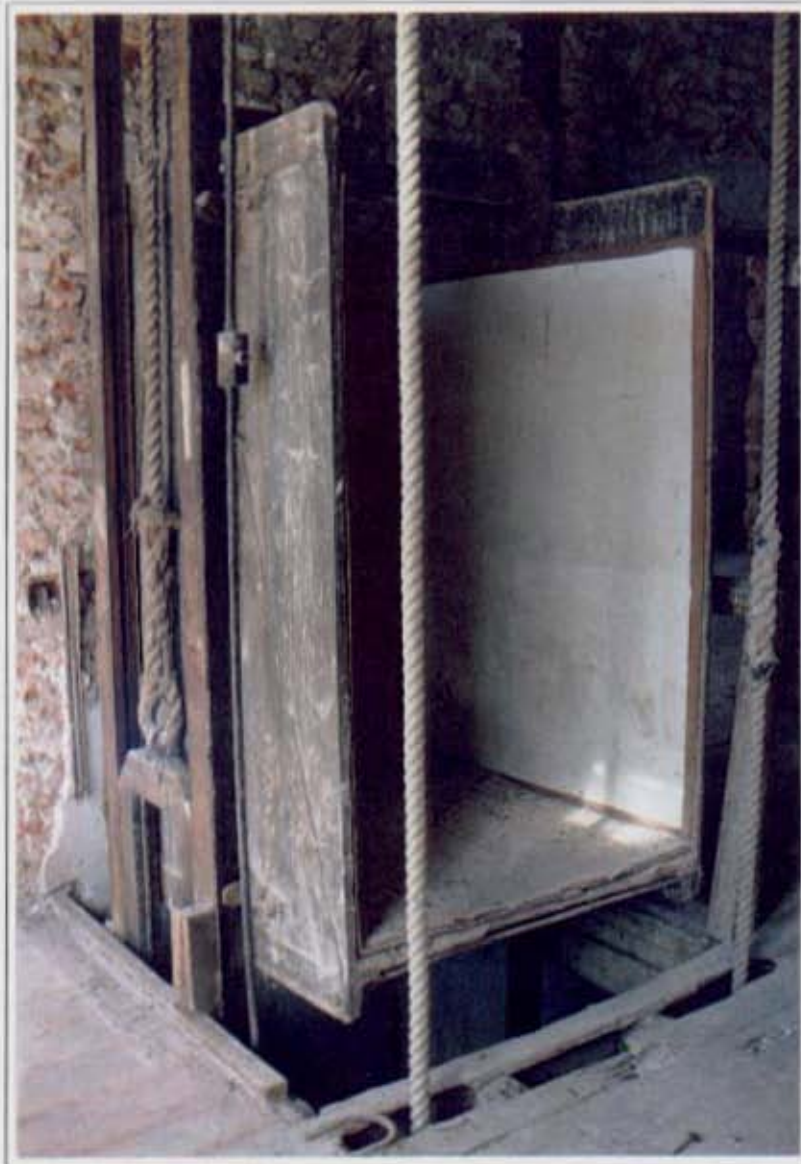
**PLATE 8:** View of the simple rope operated lift.

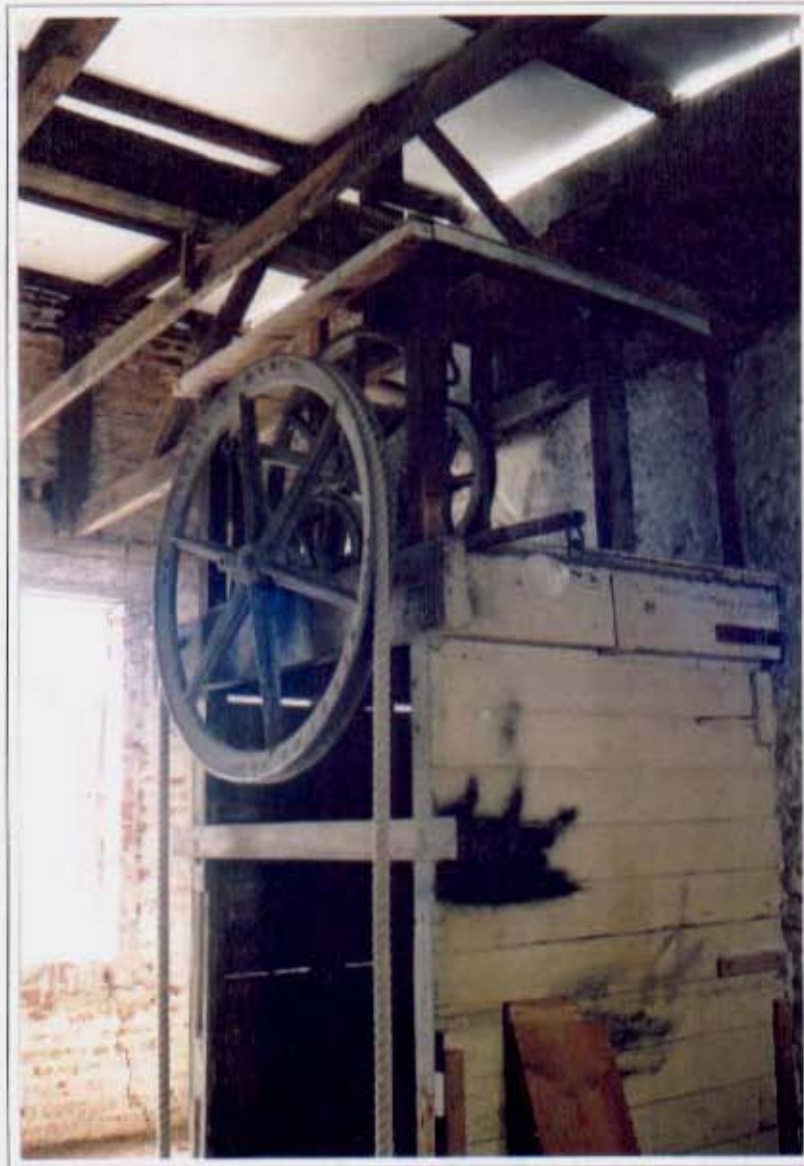
**PLATE 9:** Winding mechanism of the rope operated lift which is still in working order.
