AN INVESTIGATION OF THE SO CALLED “WELL” IN THE COURTYARD OF MARTIN MELCK HOUSE: STRAND STREET, CAPE TOWN

Gabriël Fagan Architects

May 2001

Archaeology Contracts Office

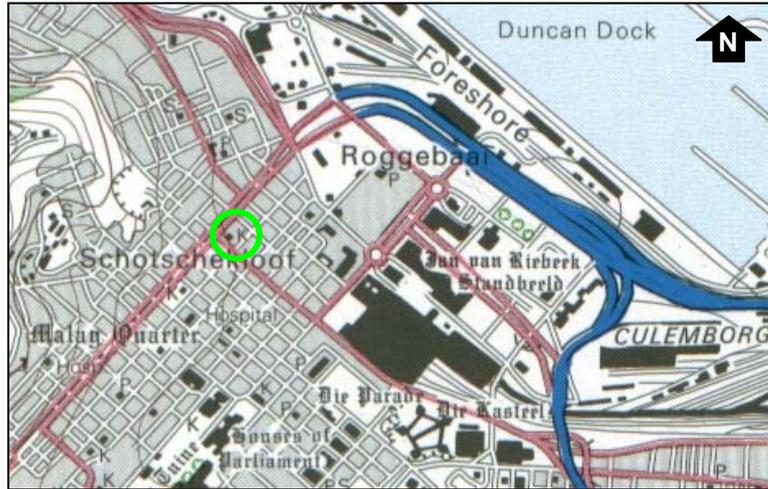
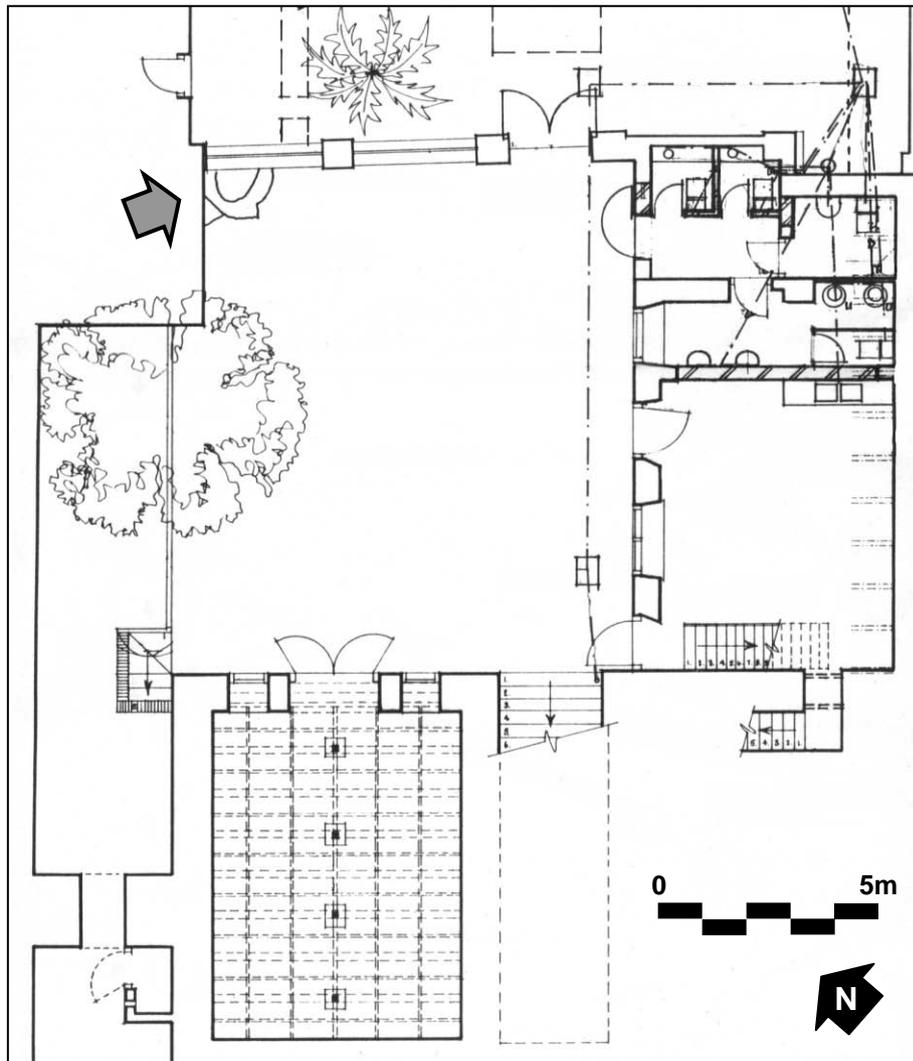
1

Location of the “well” in the courtyard of Melck House

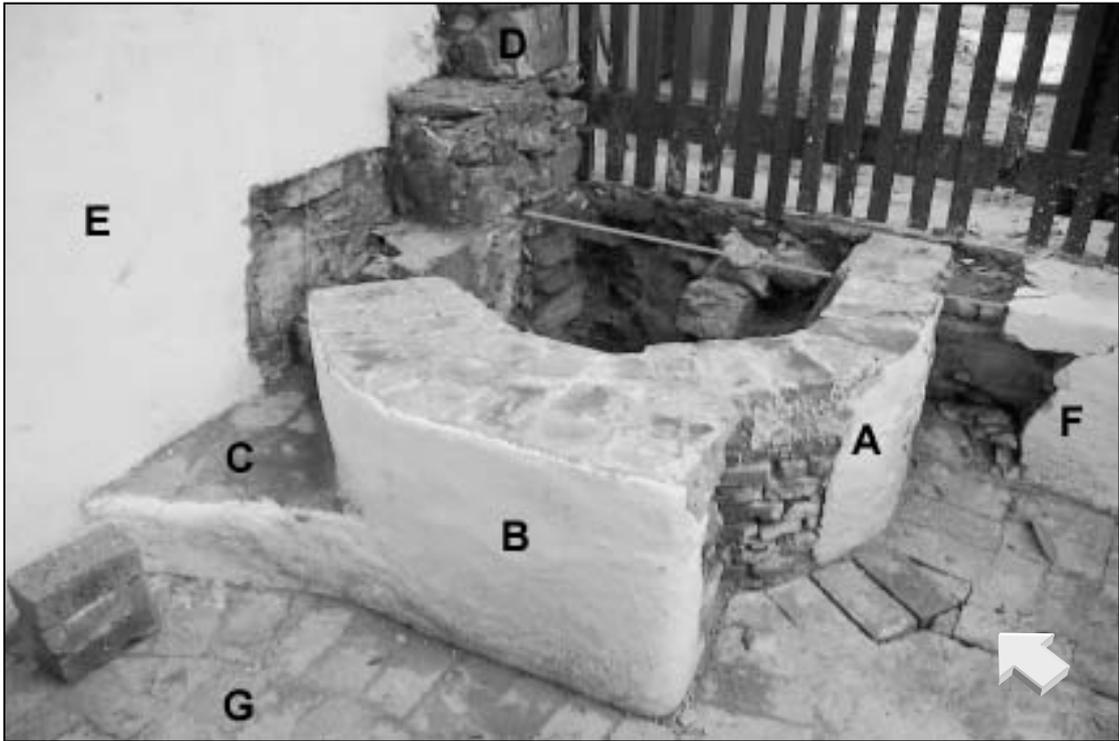
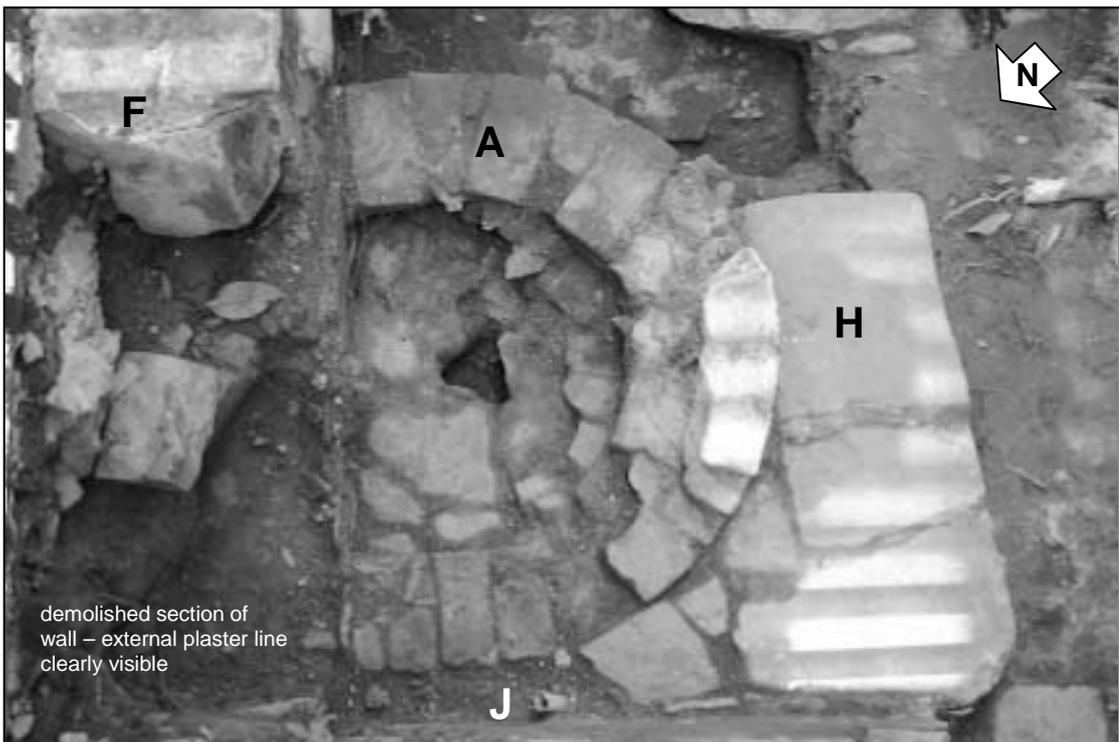
2 Structural components of the courtyard feature: Melck House

Figure 2 shows the structure with the interior plaster removed and external plaster removed from strategic areas where it was necessary to determine if structural components locked together. Various parts of the feature have been labeled to aid discussion. Additional views of the structure can be seen in the 6 photographs at the back of the report and should be viewed in conjunction with Figure 2. The exposed surface brickwork to a depth of three courses on (A) and (B) was recently done using modern cement.

- A** Maroon klinker brick structure with lime mortar.
- B** Red sun dried brick structure with mud mortar.
- C** Brick infill.
- D** Stepped stone structure abutting butters wall (E).
- E** Butters
- F** Courtyard dividing wall built with stone and plastered originally with lime plaster. Grey line shows where wall has been demolished.
- G** Modern brick paving.
- H** Original courtyard paving.

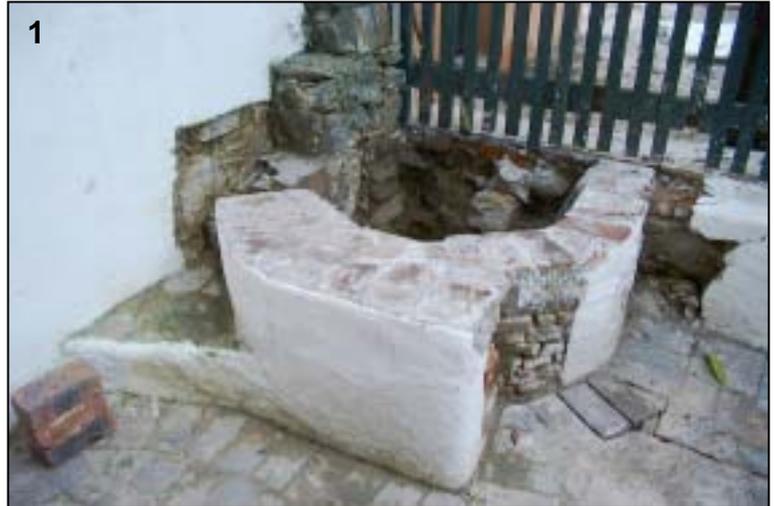
View of the structure looking north.

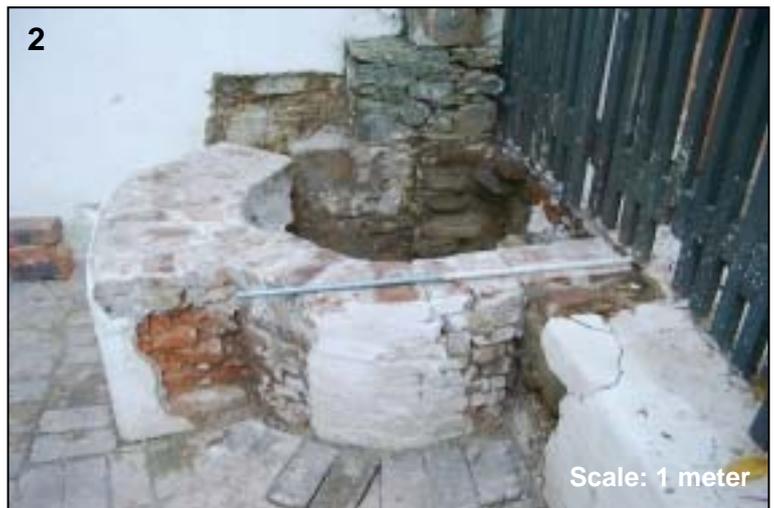
View of the structure looking west.

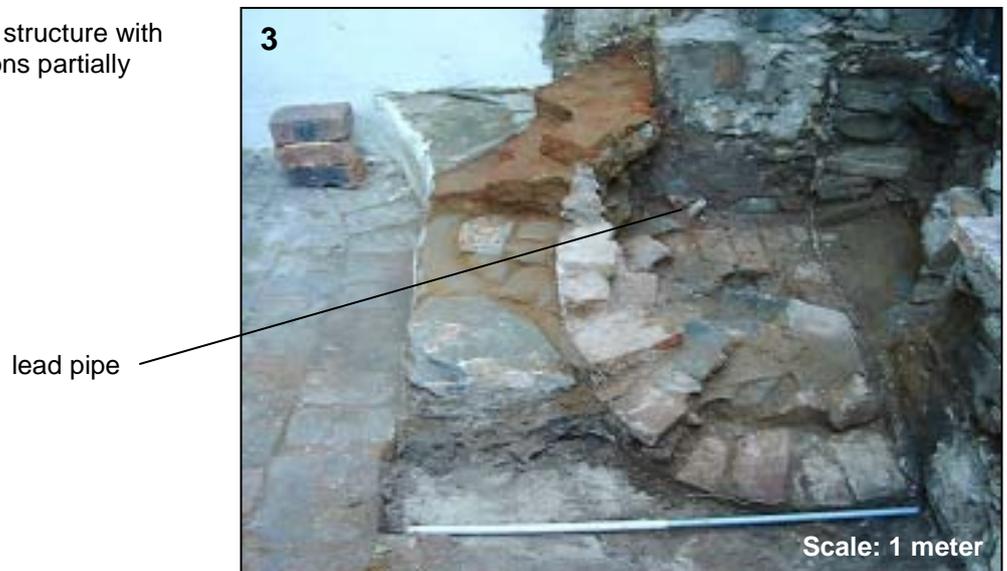
View of the structure with later additions partially removed.

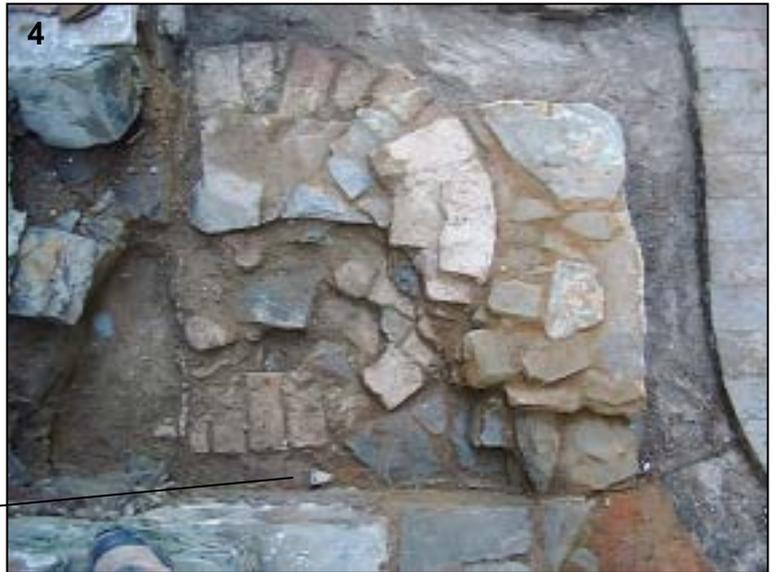
View of the structure from above with later additions partially dismantled.

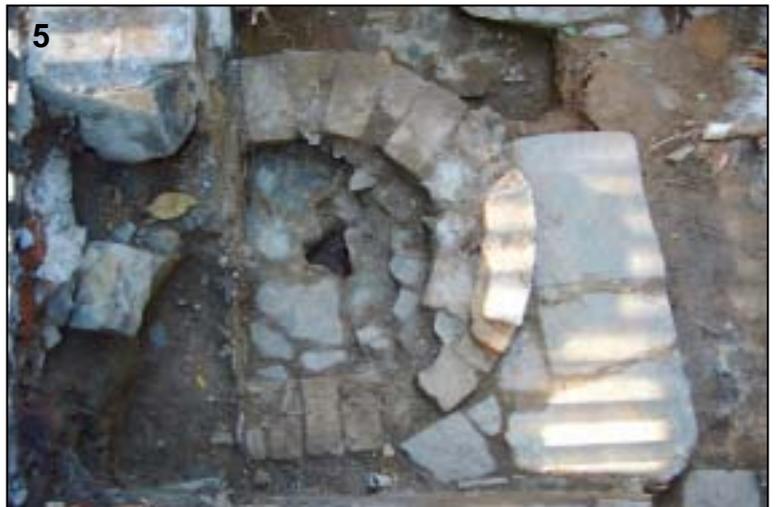
View of the structure from above showing *in situ* paving at right and stonework at the base of the feature.

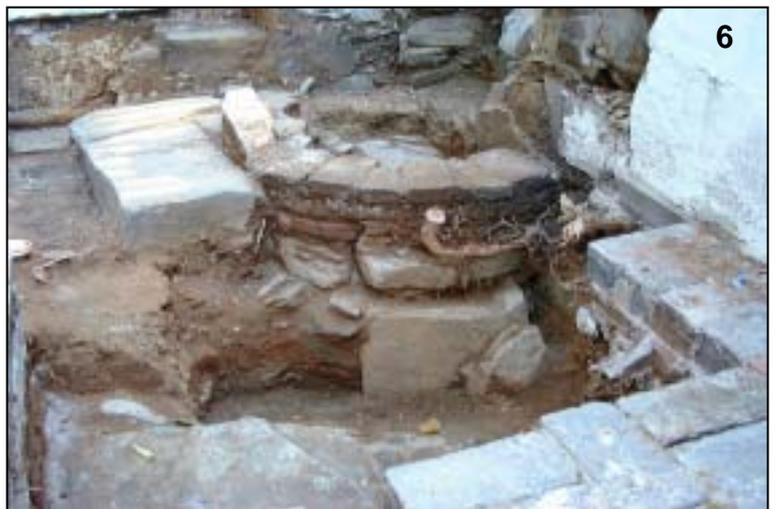
any link between the few remaining bricks on the west and those on the east as a result of the incorporation of (A) into the later structure (B). When we dismantled (B) it became very clear that a semi-circular structure was present built primarily from red/maroon klinker bricks with dimensions (230x110x42mm), secured with lime mortar. Toward the bottom were also some bricks with dimensions (200x80x45mm). The exterior view suggested that the structure was built entirely of brick, when in fact exposure of the interior showed that rocks and brick fragments had been used in most places and what was visible from outside was mostly a façade of brickwork. The roughness of the construction on the interior suggests that either the feature was never intended to be open on the inside, or, that an earlier, neater construction which had been open, was partially demolished and later rebuilt for a slightly different purpose. The structure is seated on a foundation consisting of a single course of rocks (Plate 6). The base of the feature consisted of a “paving” of stone. The klinker appears to have been laid on top of this “paving” which can be seen projecting below the wall in Plate 6.

View of the below ground parts of the structure looking west. In situ paving stones at left.
