# **AN PHASE 1 ARCHAEOLOGICAL ASSESSMENT OF A PORTION OF ERF 1938, MOUILLE POINT**

Prepared for  
**Cape Technikon**

July 2004

Prepared by  
**D.J. Halkett**

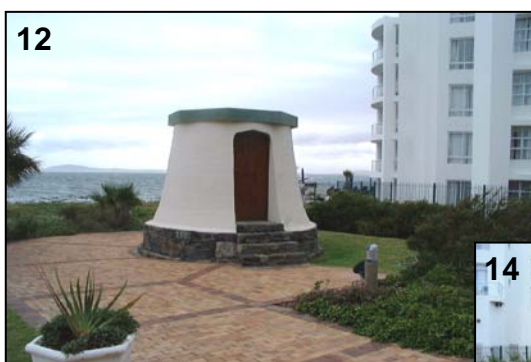
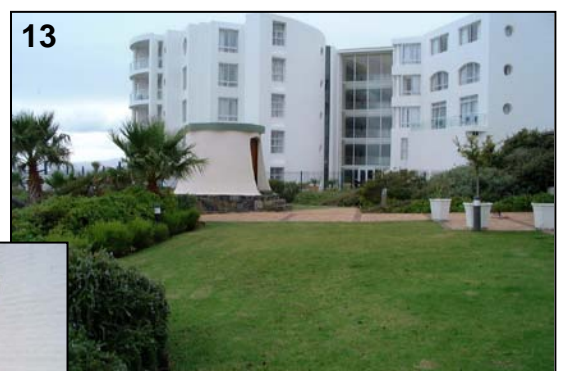
The light unit was probably removed at that time, but the base and part of the tower survived demolition and can still be seen on the site today (Plates ?- ?).

Some consideration should be given to fully excavating the base of the old lighthouse and interpreting the historic features by way of appropriate signage.

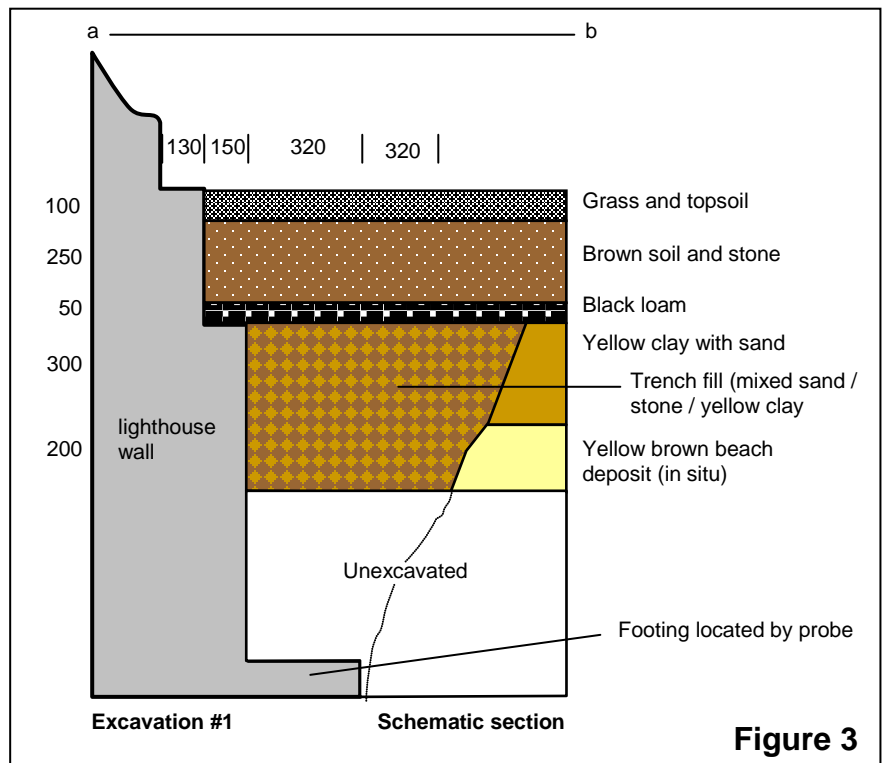
**Figure 3**

We found *in situ* ground at approximately 400mm below present ground surface. There was clear evidence of a foundation trench cutting through these deposits. We use the term *in situ* loosely here as the ground through which the foundation was excavated consisted of a layer of material some 300mm thick relating to human activity (believed to be the construction and use of the fort) that lay immediately above old beach deposit (yellow/brown sand with marine shell). The latter is truly *in situ*.

Indications are that the present surface is approximately 300mm above the historic surface.

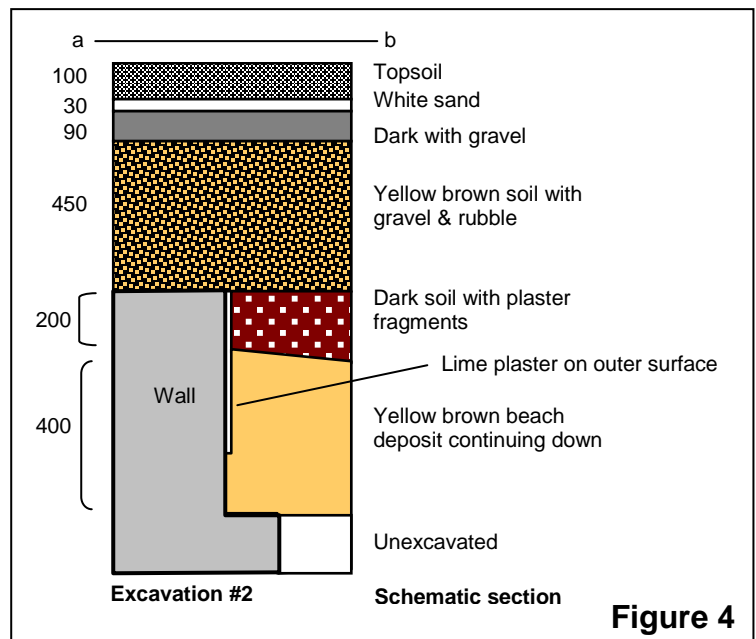
**Figure 4**

The schematic sections presented in Figures 4 and 5, show the position of the remains in relation to present ground level. Worth noting is the presence of a well preserved layer of lime plaster on the seaward side of the wall above the foundation step. The foundation was dug into beach deposits in exactly the same way as with the later lighthouse.

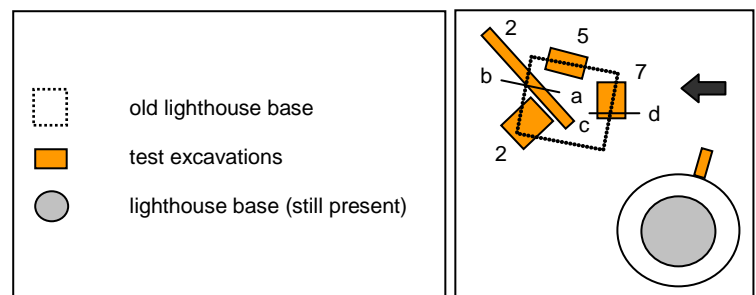
**Figure 5**

in test hole 7, that foundation steps are present on both sides as indicated in Figure 5.

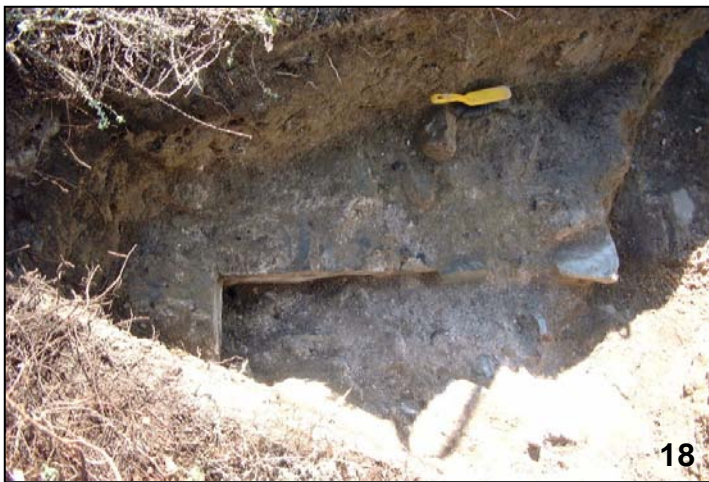
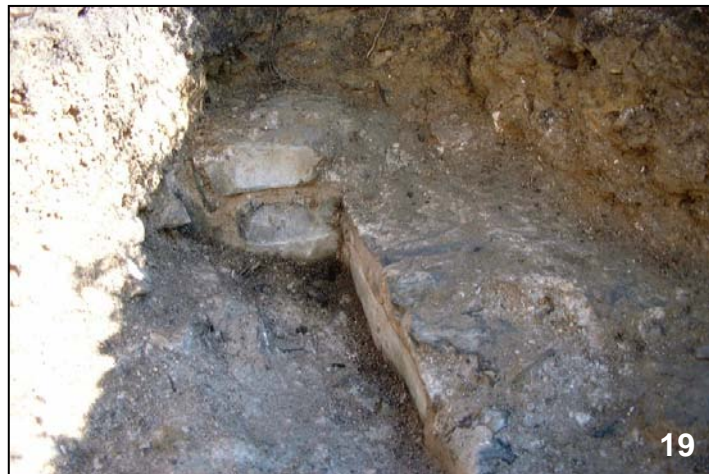
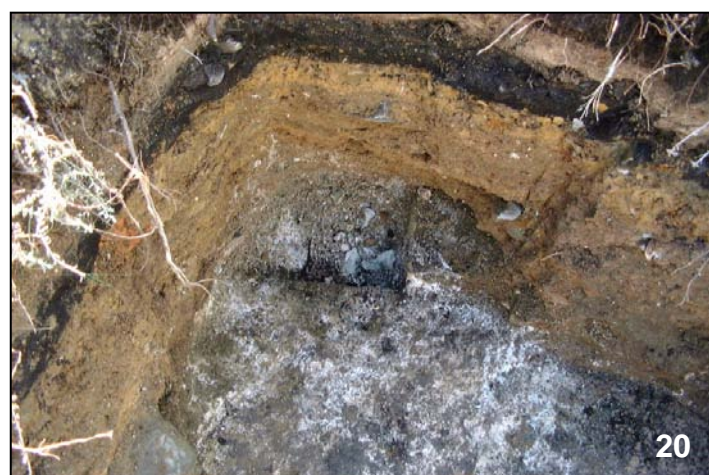
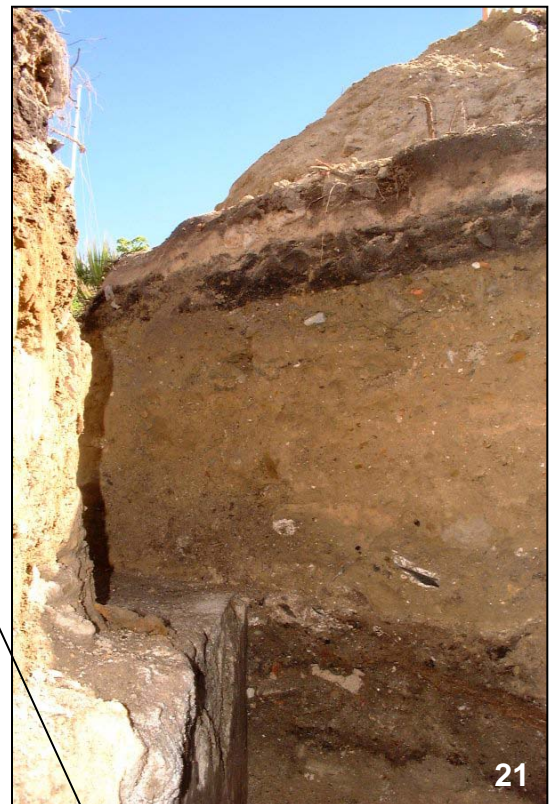
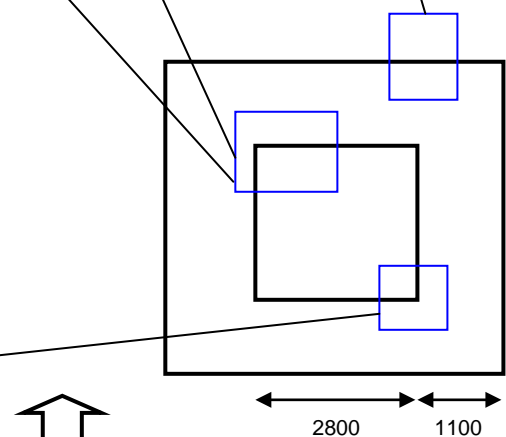
Schematic depiction of the lighthouse base showing strategic features that were intercepted.

Part of the exterior wall (east side) was exposed in hole 5. The wall alignments in holes 5 and 2 meant that we could estimate the NE corner (outside). By adding the wall width measurements we were able to plot the entire base. An accurate drawing showing the old

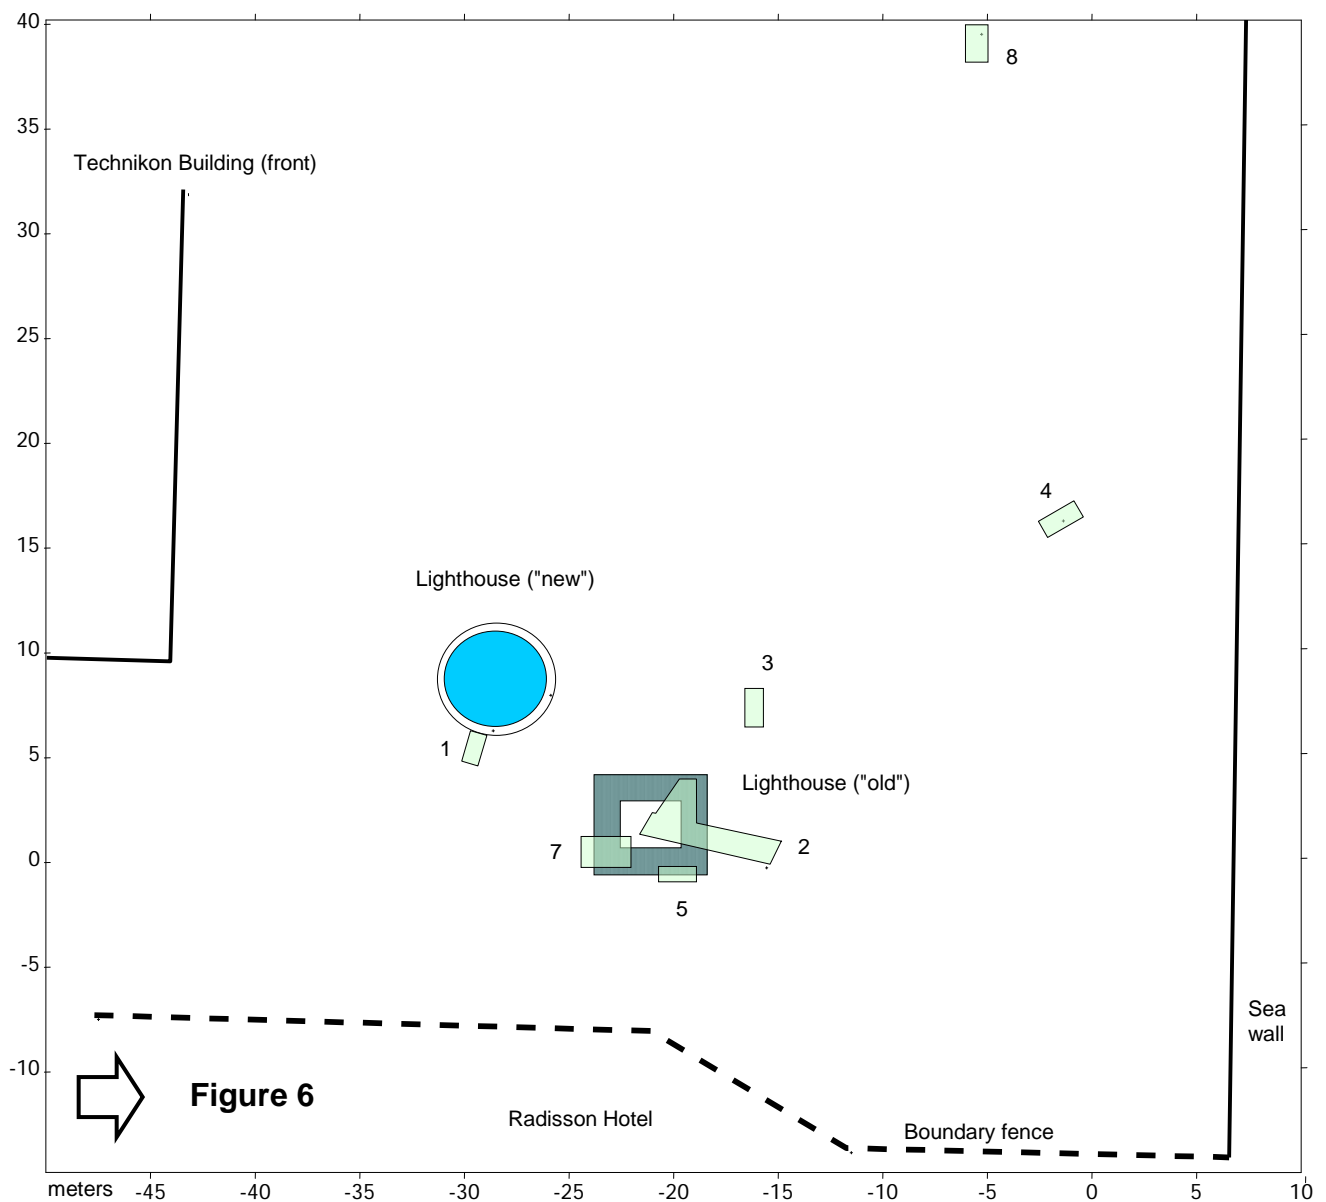
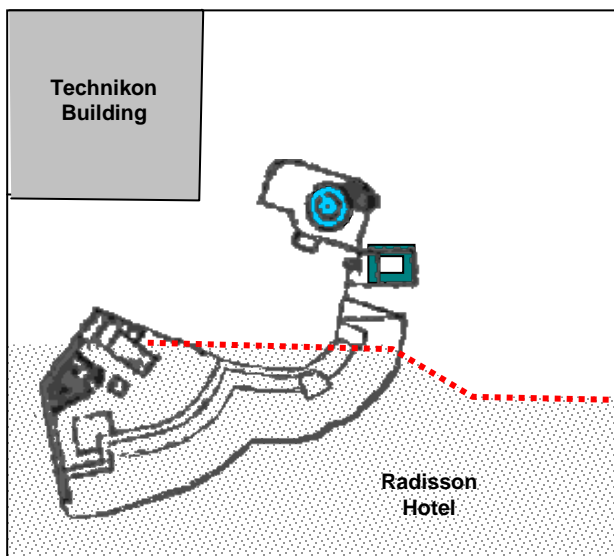
The above drawing shows features as surveyed. The smaller drawing at left shows the position of the Mouille Battery in relation to modern features. Although there may be some inconsistencies in the old plan, the fit between the modern surveyed positions of the lighthouses and those on the Wilson survey of 1878 is very good. The dotted red line shows the boundary between the Technikon property and that of the Radisson Hotel. It is clear that most of the fort lay to the west of the boundary and as such has probably been obliterated by the development.

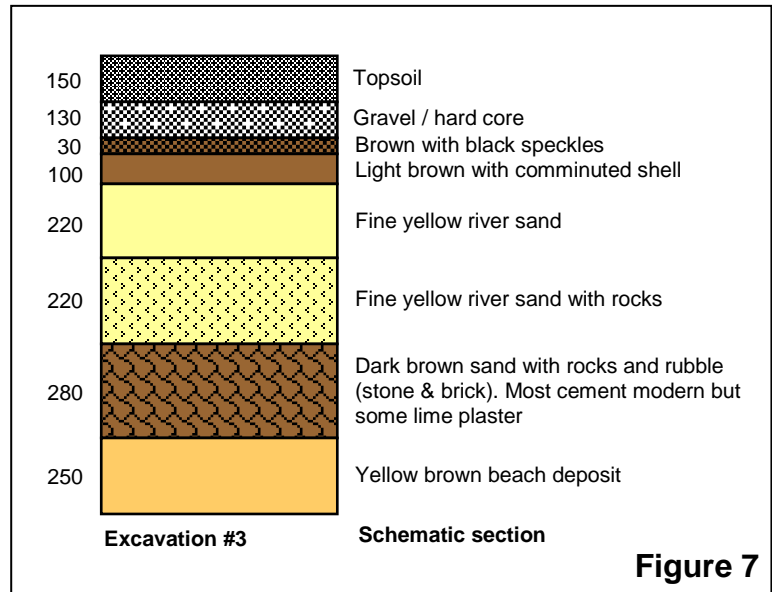
The location of the hole is shown on Figure 2. No structural remains were encountered in this hole. The profile in Figure 7 indicates several layers of fill lying above the *in situ* beach material.

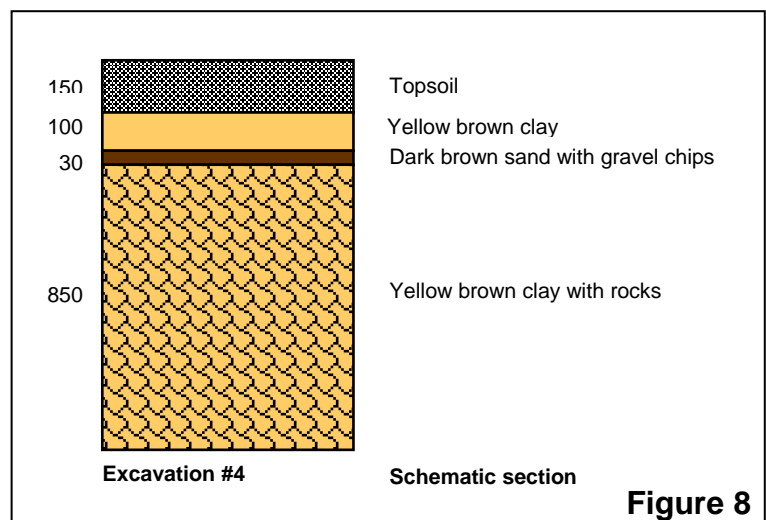
The location of the holes is shown on Figure 2. Being positioned towards the coastline, the holes are in an area that would have been active shoreline during the first half of the 19th century. We encountered no *in situ* deposits or any structural remains and the hole was abandoned. The bulk of the material consists of clay and rubble probably introduced at the end of the 19th century as landfill behind a sea wall. As both of the profiles are very similar, only the one from hole 4 is shown in Figure 8
