ARCHAEOLOGICAL EXPOSURE OF AN IRRIGATION CHANNEL, AVENUE HOUSE MOWBRAY

Prepared for

Trevor Thorold Architects

March 2001

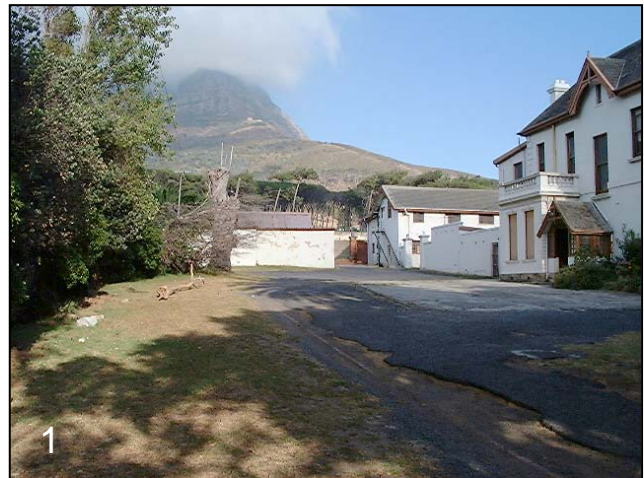
An initial site inspection of the Avenue House property revealed that the alignment of the canal was marked by a distinct depression along the south side of the garden as far as the outbuildings and rear yard to the west (Plate 1 shows the depression under vegetation at left). Close to Avenue Road, the depression leads to a modern cement and brick culvert to divert water under the road.

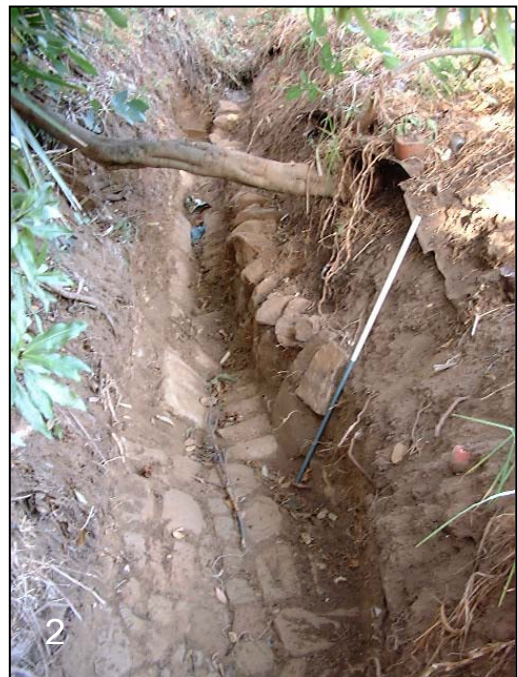
- The furrow exists between the avenue house outbuilding (west) and the culvert that diverts flow under Avenue Road (east). The actual length of surviving furrow is estimated to be 55m.
- The upslope section of the furrow between the outbuilding and the directly adjacent to the front of Avenue House (20m) is built from homemade concrete blocks arranged to form a "v" shaped channel augmented on the sides with quartzite (TMS) stones. (Plate 2 shows the concrete furrow leading into later cobble furrow). The upper portion of the channel is quite deeply buried and lies at a depth of 700mm - 1200mm below the current land surface.

- The west section of the furrow built from concrete blocks represents a later building phase. It is desirable that as much as the furrow be conserved as possible, however, if sections of the furrow need to be demolished it is best that the concrete block portion be sacrificed rather than the cobbled portion.

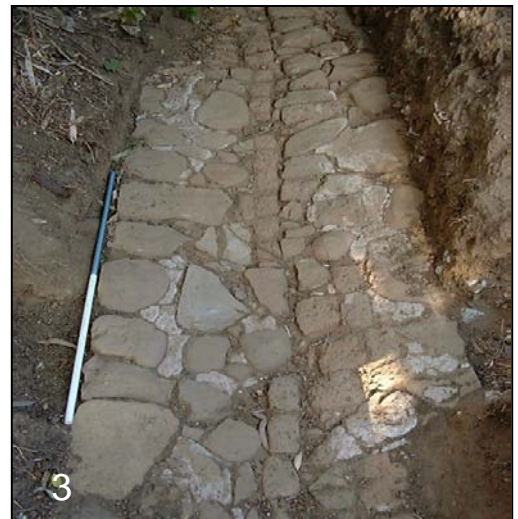
- At a point adjacent to the front of Avenue House the construction method of the furrow changes to a cobble base of shallow "V" form some 750mm wide.

In some places lime mortar can be seen indicating a possible 18th century date. (Plate 3 shows a detail of the cobbled furrow).

- The cobble furrow shows much evidence of repair with a variety of materials ranging from Dutch bricks, English frog bricks and Portland cement. The most easterly (lower 30m) section of the furrow has a curved base and also shows evidence of lime mortar and repairs.

- The stretch of cobbled furrow between the Avenue Road culvert and adjacent to the front of Avenue house is best suited to conservation on account of its original quality.

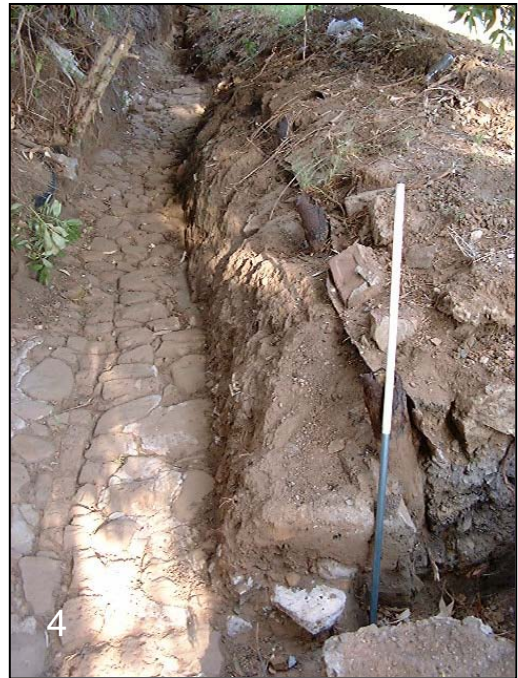
- There is good evidence that soil has been transported onto the site to raise the garden level of Avenue House. In the lower (east) section, the soil has been held back from the furrow by a corrugated iron shoring, fragments of which are still visible, but highly corroded. Furthermore there is an appreciable difference in elevations between the land surface of Avenue House Garden, and the property to the south, which is lower. (Plate 4 shows the corrugated iron sheet behind 1m scale).

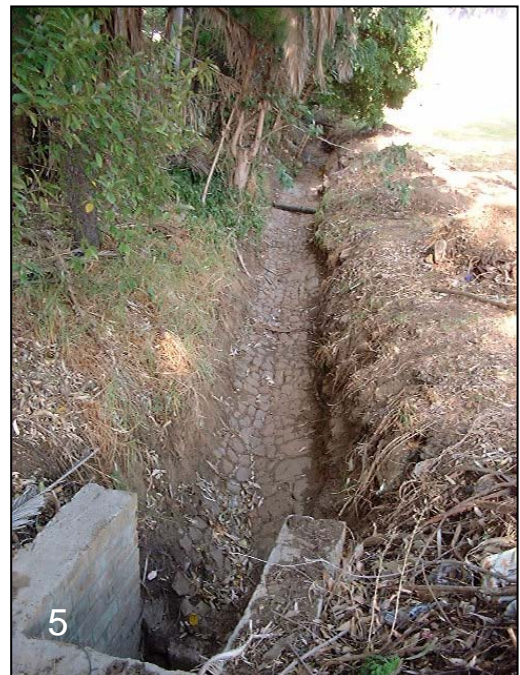
A well-preserved portion of a cobbled irrigation furrow exists along the southern boundary of the Avenue House property. The furrow was probably built during the 18th century to lead water off the slopes of Devils Peak into what used to be parts of the old Welgelegen agricultural lands, now occupied by suburban Mowbray. Thus, the remaining portion of the furrow symbolises Mowbray's rural origins and is therefore a heritage resource of local significance. (Plate 5 shows a view of the furrow from the culvert, westwards).
