INVESTIGATION OF STONE STRUCTURE: LANGEBAAN COUNTRY CLUB

Langebaan Country Club

July 1993

Archaeology Contracts Office

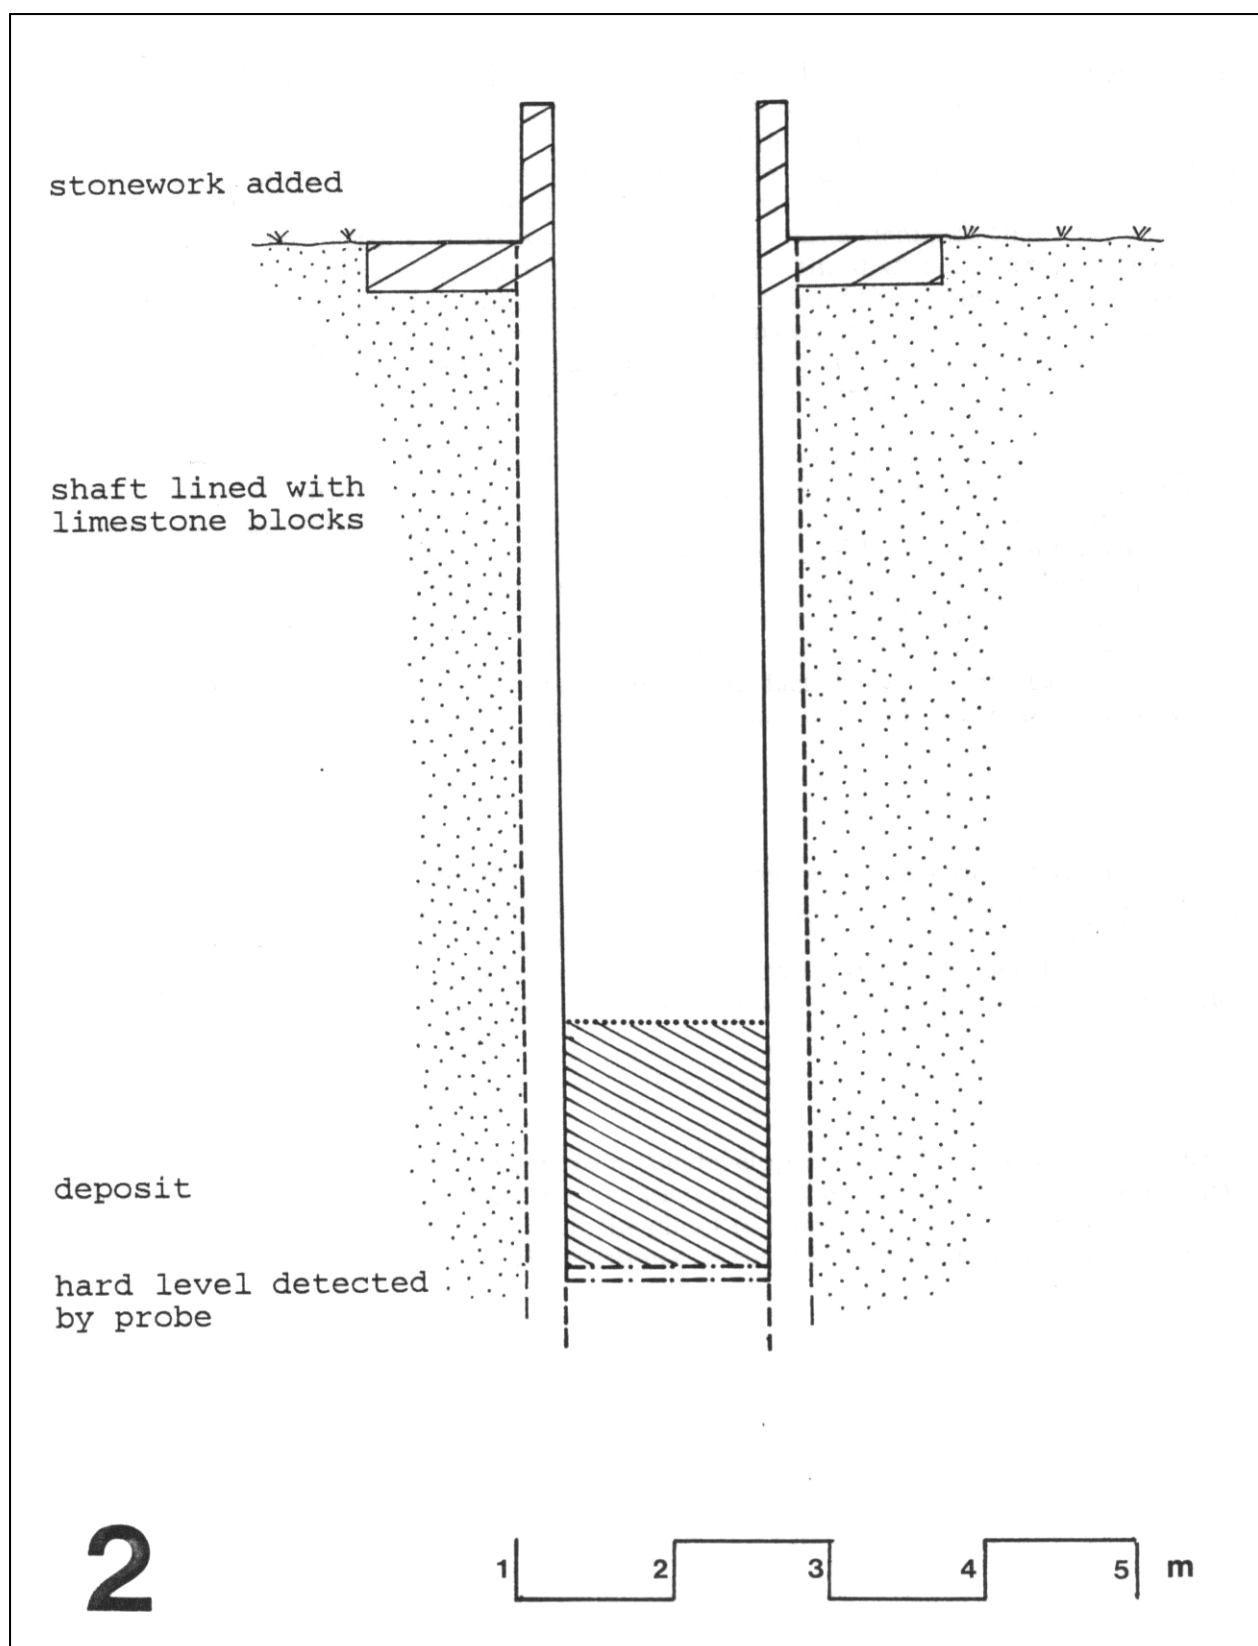
A schematic section of the structure is presented in Figure 2. With the use of a long ladder a descent was made into the shaft after an inspection from the surface satisfied us that the sides were stable. The shaft which has a diameter of approximately 1.3 meters is constructed with limestone chunks, none of which appear to have been specifically dressed for the construction. It would appear however that flatter faces or edges have been selected to face onto the shaft. No mortar is observed between the blocks in the original part of the shaft. The addition of blocks at the surface, and the platform surrounding the shaft have been built with cement.

Because the blocks are not dressed, large gaps occur between the stones. Through these gaps more stone is visible. It appears that this is a rubble packing behind the facing stones in the shaft. The groundsman had earlier commented to us that while building the addition at the top of the shaft he had noticed that a "pavement" of limestone chunks extended some distance around the perimeter of the shaft. This may have been the top of a surrounding rubble packing which extended the length of the shaft but it is not possible to confirm this without conducting more substantial excavations. There were no indications that any fixtures had been attached to the walls of the shaft.

Deposit was encountered in the shaft at a depth of 6 meters from the present lip. Two small test pits were dug to a depth of approximately 0.5 meter to reveal a uniform, light gray, sandy deposit. From this point a steel probe was pushed down into the deposit at various places to try and establish an approximate depth of the feature. On four occasions we had refusal at depths ranging between 1.6 and 1.7 meters below the upper part of the deposit. When the probe was withdrawn on all these occasions no indication of a water table was evident although dampness was detected. This dampness is probably due to precipitation from the surface not being evaporated in the depths of the shaft. Probe refusal was against a hard surface or objects. It is not possible to say with absolute certainty that this is the stone base of the structure without more excavations being conducted in the shaft.

The structure is not in any danger from the development of the area and has in fact become a feature of the site at hole 4. As such no further mitigatory action on our part is necessary. It remains the option of the client to commission further investigation of the circumstances surrounding the existence of the well should it be deemed necessary.
