# **Inspection of Destruction of Archaeological Deposits and Archaeological Impact Assessment of Further Construction Related Activities**

**11 Diaz Road, Jeffreys Bay, Jeffreys Bay Magisterial District,  
Eastern Cape Province: Construction of Residential Units**

**Lamprecht Properties (Pty) Ltd and the South African Heritage Resources  
Agency**

**Peter Nilssen**

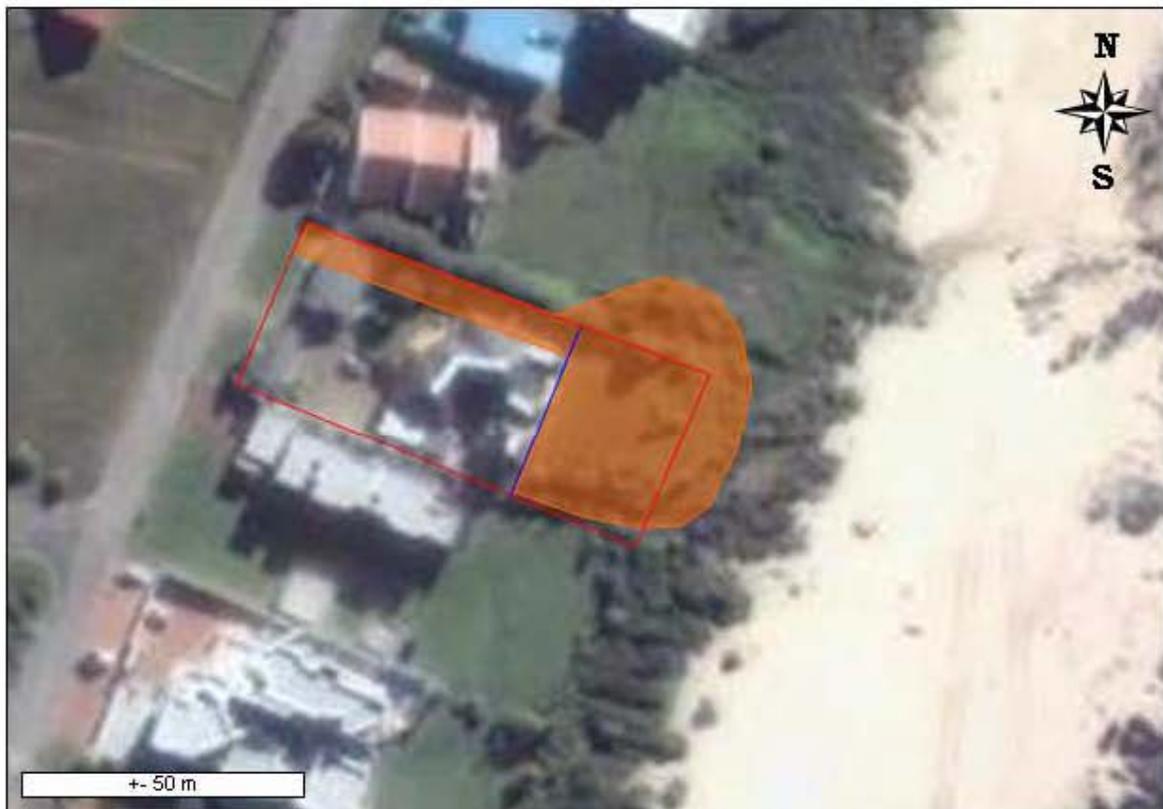
Archaeological materials were identified on the ground surfaces in the vicinity of the storm water piping and in the eastern portion of the property as indicated with orange shading in Plate 2. Note that the orange shaded area in Plate 2 is a schematic representation of the affected area that was not surveyed accurately. Archaeological materials consist mostly of medium to low density scatters of fragmented marine shell (Plate 7). Species noted include brown mussel, whelk, alikreukel, perlemoen and a variety of limpet species. Several shell fragments are burnt. While a few stone artifacts were recorded, only three fragments of animal bone were identified and are rare (Plate 8). No Cape coastal pottery was seen. Other cultural remains including modern materials such as plastic, glass, ceramic and building rubble are present and mixed up with archaeological remains. The mixture of material remains from temporally separate occupations indicates that prehistoric archaeological material visible on the ground surface is in secondary context. Careful examination of exposed profiles revealed that, at the time of this inspection, no archaeological materials are visible in primary context.

Plate 2. Enlarged area as indicated in Plate 1 showing the approximate outline of 11 Diaz Road in Jeffreys Bay (red). Left and right of blue line are western and eastern portions of the property respectively.

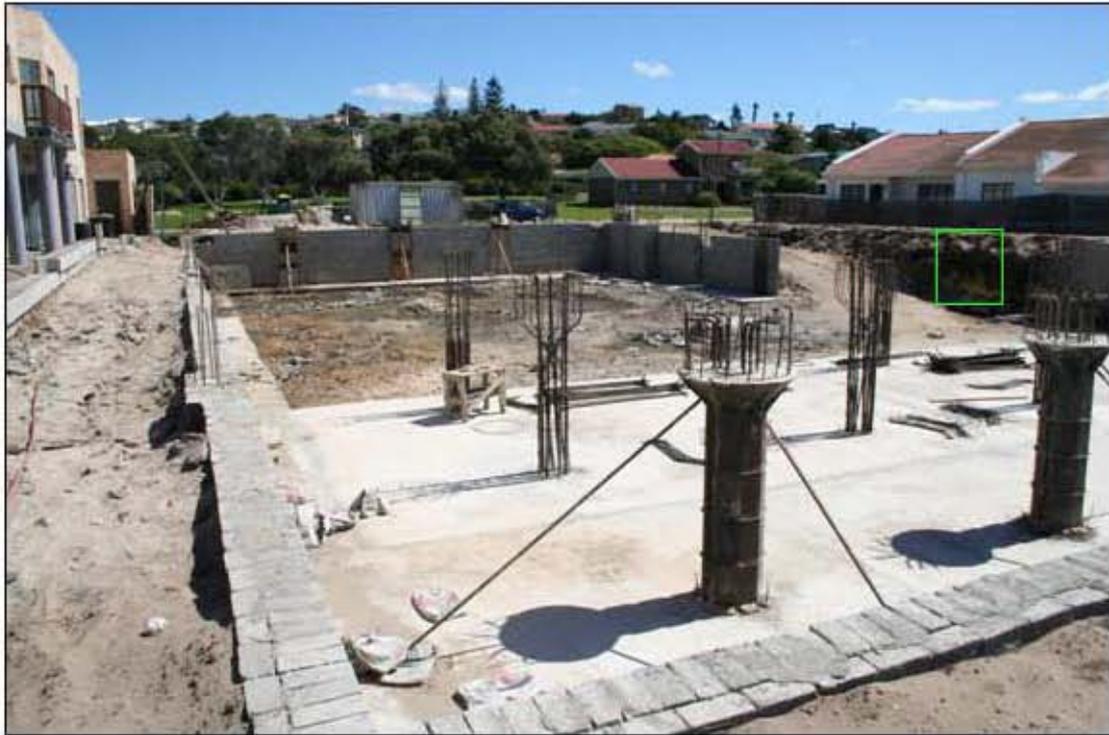
The western portion of the property consists of a partially constructed basement excavated through mostly soft sediments and partially into a hard shale bedding (Plates 2, 3 & 4). The profile in Plate 4 shows layers of - from the bottom up - shale, ancient beach (probably mid Holocene), calcrete and topsoil. The eastern portion of the property is a leveled area that’s surface consists of a mixture of sands and soil and that lacks vegetation (Plate 5). In an east-west trajectory along the northern extent of the property is where Lamprecht Properties (Pty) Ltd installed storm water piping under instruction from the local municipality (Plate 6). Nearly the entire property shows evidence of recent construction activities including excavation, earth moving and construction.

Plate 3. Basement and footprint of new structure in western portion of property (see Plate 2). The profile shown in Plate 4 is framed in green.

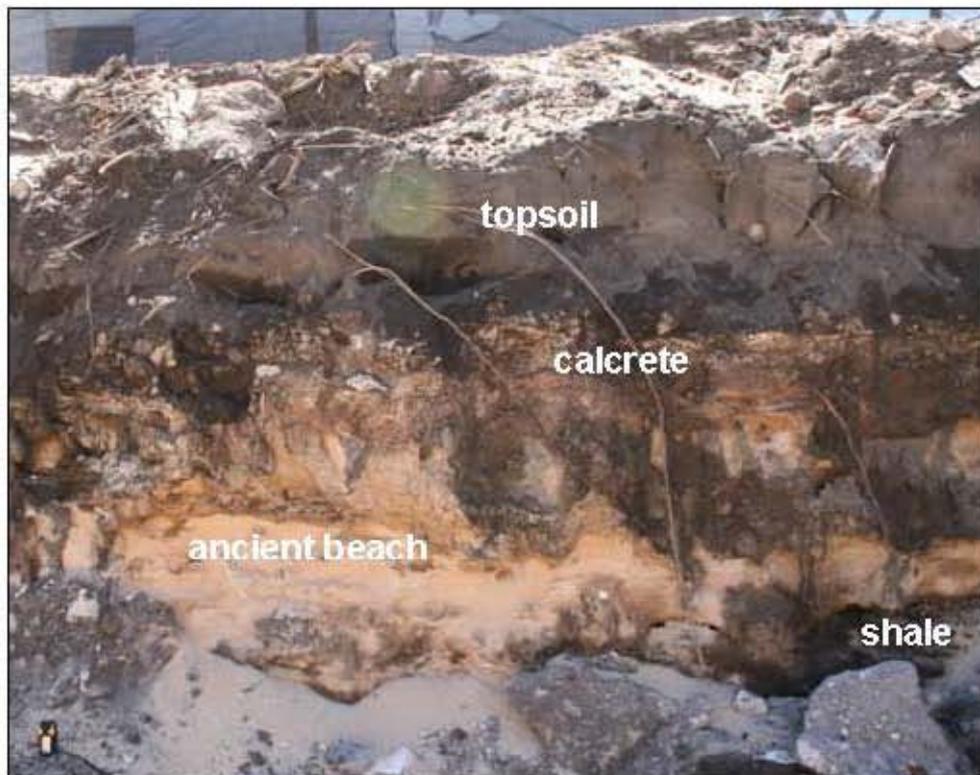
Plate 4. Enlarged profile as indicated by green frame in Plate 3. The shale base is more clearly visible in other photographs. The ancient beach is probably of mid Holocene origin.

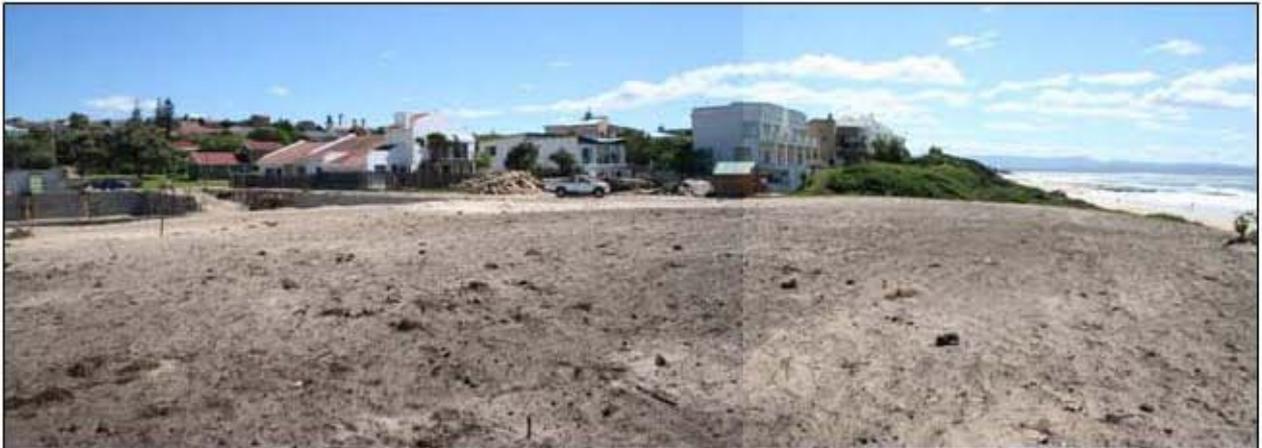
Plate 5. Joined images showing eastern portion of property with levelled surface of sands and soil.

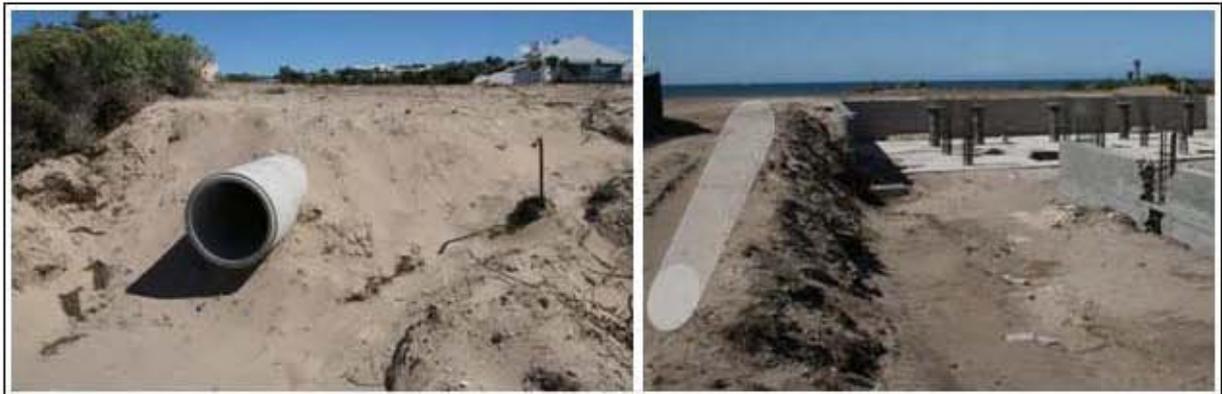
Plate 6. Location and trajectory of storm water pipeline along northern extent of property. Left image taken from east (beach) and right image taken from west (road) with schematic placement of pipe in grey.

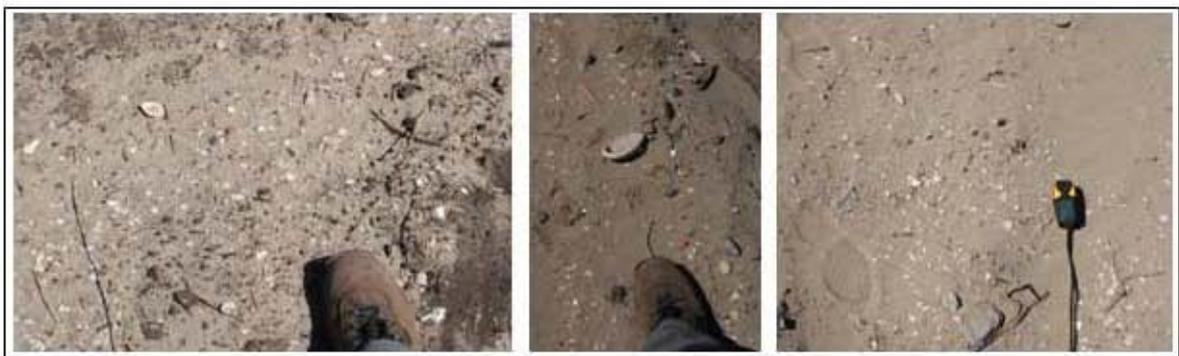
Plate 7. Examples of surface scatters of mostly fragmented marine shell. Size 9 boot and hand held GPS for scale.

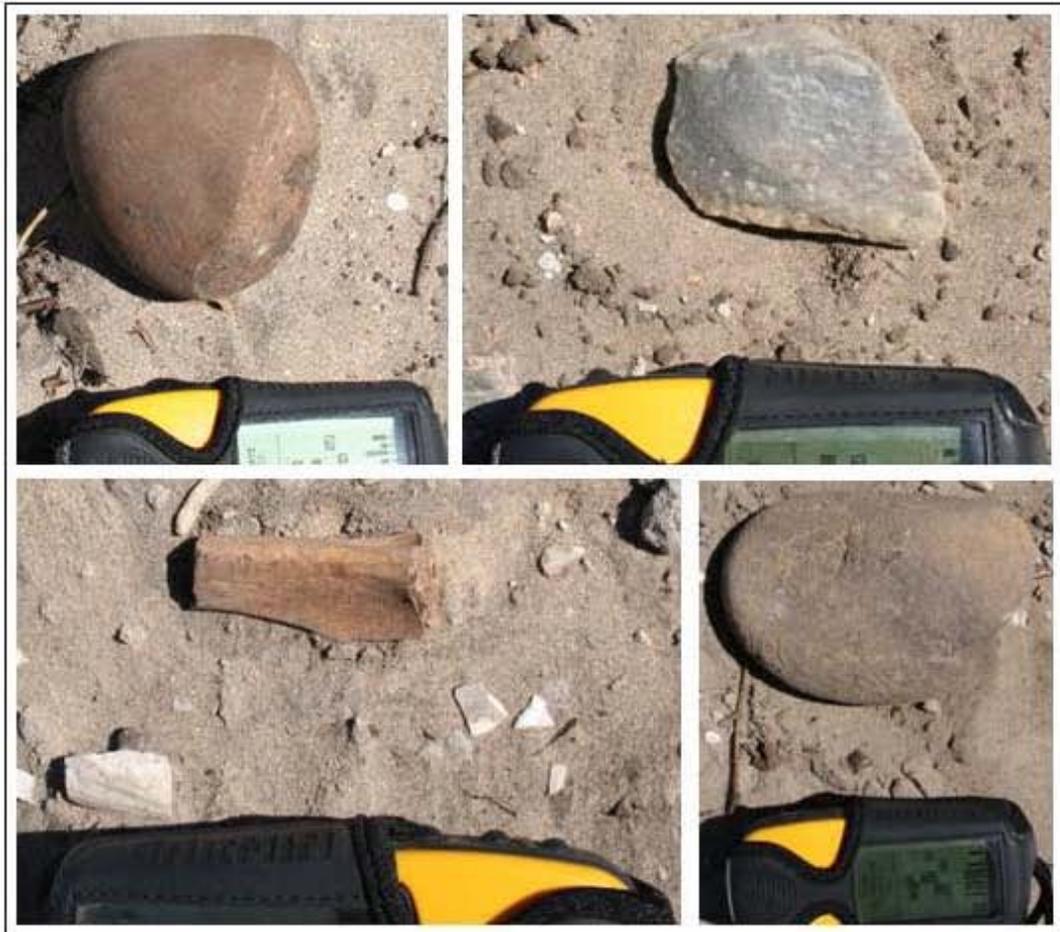
Plate 8. Examples of archaeological remains. Clockwise from top left: combination hammer stone and upper grind stone, flake in quartzite, upper grind stone and proximal tibia fragment of a juvenile medium-small bovid (poss. sheep).

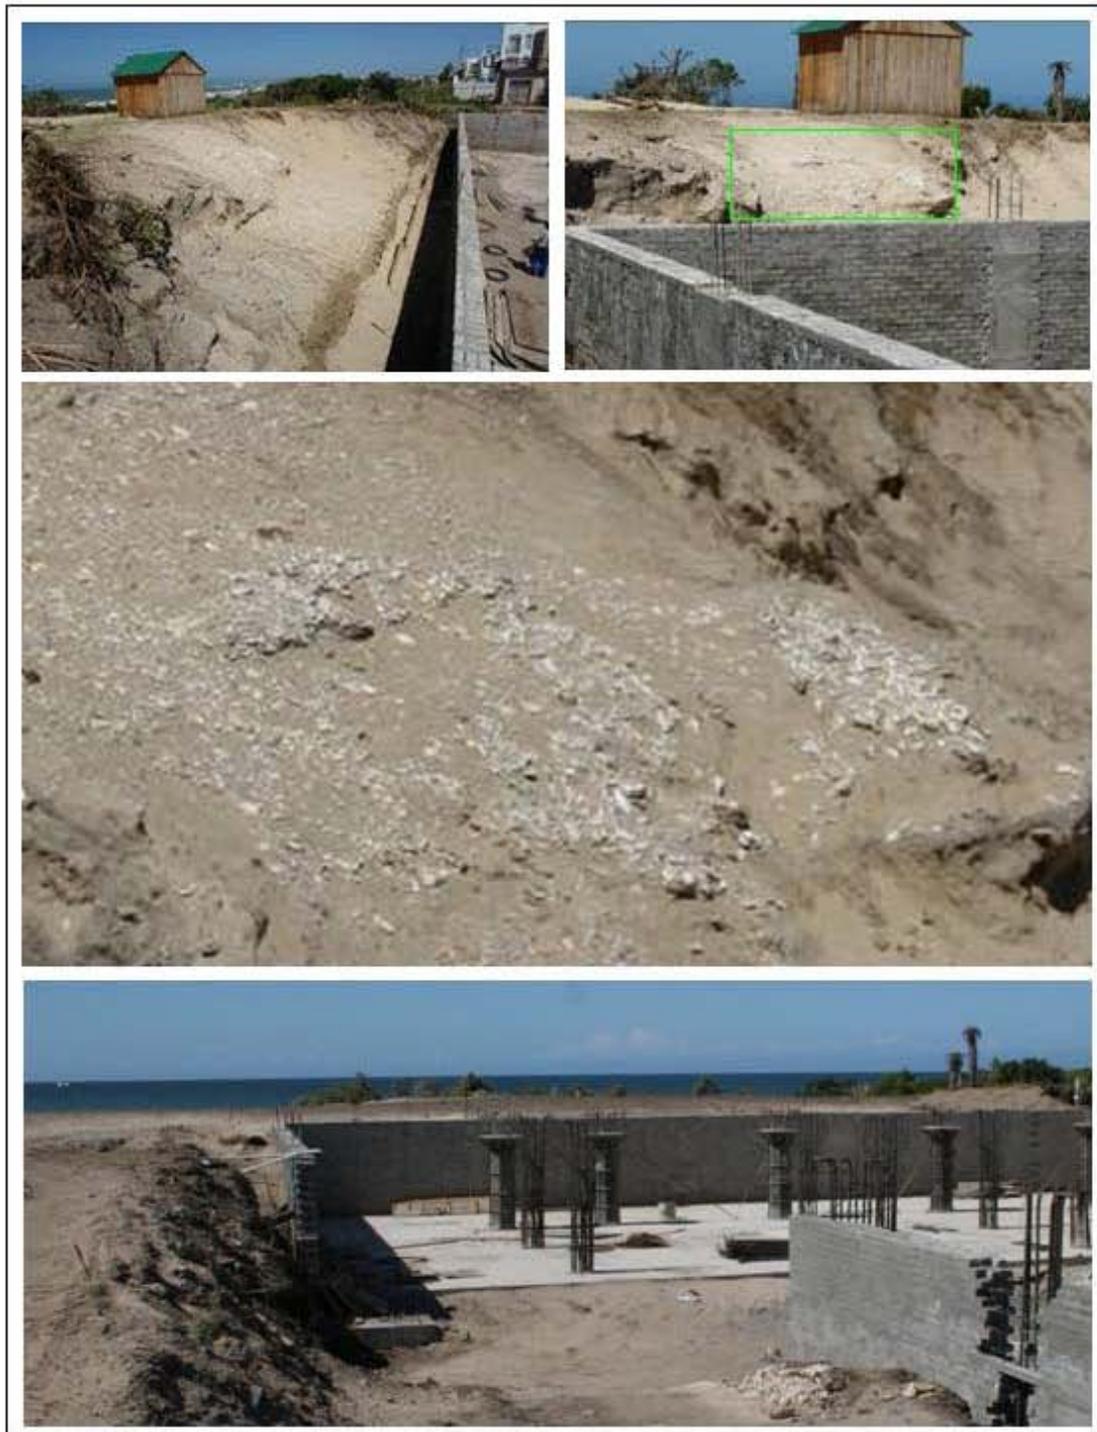
Comparison of my observations with those provided to SAHRA by Dr. Binneman shows that intact archaeological shell midden deposits were present on the property prior to my inspection (Plate 9).

Plate 9. Top three images show dune containing archaeological shell midden materials (from report Dr. Binneman submitted to SAHRA). The middle image shows enlarged details of the area framed with green in top right image. The bottom image is comparable with the top right image, but the former was taken from further to the west.
