AN ASSESSMENT OF IMPACTS ON HERITAGE SITES AT WESTFORD, KNYSNA.

Grant Johnston Associates cc.

September 2002

Archaeology Contracts Office

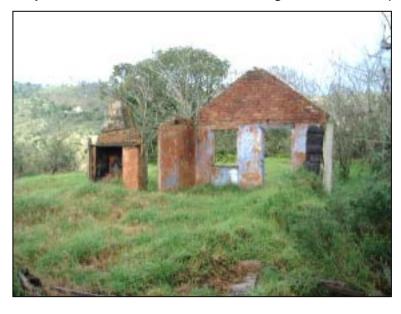
3.2 Ruin 2 (34°00'22.0"S, 23°00'34.9"E)

Only the western end of this building has survived probably as a result of having been

rebuilt with harder brick than the mud brick used in other parts. The placement of the chimney and gable are reminiscent of the building that we refer to as "old cottage 1" found on the upper slopes of the property.

Significance: The building probably dates from the late 19th/early 20th century. In its ruinous state the building has little value.

Mitigation: No mitigation is required.

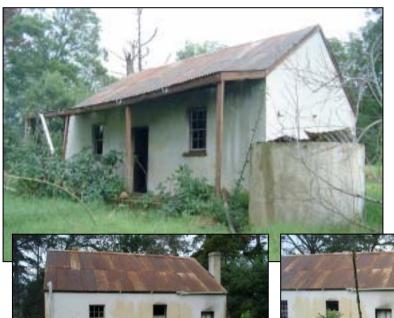
3.3 Old cottage 1 (34°00'32.8"S, 23°00'12.3"E)

Description: Located on the upper slopes of the property in a forest clearing, this small cottage is still in relatively good condition and the presence of PVC downpipes and gutters, and presence of litter suggest use until fairly recently. Partition walls and ceilings made from matchwood define 3 rooms. Generally the interior is in poor condition with wooden floors having been largely removed.

Joinery varies from opening to opening suggesting modification over the years. The roof pitch is moderate and thus may have been designed for corrugated iron rather than thatch.

Significance: The building probably dates from the late 19th/early 20th century and is a good example of vernacular building style. The use of matchwood paneling in addition to ceilings has been seen in other south coast vernacular buildings dating to the late 19th C (A. Malan pers com)

Mitigation: Adaptive re-use is an option. Demolition will require permission from SAHRA.

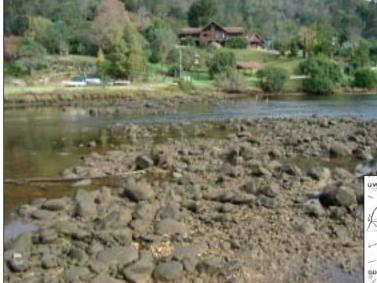
3.7 The old drift (34°00'39.2"S, 23°00'58.8"E)

spot due to the presence of surface rock outcropping. This seems to have been enhanced by additional rocks.

Significance: This was the only place where the Knysna river could be crossed in earlier days and so was crucial to the development of the town of Knysna. Many travelers report watching the progress of the construction of the brig on the slipway nearby while waiting for the tide to recede to enable crossing of the drift.

Mitigation: The drift will technically not be impacted directly by the developments. The point of the river bank where it exits is state land

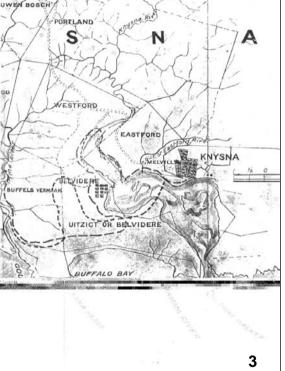
Description: The old drift is still very visible at low tide, even though the rocks have become a little scattered over time. The wagon track and drift are clearly seen on the extract of a 1904 plan showing proposed railway routes. Originally the site was probably chosen because it was a naturally shallow

presently managed by the South African National Parks Board. However, the increase of recreational use of the river brought about by the Westford development may well have impacts. The conservation of the drift should be dealt with as part of an overall management plan for heritage sites in the area. It could an additional point of interest if ever the slipway museum idea comes to fruition.
