# **A HERITAGE SCOPING STUDY OF THE FARM HANGLIP, PLETTENBERG BAY**

**Chris Mulder and Associates Incorporated**

May 2004

**Archaeology Contracts Office**

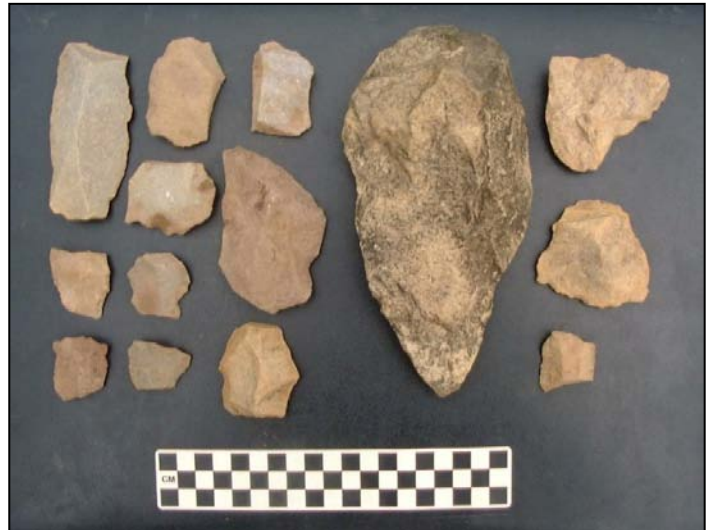
**Description:** The site consists of a scatter of MSA (Middle Stone Age) and ESA (Early Stone Age) stone artefacts around a small man-made pond. The artefactual material has been exposed by the removal of the topsoil during construction, and subsequent erosion. All the artefacts are made on quartzite, the MSA on grey and reddish varieties, while the ESA seems to be more on a brown variety. A selection of the artefacts is shown in Plate 5. The most distinctive artefact found is a handaxe. This is a fine specimen that was made on a large end struck flake and was retouched unifacially.

**Plate 5:** A selection of stone artefacts from HK 001

**Mitigation:** No mitigation is suggested.

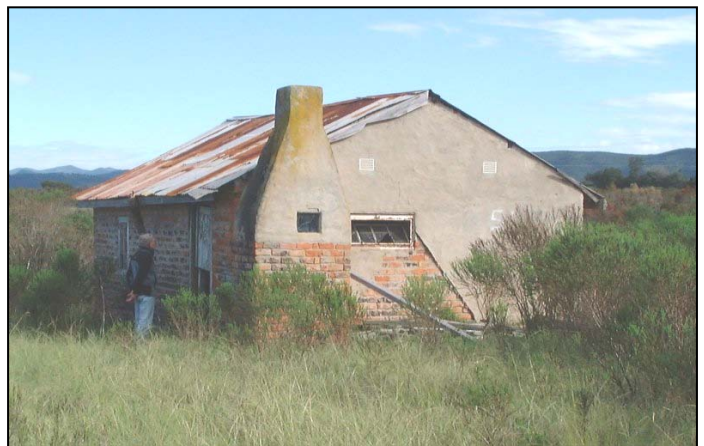
**Description:** A small brick and cement structure now used as a store and shown in Plate 6. The building is in a general state of disrepair and no longer in use. The presence of a chimney, and proximity to a dam, suggests that it once served as a dwelling. The use of a mixture of relatively modern building materials suggests that it was built in the 20th century and is probably not more than a few decades old.

**Plate 6:** A dwelling later used as a store

**Mitigation:** No mitigation is suggested. It should not be necessary to apply for a permit to demolish the structure, unless clear evidence is found that it is more than 60 years old.

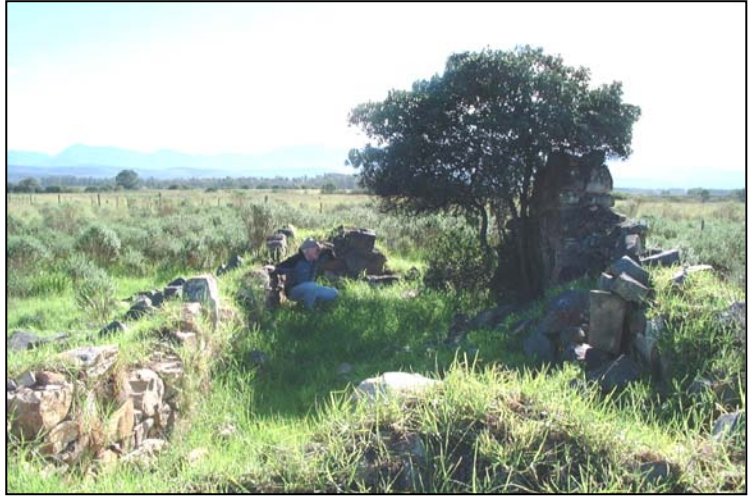
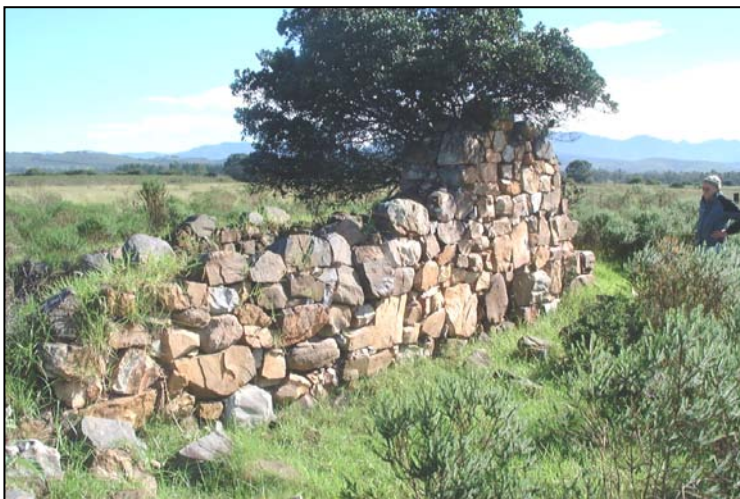
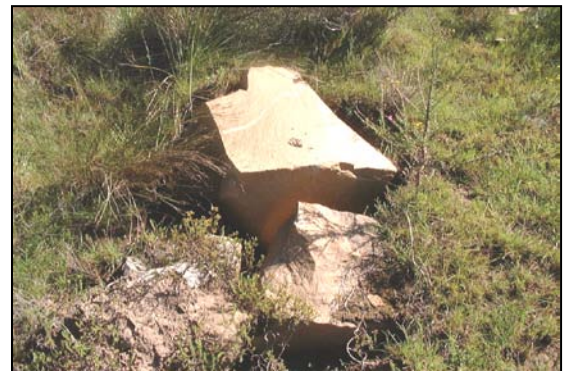
**Description:** This is a small complex of features consisting of the ruin of a dwelling (003, Plate 7&8), an area of disturbed stone "alignments" that may represent an additional building/s (003A), and a nearby stone quarry (003B, Plate 9) from where the stone was brought for the construction of the buildings. The presence of good quality quartzite close to the surface was probably the reason for originally locating the buildings in this area. No associated household dumps were

**Plates 7,8,9:** The ruins of a house on the escarpment. A source of stone is found in a nearby quarry.

located although occasional fragments of 19/20<sup>th</sup> century refined earthenware were observed in the vicinity. It is difficult to date the structure precisely, but it seems likely that it could date to the end of the 19<sup>th</sup> century.

**Mitigation:** This may be amongst the earliest structures on the farm. Demolition will require a permit to be issued by the Provincial Heritage Resources Authority. If demolition is to occur, the site should be the subject of a more detailed level of investigation. This should include archival research, clearing of grass and surveying of the structural elements and excavation of samples of any dumps that are located.

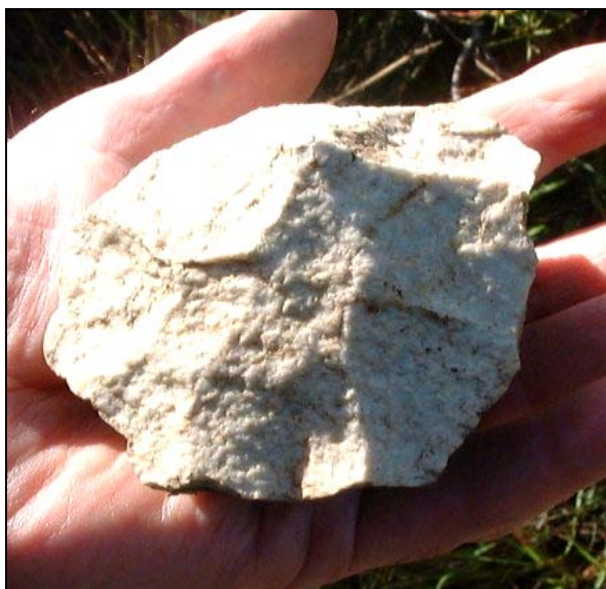
**Plate 10:** A large core made on quartzite

**Mitigation:** As artefactual material is likely to be in secondary context, no mitigation is suggested. It would be useful to know if there is in fact an occupied rock shelter in the ravine.

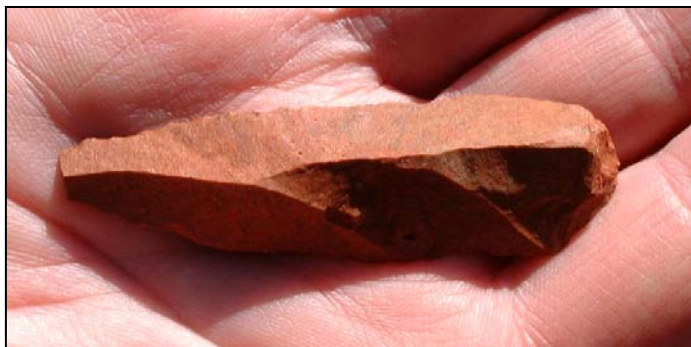
**Plate 11:** A characteristic MSA blade made on chert

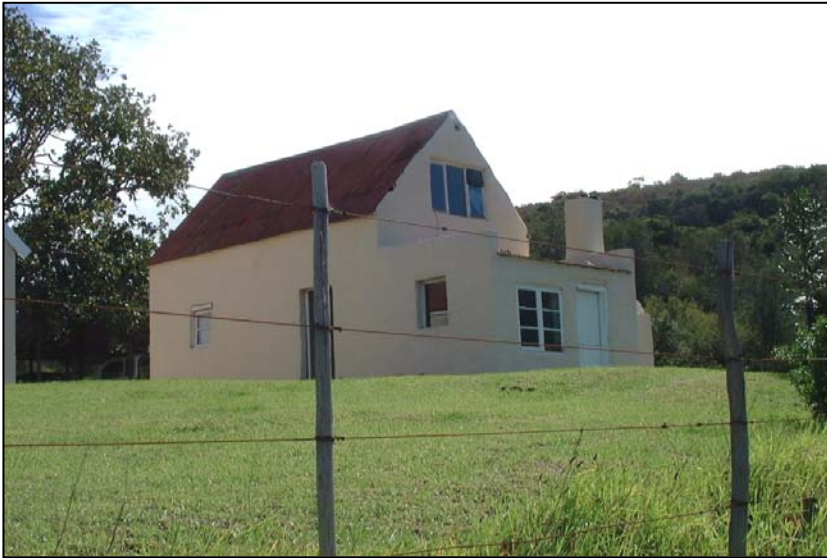
**Plate 12:** A vernacular style building

**Description:** This vernacular building is on the property of Mr Van Zyl, between Wadriif and Vryheid.

It has been well maintained and is still in use. It probably dates from the later part of the 19<sup>th</sup> century.

**Mitigation:** Permission will be required to demolish or modify the building in terms of section 34 of the NHRA.

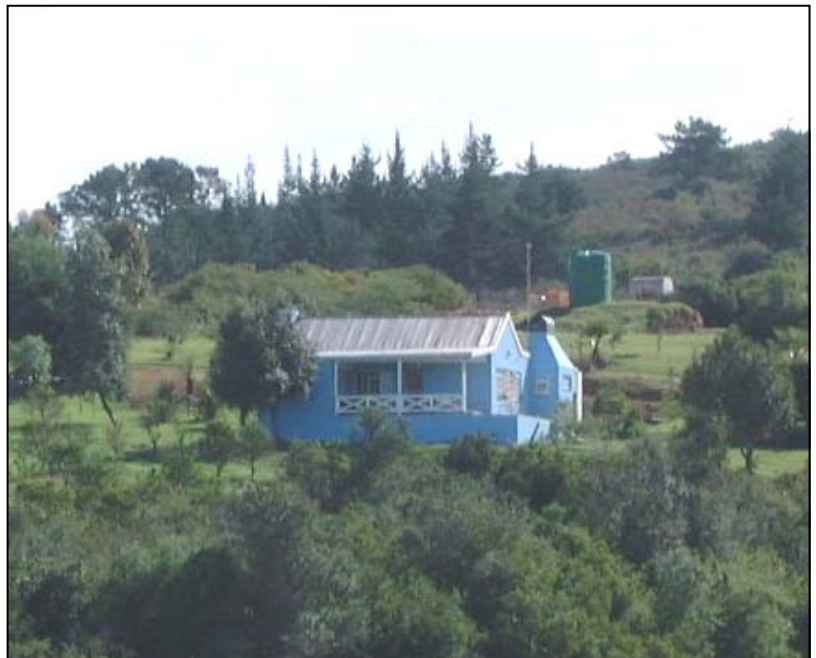
**Description:** A small vernacular building that has also been well maintained and is still in use. It probably dates from the late 19<sup>th</sup> century.

**Plate 13:** A vernacular style building

**Mitigation:** Permission will be required to demolish or modify the building in terms of section 34 of the NHRA.
