Agency for Cultural Resource Management

20 April 2006

ARCHAEOLOGICAL INSPECTION AND ASSESSMENT OF A HISTORIC LIME KILN ALONGSIDE DIVISIONAL ROAD 1131 MALMESBURY

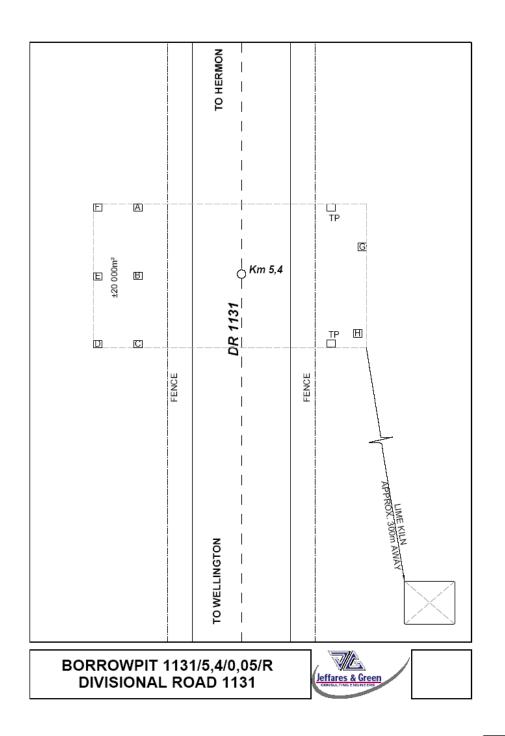
Figure 8. Plan of the extent of the proposed borrow pit.

The proposed borrow pit will not impact negatively on the historic lime kiln on the Farm Botmansdrift. Figure 8 clearly indicates that the southern boundary of the footprint of the proposed borrow pit is located about 300 m from the kiln. A farm fence and wide drainage area also separates the proposed borrow site from the kiln, which is located on a small hillock.

- The proposed project should be allowed to proceed as planned.
- The historic lime kiln, the immediate surrounding area and all associated material must not be disturbed or damaged in any way during the excavation of the borrow pit.
- A Phase 1 Archaeological Impact Assessment of the proposed borrow pit is not required, since the site is already in a severely disturbed and degraded state.
