DOCUMENTATION OF DISTURBANCE AT THE HISTORIC SLAVE LODGEVERGELEGEN ESTATE, SOMERSET WEST

Vergelegen Wine Estate

June 1998

Archaeology Contracts Office

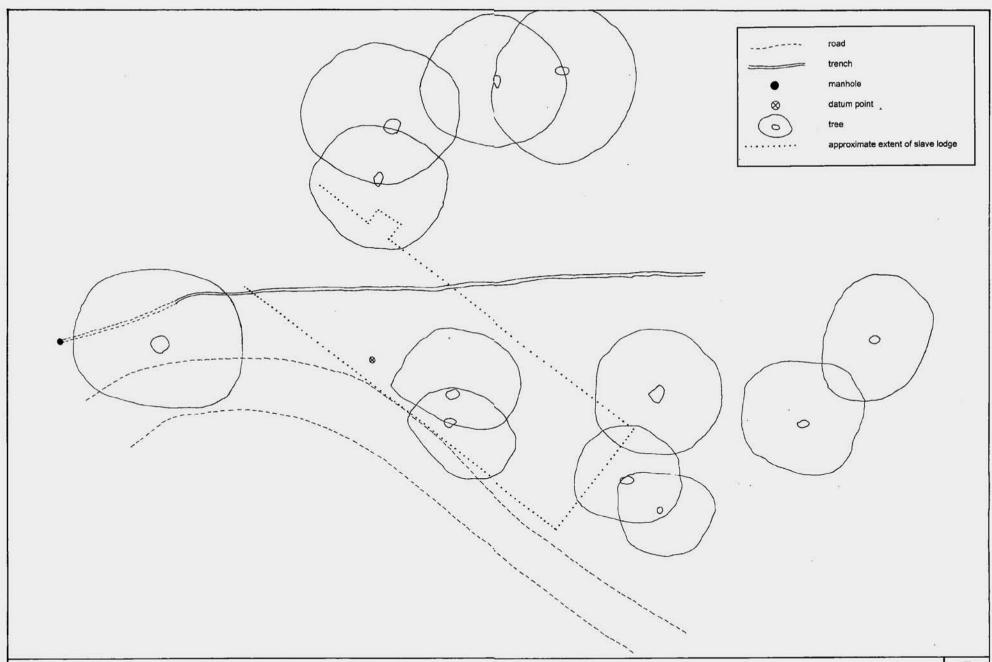
The area was surveyed using a *Leica* Total Station and a drawing prepared using the readings (Figure 1). Readings are presented in Table 1.

While surveying the trench and other objects such as the trees and road posed no problems, no structural features of the slave lodge are exposed to allow the building remains to be accurately plotted onto the drawing. By using an earlier drawing of the lodge (Markell 1993) we have approximated the location of the trench relative to the slave lodge to give some sense of what damage has occurred (Figure 2).

3.1 We presume that the reason for filling in the trench is because cables have been laid in it. This raises a problem in the sense that if any problems are experienced in the future someone will have to dig up the cable. Since the trench has not been clearly marked it may be difficult for the average contractor to relocate it without some exploratory digging. This could result in more damage. To avoid this problem it is recommended that some form of marker pegs be placed at intervals on the surface along the course of the trench. Short lengths of white PVC conduit may be an option.

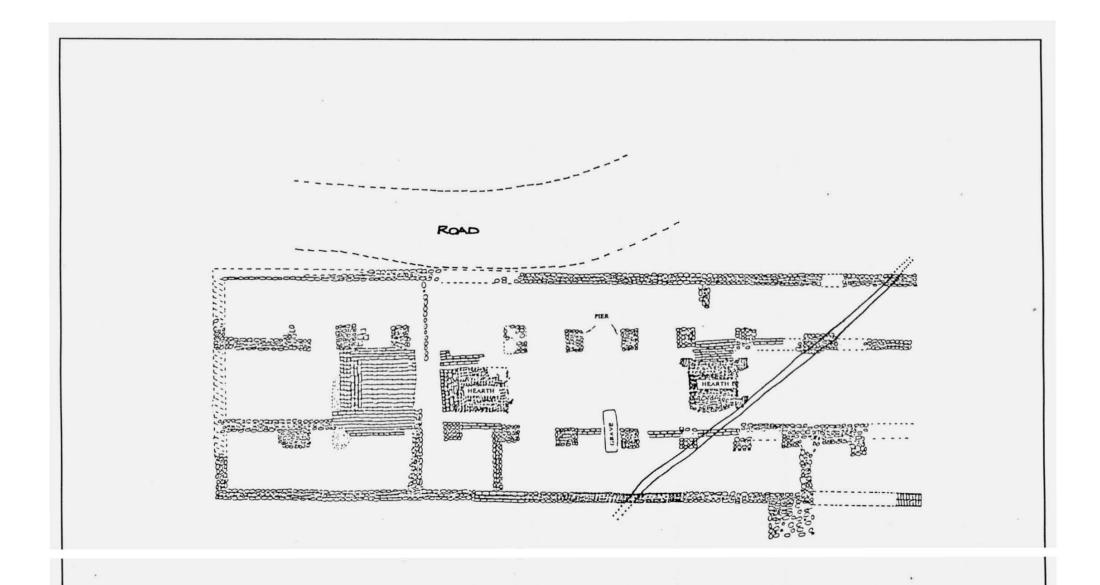
2

The approximate position of the trench superimposed on an earlier drawing of the slave lodge. Reference: Markell 1993.

- 3.2 Barriers should be erected around archaeologically sensitive areas to prevent a recurrence of this problem. The type of construction should be of a type that will leave no doubt that something is being protected. Additional signage may need to be added forbidding any digging, either manual or mechanical within the demarcated area.
- 3.3 While the mill, slave lodge and winery have been easy to identify, locations of some other buildings are not clear as they have never been excavated. The buildings in question appear to the east of the slave lodge on an old plan of 1712 (Figure 3). Vergelegen Wine Estate should take note of this and ensure that no large scale trenching or earthmoving occurs here without an impact assessment first being conducted.
