ARCHAEOLOGICAL INVESTIGATION OF THE TERRACE AND
ROADWAY BEHIND THE EISENBURG HEREHUIS

Prepared for
Dept of Local Government, Housing and Works
Administration: House of Assembly

March 1994

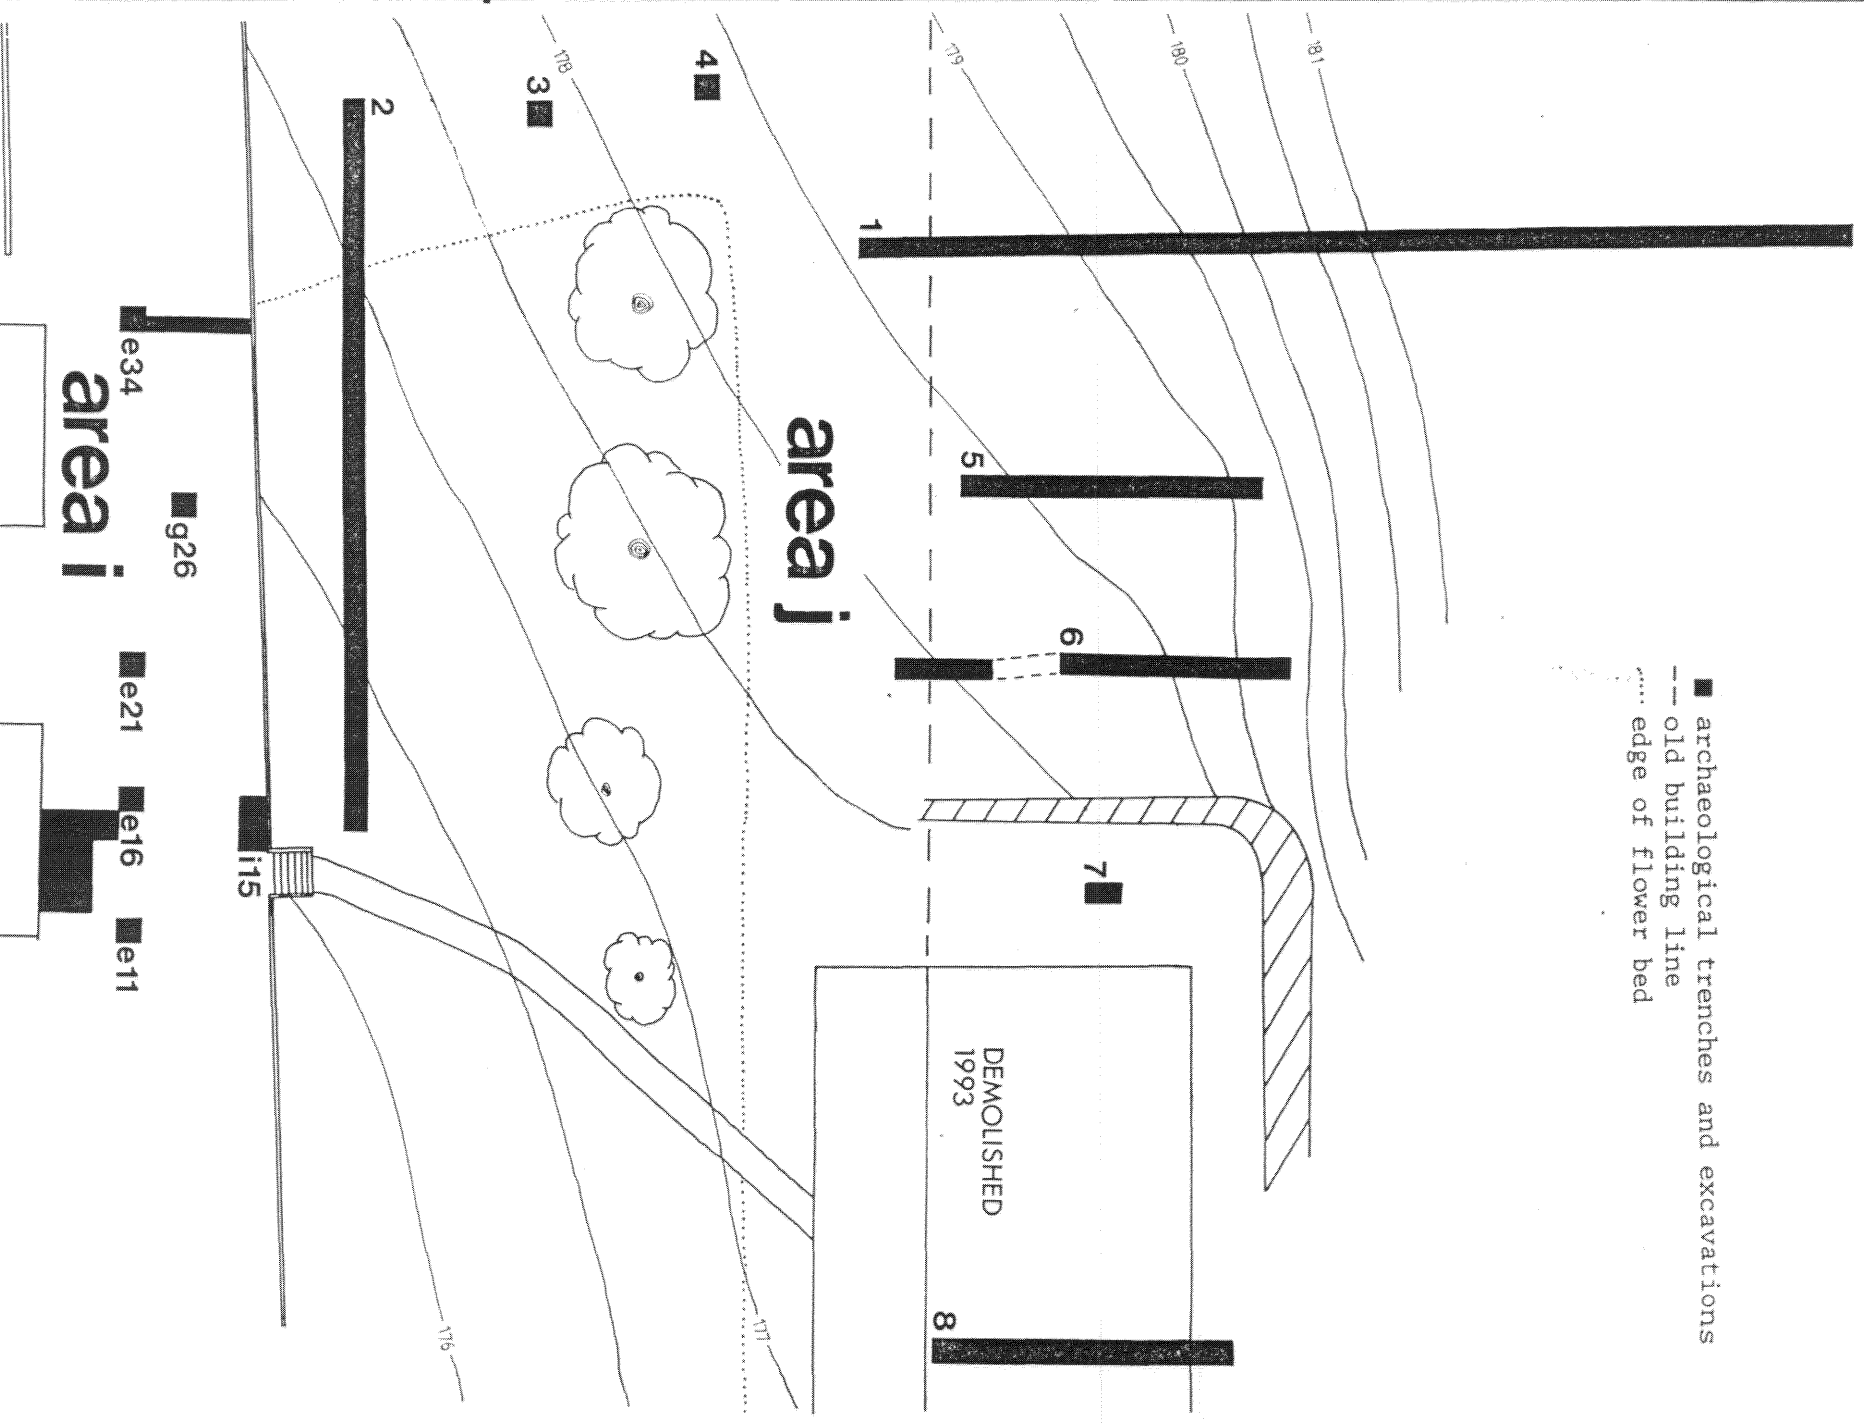
2.1

The latest investigation has focussed on two areas. Following the system of labelling decided on in the original investigation, the two areas in question here, namely, the roadway behind the house and the grassed area above the retaining wall, have been labelled areas I and J respectively. The locations of these areas are shown in Figure 2.1.

The purpose of excavating on the terraced area was twofold. Firstly, our brief required us to isolate the historic surface/s as a guide to the landscaping specialists whose task it will eventually be to restore to as close to the original levels as possible, and at the same time look for indications that other buildings may have been located between the demolished line and the present *Herehuis*. Secondly, tests would establish whether the positions of the demolished buildings could be ascertained by identifying traces of foundations. These tests would also show if any associated archaeological deposits had been preserved. The positions of the exploratory trenches are marked in Figure 2.1.

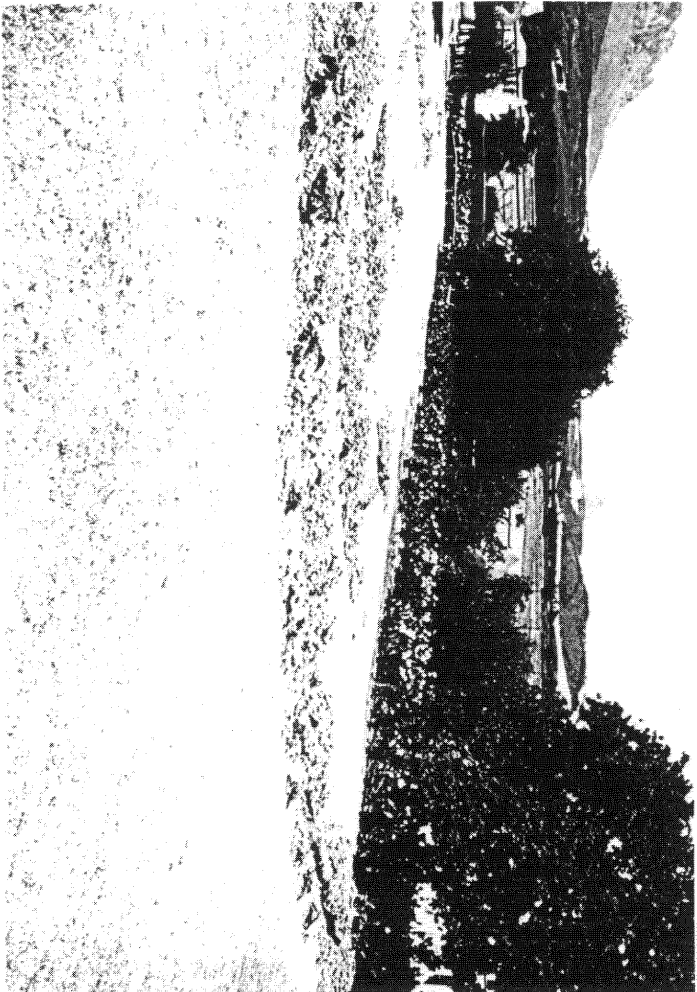
To our surprise, the trenches revealed no trace of any buildings. In fact no trace of either foundations or indeed any building rubble is evident. The conclusion that one must draw from this is that the demolition was extremely thorough and that foundations were completely removed. The stratigraphic sequence seems to confirm the fact that the area has been vigorously cleared in that no naturally weathered surface is detected. The sequence consists of a light grey unit of imported soil resting immediately above clays resulting from decomposition of local bedrock. The interface between soil and clays (clays vary from yellow to red/grey) is clearly marked with no protracted gradation from one to the other occurring. Plate 7 shows a view of trench 1 in which the proximity of the yellow clay to the surface can clearly be seen. Plate 8 shows the level patch where the old buildings would have stood with test trenches transecting it.

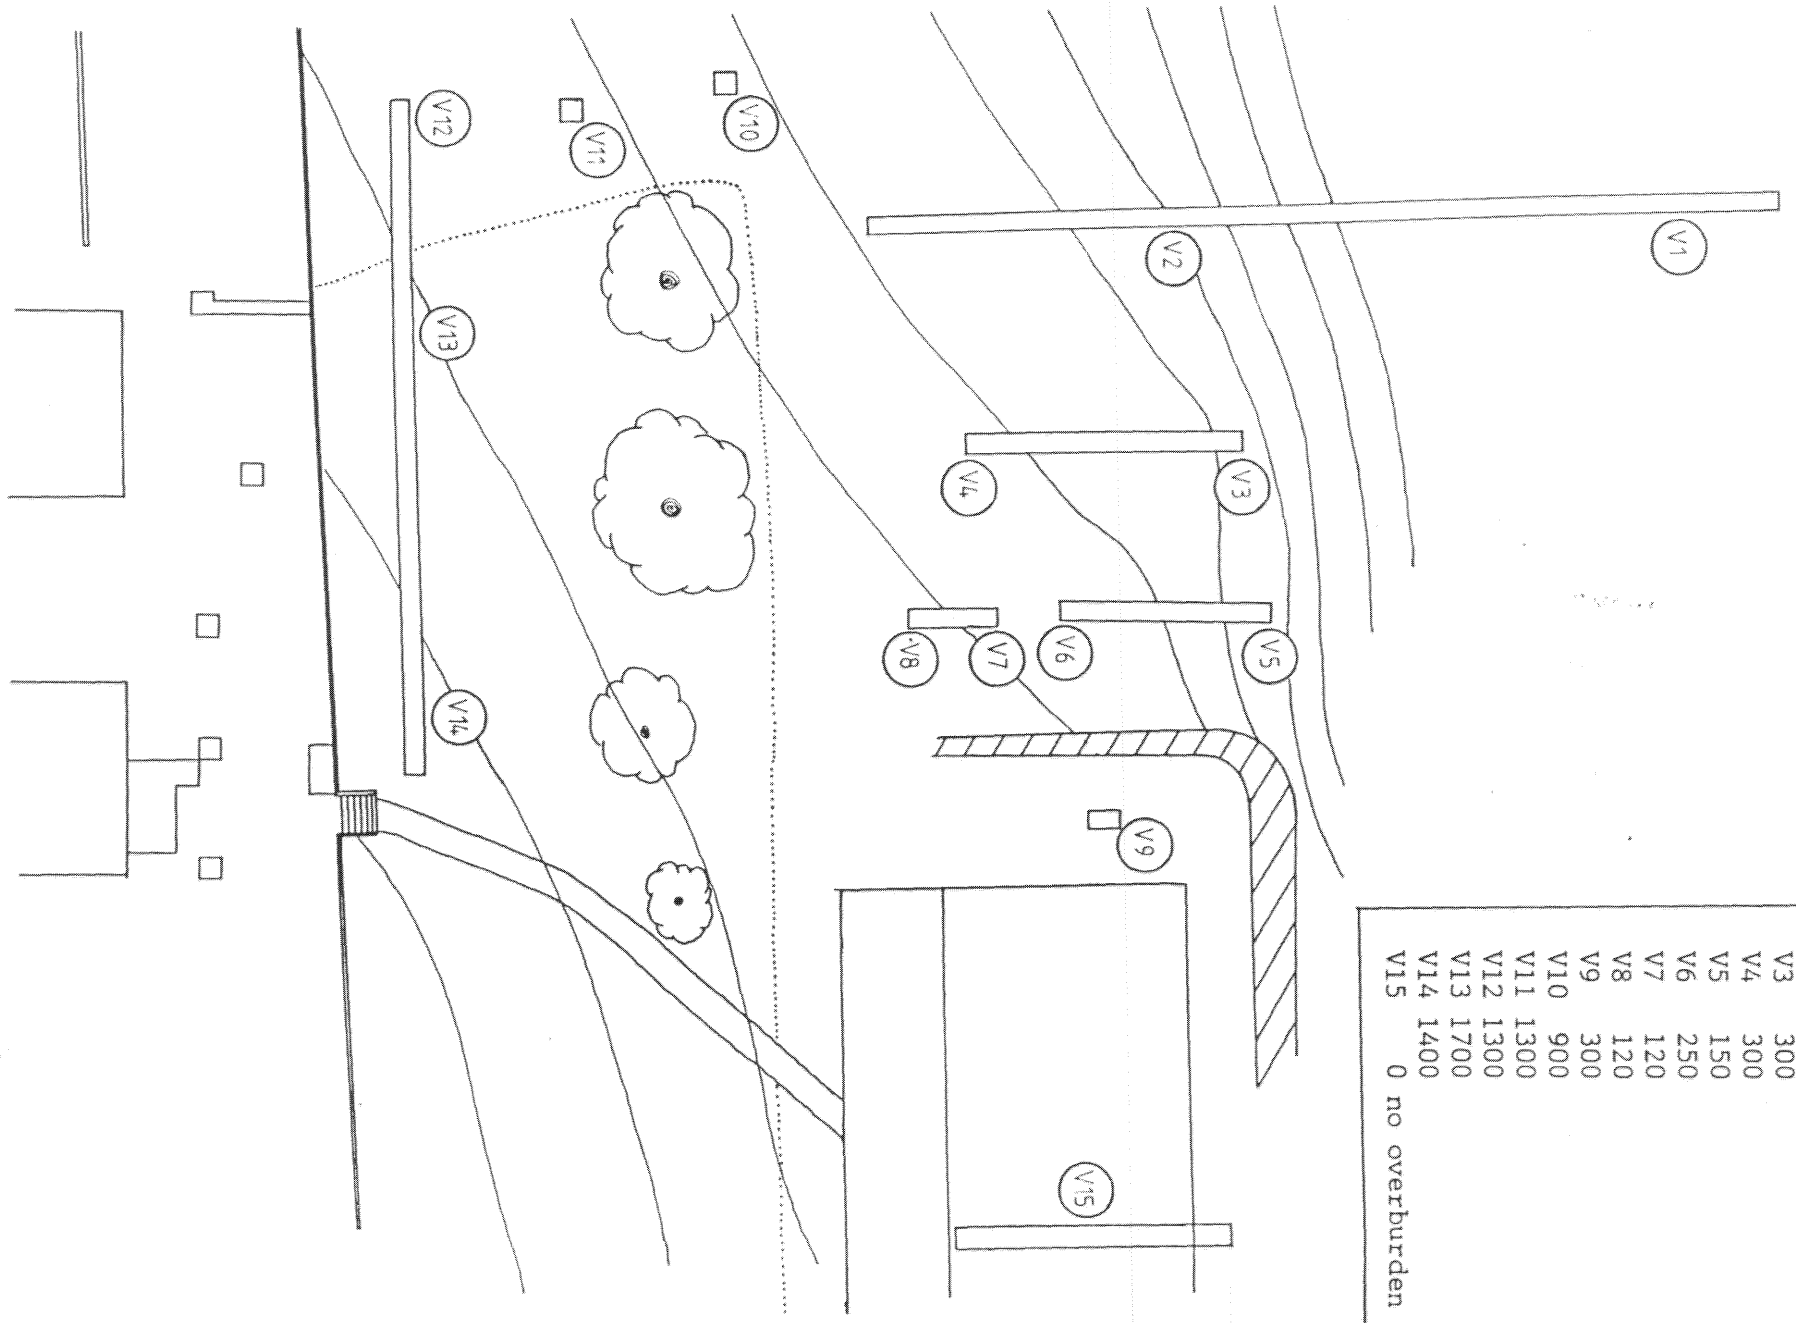
2.5

herehuis with a more steep incline occurring at the point where the old buildings stood (substrate found at approximately 150 centimeters below present surface). This would mean that the level area behind the *herehuis* would have originally been much larger. The depth of the substrate at various points in the test holes below the prevailing surface is presented in Figure 2.5.
