**AN INVESTIGATION OF AN HISTORIC WELL ON ERF  
1878 (PTN OF ERF 20) AND ERF 4603 (PTN OF ERF 1878),  
ST. HELENA BAY**

**Nations Hero Investments (Pty) Ltd**

January 2006

**Archaeology Contracts Office**

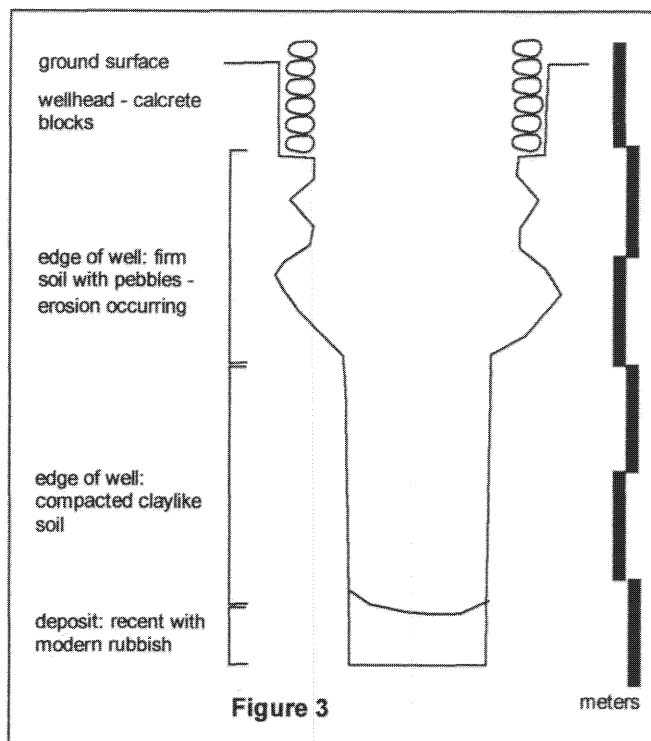
On arrival, we determined by measurement that the depth from top of the wellhead to the infilled base to be 5 meters (Figure 3). The wellhead was constructed from dry packed calcrete blocks (rim skimmed with cement) while the lower part of the shaft was unlined natural substrate. No water was present. The diameter of the shaft at surface measured 1.8 meters, while at the base of the erosion zone, diameter was measured at 1.5 meters. A selection of photographs can be found at the end of the report.

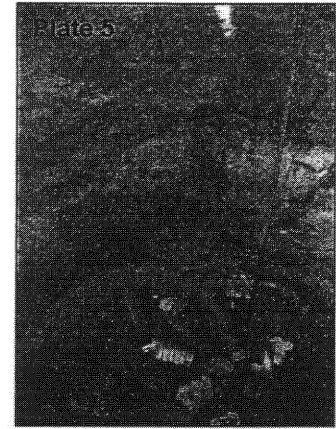
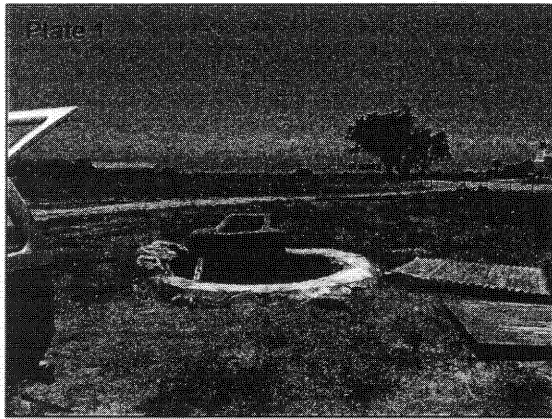
Plates 1&2: Two views of the well head and attached drinking trough
