'Sillery Furrow'

Erf 2274, Constantia

HWC Reference No: C13/3/6/2/1/1/1/A6

Report Prepared for Doug Jeffrey Environmental Consultants

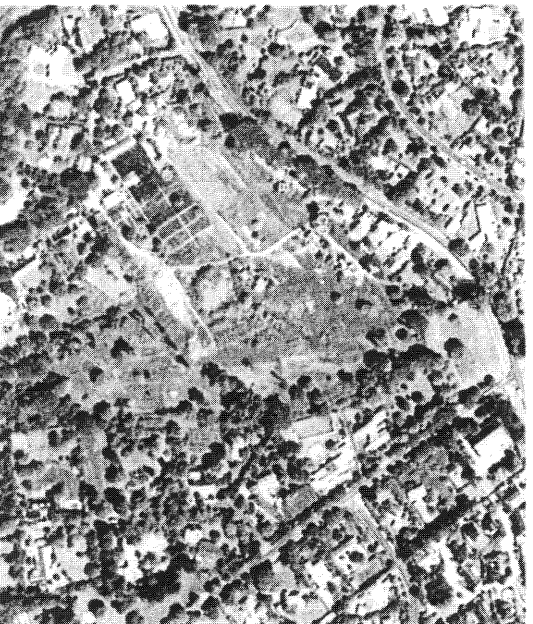
Figure 4: Aerial photograph showing position of the test trenches.

A trial excavation by ACO (Orton & Hart 2004) confirmed that the furrow was still extant, but was filled with 20th century building rubble and debris. Our brief was to confirm the alignment of the furrow through two additional trial excavations. The area along the northern boundary was investigated by foot. The trial excavations were placed as close to midway between the ACO trial excavation and the ends of the furrow as were possible (Figure 4). A steep embankment to the west of trial excavation B effectively obscured the furrow. No oak trees have been preserved along this embankment.

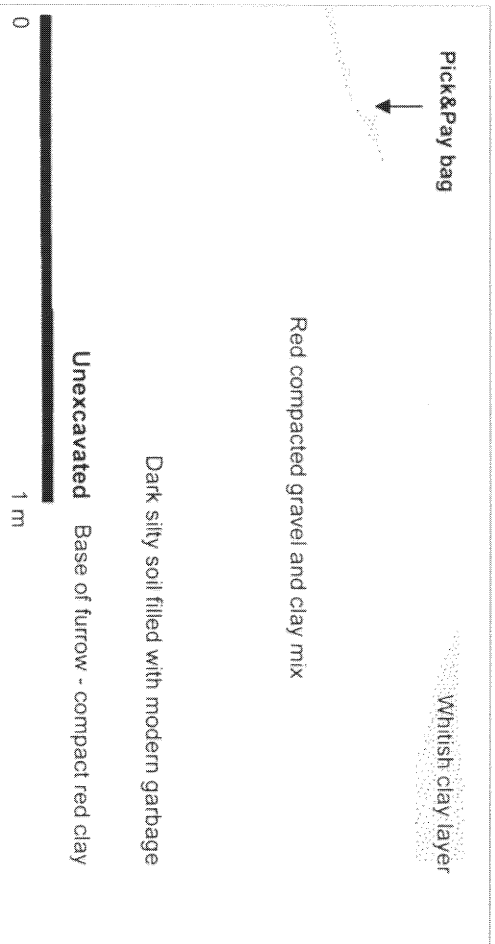
In the northern part of the test trench, the soil was dark and silty and full of modern rubbish; plastic bags, bottles, blankets, a part of a mattress and a 1964 ½ cent coin. Underneath this dark soil, was a red compacted clay. The furrow at this point, formed a rather shallow ditch (Figure 5 and 6). The ACO test trench was covered with a lot more building rubble. The furrow may have appeared more V-shaped owing to the build up of the soil and rubble around it. Mark Smith remembered, as a child, walking in the furrow during summer, when there was little water in it. His recollection was that the furrow was quite shallow near their houses, but deeper towards the Lady's Mile Extension and the Old Sillery farmhouse.

Figure 5: Western section of a portion of Test trench ~~B~~ A. (The straight line through the centre of the sketch is the line level.)

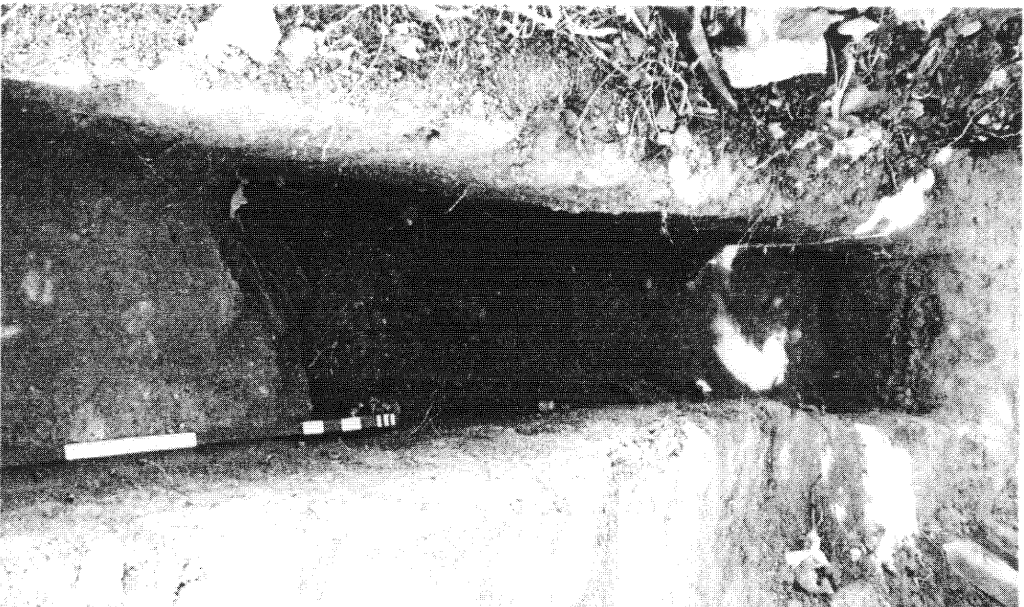
Plate 1: View across test trench, looking northward. The yellow clay at the bottom of the plate is the furrow embankment.

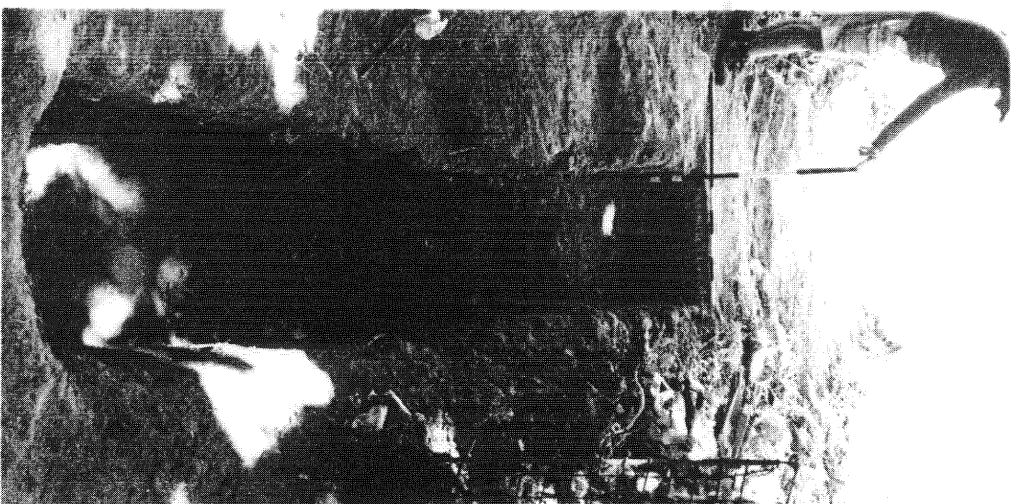
Plate 2: View across test trench, looking southward.

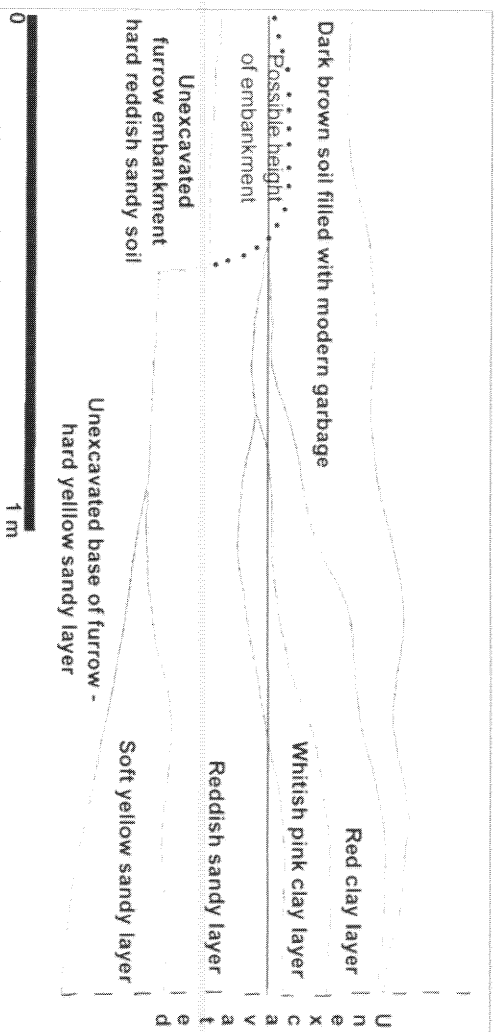
An area just south of the oak tree was cleared of vegetation and loose building rubble. A test trench 50cm wide was then dug. Underneath the loose rubble was a reddish orange clay layer about 10 cm thick. Immediately below this was a whitish pink clay layer. Below these clay layers was a reddish sandy layer about 20 cm thick. Directly beneath it was a yellow silt layer which was only present in the northern edge of the trench closest to the tree, representing the middle of the furrow. The furrow embankment presented as a hard reddish layer of very dry, but fine grained soil. The base of the furrow, underneath the yellow sandy silt, was formed by a hard compact yellow very fine grained soil, again, very dry (Figure 7 and 8).

Figure 7: Western section of Test trench B. (The straight line through the centre of the sketch is the line level.)

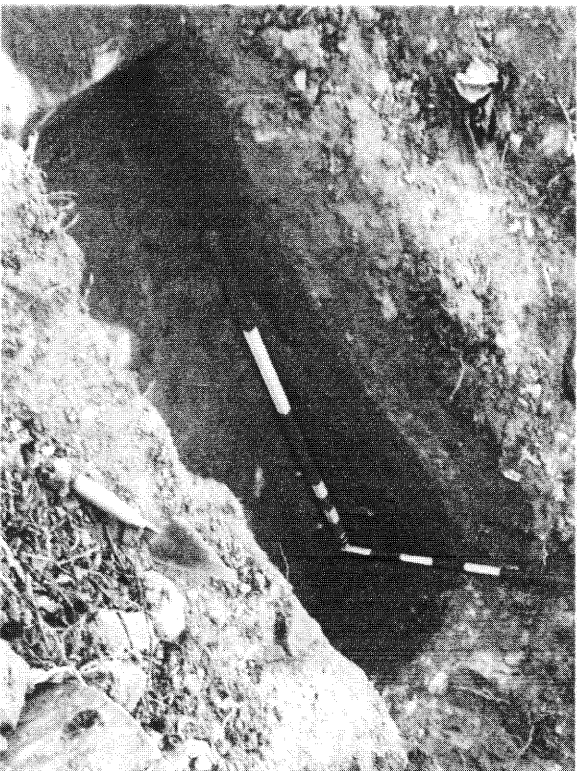
Plate 3: View of the test trench. The furrow embankment is visible on the bottom left of the plate.

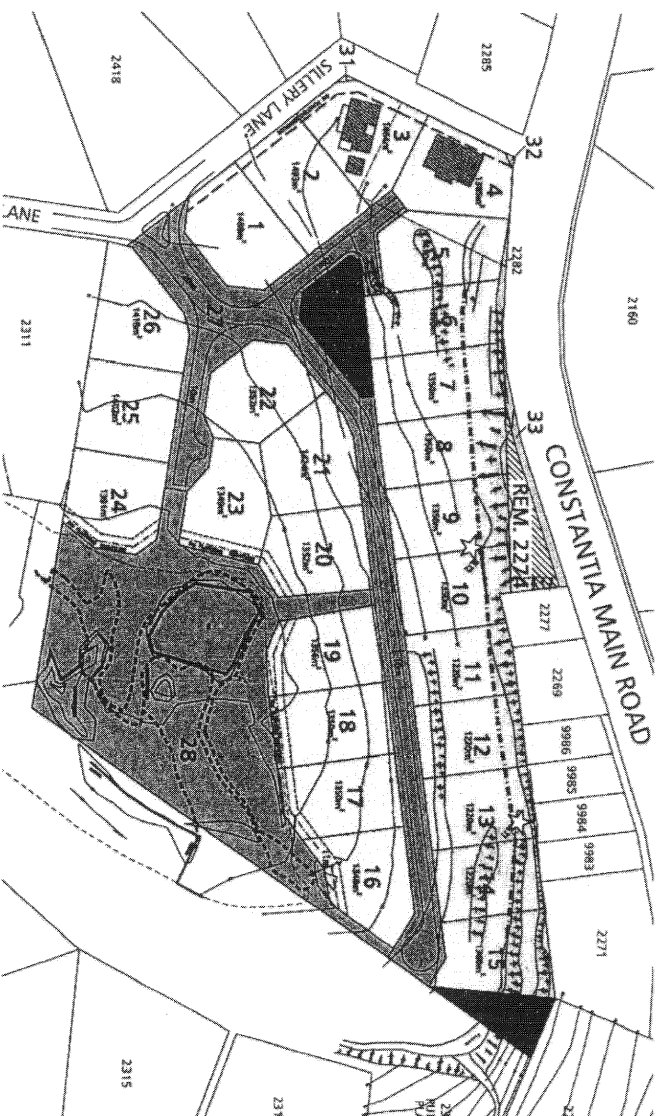
The furrow lies close to the northern boundary of the erf and the oak trees are growing virtually on the northern edge of the furrow. Figure 9 (detail from the Development Proposals Figure 8.1) shows the location of the test trenches and confirms that the dashed line described on the original as the 'approximate alignment of the furrow', is indeed an accurate reflection of the alignment of the furrow.

Figure 9: The white stars indicate the position of the two test trenches (Figure 8.1: Development proposals - Proposed Subdivision of Erven 2274 & 2286 Silery, Constantia 2004)

Following the recommendation by the Minister of Cultural Affairs, Sport and Recreation, relating to the EIA for the proposed subdivision of Erven 2274 and 2286 (Stali 2005), it has been agreed that a servitude should be registered over the furrow and that it be provisionally protected under the National Heritage Act (25 of 1999).
