# ARCHAEOLOGICAL INVESTIGATION OF THE WINE CELLAR AT HAZENDAL

**Hazendal Wine Estate**

July 1995

**Archaeology Contracts Office**

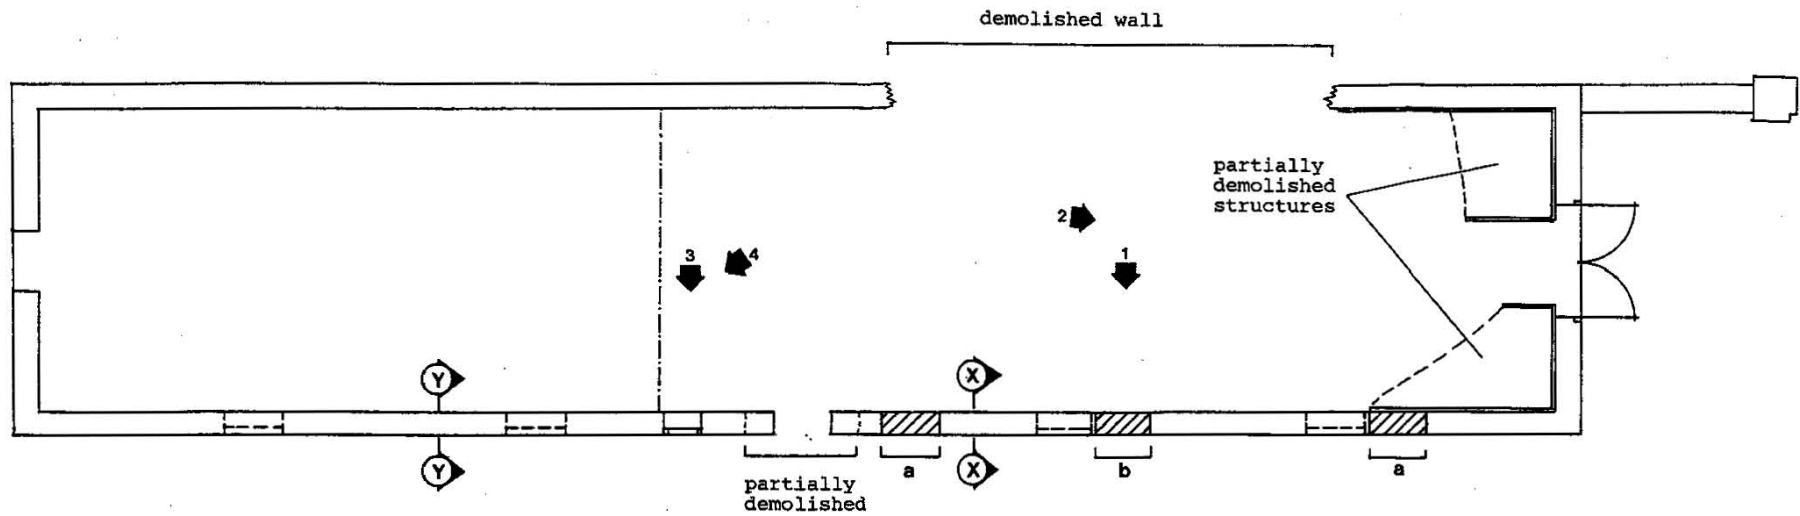
A schematic diagram showing the various building materials used in the east wall is presented in Figure 2.

- ➡ photographic view
- a bricked up windows
- b bricked up door

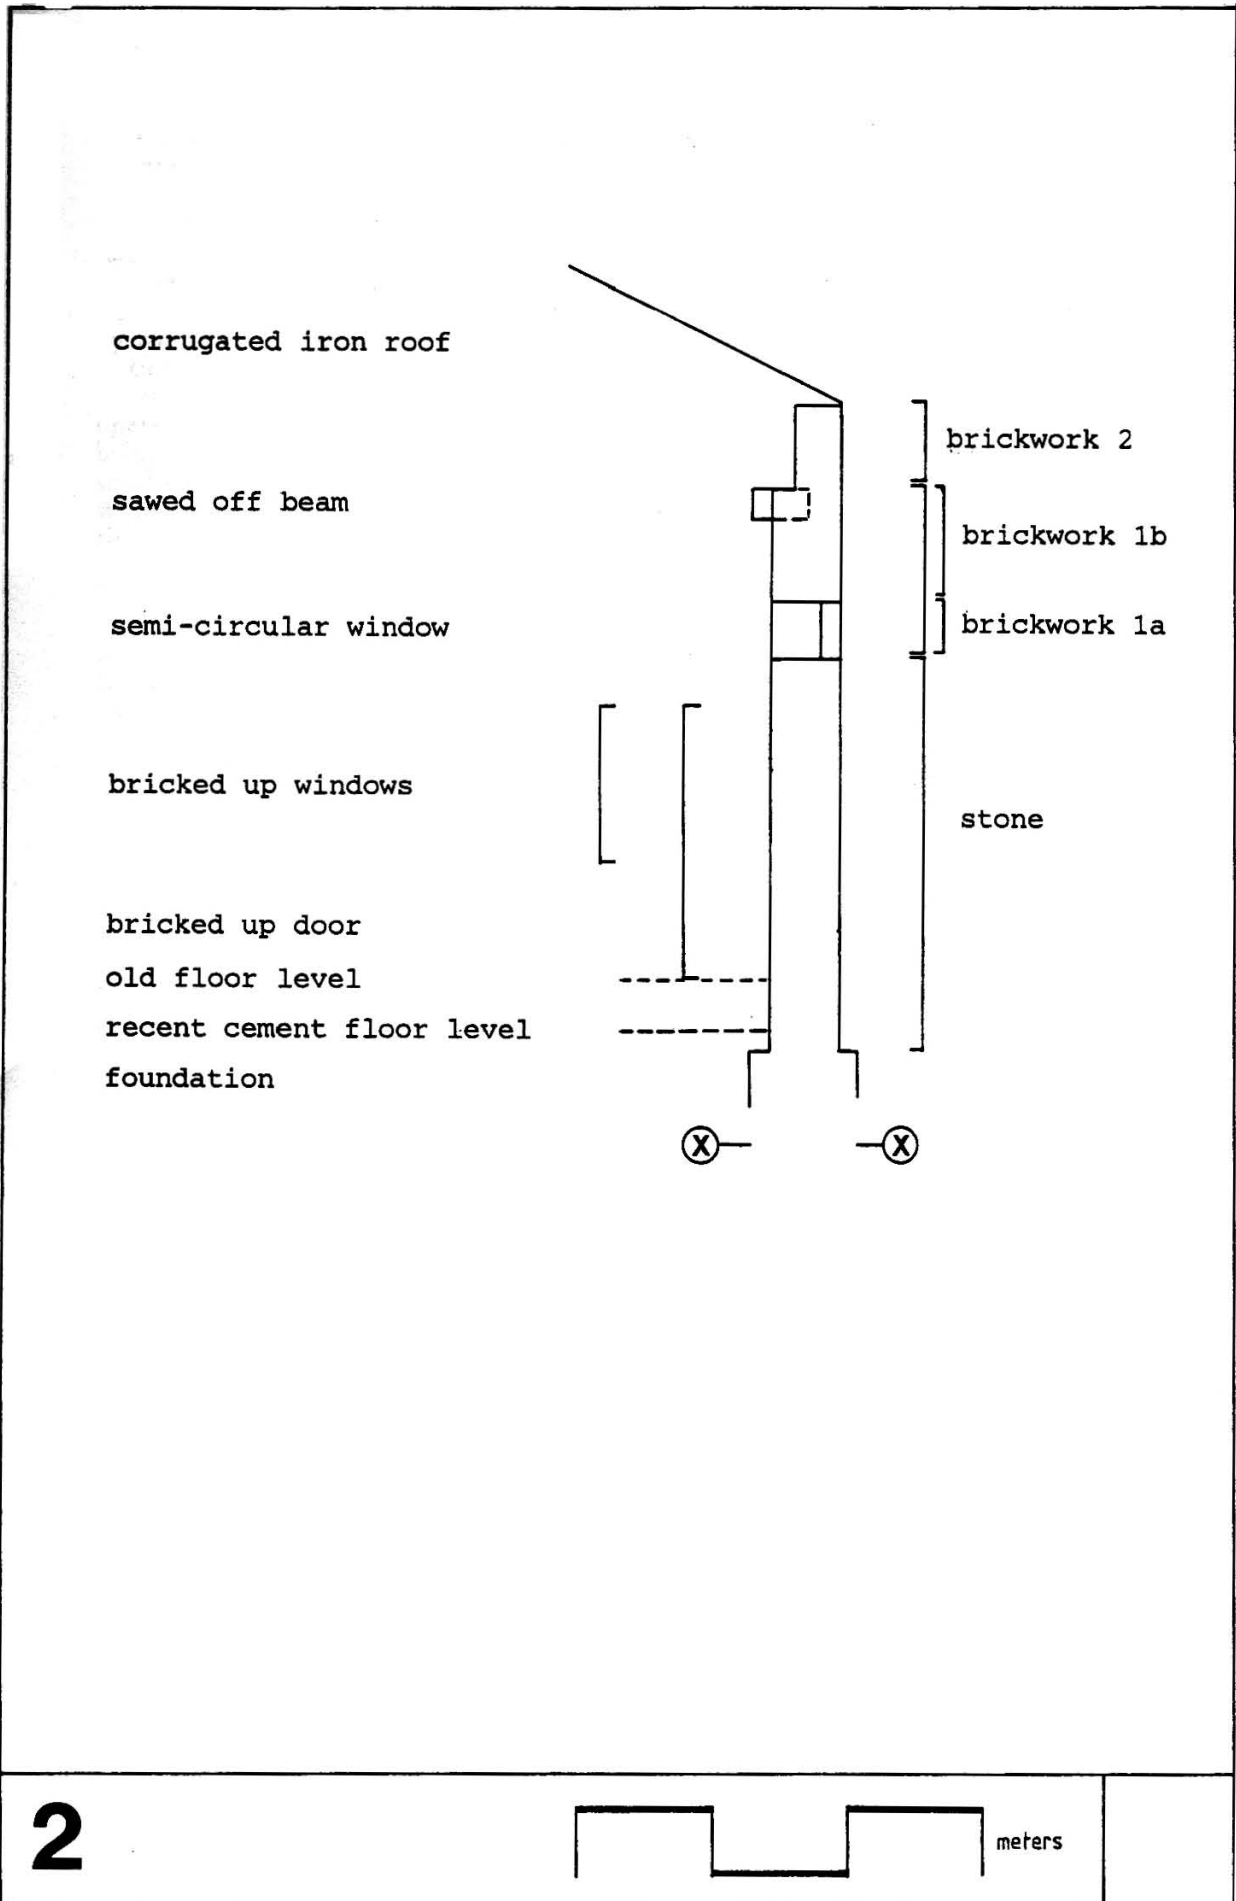
1

The foundation and most of the upper wall is made of stone. This appears to be granite and is undoubtedly of local origin. Resting atop the stone is a section of brickwork which can be divided into two types, namely three courses of unusually large bricks (230x120mm) immediately on top of the stone, and then seven courses of "standard" bricks (average 230x80mm). On top of these and set slightly back are another five courses which are still covered by modern plaster. This sequence can clearly be seen in Plate 1. A bricked-up door, centrally placed in this half is bordered by windows at either side, also bricked-up. These features are located in the stone section of the wall. The neatness of the northern edge of the door is an indication that the stone wall phase and the door are contemporaneous. The southern edge has some unevenness in which brick infill has been used to even out the edge prior to the frame being fitted and may indicate that the door was widened at some stage. Only the southernmost of the two windows is entirely visible (one is obscured by a concrete structure - Plate 2) and though the edges are not even, was probably built at the same time as the door.

The brickwork lying on top of the stone consists of two types as already described. In our opinion the three courses of large bricks are contemporaneous with the stone wall and may have been used to seat cross beams. The upper courses of brickwork appear to have been added later to raise the height of the building overall as the sawed-off tie beams were seated in the upper part of this brickwork. The semi-circular windows were added at the same time and the door and windows bricked up. This may not have been completed immediately as the brick size of the infill (average 235x60mm) is different to those in the other brick alterations. This phase of work was probably conducted when the building was extended and enlarged for use as a wine cellar.

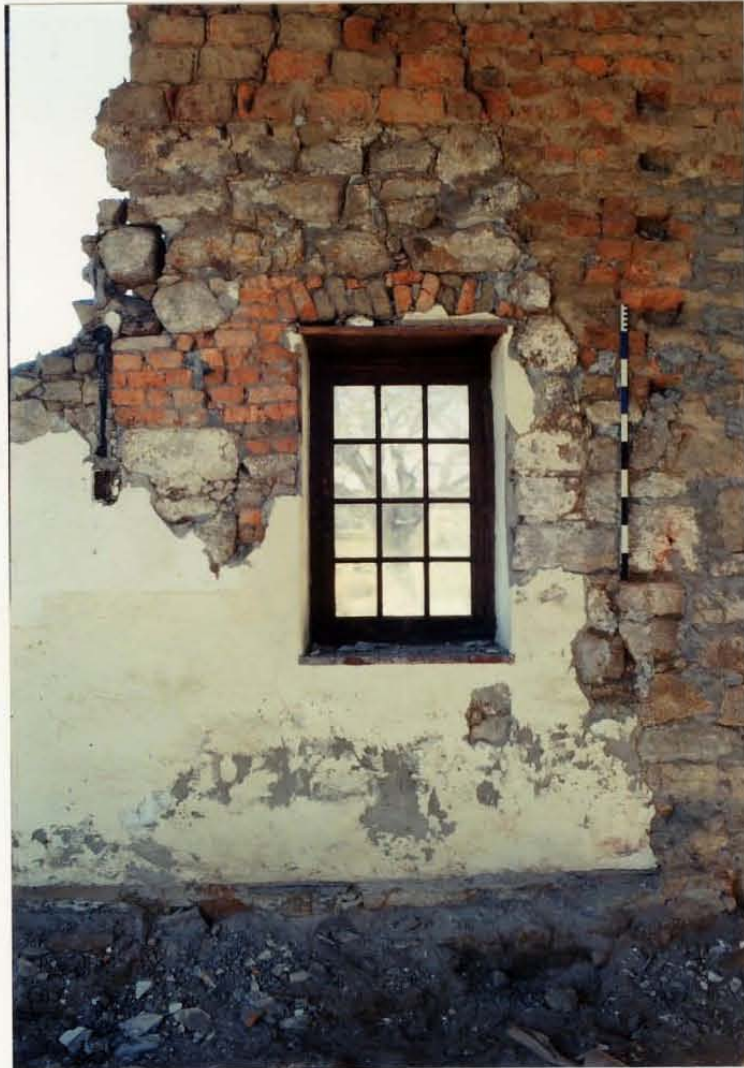
The building pattern as described in the northern half of the barn extends as far as the small existing casement window to the south of the now demolished main entrance. Details of the structure at this point can be seen in Plates 3 and 4. Of note is the change in the height of the stone portion of the east wall at this point and the accompanying increase in the amount of brickwork. Particular note should be made of the discontinuation of the use of large bricks. The small casement window is clearly a later addition and may have been inserted into an existing wider aperture but this is not clear.

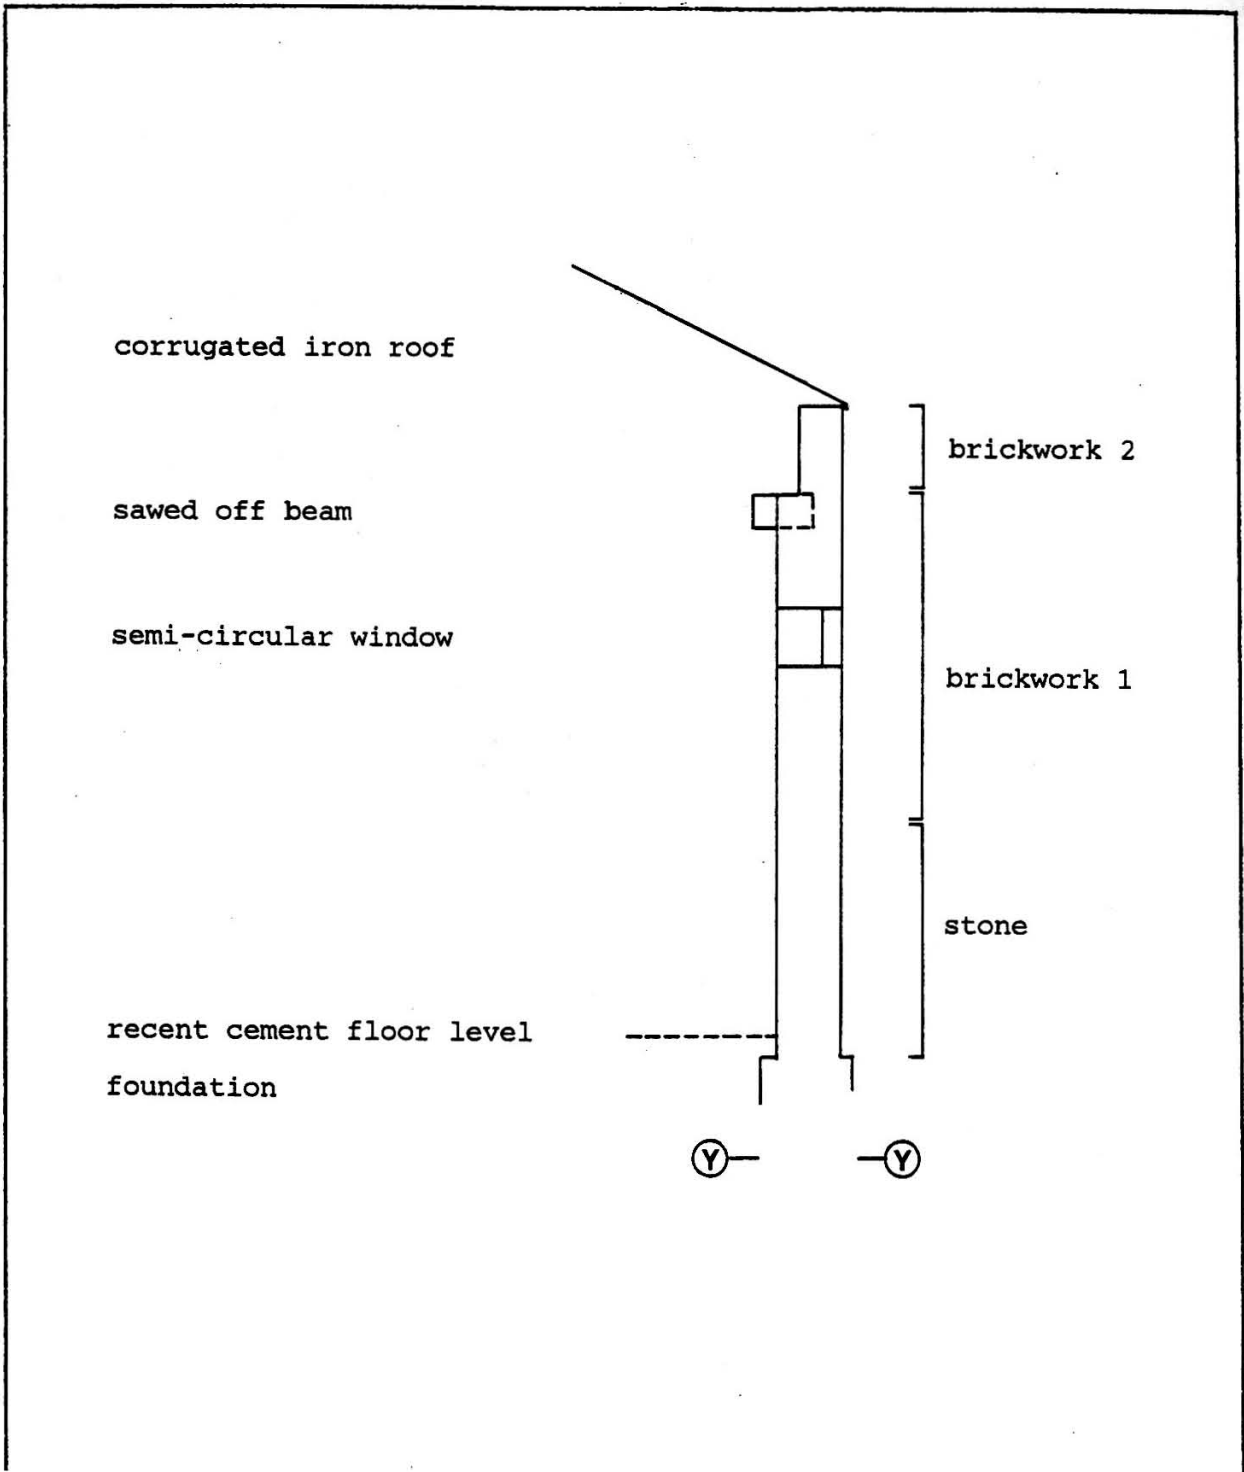
**3**

A schematic diagram showing the various building materials used in the east wall is presented in Figure 3.

In our opinion this part of the cellar is later in age than most of the northern section. The similarity in the stonework between the two halves is probably due to the fact that at least a portion of the stone was derived from the demolished southern wall of the original structure. While we cannot entirely rule out the possibility that a low stone wall was in existence at the same time abutting the building in the north section (kraal or low roofed building), it would be unusual and we consider this to be an unlikely scenario.
