AN ASSESSMENT OF STONE RUINS AT THE SITE OF THE PROPOSED EXTENSION OF BORROW PIT DR01264/9.8/L/75 ON THE FARM “THE REQUEST” 547, CALEDON

(In terms of Section 38 of the NHRA of 1999)

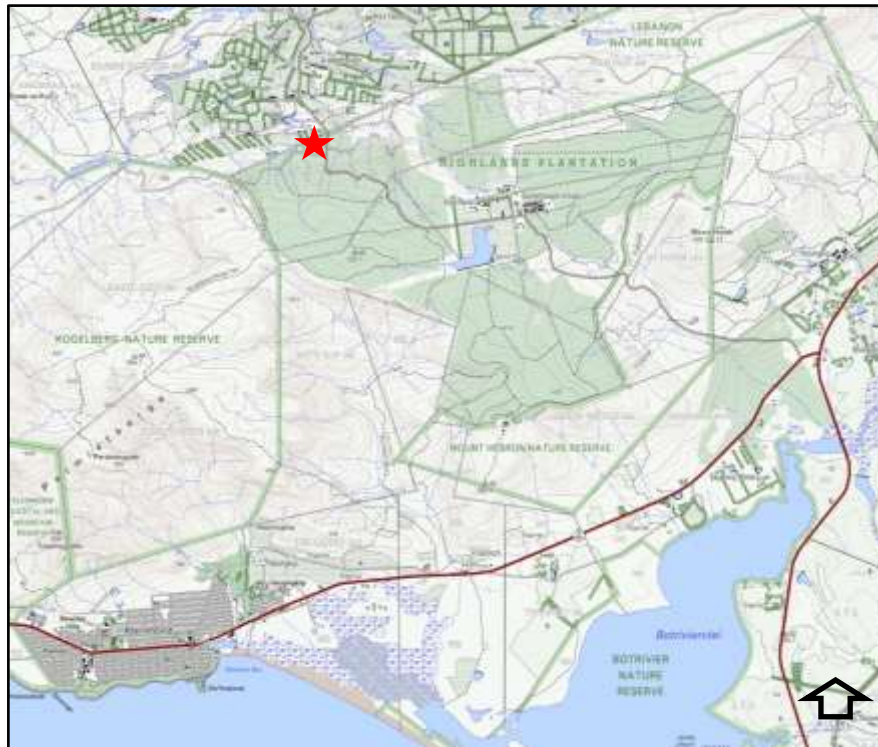
Figure 1: Location and context of the site, marked by the red star (3419AC Hermanus: Chief Director of surveys and Mapping)

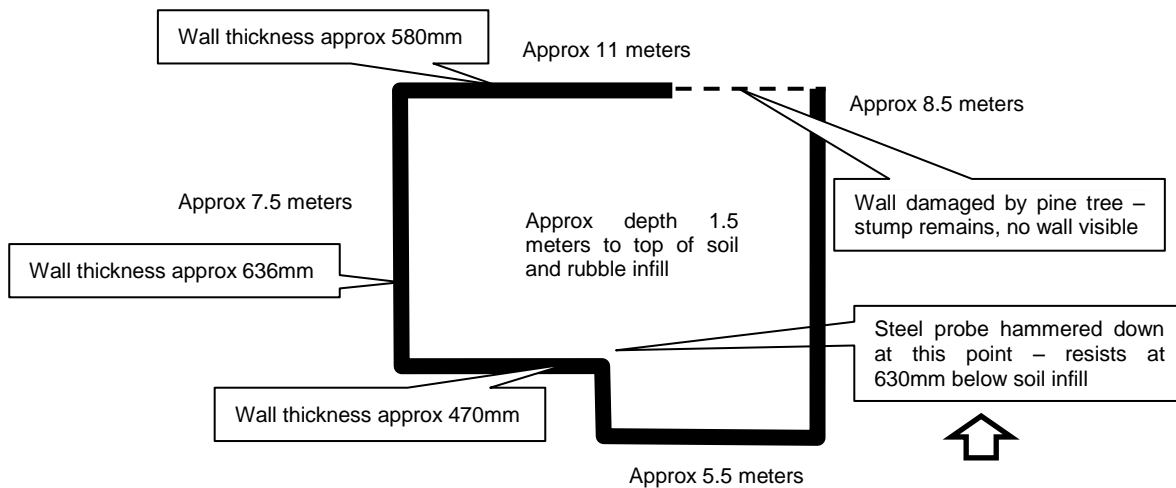
Figure 3: Sketch plan of the possible industrial structure

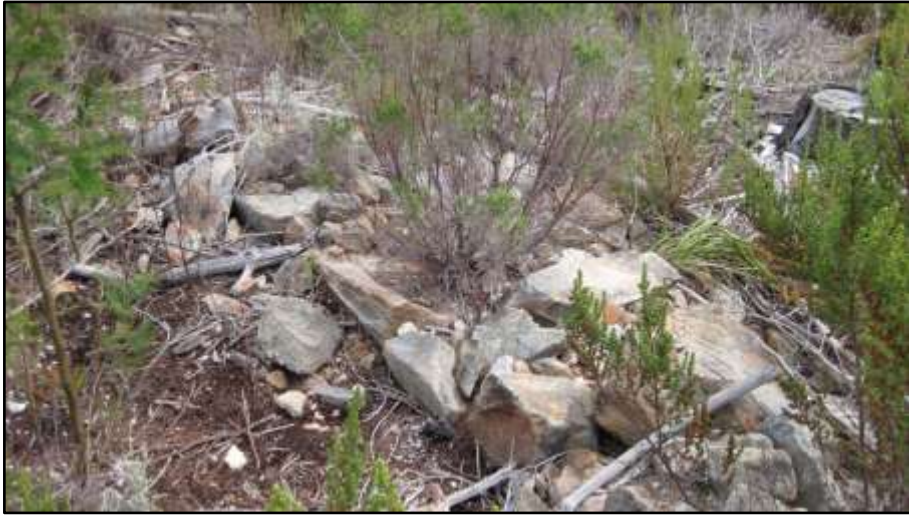
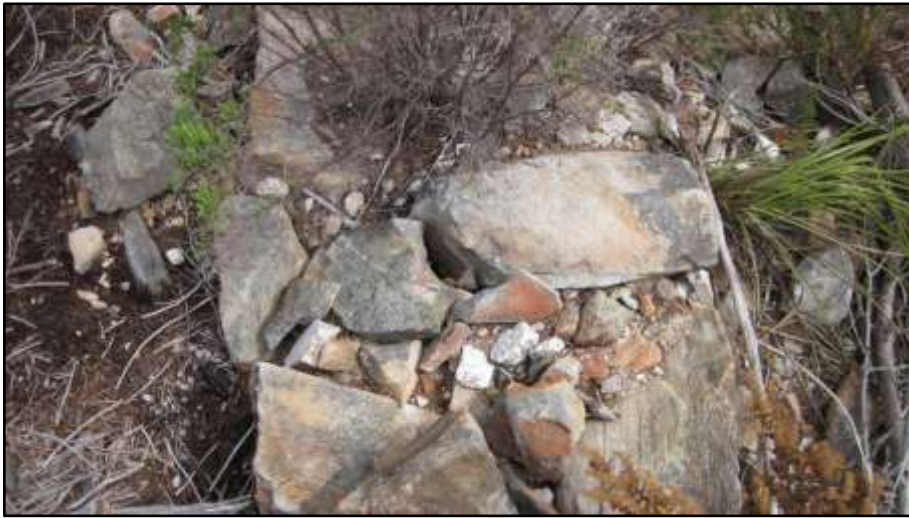
Plates 4 and 5: The walls of structure 2 are substantially overgrown and damaged by subsequent plantation growth. In places however the foundations are well preserved.
