ARCHITECTURAL HERITAGE ASSESSMENT

APPLICATION TO DEMOLISH EXISTING BUILDINGS

For the proposed expansion of Africanos Country Estate
on Portion 228 to a portion of Portion 74 of the farm Commando
Kraal, Estate no.113, near Addo in the Sundays River Valley Local
Municipality, Sarah Baartman District Municipality, Eastern Cape,
South Africa.

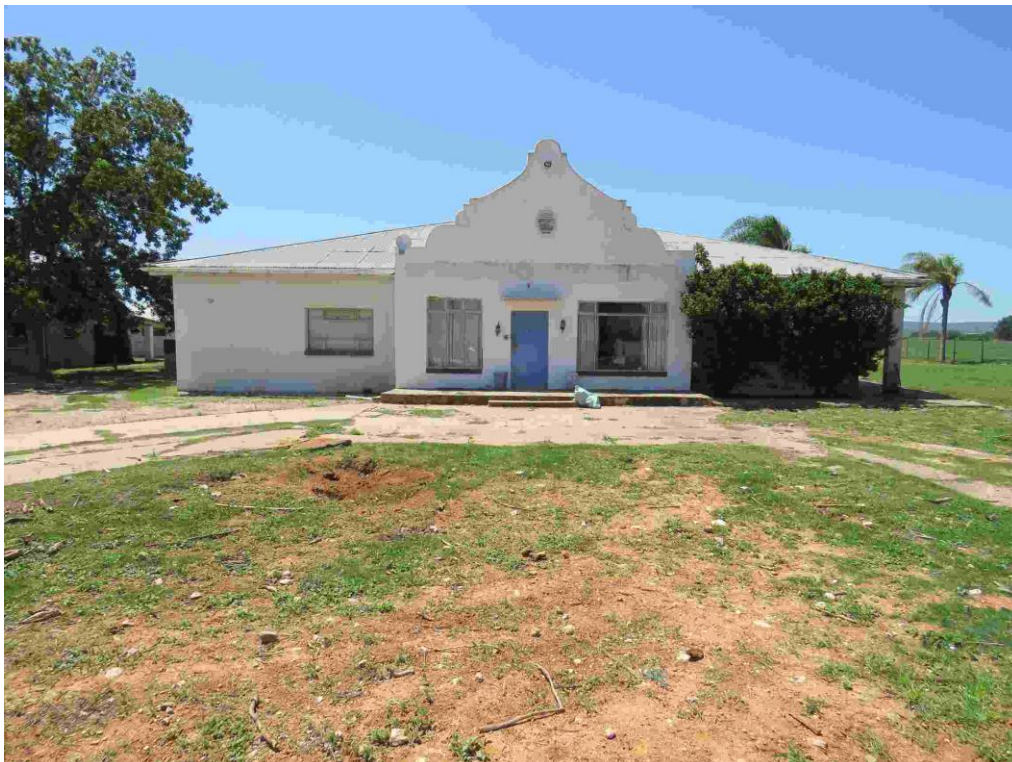
Fig. 4: Front facade of the Farmhouse

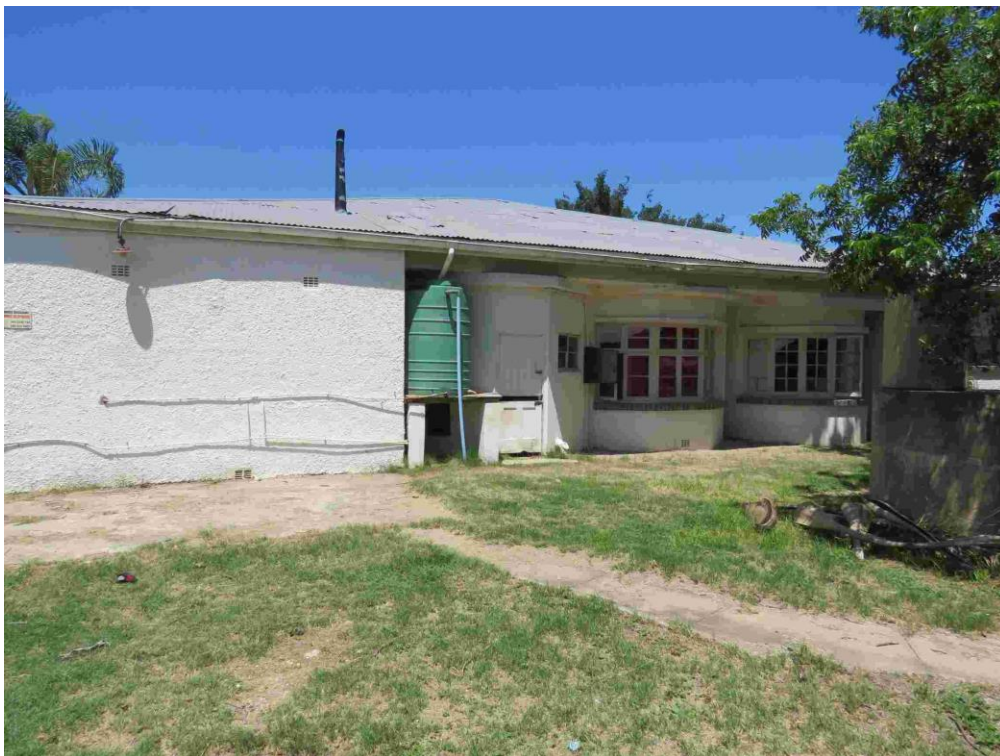
Fig. 6: North-west view of the farmhouse showing bay windows which have been added to the original farmhouse

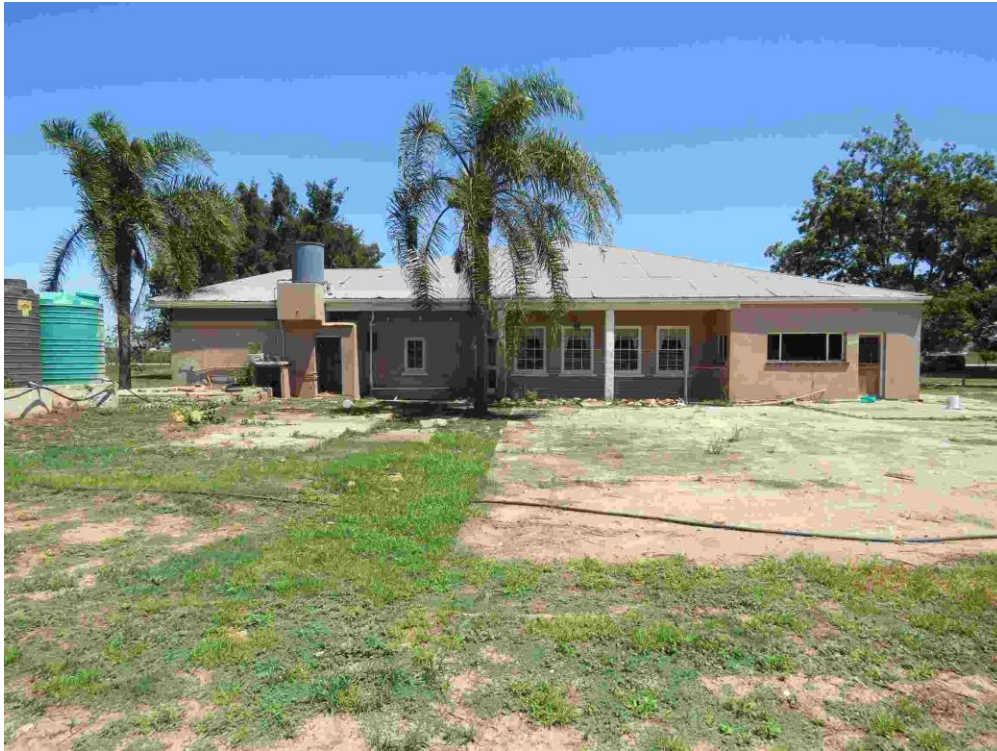
Fig. 7: Rear view of the farmhouse

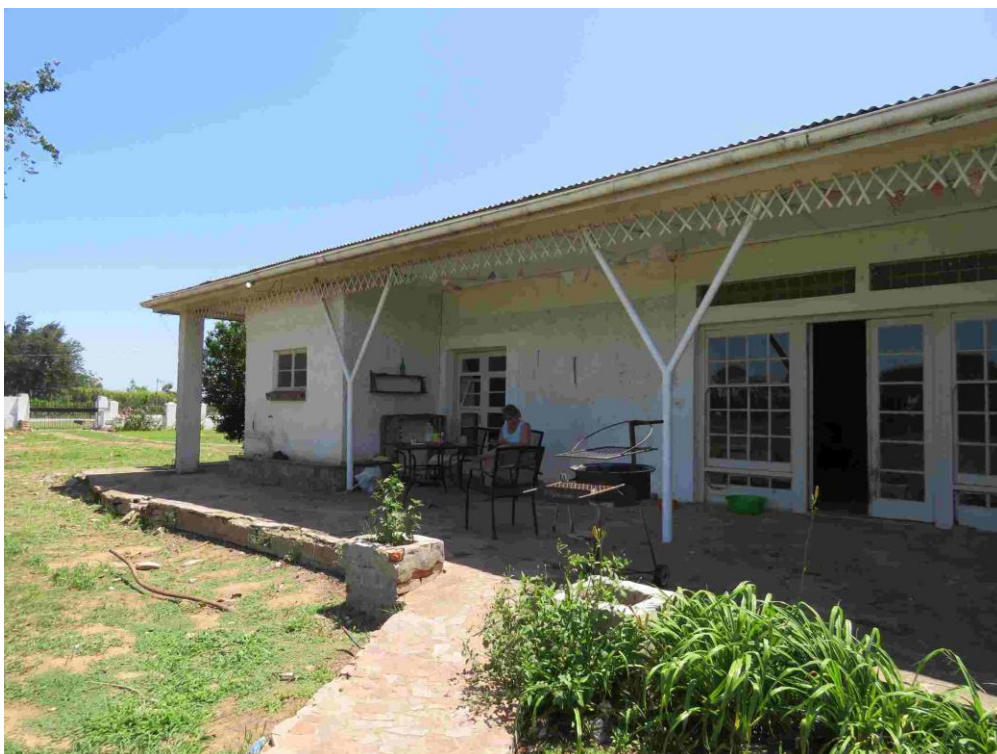
Fig. 8: South-east side of the farmhouse showing relatively new verandah with steel-frame supports, dating back to around the 1960s

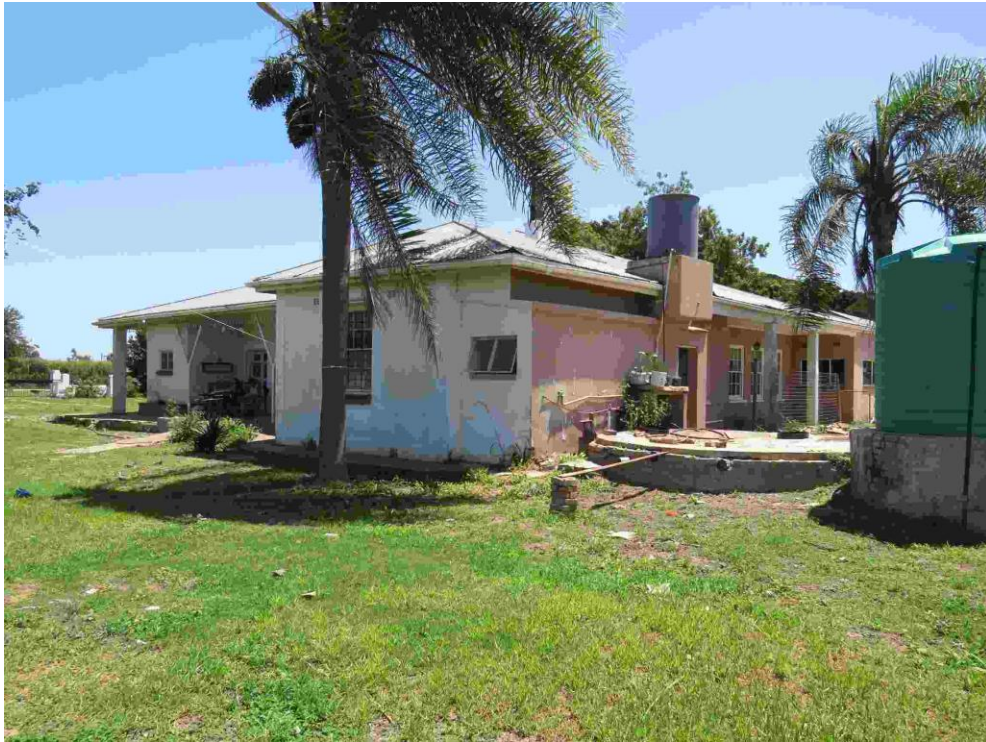
The building has not been maintained for many years, and several cracks are evident in the structural walls, and there is also evidence of leaks coming through some of the roof junctions.

Fig. 9: View of the farmhouse showing peeling plaster, cracking walls and general state of disrepair due to lack of maintenance

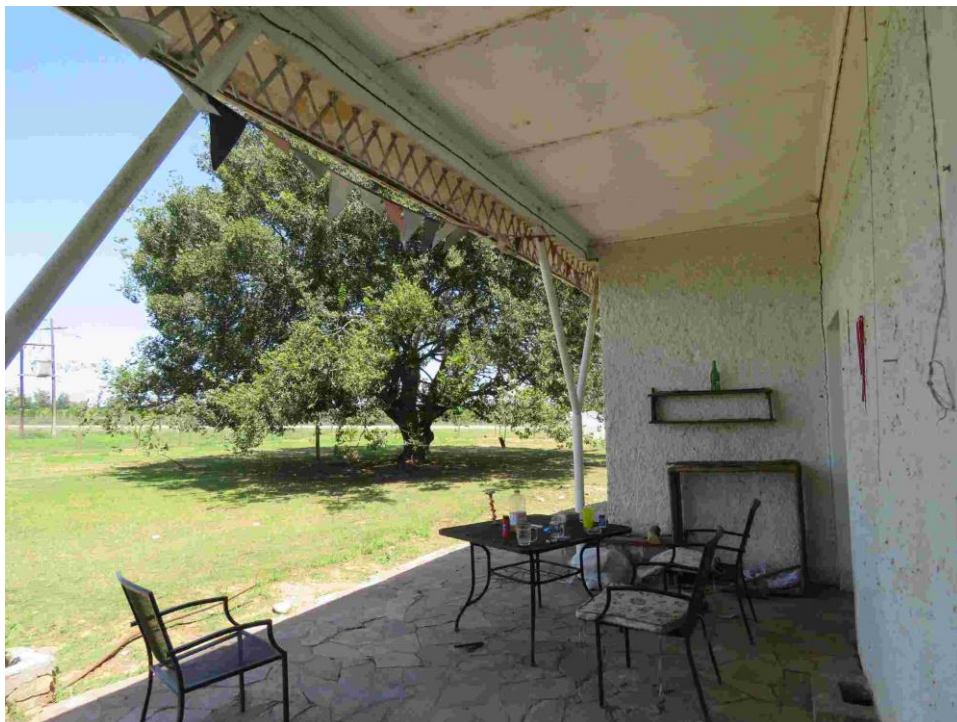
Fig. 10: Closer view of verandah addition

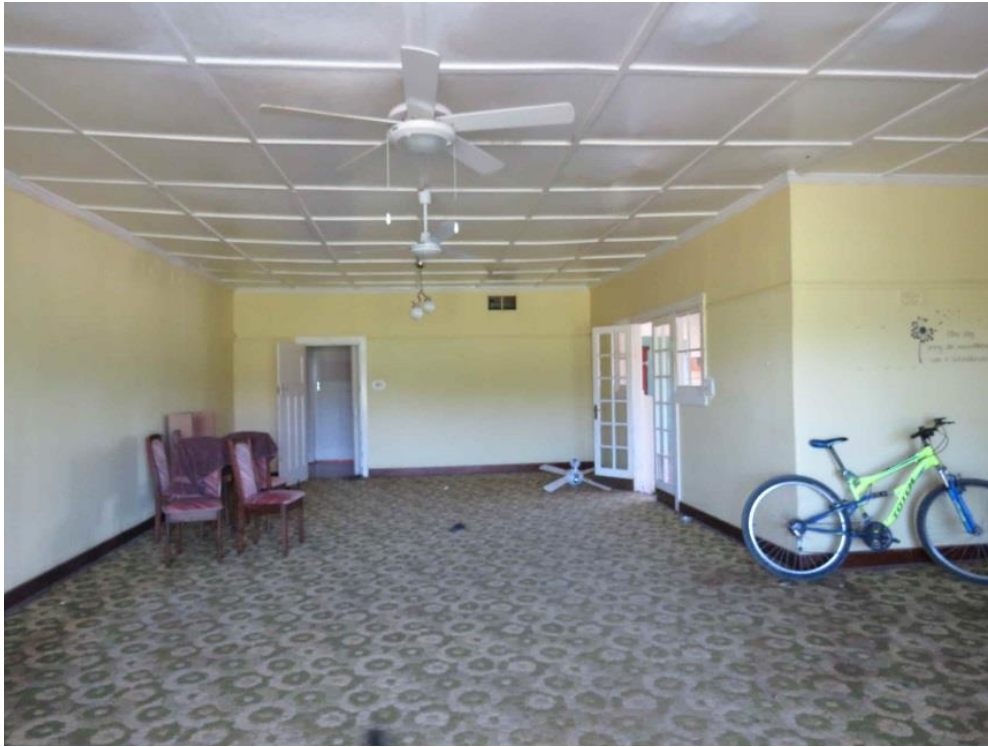
Fig. 11: An unoccupied room inside the farmhouse, showing sagging ceilings. The door on the far right of this photograph is one of the external doors of the original farmhouse

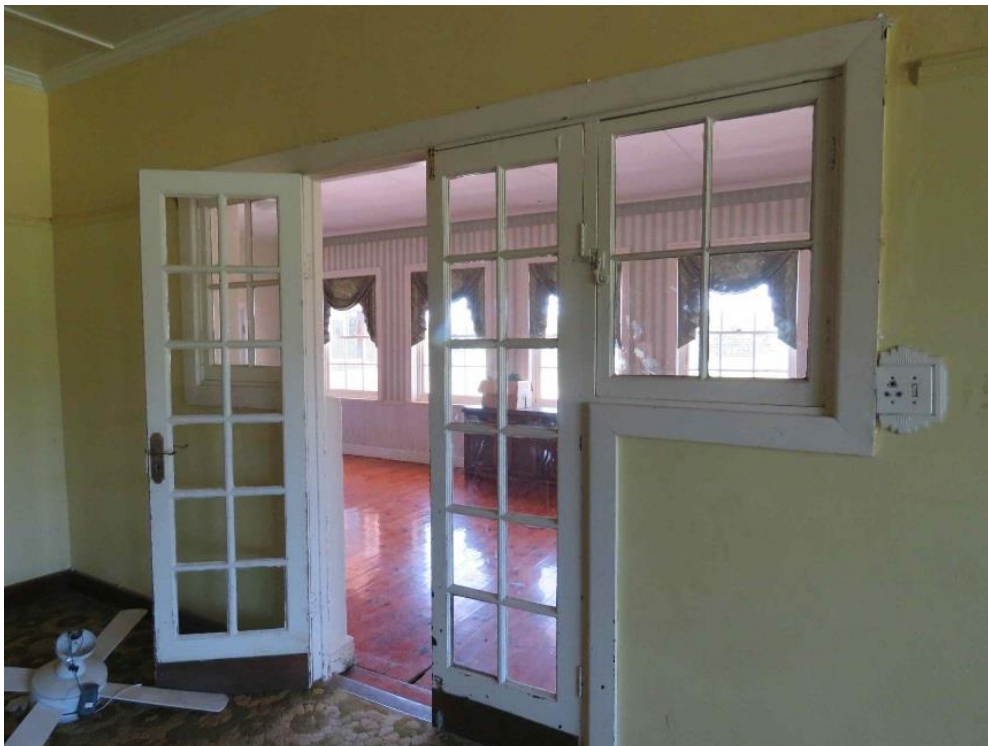
Fig. 12: Closer view of the external doors to the original house, which are now internal due to an extension

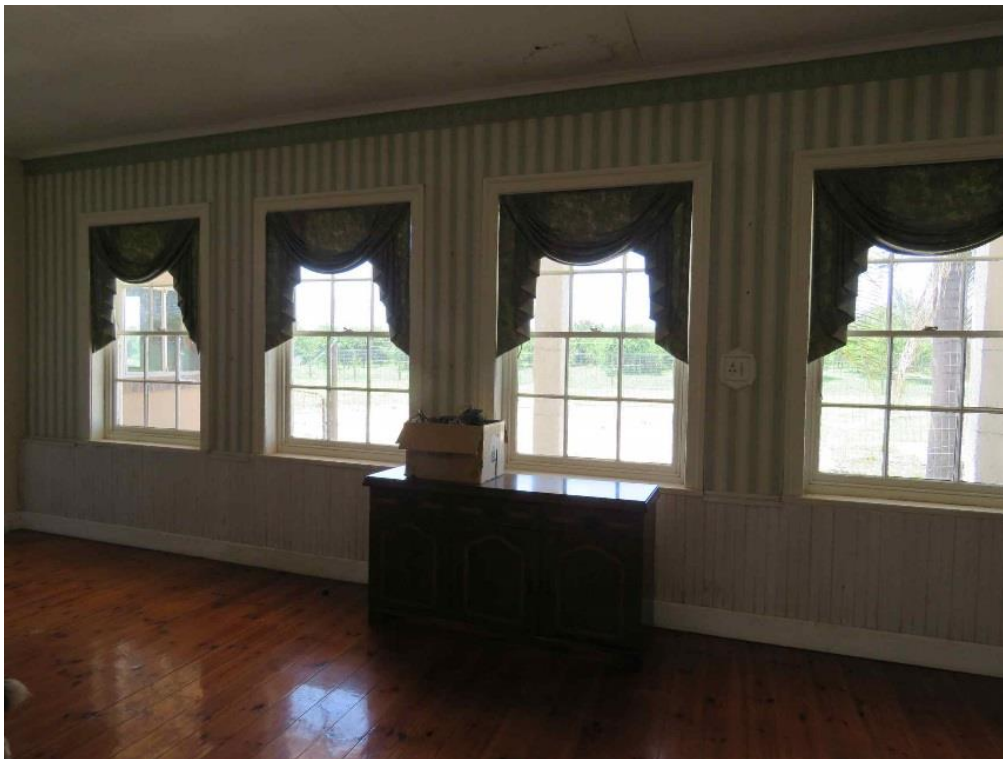
Fig. 14: Internal view of additions to the original farmhouse

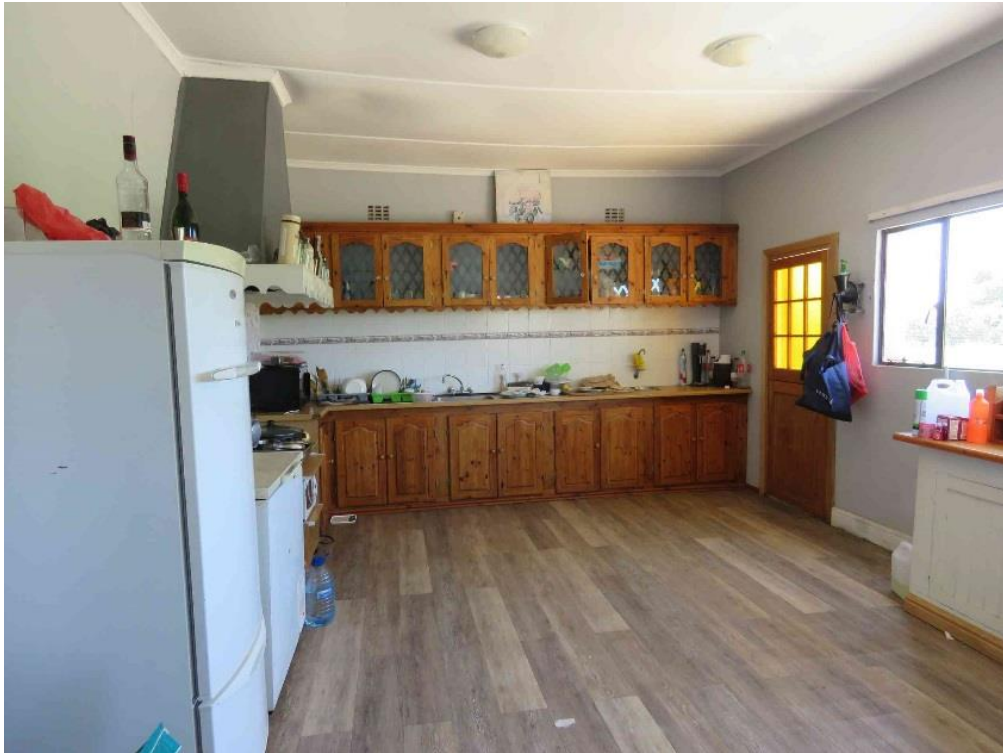
Fig. 15: Internal view of kitchen which was possibly added in the 1960s, showing steel-frame windows

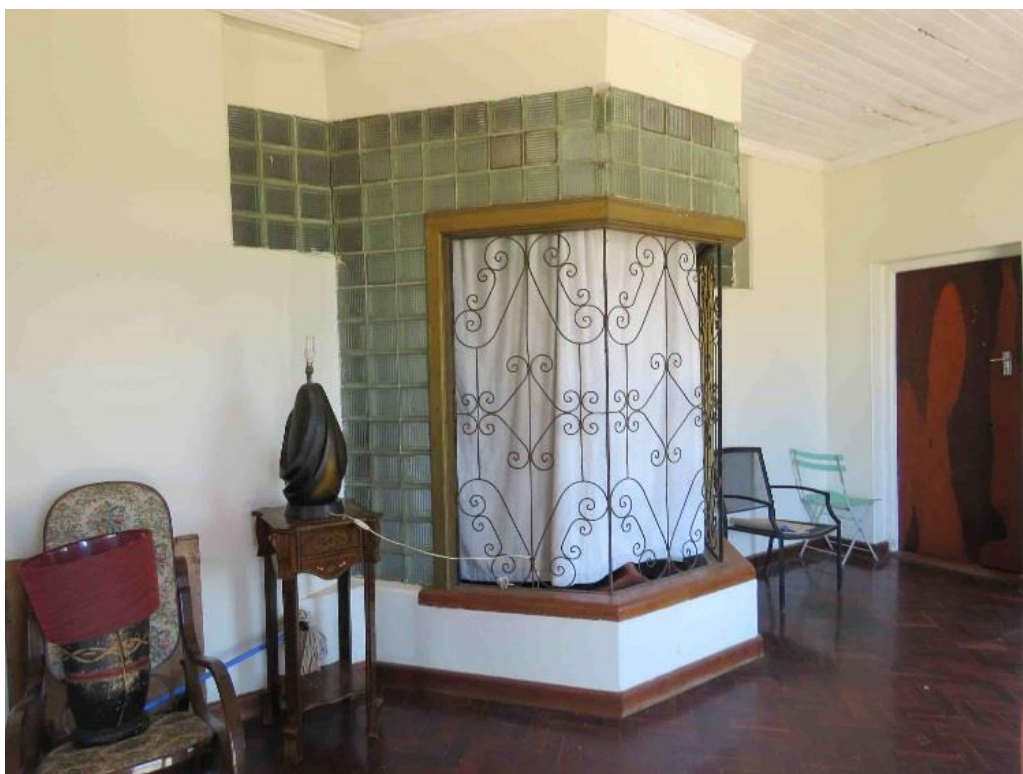
Fig. 17: View of recent ad-hoc alterations, showing no concern for the architectural character of the original farmhouse

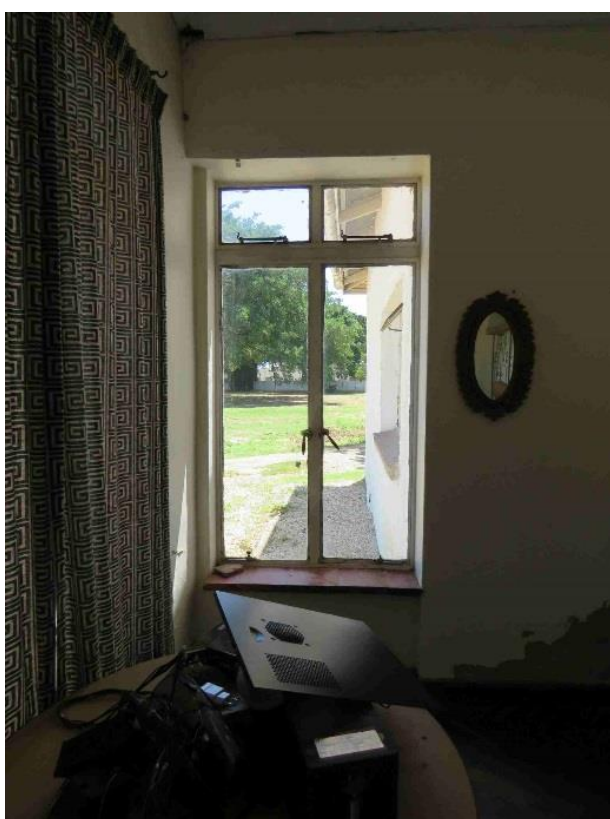
Fig. 18: Internal view of additions to the front of the house, showing steel-frame windows, in contrast with original timber-framed windows and doors

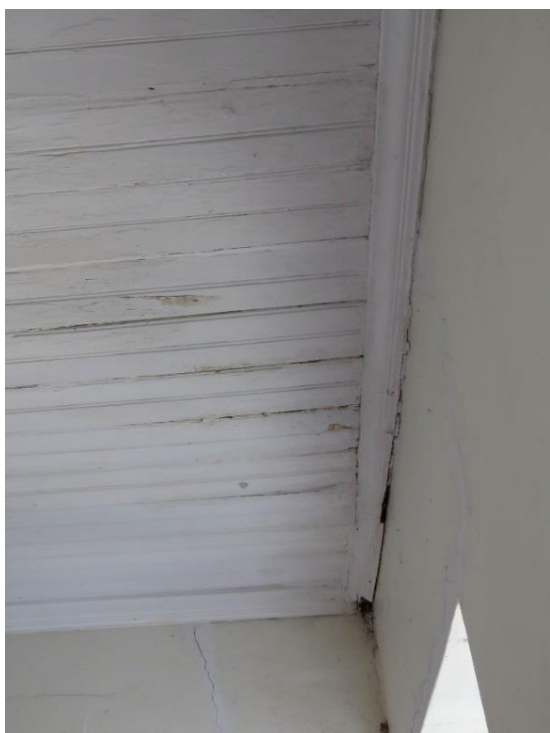
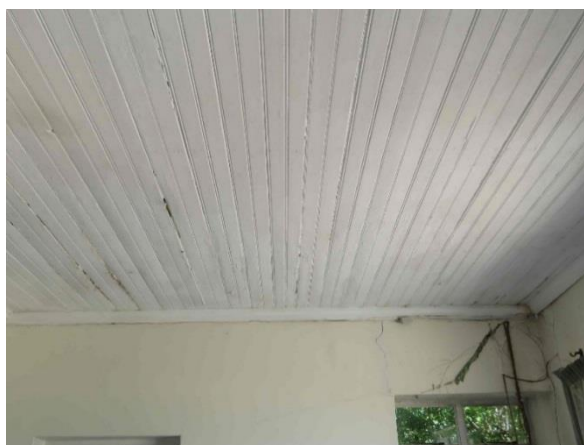
The existing building is therefore a mixture of several different architectural styles and materials, and the result is a structure which has no architectural or heritage value. In addition to this, the building is in a poor condition, with broken roof sheeting, which must lead to water leaks, as well as several cracked walls.

Figs 19 & 20: Ceilings showing evidence of leaks from the rusted and poorly maintained corrugated iron roof sheeting

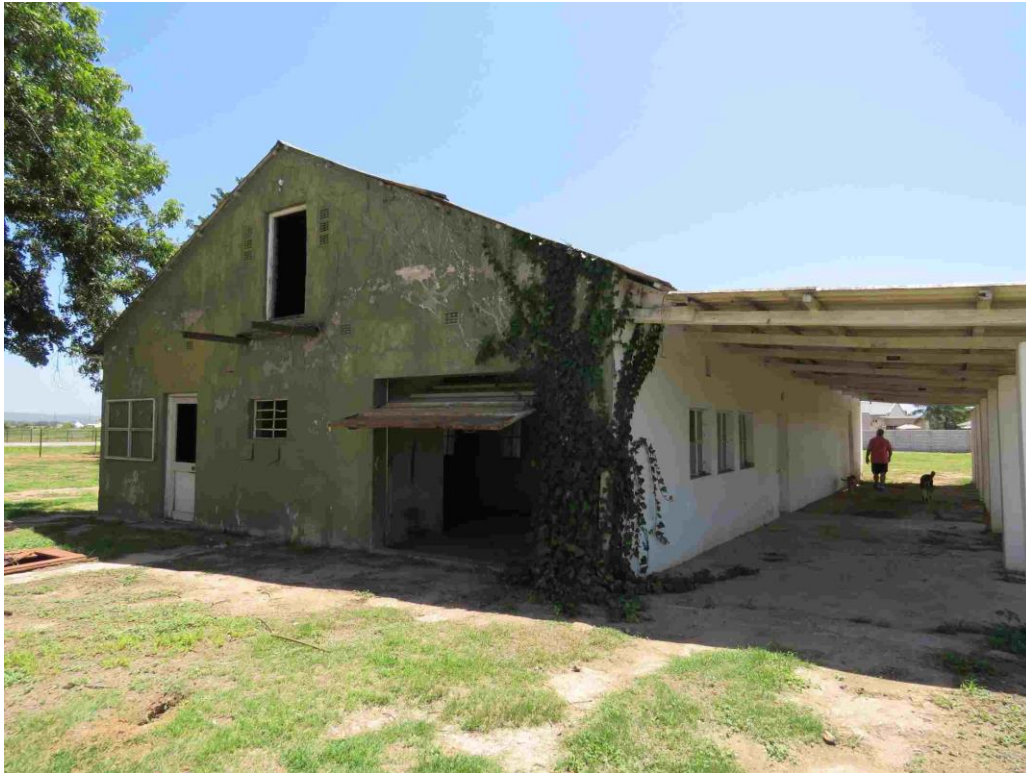
Fig. 21: Rear (north-east) view of the shed showing pitched roof with lean-to roof on columns

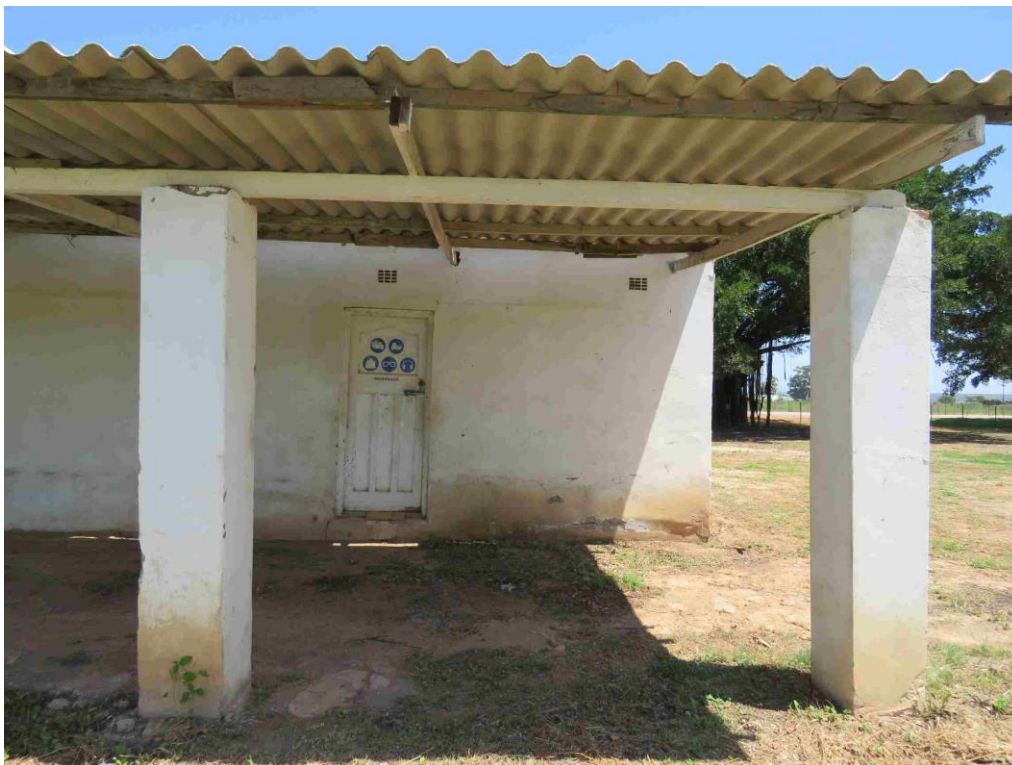
Similar to the farmhouse, the shed building does not have any historical or architectural value, as it is eclectic and in a poor condition. It shows evidence of rising damp, as well as leaks from the poorly-maintained corrugated iron roof.

Fig. 24: Rear view of shed building, showing new asbestos roof, as well as evidence of rising damp

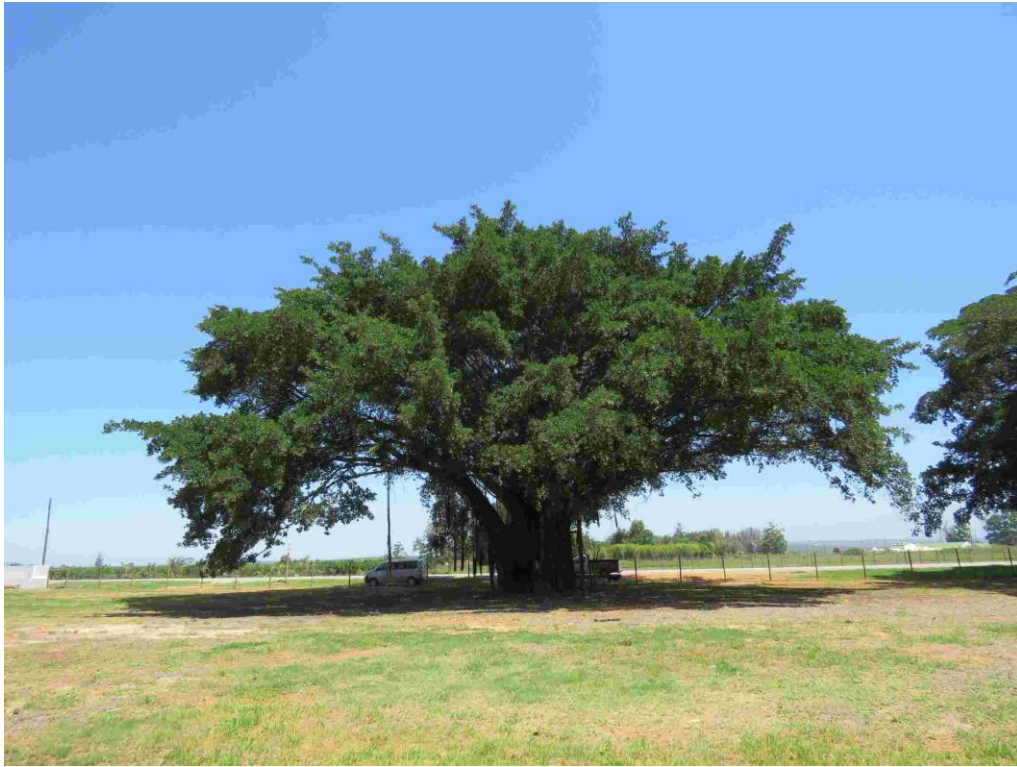
Fig. 28: Existing fig tree which is situated in the proposed parking area

It is, however, recommended that the existing trees on the property are preserved as they are very old and well-established. Some of them are situated in the area where the proposed parking lot will be situated, and could provide valuable shade to cars. In addition to this, they will break the monotony of the immense parking lot, which is totally inappropriate to the rural context. In this respect, it is strongly recommended that the proposed parking area be divided into smaller parking lots between the buildings and the trees. This, in addition to the presence of the trees, will visually “soften” the proposed development as the site is in a rural, not an urban context. I therefore strongly recommend that all the existing trees form part of the new development.

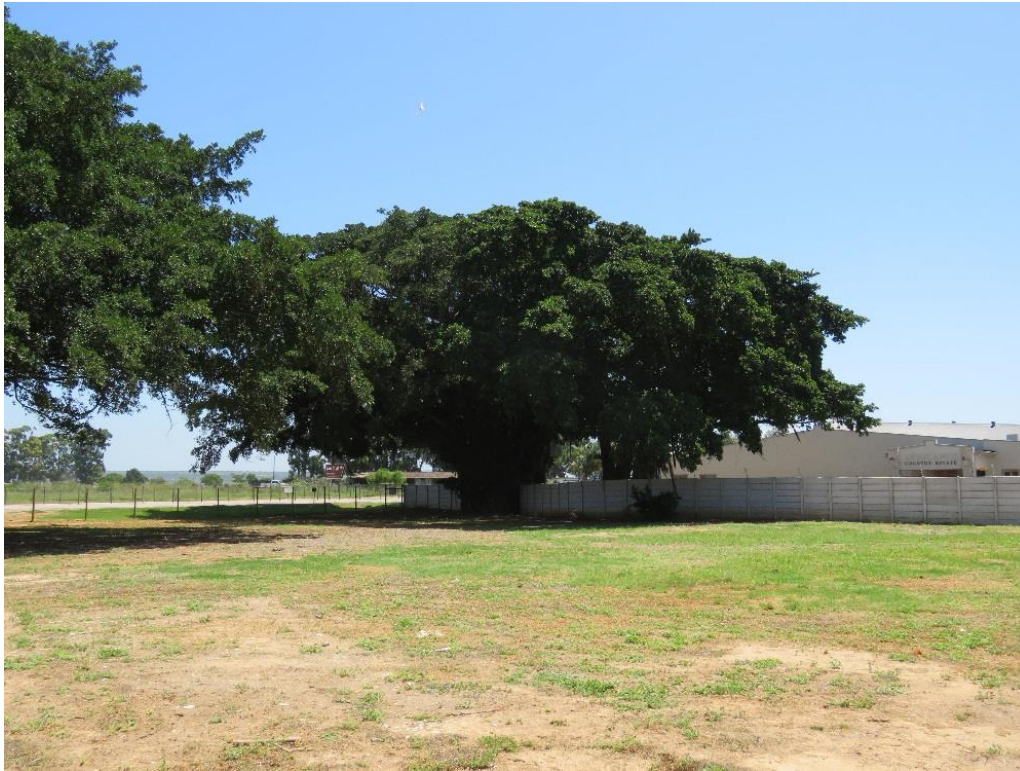
Fig. 28: View of the boundary between the existing Africanos Country Estate and the proposed development area, showing huge fig tree on the boundary
