**The archaeological survey of rock art sites in
the ~3km radius of the Sonae Novobord (Pty)
Ltd, Rocky's Drift, Mpumalanga**

For Sonae Novobord (Pty)

Date: 29 October 2006

**By Gavin Anderson & Louise Anderson
Umlando: Archaeological Tourism and Resource
Management**

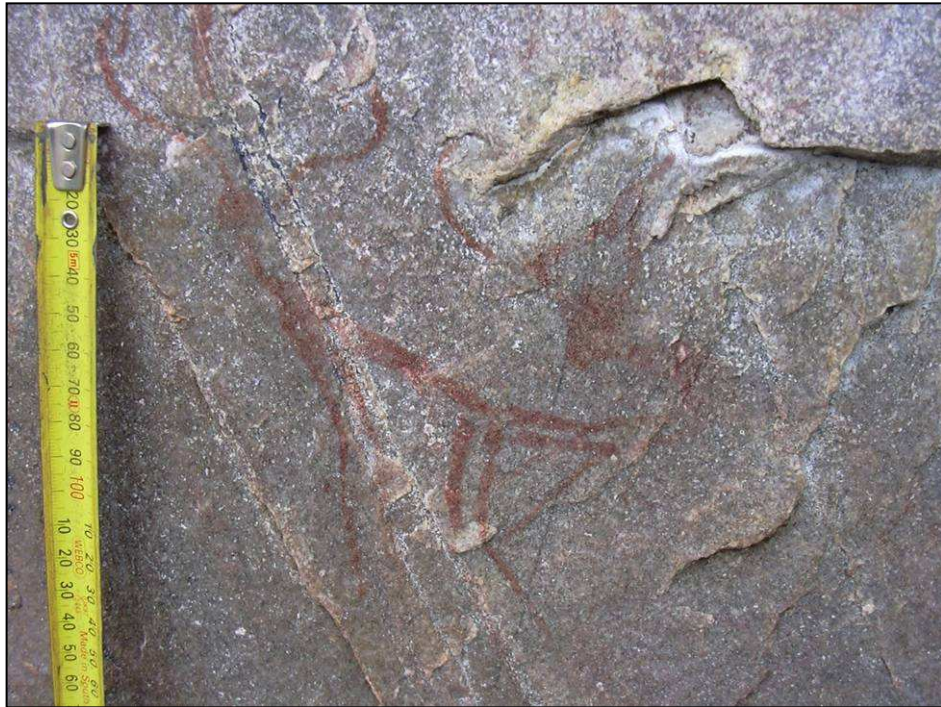
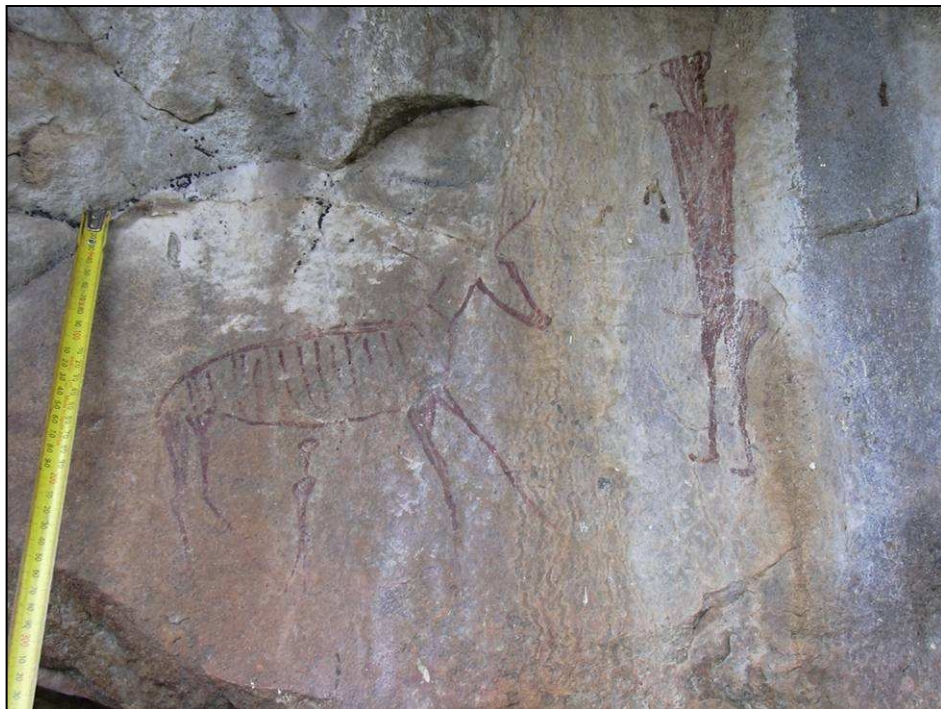
FIGURE 1: PANEL AT BOT1

Art is situated in 3 main areas. On the far left it is very faded. In the middle are three outlined images; while on the right are a series of several images. This will deal with the images from right to left (Fig 1).

Long line ending in two possible feet facing left. To the right is an outline of the rump and tail of an animal. Approx. 60 cm below is an impala-type of animal (horns are curved). The animals are in a medium faded state of preservation.

Just below this are two humans in a bending forward position (Fig. 1 top). Right human is holding onto the hips of the left human. The former is only visible from the torso upwards. Both humans have Nguni cattle-type horns on their heads. These are in a medium faded condition. Below this is a faded human facing left. Only the upper body remains. The human is holding a bow.

Around the corner, to the left, is the second or middle frieze (fig. 1 bottom). This frieze consists of two antelope and one human. The outlines of these images are fairly well preserved despite the water erosion. The water has, however eroded the non-red paint. The main antelope is a possible bushbuck, (although it could be a nyala or kudu) facing the human. I suggest bushbuck due to the size of the horns, tucked tail and stripes on the mouth area. The stripes on the body and mouth are still clearly visible. Below this antelope is the rear view of a possible similar antelope. The human is a male with an erect penis and signs of steatopygia. The important feature is that the lines of the bushbuck are reproduced on the head and torso of the human.

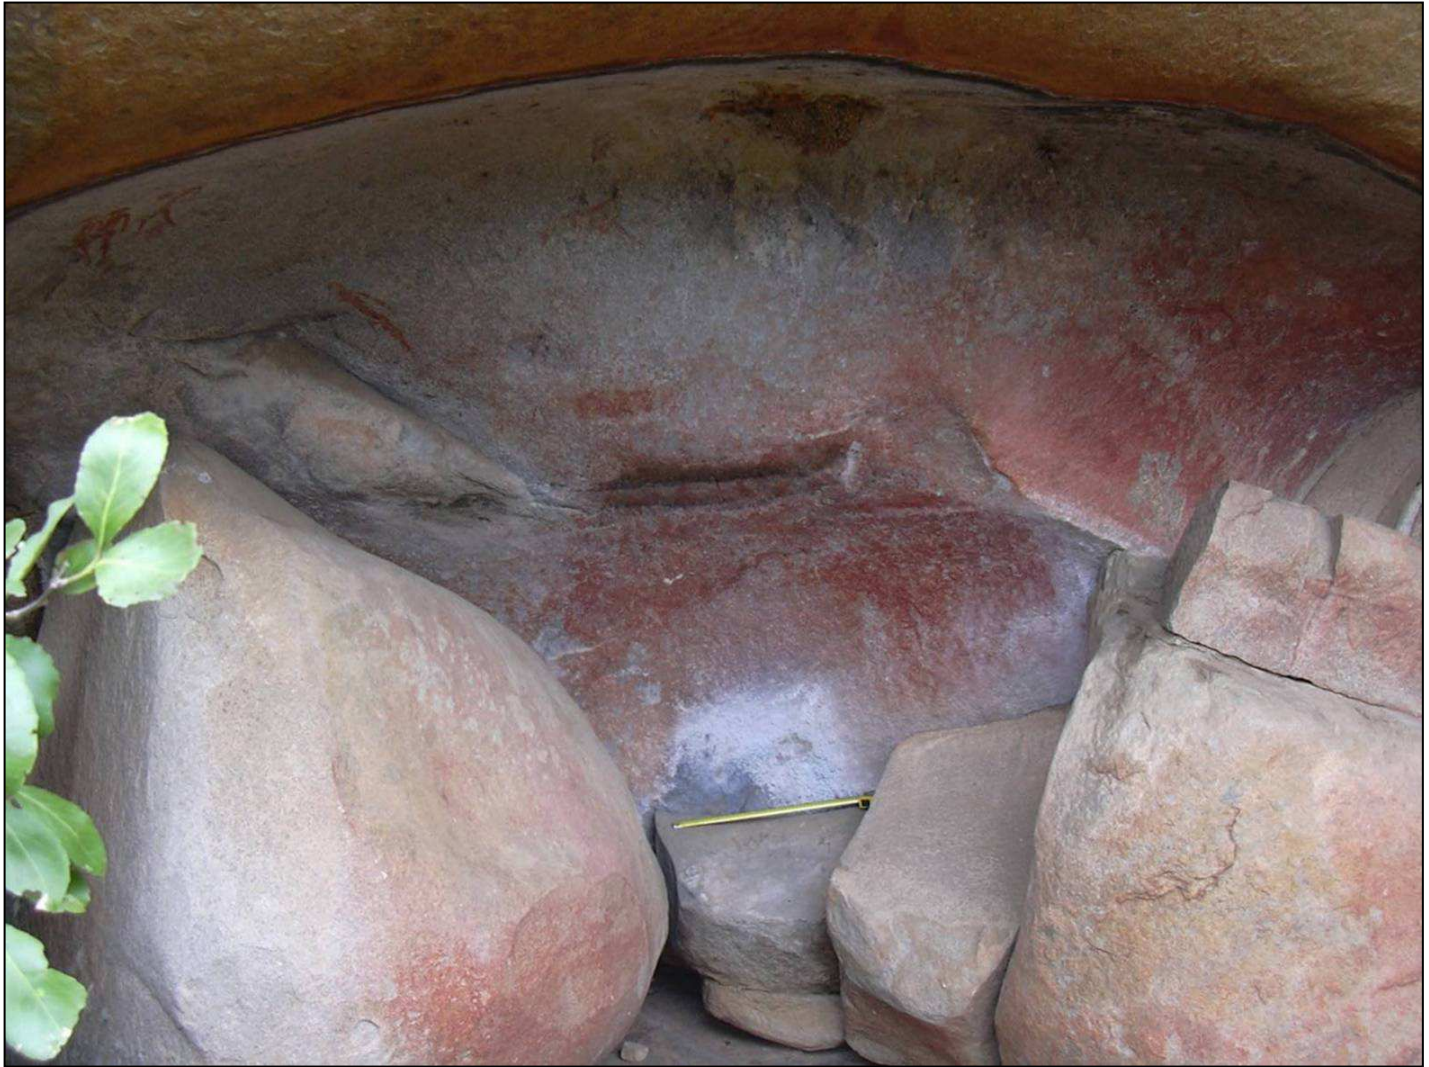
FIG. 2: GENERAL PANEL AT BUNDU

This site consists of various panels on three boulders (Fig. 2). The main panel is located in an exfoliated area. A part of this area is washed by water and the art is poorly preserved. Other areas of the boulder are fairly well preserved. Two other panels exist on two separate boulders. Both of these panels are poorly preserved as people viewing the art at the main panel have rubbed them.

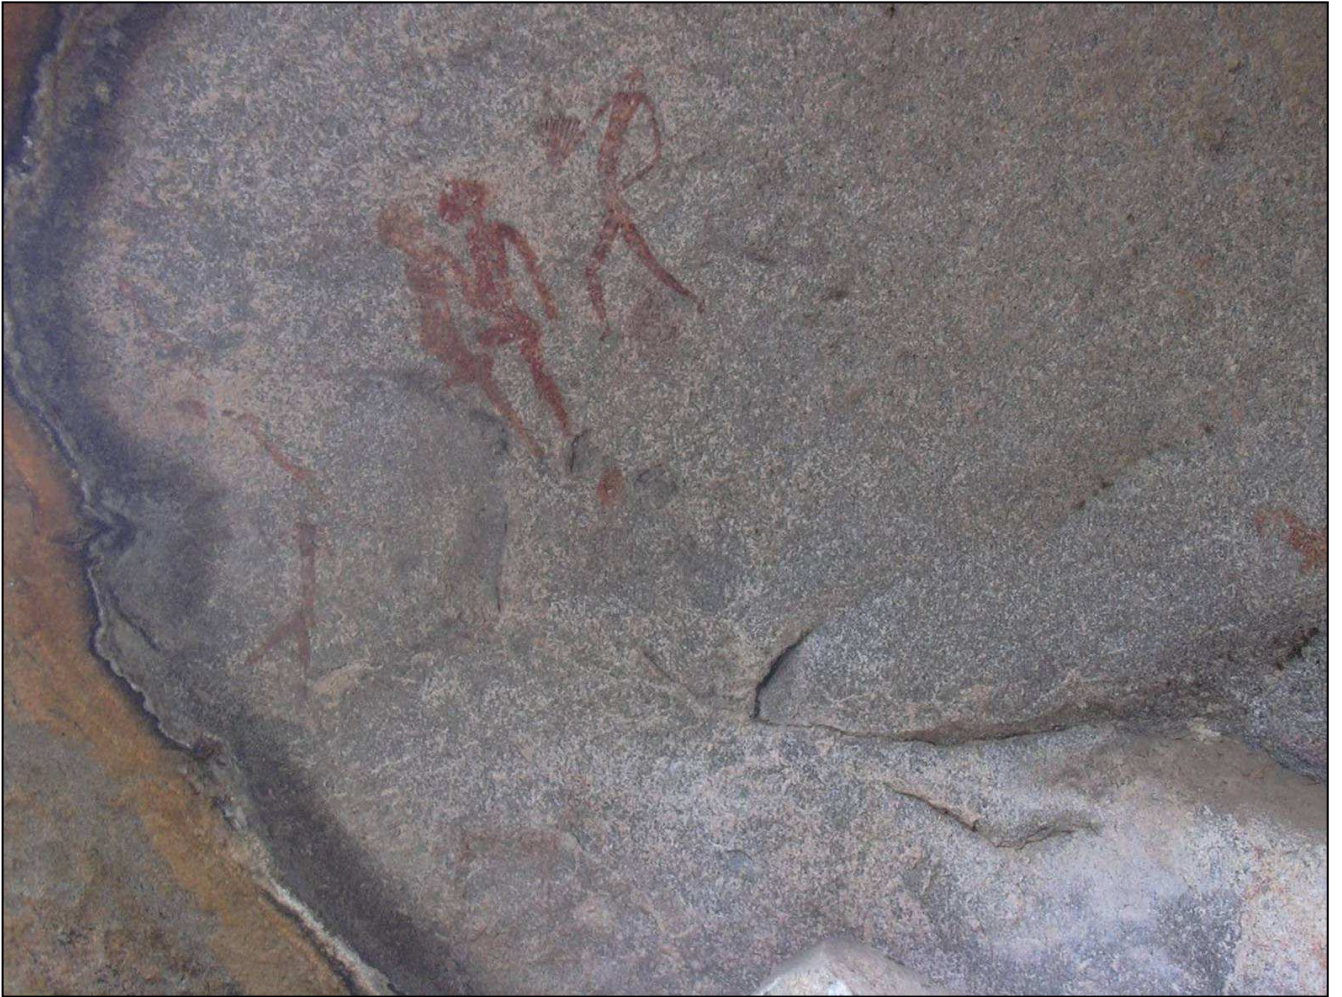
FIG. 3: IMAGES OF HUMANS AND ARROWS AT BUNDU

Panel 1 consists of four humans, one antelope and a few smears (fig. 3). The smears are in faded orange-red, with a faded human facing left. This human is carrying a bow and long stick, and possible quiver. There is a group of three males, all whom are facing left. The two left-hand side males each have one leg raised up. The middle human has had bits of its face chipped off, either in an attempt to remove the art or the ochre. The far right male is in a walking position and is holding a long stick, a bow and several arrows. The arrows are the most intriguing part of this image as they are composite arrows. The arrows consist of three parts (from bottom to top):

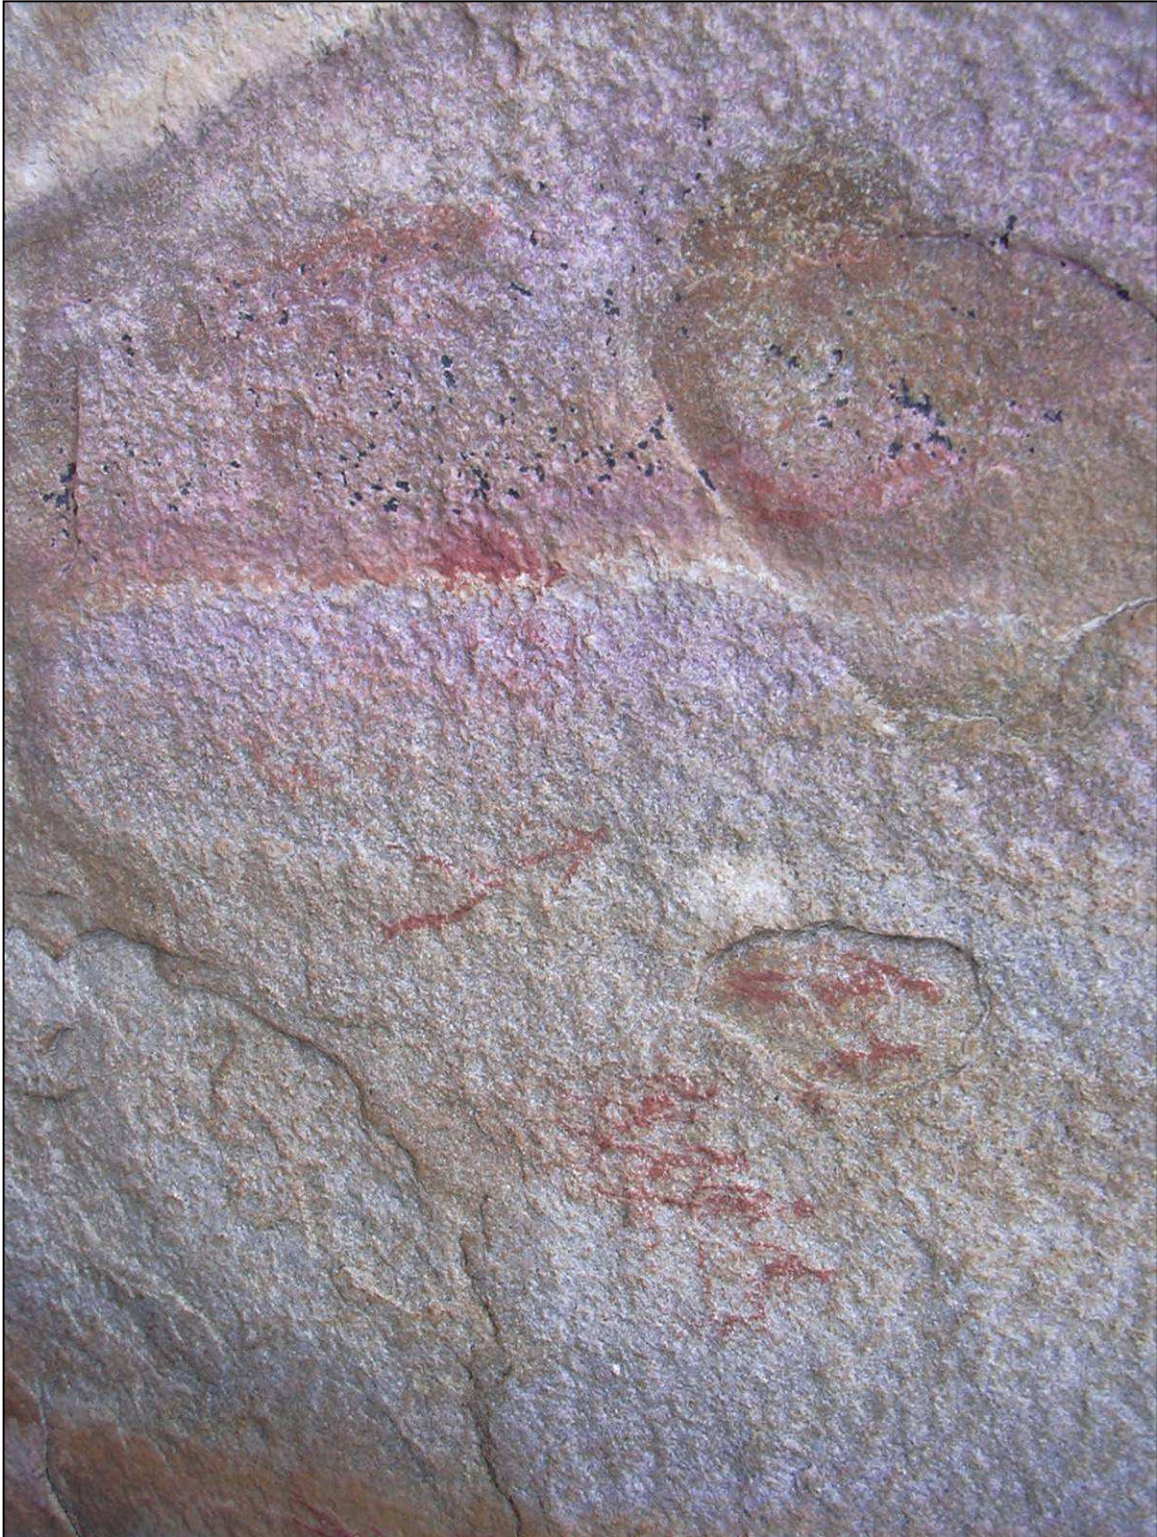
Fig. 4: GENERAL IMAGES AT ULOW1

The site is located between two boulders and is east facing. The images are poorly preserved as a result of water erosion (fig. 4). The top left human is very faded and painted on an exfoliated area. To the right are two faded humans who are also painted in an exfoliated area. The two humans are holding hands. The left-hand side human is facing right and standing upright, while the right-hand side human is facing left and slanting to the left. Below these humans is a single human (~15cm in height) facing the group of humans to the right and a small palette. There are four faded humans in this group and they are in a walking position, facing right. Below, and to the right, is a faded human facing right, in an exfoliated area. This human has been scratched and/or pecked.

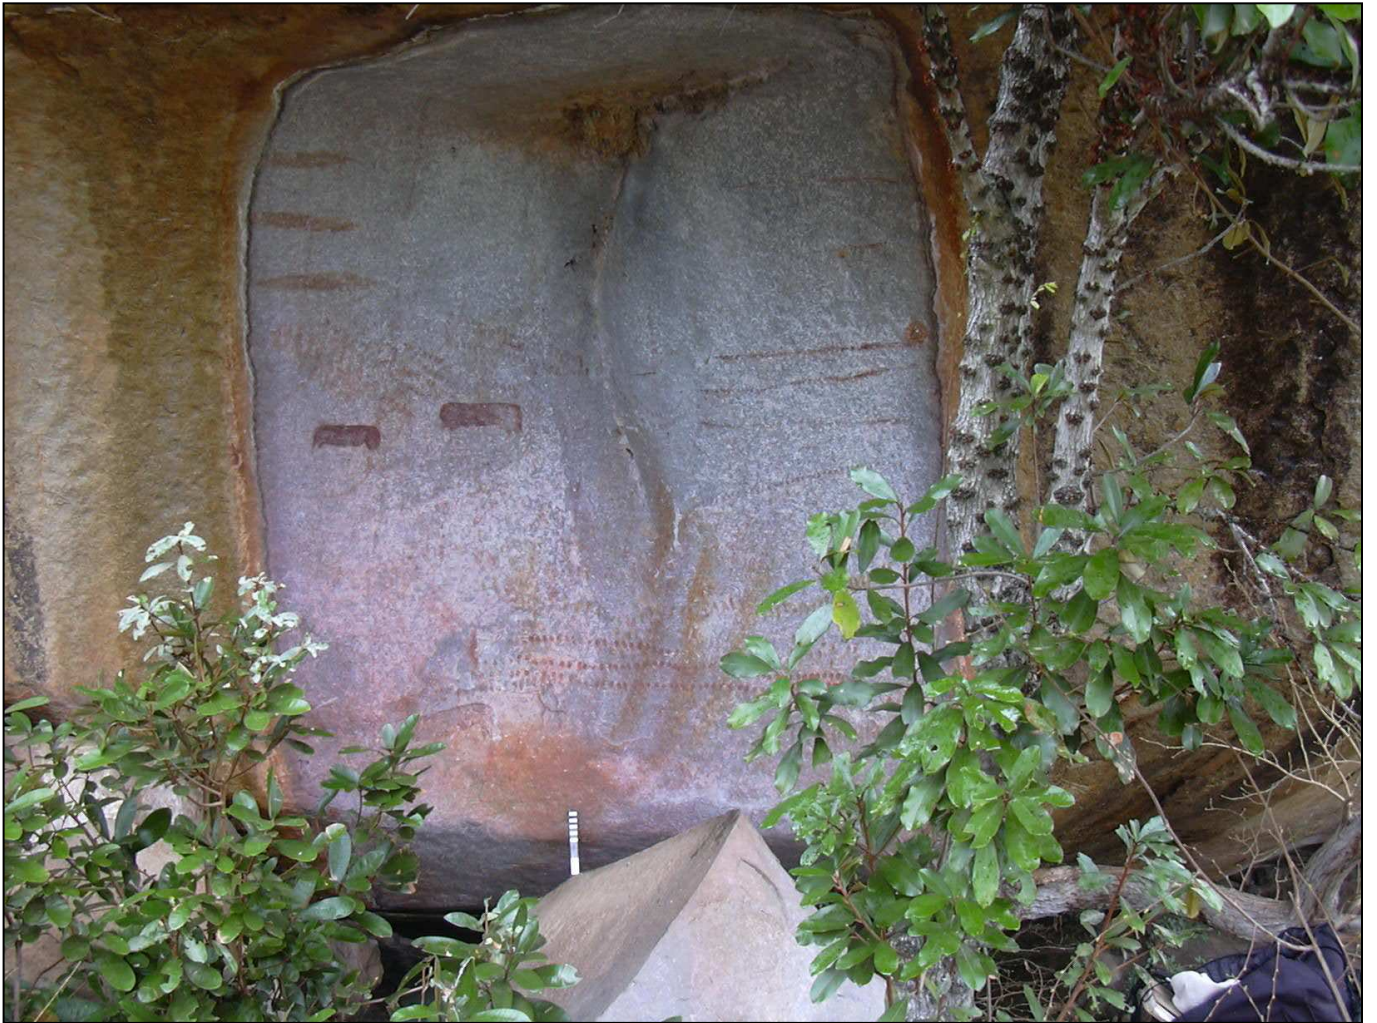
FIG. 5: GENERAL IMAGES AT ULOW2

The site is ~10m south of ULOW1, and is located on a large exfoliated section of a boulder that is northwest facing (fig. 5). This panel is of interest in that it has two different styles of painting, if not artists from different cultural backgrounds.

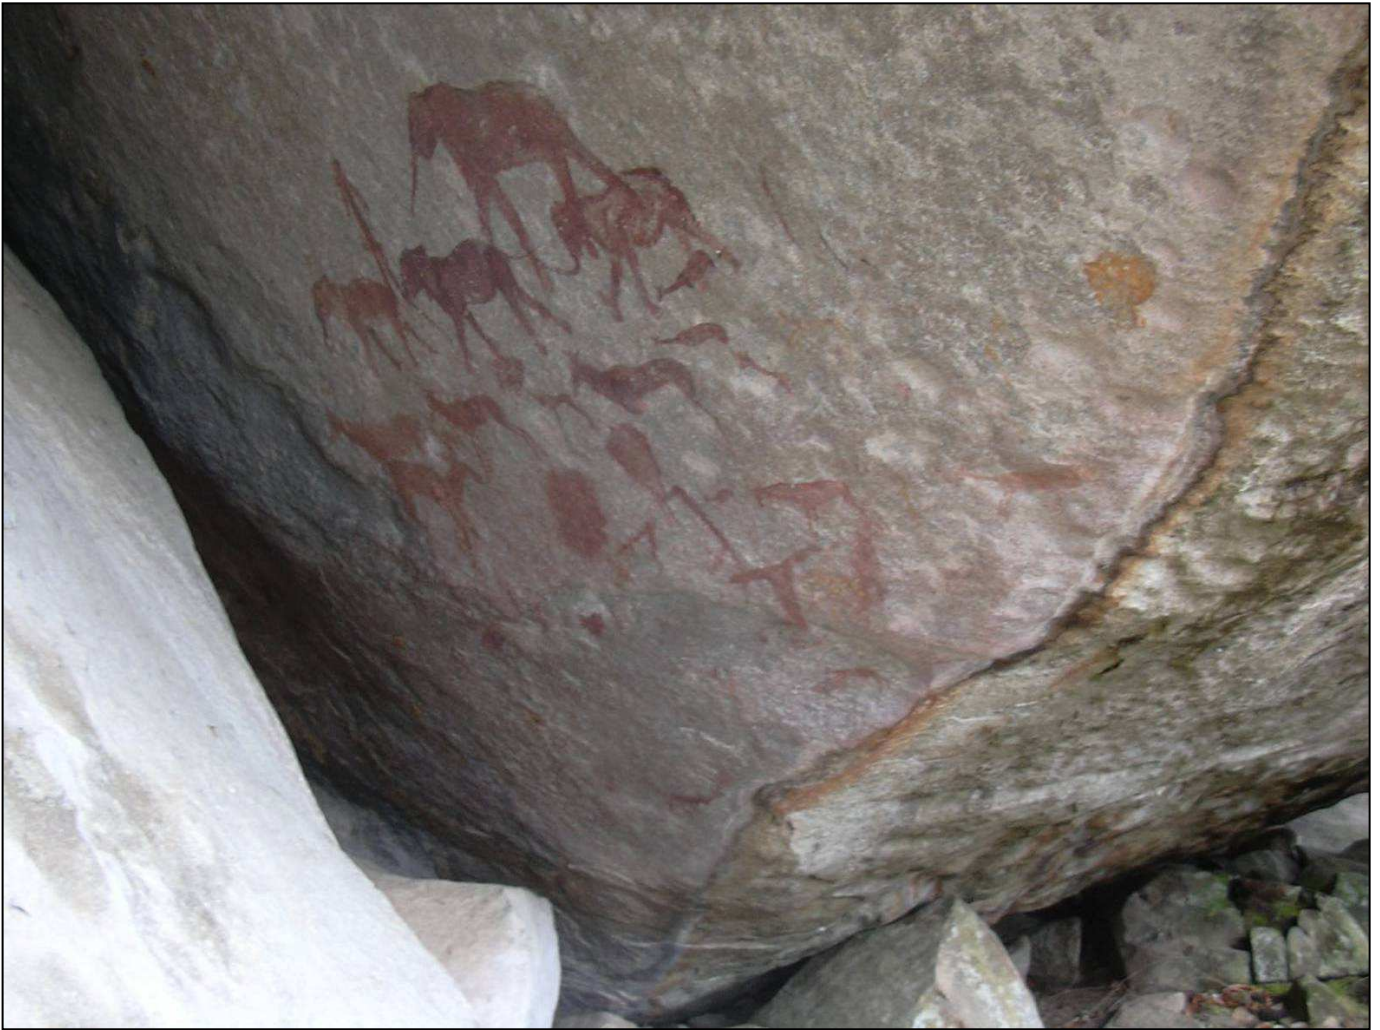
FIG. 6: GENERAL IMAGES AT ULOW3

The site is ~20m south of ULOW2 and is located in a crevice created by two boulders. The images at this site are fairly well preserved, and are probably one of the best preserved panels in this survey (fig. 6). There is pottery and stone tools on the ground.

- Row of four hartebeest (?) facing left in a reasonably well preserved state. On the far left is another hartebeest facing right. The main hartebeest has been chipped/pecked and with black pen/khoki graffiti.

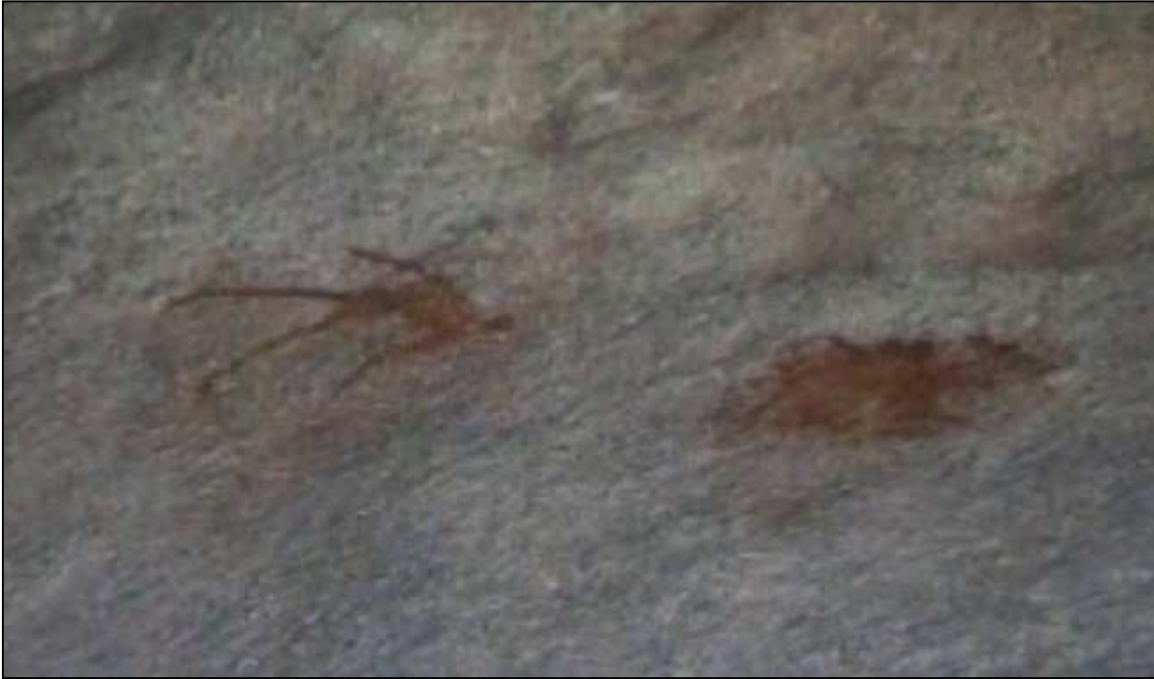
FIG. 7: GENERAL IMAGES AT ULOW4

There are two images at this site (fig. 7): one human and one palette. The human is walking downwards, or vertically. The palette may have been rubbed, or smeared. This rubbing or smearing would have been done intentionally.

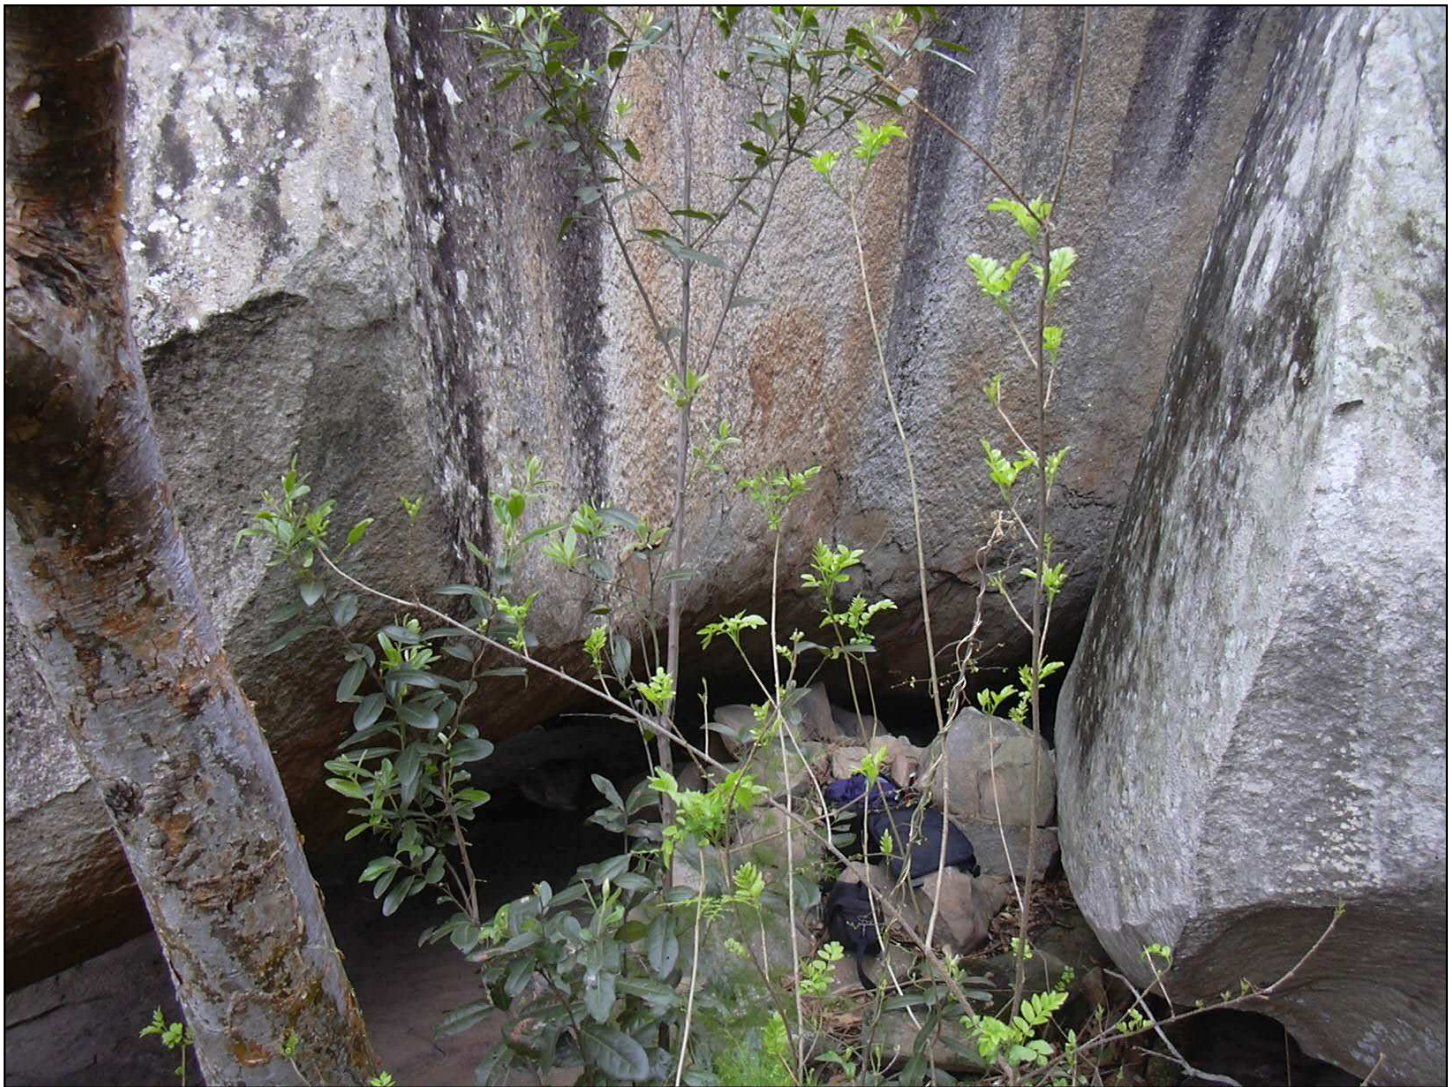
FIG. 8: GENERAL IMAGES AT ULOW5

The site is located on the other side of the boulder from ULOW3 and ULOW4. It is a large image, ~63cm in length (fig. 8). The painting is very faded and appears to be in a water seepage area.. The animal is facing right and has a long tail. The head was probably in a different colour. The animal could be either an elephant or an eland.
