PHASE 1 ARCHAEOLOGICAL ASSESSMENT OF ROBBEN ISLAND WORLD HERITAGE SITE.

April 2001

Archaeology Contracts Office

University of Cape Town

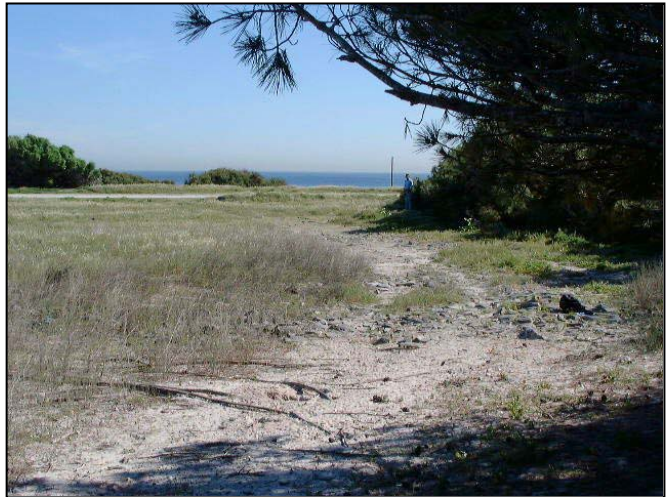
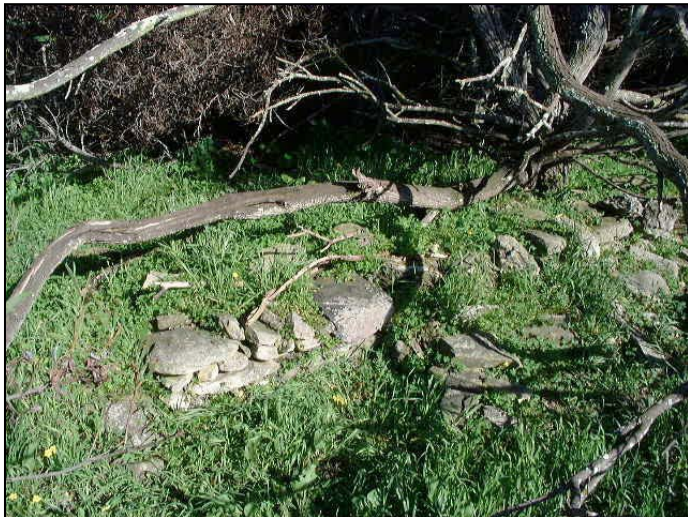
DESCRIPTION: The above waypoints locate a collection of stone walls, suggested in this survey to represent the remains of vegetable gardens of the DEIC period. These consist of a complex of tumbled down stone alignments, most of which are heavily overgrown and partially buried. The structures, which are visible on the 1985 aerial photograph of the island²⁶, take the form of a number of square enclosures, possibly representing the remains of small walled gardens established by officials of the DEIC. Each rectangular feature or field is about 30x50m - the stone walls designed to possibly keep penguins and sheep (owned by the DEIC) away from the crop. No less than 10 walled enclosures were identified, along with a many stone alignments that represent the remains of others that have been damaged or covered. Where wall alignments have been protected by thick bush, preservation is better. The alignments extend in a north westerly direction towards the perimeter road. An alignment is visible in the perimeter road while another is visible between the perimeter road and the shore.

VULNERABILITY: Movement of animals, roots of alien trees, and to some extent, vehicle movement is slowly impacting the walls. There is a wall alignment in the western perimeter road, which will be threatened by the proposed upgrading of the road.

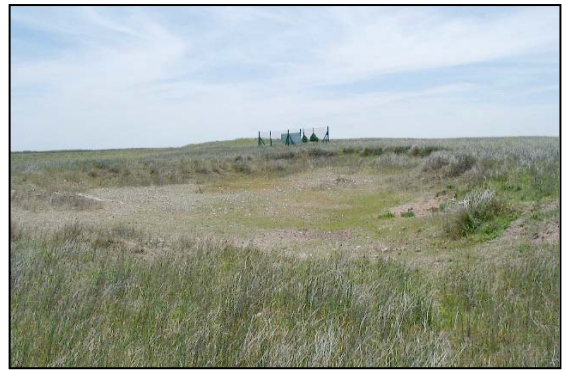
DESCRIPTION: A large shallow excavation into the calcretes and surface sand near the airport. This may be a borrow pit for sub-base for the runway.
CHRONOLOGY: ? WW2.
CONTEXT: Person made landscape feature.
LINKAGE: Geographical association with airport.
SIGNIFICANCE: Unknown
VULNERABILITY: Not currently impacted.
FURTHER RESEARCH: Oral history.
JPEG: wpt134.

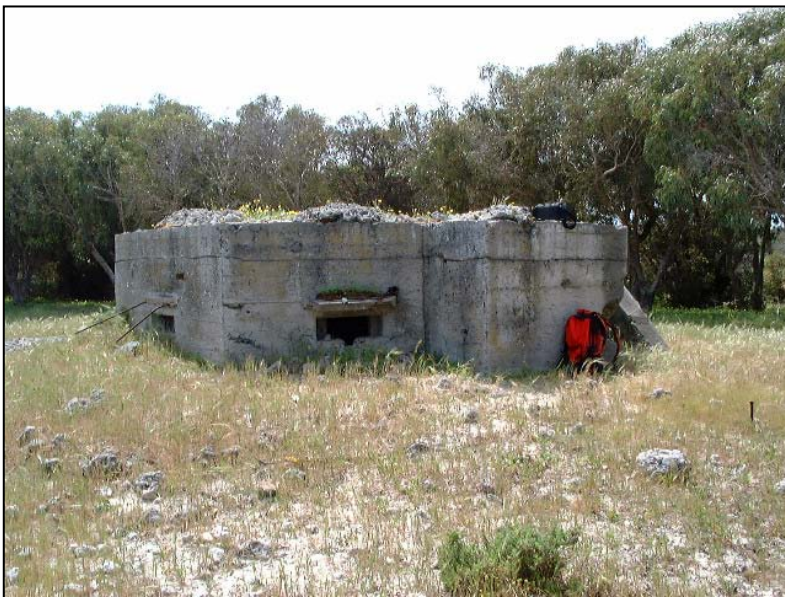
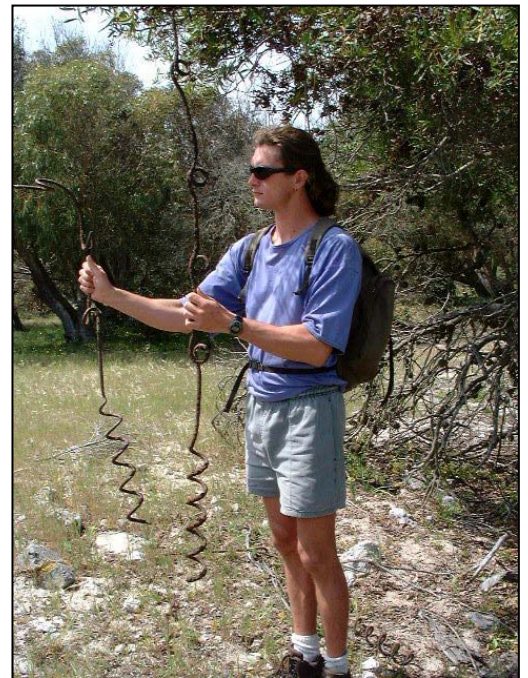
WPT: 191

DESCRIPTION: Concrete machine gun post, with 3 gun ports facing towards Table Bay. Steel gun port shutters in place but entrance hatch (rear) has been removed. This machine gun post is one of the typical 3 gun port variety that are relatively common the island.

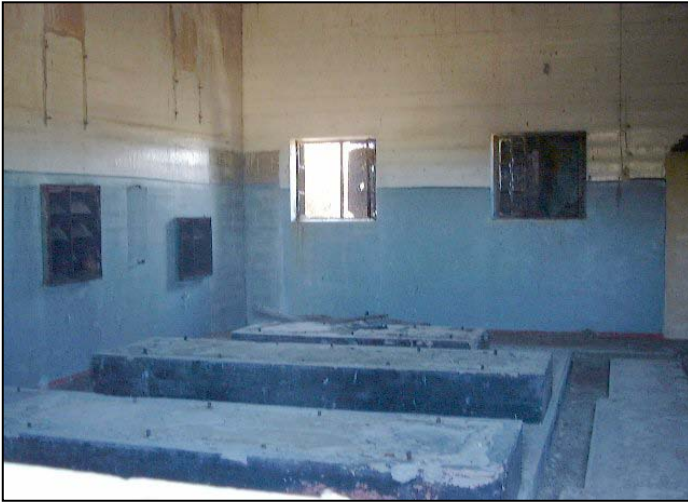
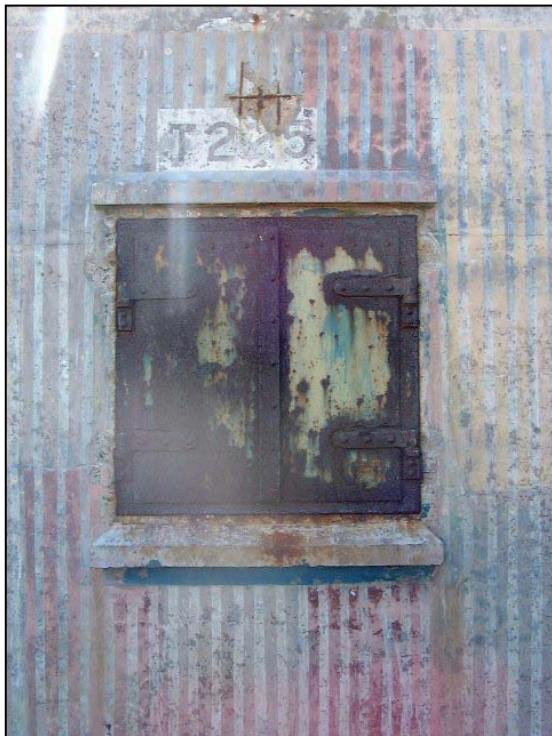
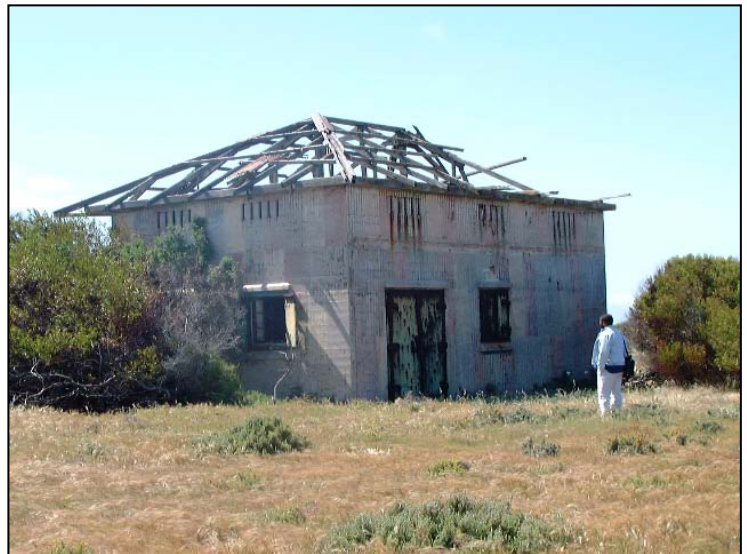
JPEG: Wpt198abcd

DESCRIPTION: Power station building (T225) with engine mountings and cable conduits in the interior. Most of the fittings have been removed, apart from the windows. Building appears to have had several different paint schemes - initially painted red and cream, later painted with WW2 camouflage. Roof is pitched ((?) to disguise it as a civil building) but actually built of flat cast reinforced concrete. Outside the building is an open cable trench leading towards one of the two search light positions on the southern shore. Site probably provided power for barracks and southern shore AA emplacements.
CHRONOLOGY: Used to provide power to facilities during WW2.

VULNERABILITY: Metal fittings and paintwork are deteriorating.

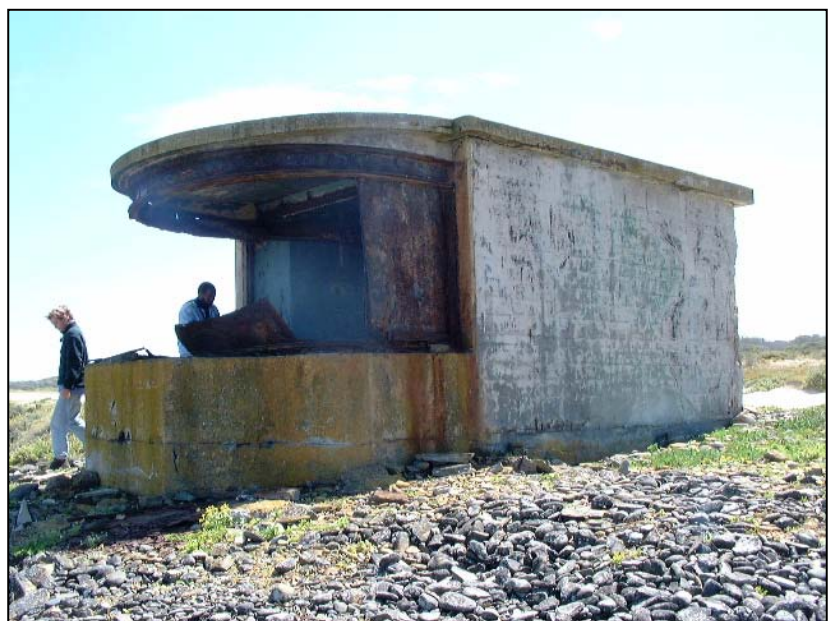
JPEG: Wpt200

DESCRIPTION: Concrete searchlight position. Front shutters have been very badly corroded; the electrical system has been stripped. Interior is painted light blue. Remnants of camouflage are still visible on the exterior.

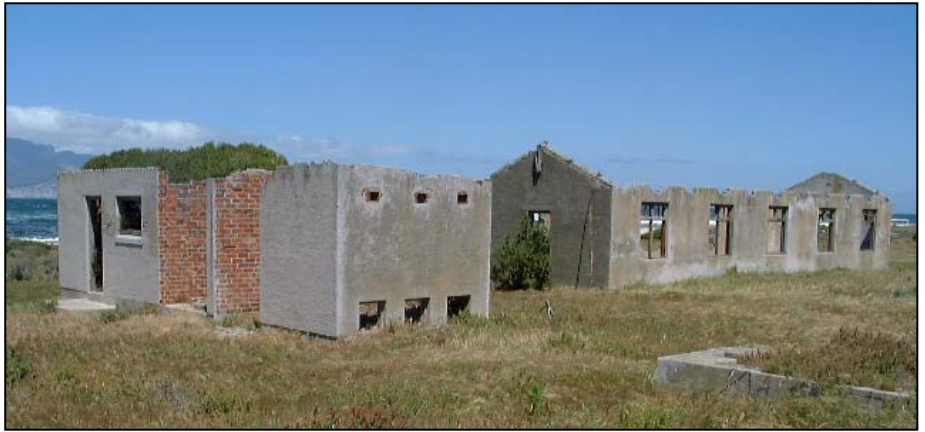
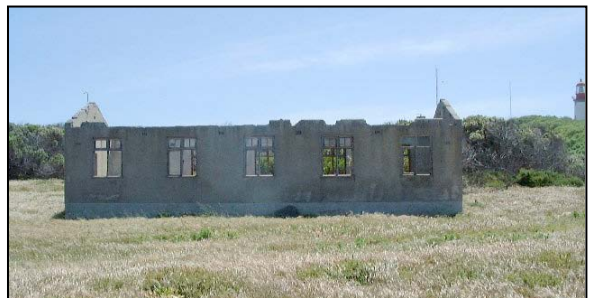
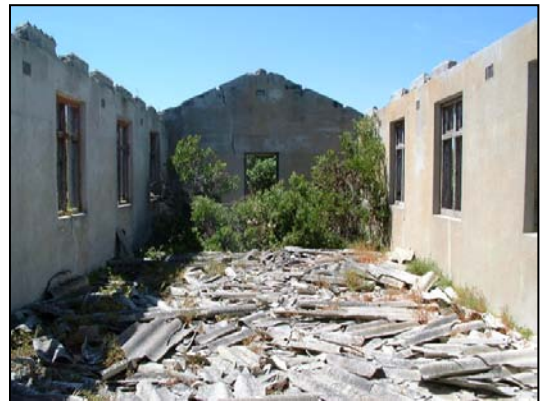
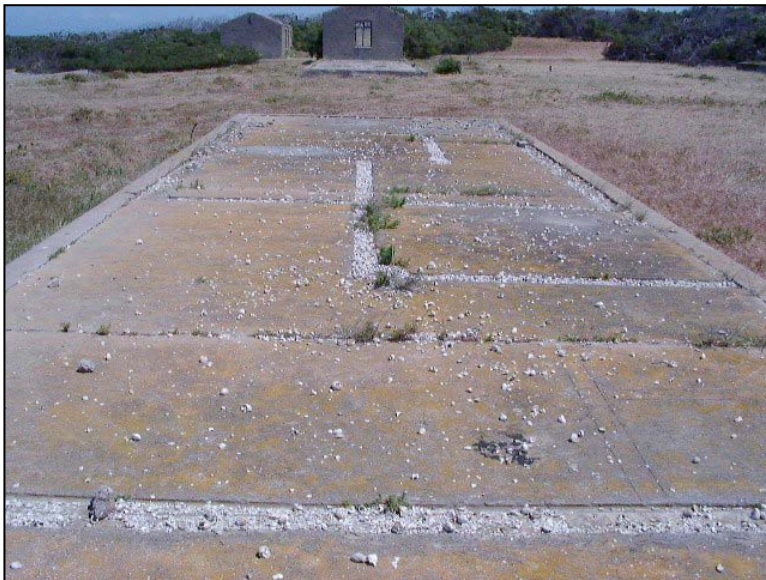
DESCRIPTION: A complex of buildings referred to as WAAS/SWANS barracks by Riley (1993). Standing buildings are in a neglected condition without roofs and missing windows and doors. Rumours of "underground passage" to 9.2 inch gun emplacements was not verified during field survey.

VULNERABILITY: Major impacts to structures have already taken place. Expected future impacts are related to natural deterioration and weathering of concrete and brickwork.

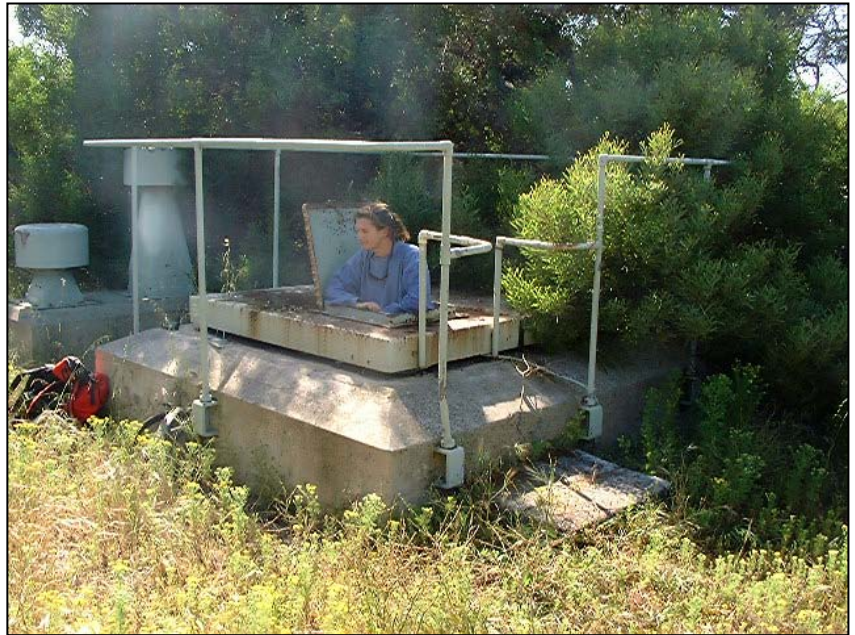
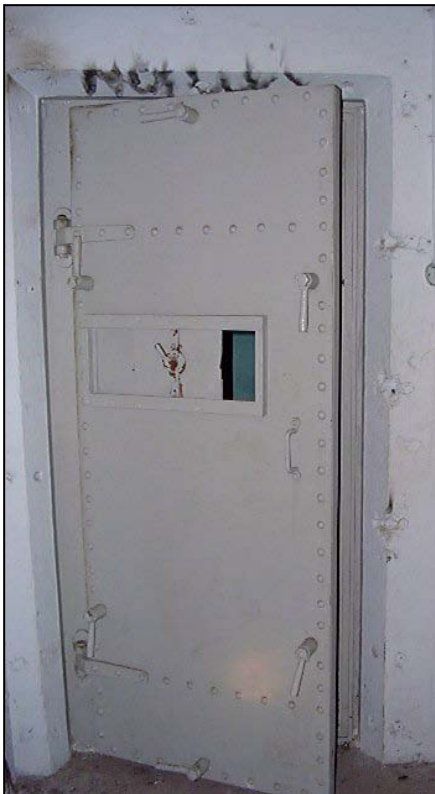
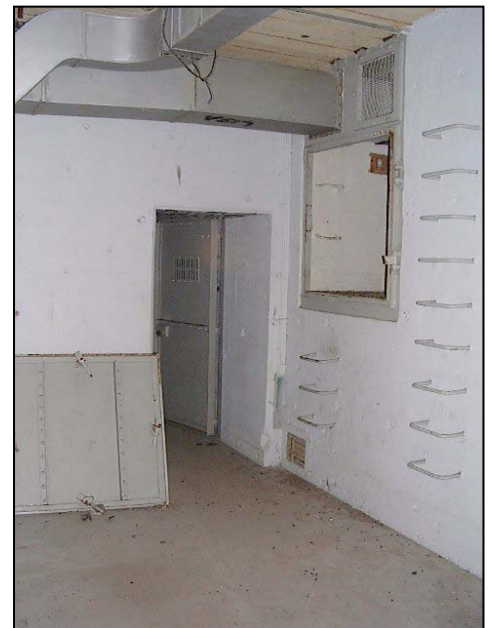
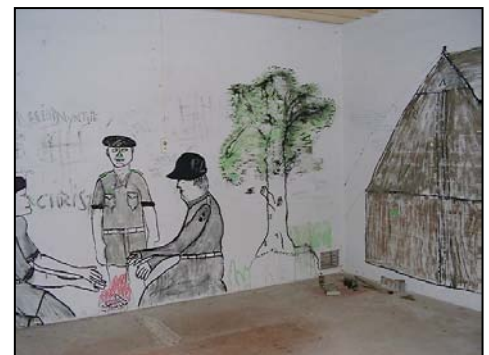
JPEG: Wpt 220a-k.

DESCRIPTION: Underground plotting room. A deeply buried WW2 bunker accessed by a series of ladders leading approximately 10m underground from a concrete and steel hatchway. The only surface indication that the bunker exists is the presence of several mushroom ventilators and the steel access hatch with steel balustrade. Below the ground surface is a complex of 4 rooms with steel doors. One of the rooms contains the air-conditioning system for the bunker – electric fans, which drew in air via ventilation shafts from the surface mushroom ventilators. Within the complex is evidence of many cable conduits for power and probably telephone connections. A most of the original fittings have been stripped. The entire underground complex is

surrounded by a circular tunnel with a drainage sump – a device also used on the battery shell magazines to control ground water seepage. The interior of the bunker is well preserved and the walls are painted light blue (similar to search light positions). The walls are covered in recent graffiti, much of it postdating 1994.

VULNERABILITY: Slow deterioration of paintwork and metal fittings, danger of flooding without operational sump drainage system.
