# HERITAGE STATEMENT FOR PROPOSED DEVELOPMENT ON ERF 20, ST HELENA BAY, VREDENBURG MAGISTERIAL DISTRICT

(Assessment conducted under Section 38 (8) of the National Heritage  
Resources Act (No. 25 of 1999) as part of an EIA)

02 September 2008

**Jayson Orton**

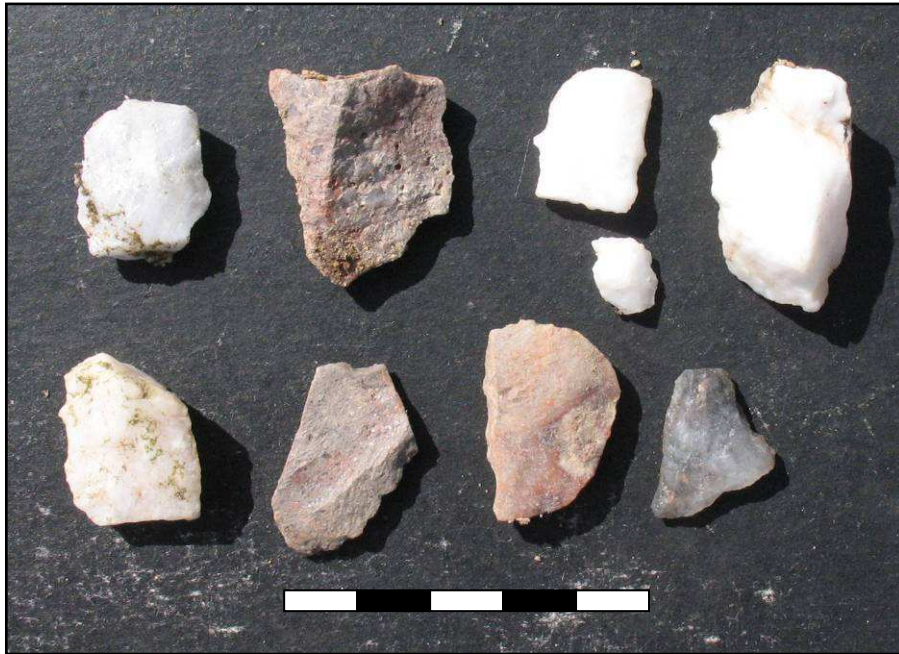
This site was located at 32° 45' 19.9" S 18° 00' 45.5" E. This site was a light scatter of quartz and silcrete artefacts located alongside an exposure of granite (Figure 9). It was also noticed that there was a general increase in the frequency of isolated artefacts as one moved upslope towards the eastern edge of erf 20. Most were in quartz but occasional silcrete artefacts were also present.

**Figure 9:** Stone artefacts from site SHB20-1. Scale bar is 5 cm long.

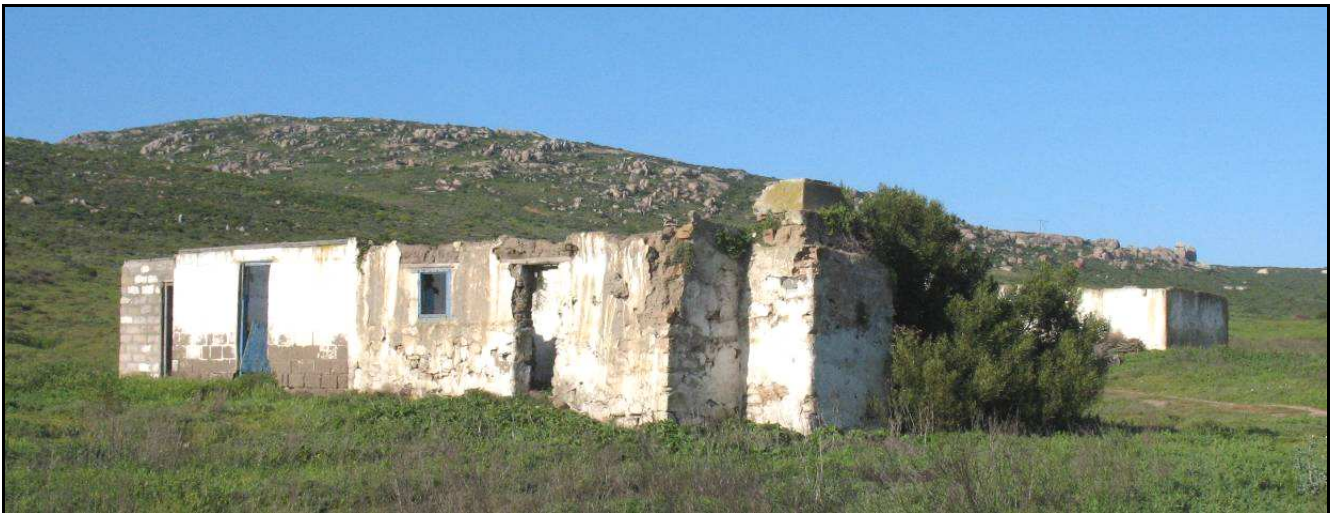
This site was located at 32° 45' 14.9" S 18° 00' 37.7" E. It is a ruined structure and, with the oldest component almost certainly being greater than 100 years of age, the site is covered by archaeology (Section 35) rather than the built environment (Section 34). It is a vernacular two room cottage which has had two further additions to its southern end (Figures 10 & 11).

**Figure 10:** View of the ruin at SHB20-2 taken from the northwest.

- A destruction permit is required for the two oldest ruins (SHB20-2 and SHB20-4). There is no reason why this should not be granted;
- The proponent is advised to develop architectural guidelines that are sympathetic to the scenic qualities of the area.
- There is always the chance that unmarked prehistoric burials could be present. Should such a find be made at any stage during the development it should be reported to Heritage Western Cape (021 483 9685) or the South African Heritage Resources Agency (021 462 4502) and an archaeologist should be contracted to remove the remains.

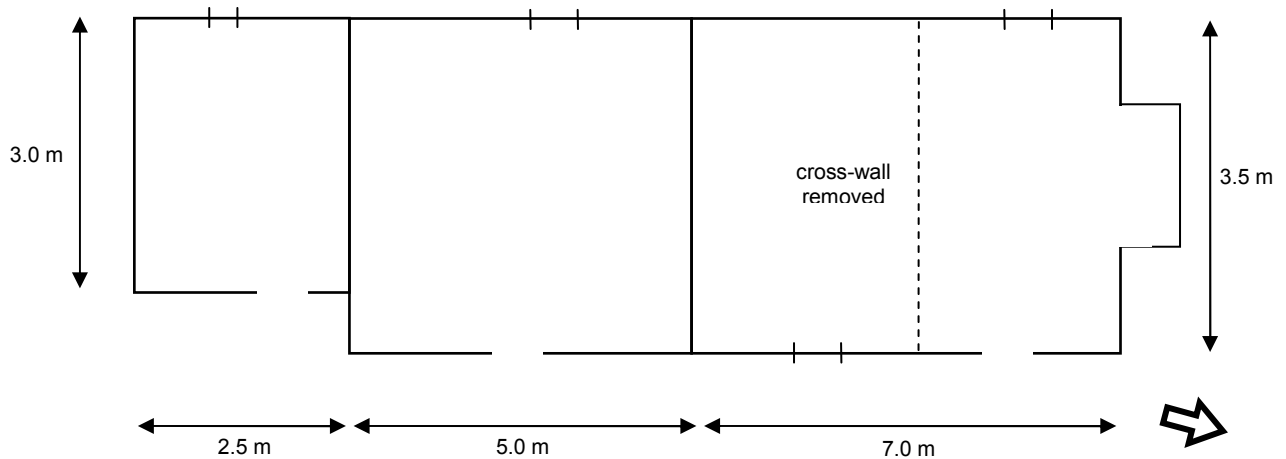
**Figure 11:** Schematic plan of the ruin at SHB20-2 (not to scale). Gaps in the walls denote doorways while pairs of short lines show windows. The oldest component is on the right and the youngest on the left. The block arrow indicates north.

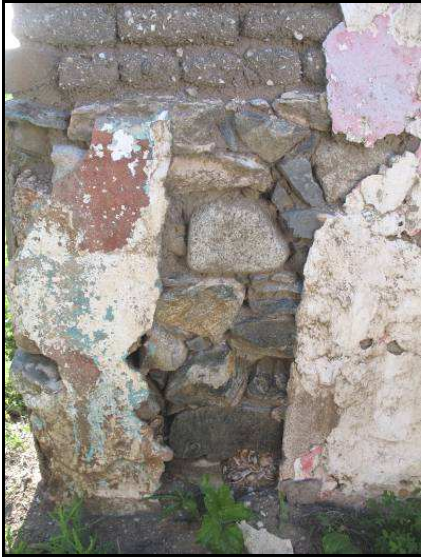
- The oldest part of this ruin, the northern end, has been built with a combination of stones and mud bricks. The rear wall has stone all the way to the top (Figure 12) while the front and north walls only have stone up to approximately 1 m (Figure 13). The southern wall was rebuilt at the time of the first addition. The cottage is approximately 7 m by 3.5 m.

**Figure 12:** The point at which the cross-wall once met the front wall. Note stones to ~1 m only.

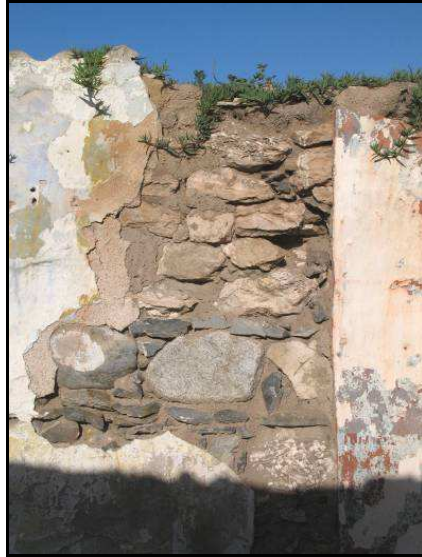
- Gaps in the internal plaster showed that a cross-wall had been present but this was completely missing at the time of inspection (Figures 12 & 13).
- The mud bricks are very interesting in that they have been made using material raided from a shell midden. The weathered bricks contain shell fragments and flaked stone artefacts (Figure 14) and a patch of palaeobeach deposit was also visible in one place inside the front wall (Figure 15).

**Figure 13:** The point at which the cross-wall once met the back wall. Note stones to full height.

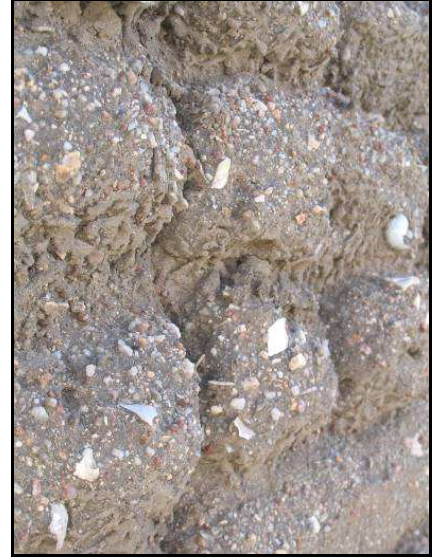
**Figure 14:** Fragments of shell and flaked stone artefacts embedded in the mud bricks.

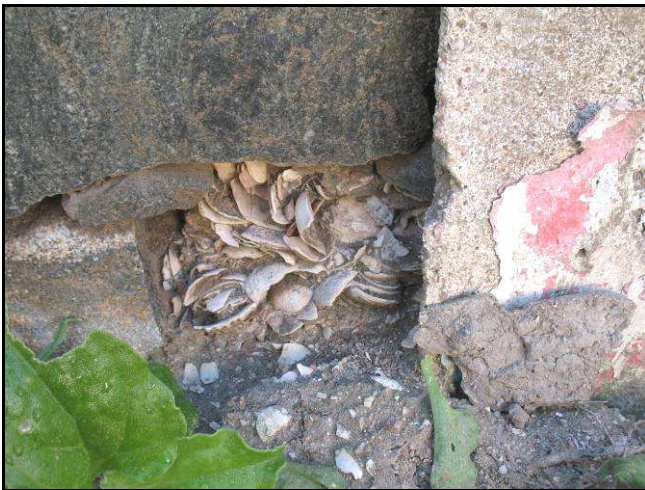
**Figure 15:** Chunk of palaeobeach deposit included within the wall. It is visible at the bottom in Figure 12.

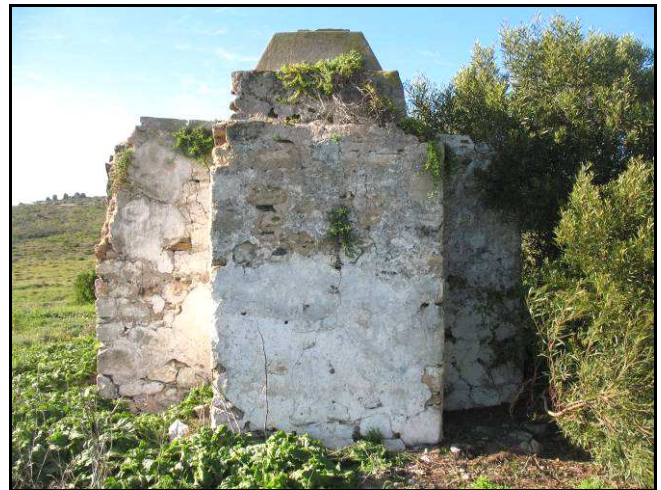
- A hearth and chimney stack is attached to the northern end (Figures 16 & 17).
- The floor is of cement but there was so much soil (about 10 cm thick) on it that it was not possible to ascertain its age. It might well have been relatively recent though.

**Figure 16:** The hearth and chimney stack on the northern end of the building.

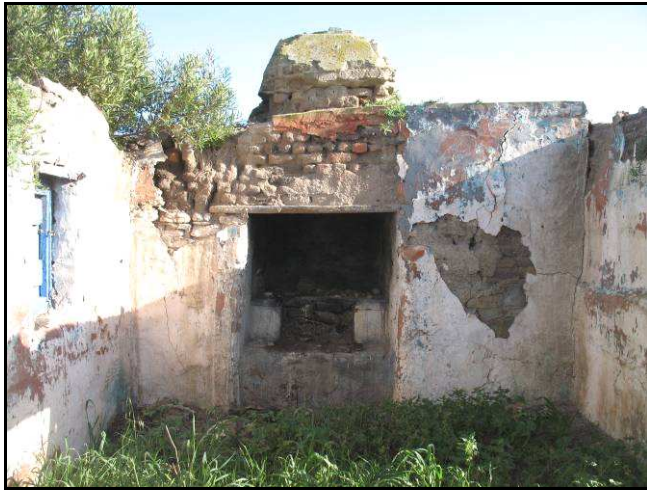
**Figure 17:** View of the hearth from the inside.

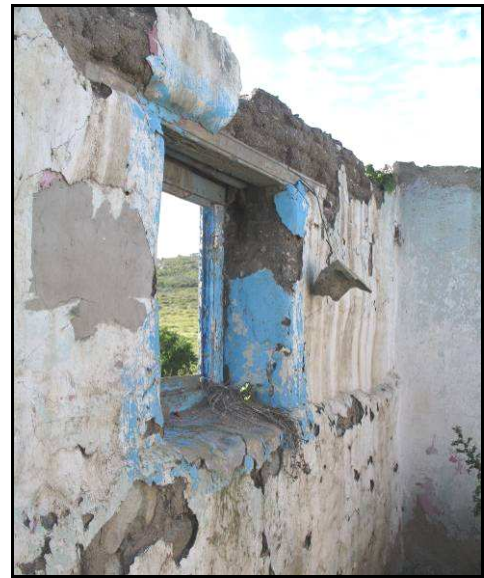
- The window and door frames, all painted blue, and the lintels are of wood (Figure 18).
- The cement along the top of the walls shows that the most recent roof was of corrugated iron (Figure 19). It was not possible to tell whether the original had been different or not.

**Figure 18:** The wooden window frame and lintel in the back wall of the northern room.

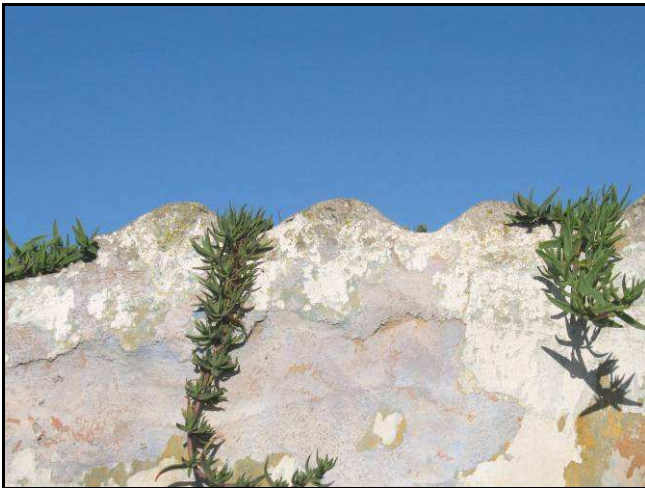
**Figure 19:** Detail of cement on top of the back wall showing the imprint of corrugated iron.

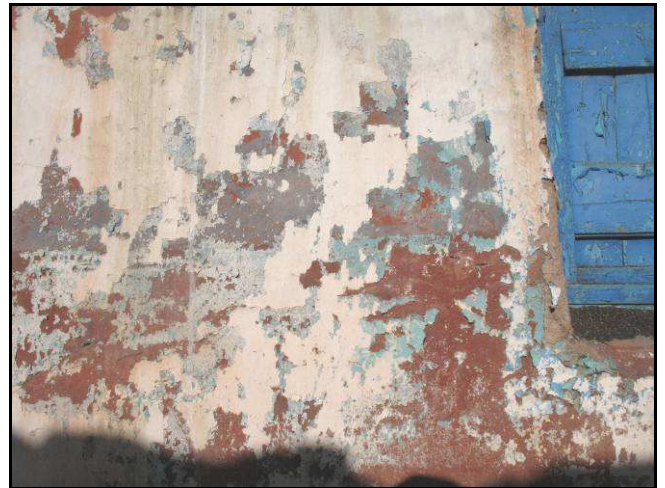
- The interior walls have had several coats of paint over the years and the visible sequence showed first red followed by grey applied to the upper half only, followed by blue over the whole wall then finally white (Figure 20).

**Figure 20:** Detail of the interior paint. Part of the broken door is also visible.

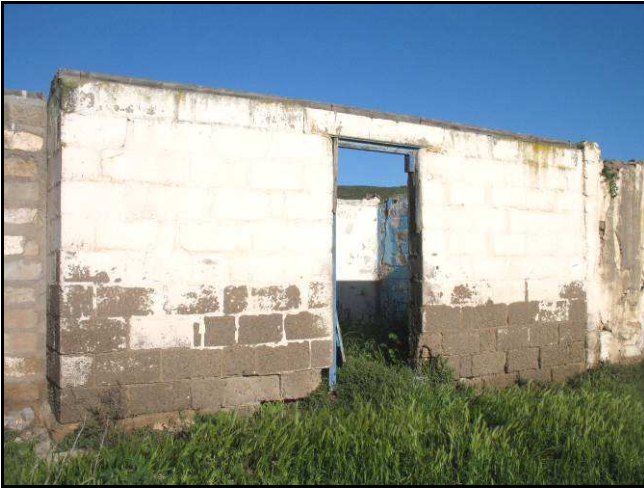
- All four walls are made of cement breeze blocks indicating that the southern wall of the original cottage was demolished and rebuilt at the time of this addition. This room is approximately 5 m by 3.5 m.
- The door frame in the front wall is of wood (Figure 21), while the window in the rear wall has a steel frame (Figure 22). The lower half of the door is still present. The door and window are not perfectly opposite one another.
- As with the oldest component, the cement on top of the walls indicates that a corrugated iron roof was present.
- The northern wall of this room is painted blue while the rest have remnants of white paint.
- It is likely that this component of the building dates to the early to mid-20<sup>th</sup> century.

**Figure 21:** Front view of the 1<sup>st</sup> addition.

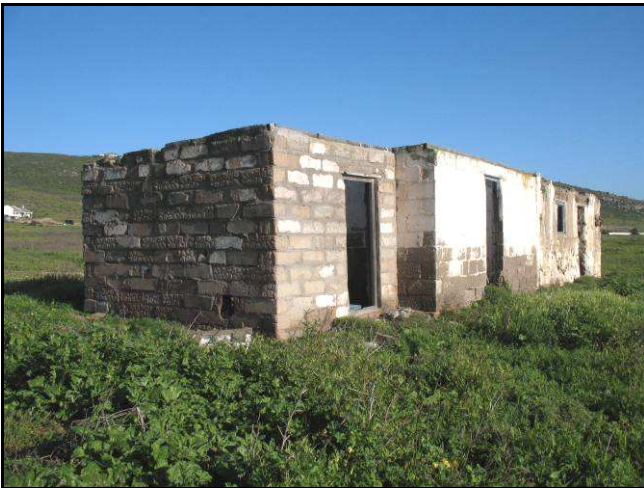
- This addition is made of decorative breeze blocks which are characteristic of the early to mid-20<sup>th</sup> century. However, they have been painted on their flat side and the fact that the blocks have not been placed facing the same way shows that the blocks had been scavenged from elsewhere and reused here. The cement is completely modern. This room is approximately 2.5 m by 3 m.
- Both the door and window frames are of wood but the window has been bricked up with modern cement bricks. Again the door and window do not align across the room.
- It seems that this addition was probably added quite recently.

**Figure 23:** View of the 2<sup>nd</sup> addition from the east.

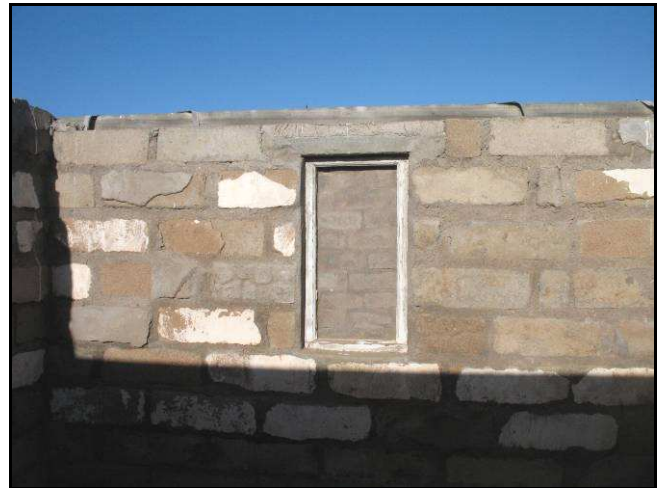
**Figure 24:** Interior view of the bricked up window.

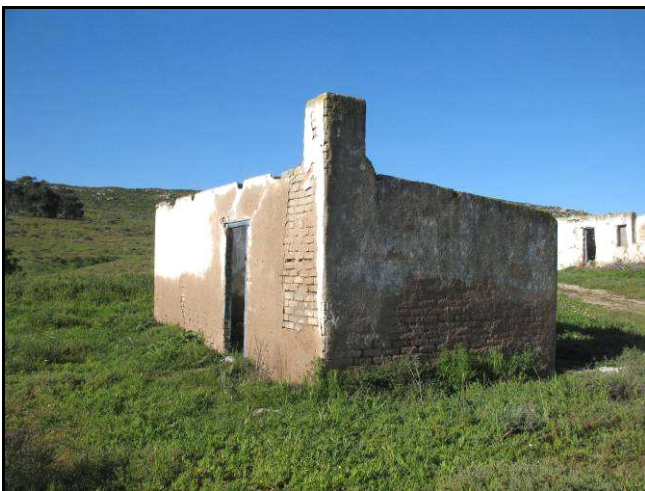
This site was located at 32° 45' 15.7" S 18° 00' 37.0" E. It is a vernacular style two-room cottage (Figures 25 & 26). While this building may be less than 100 years of age, it has been included here to be safe.

- The walls are made of cement bricks but they are not modern. The mortar used in the walls is mud. The cross-wall, which was just a single brick-width thick, has been removed (Figure 27).
- The door frame is of wood and only wooden lintels are present in the two window openings in the back wall (Figures 27 & 28). The southern window has been bricked up with modern bricks and cement.
- An internal chimney stack is located in the northwest corner (Figure 29).
- Most of the inside has been painted in white but blue and red paint are present around the hearth and chimney stack (Figure 29).
- Again, cement on the top of the wall above the northern window shows that a low-angled corrugated iron roof used to be present (Figures 28 & 30).
- This ruin probably dates to the early 20<sup>th</sup> century.

**Figure 25:** View of the ruin at SHB20-3 as seen from the north.

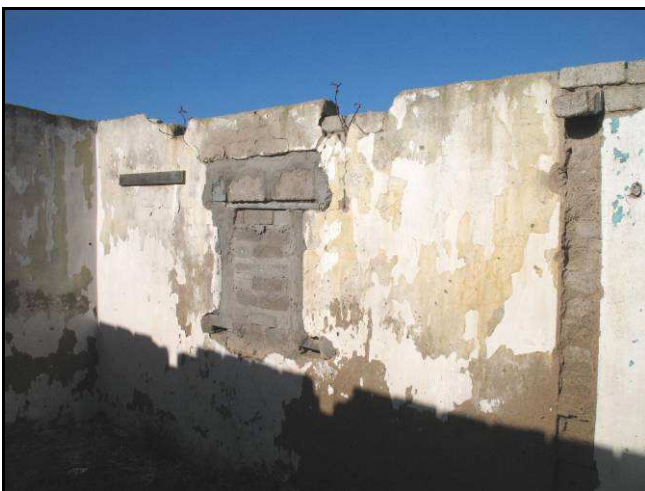
**Figure 27:** The bricked up southern window and the scar where the cross-wall used to be.

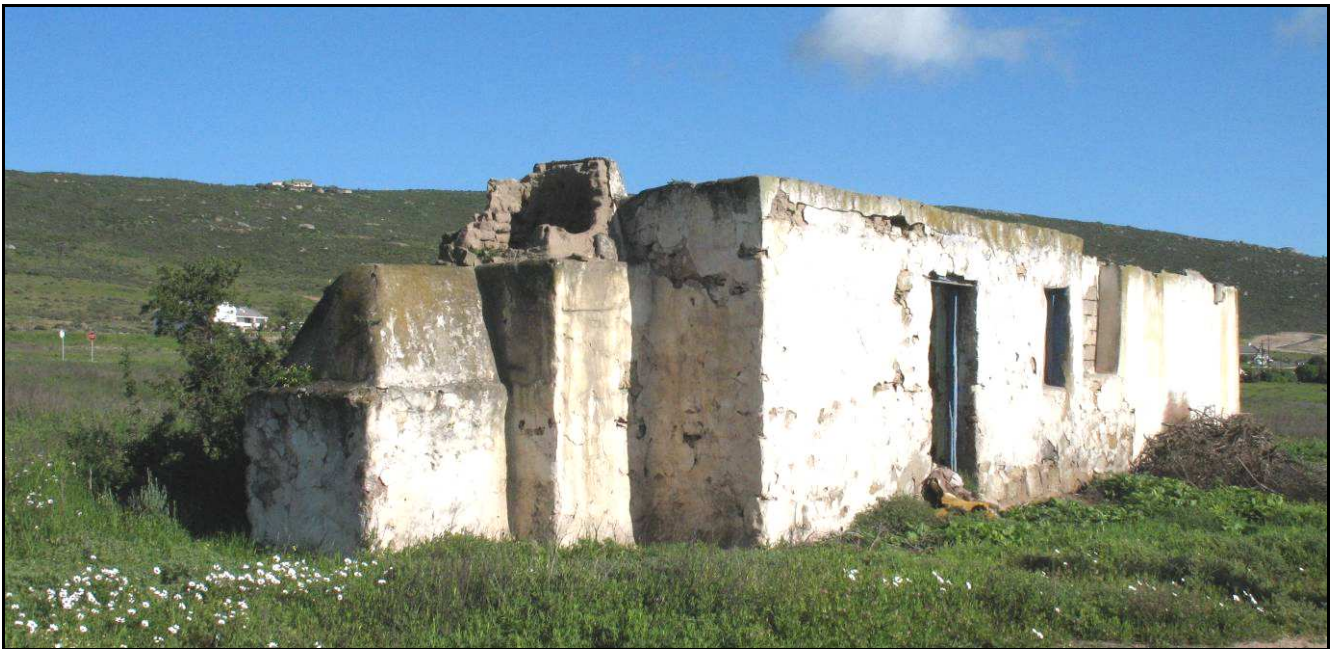
This site was located at 32° 45' 16.5" S 18° 00' 36.4" E. It is a vernacular two room cottage with an additional room added to its northern end (Figures 31 & 32).

**Figure 31:** View of the ruin at SHB20-4 from the east.

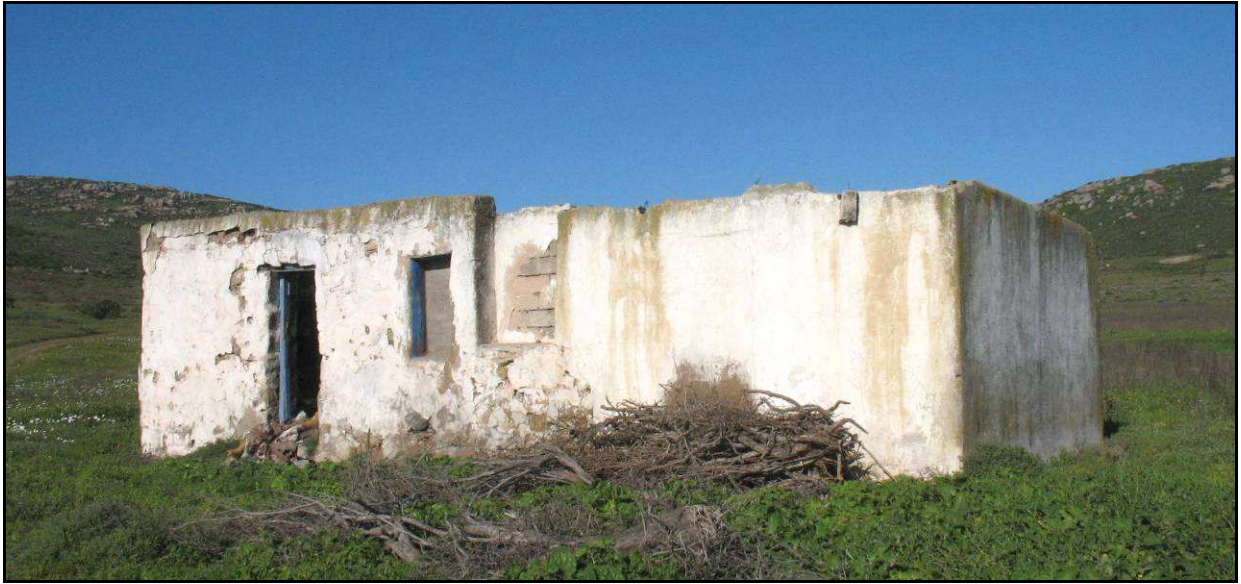
- This structure was made from stone while the addition to the northern end was done with breeze blocks giving a more even surfaced wall (Figure 33). All walls are still intact up to roof level. A chunk of palaeobeach deposit was also noted in the front wall.

**Figure 33:** View of the front of SHB20-4 showing the differing walls of the original (left) and newer (right) parts.

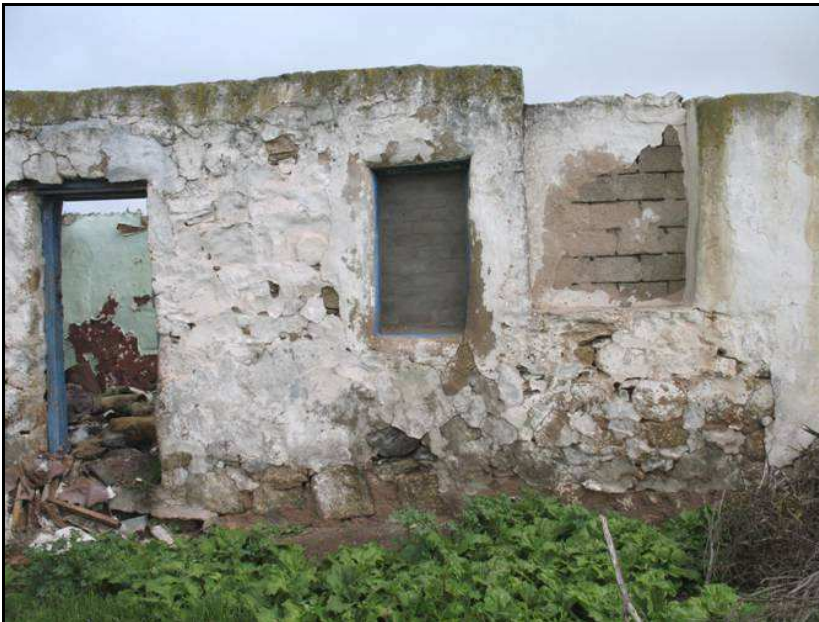
- Three windows penetrate the wall with all having been bricked up. A fourth “window” is visible only on the outside and extends all the way to the top of the wall (Figure 33 & 34).

**Figure 34:** The central part of the front wall showing the peculiar bricked-up “window” alongside the other bricked-up front window.

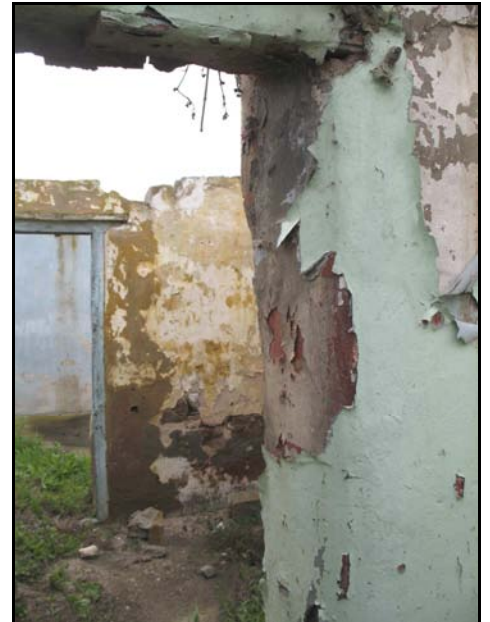
- The external door has a wooden frame (Figure 34), while the northern internal door used to have one. The southern door had no frame and the plaster was rounded off on the edges (Figure 35).

**Figure 35:** The northern (far) internal door has a wooden frame while the southern one (foreground) has a lintel but no frame.

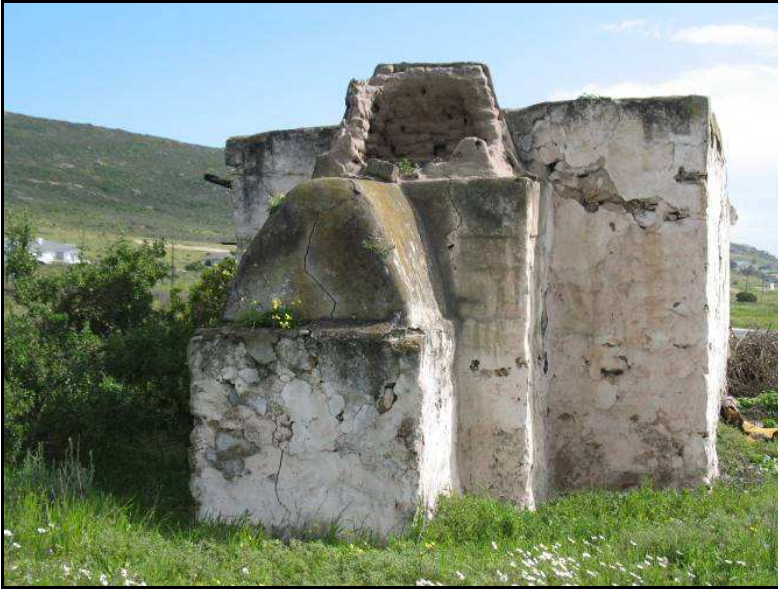
- A hearth and chimney stack are attached to the southern end and an oven is attached to this (Figure 36). No entrance is present on the outside and it is assumed that the entrance to the oven is low down within the hearth – it is now obscured by rubble and mud from the collapsed chimney (Figure 37).

**Figure 36:** View of the external hearth and chimney stack with attached oven on the southern end of the ruin.

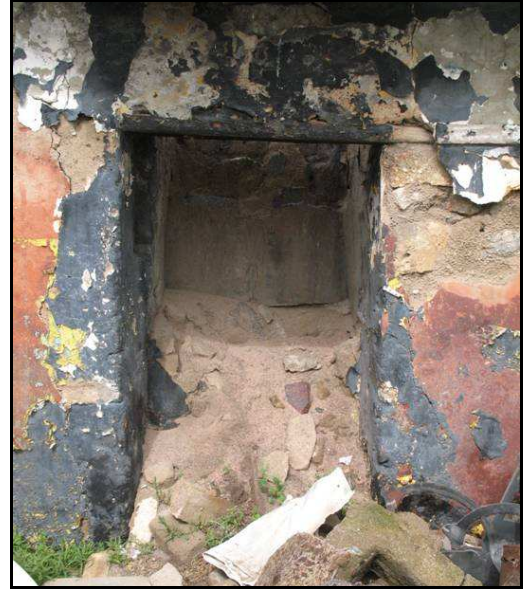
- The sequence of paint on the wall in the entrance room is as follows from oldest to youngest: red / green / red / red / layer of newspaper / white / blue / mint green. The newspaper was probably not more than a few decades old. The mint green colour can be seen in Figure 35 while the paint around the hearth was different (Figure 37)

**Figure 37:** The inside of the hearth filled with rubble from the collapsed chimney.

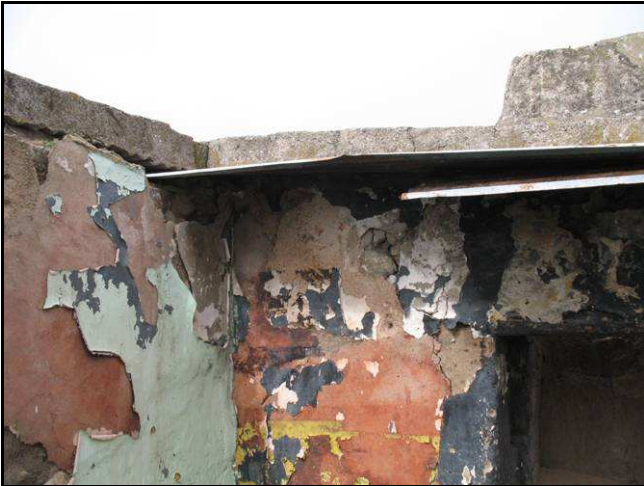
- The roof was of corrugated iron with some still present above the hearth. The more modern materials above the iron show that this was a more recent replacement though (Figure 38).

**Figure 38:** The remaining section of corrugated iron roof with modern bricks and cement above.

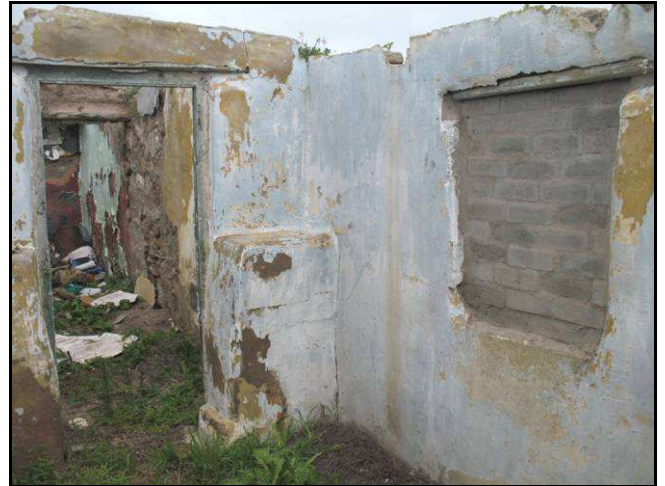
- A further feature to note is the presence of a thick “step” along the lower half (Figure 39). This may have been for strengthening purposes.
- The original structure is almost certainly late 19<sup>th</sup> century, while the addition is early to mid-20<sup>th</sup> century.

**Figure 39:** View from the northern addition through the doorways and showing the recently bricked up rear window and the buttress along the original northern wall.

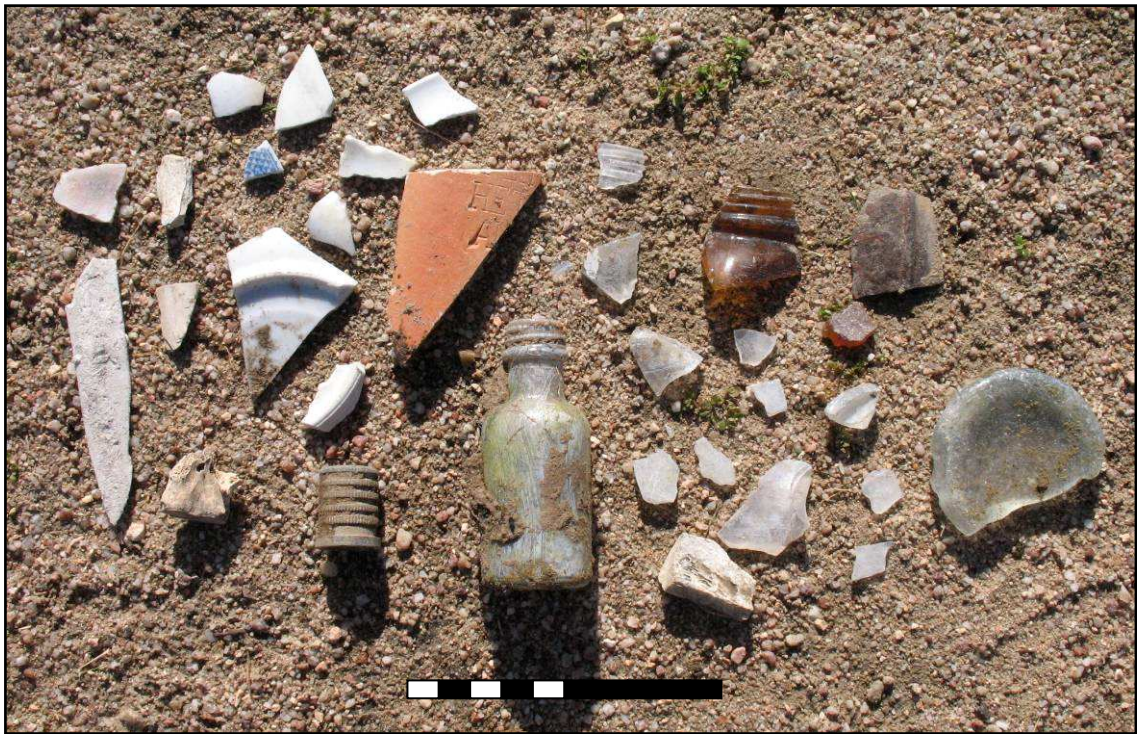
This site represents the historical artefact scatter located in the general vicinity of the three ruins described above. While most of the material is clearly of 20<sup>th</sup> century origin, there are a few items that do date to the 19<sup>th</sup> century (Figure 39). A single fragment of late 19<sup>th</sup> century blue and white willow-pattern ceramic was noted and the brown stone ware could date to the late 19<sup>th</sup> or 20<sup>th</sup> centuries.

**Figure 39:** Historical and modern artefacts from the scatter around the three ruins.

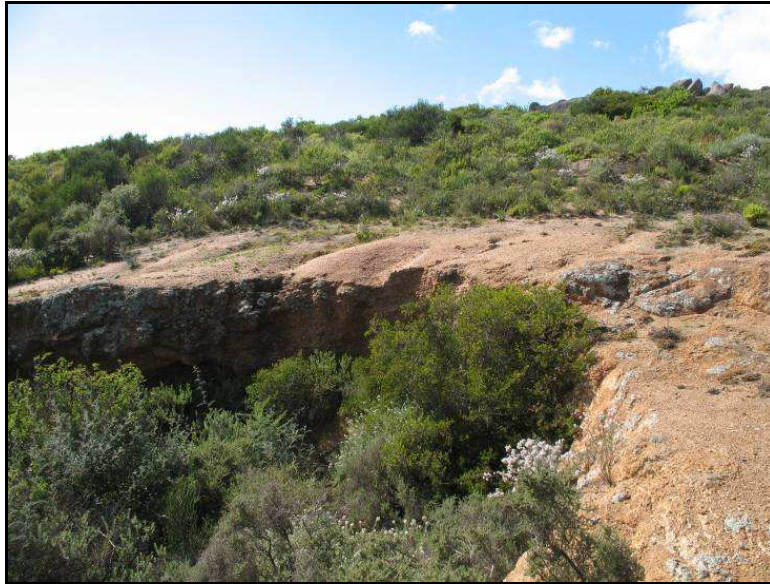
This site was located at 32° 45' 20.7" S 18° 00' 43.7" E. This a small, informal granite quarry where rock has been excavated from the hillside, possibly for use in construction. It is well weathered and likely to be quite an old feature (Figure 41).

**Figure 41:** View of the old informal granite quarry.

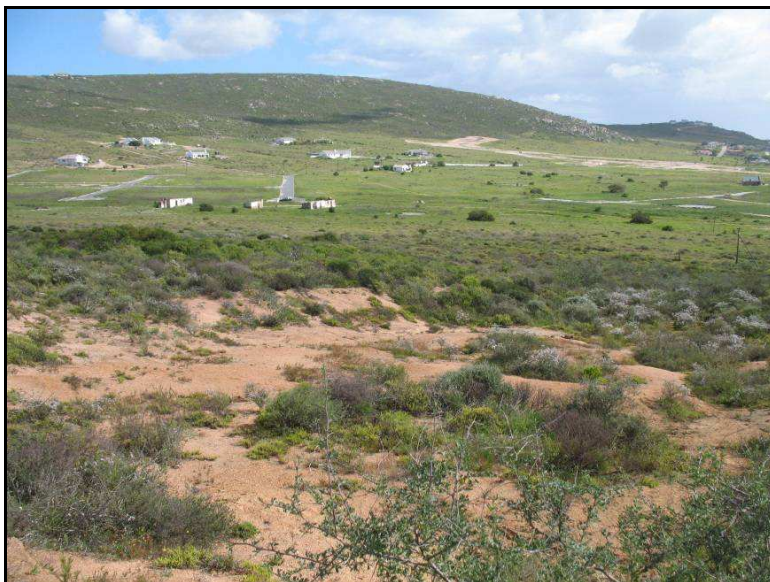
This site was located at 32° 45' 19.1" S 18° 00' 46.5" E up on the west-facing slope. It is an old borrow pit where granitic gravel was removed in the past. It is well overgrown (Figure 42). This site may be located just outside the western edge of the property.

**Figure 42:** View of the old borrow pit with the ruins at the foot of the slope in the background.
