AMAFA APPLICATION:

APPLICATION FOR HOUSE DEMOLITION

Street address: 5 Fremantle Road, Bellair, Durban

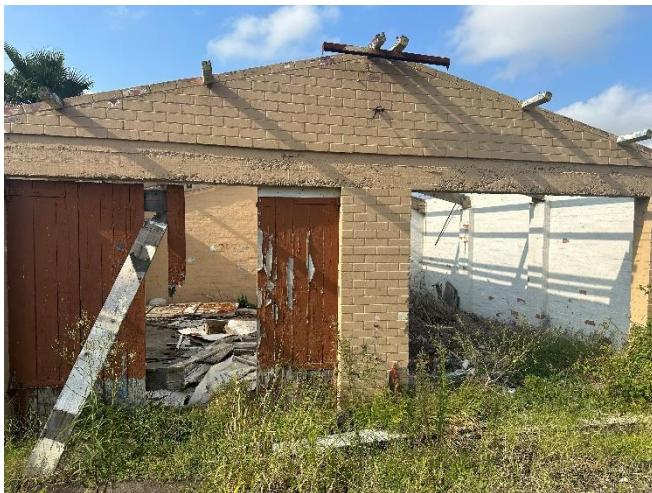
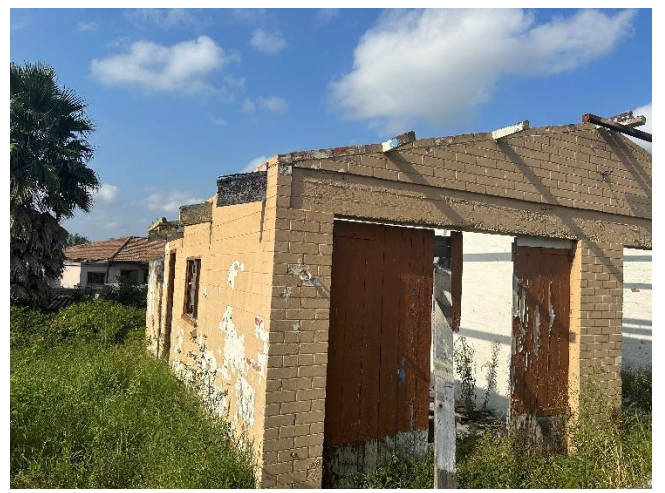
THE ROOF WAS STRIPPED BY VAGRANTS AND SOLD. THE STRUCTURE IS EXPOSED TO THE SKY.

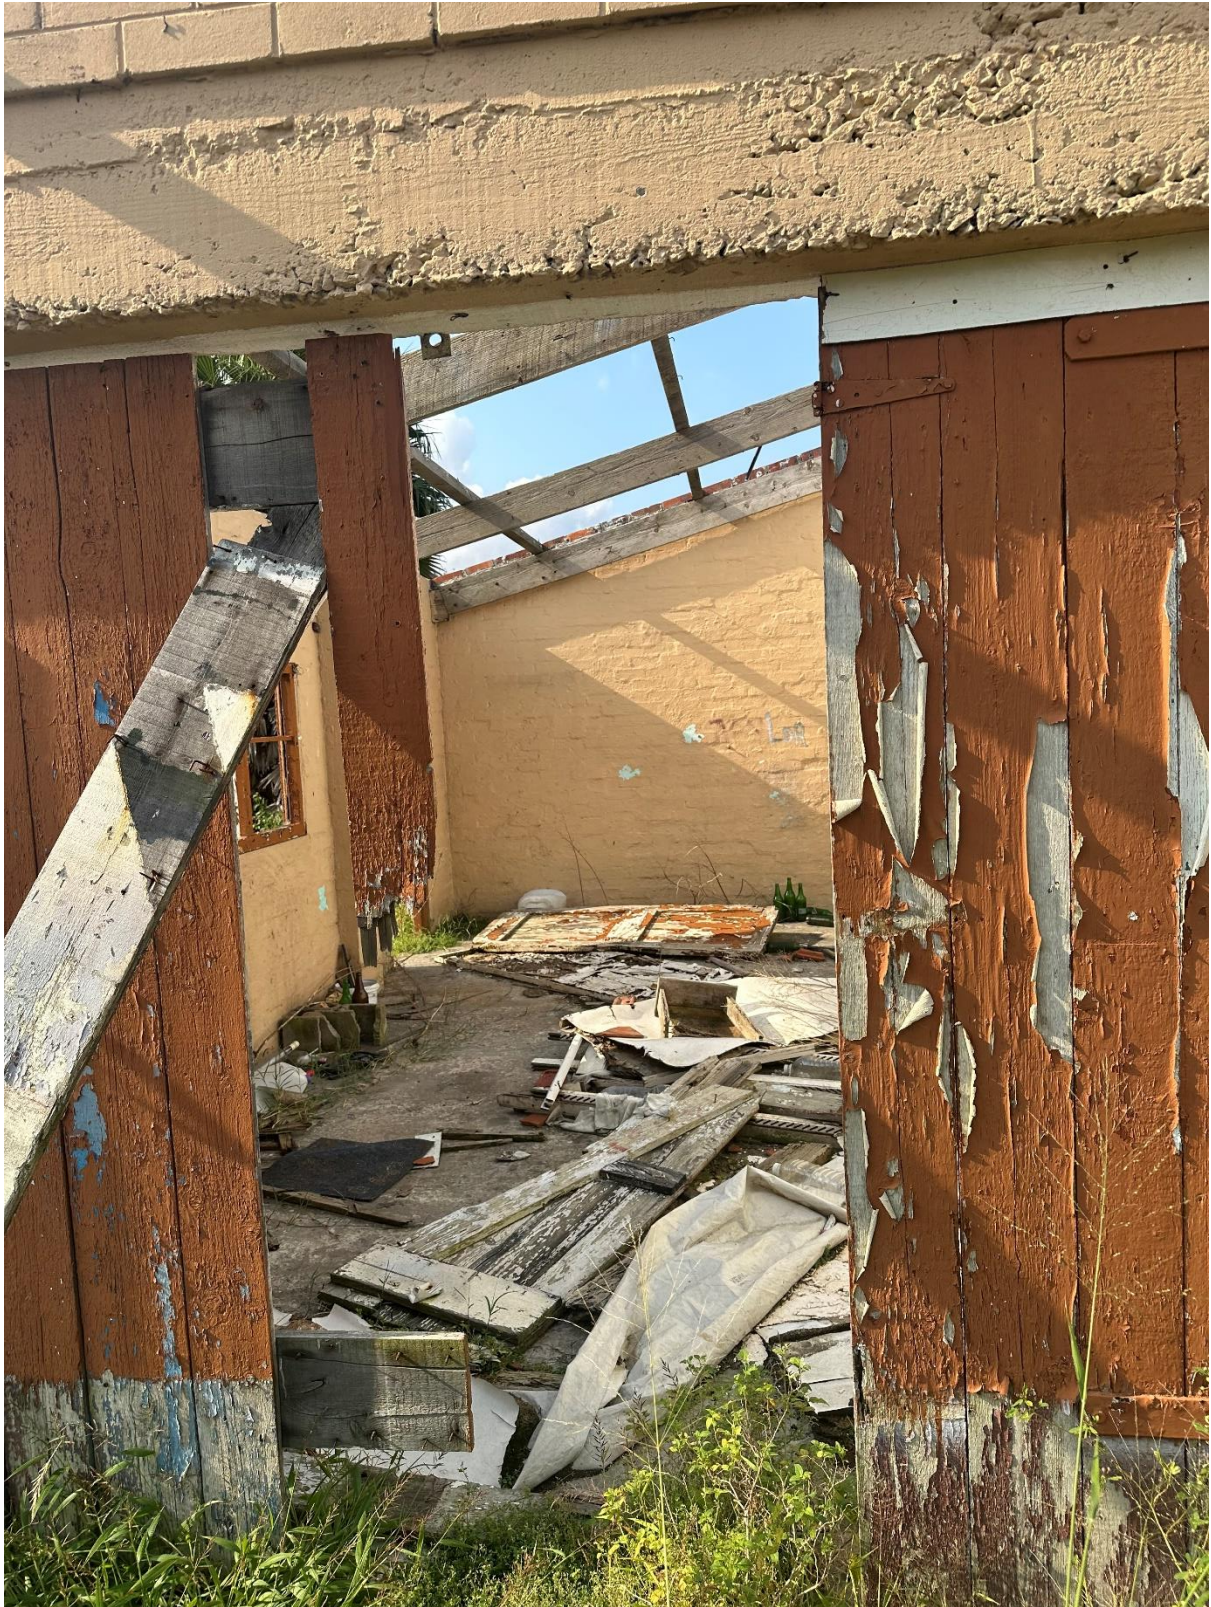
INTERIOR VIEW OF GARAGE, ONE CAN OBSERVE THE STRUCTURE IS COMPLETELY STRIPPED/

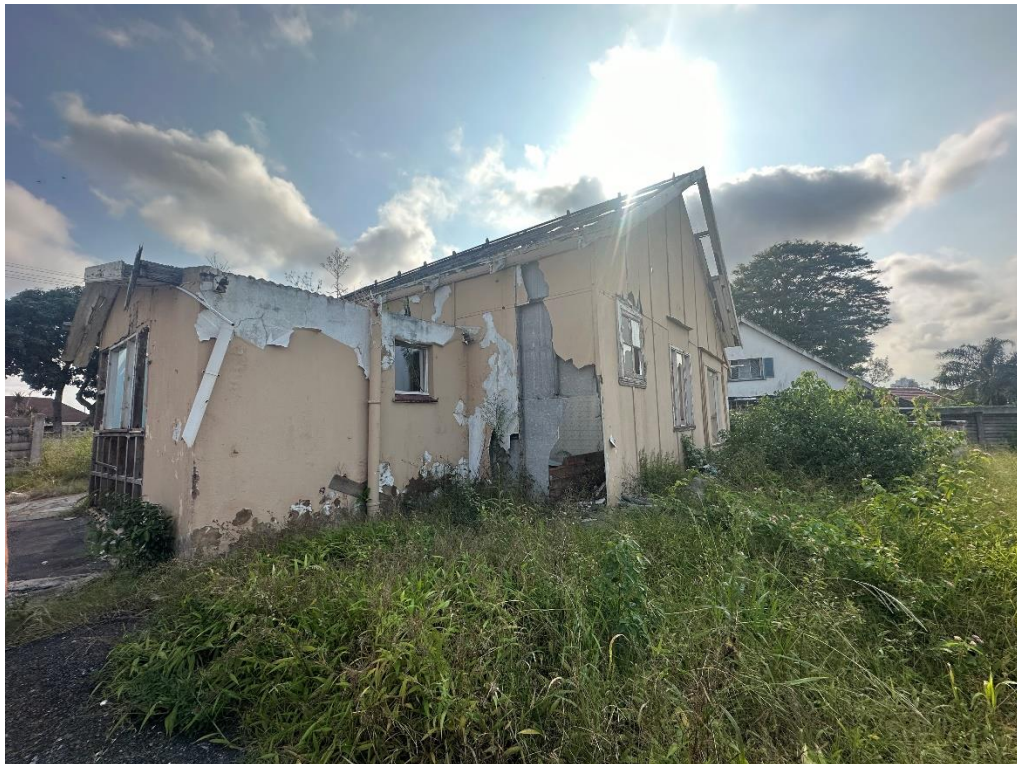
NORTH-EAST REAR ELEVATION. THE FAÇADE HAS BEEN COMPLETELY RIPPED; THE ASBESTOS HAS ALSO DETERIORATED.

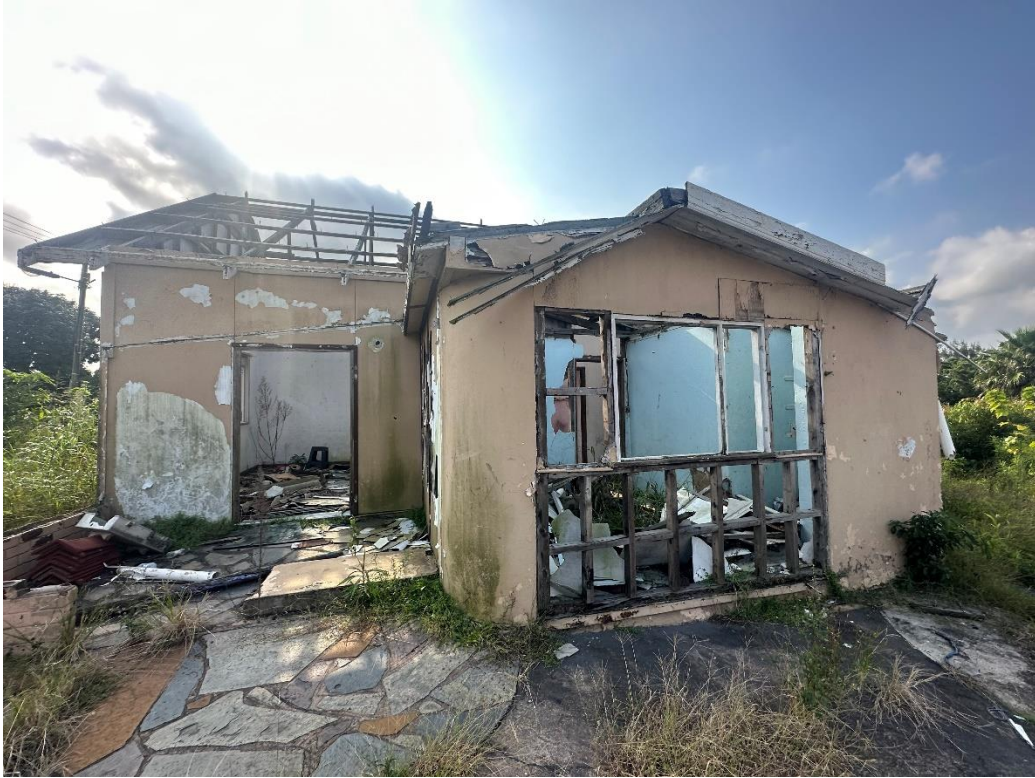
The house needs to be urgently demolished to prevent vagrants sleeping on site. The risk of the structure further deteriorating needs to be taken into account. The walls are collapsing due to the asbestos that was used in the construction and the timber frames used for the walls are rotten.

NORTH-WEST ELEVATION, ENTRANCE VIEW. AGAIN ONE CAN OBSERVE THAT THE STRUCTURE HAS DETERIORATED AND THE WOOD THAT HAS ROTTEN

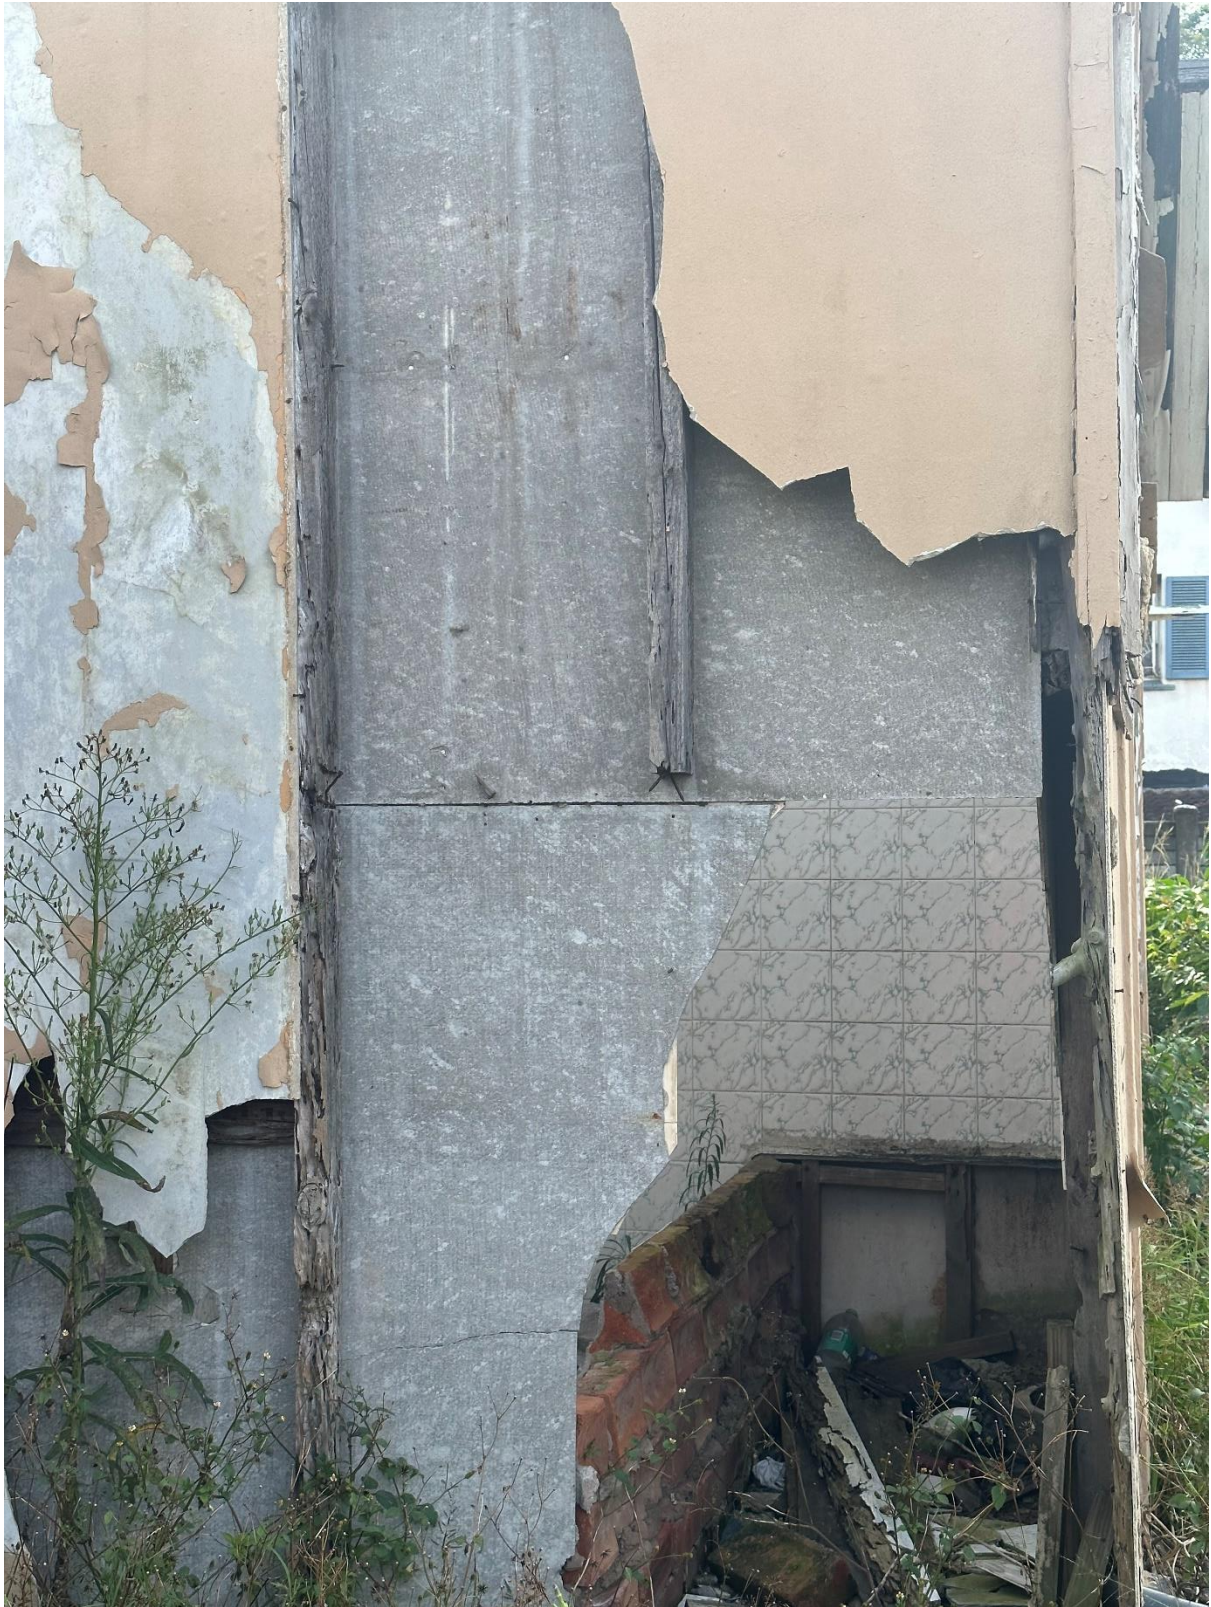
EXAMPLE OF WALL CONSTRUCTION CONSTRUCTED OUT OF ASBESTOS, WOOD FRAME PANELING AND

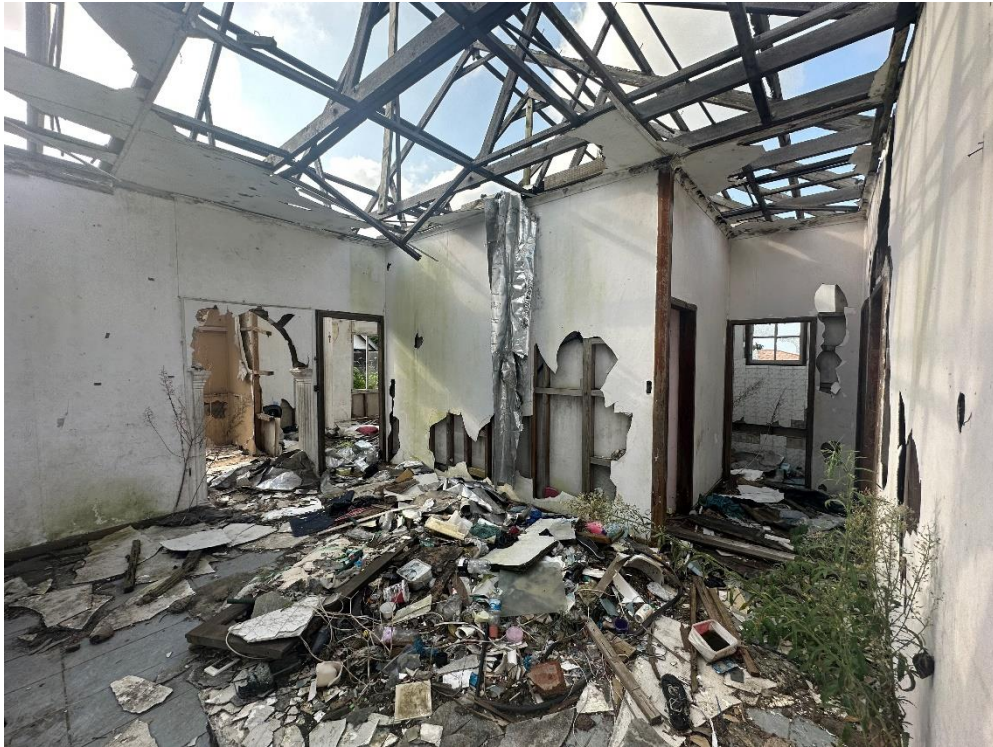
INTERIOR VIEW OF HOUSE – DAMAGED WALLS AND FLOOR, THE ROOF HAS BEEN COMPLETELY STRIPPED

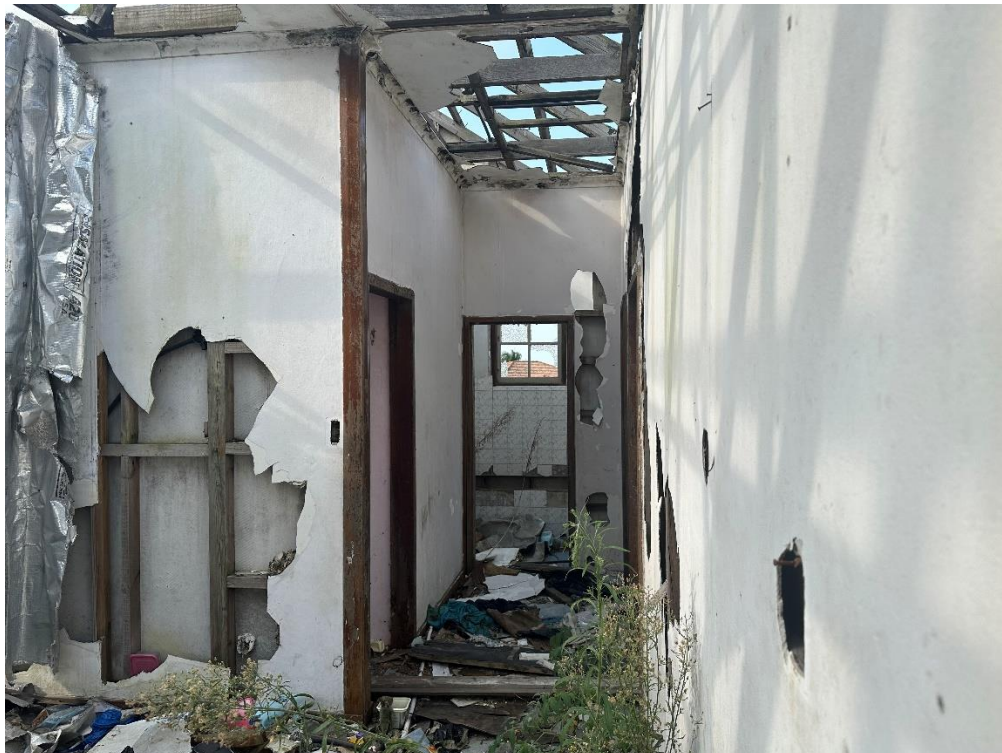
INTERIOR VIEW OF HOUSE – DAMAGED WALLS AND FLOOR, THE ROOF HAS BEEN COMPLETELY STRIPPED

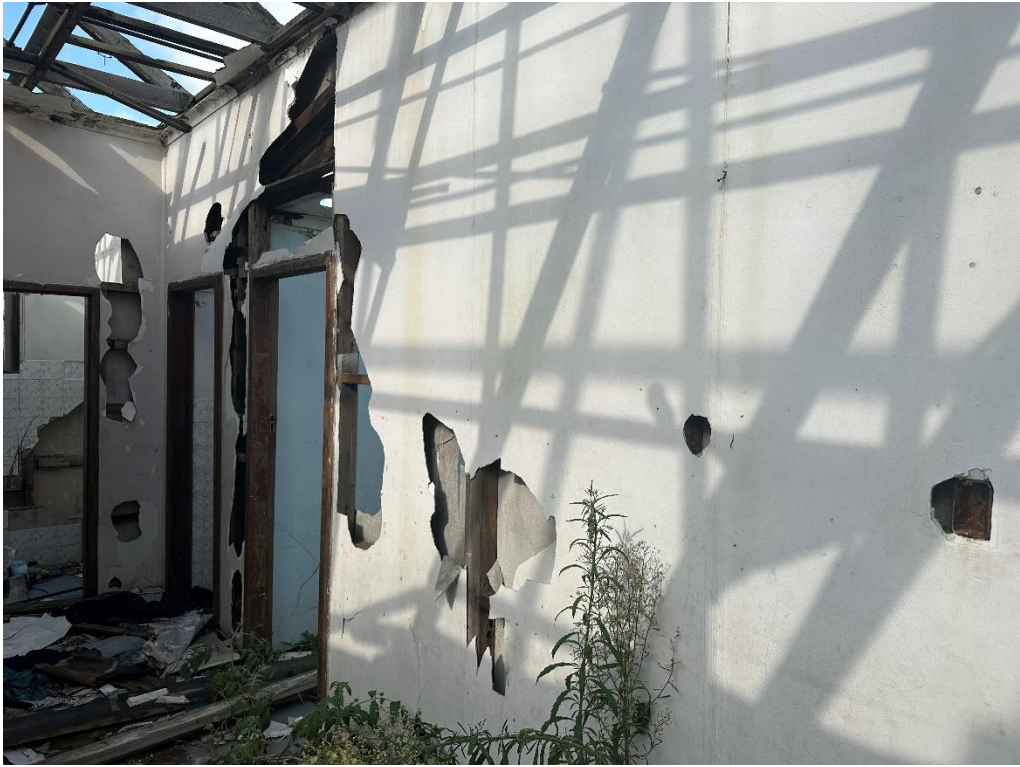
INTERIOR VIEW OF MAIN HOUSE, SHOWING EXTENSIVE DAMAGE

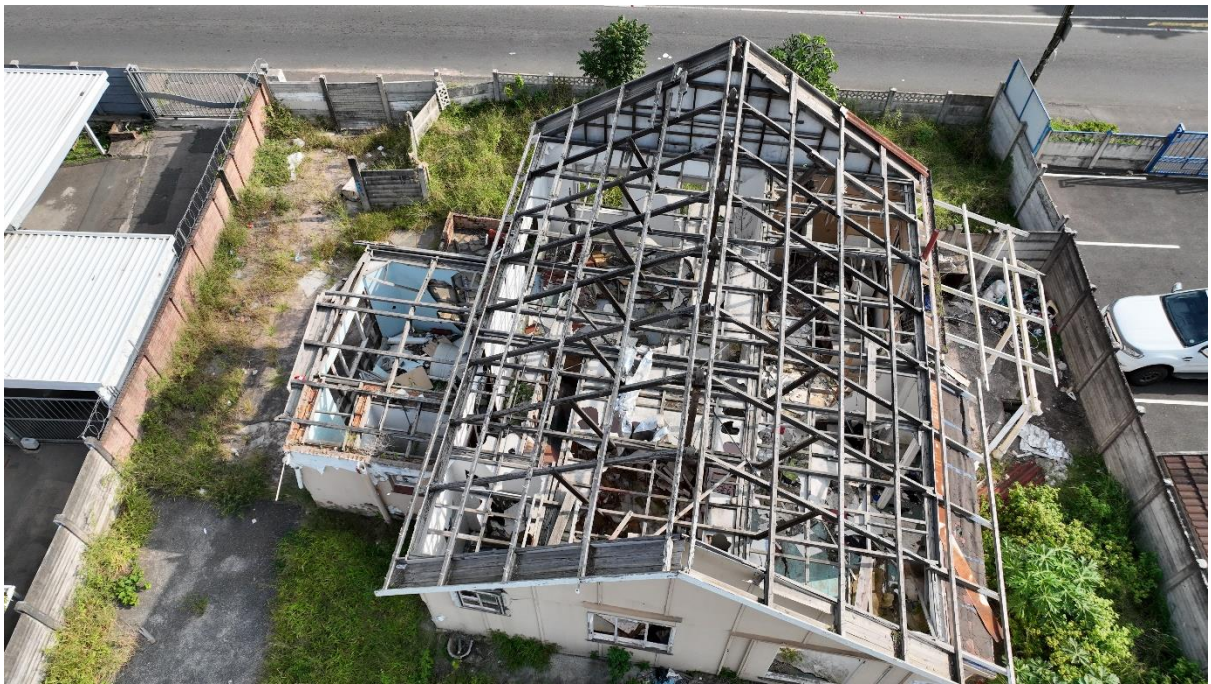
AERIAL VIEW OF DAMAGED AND STOLEN ROOF

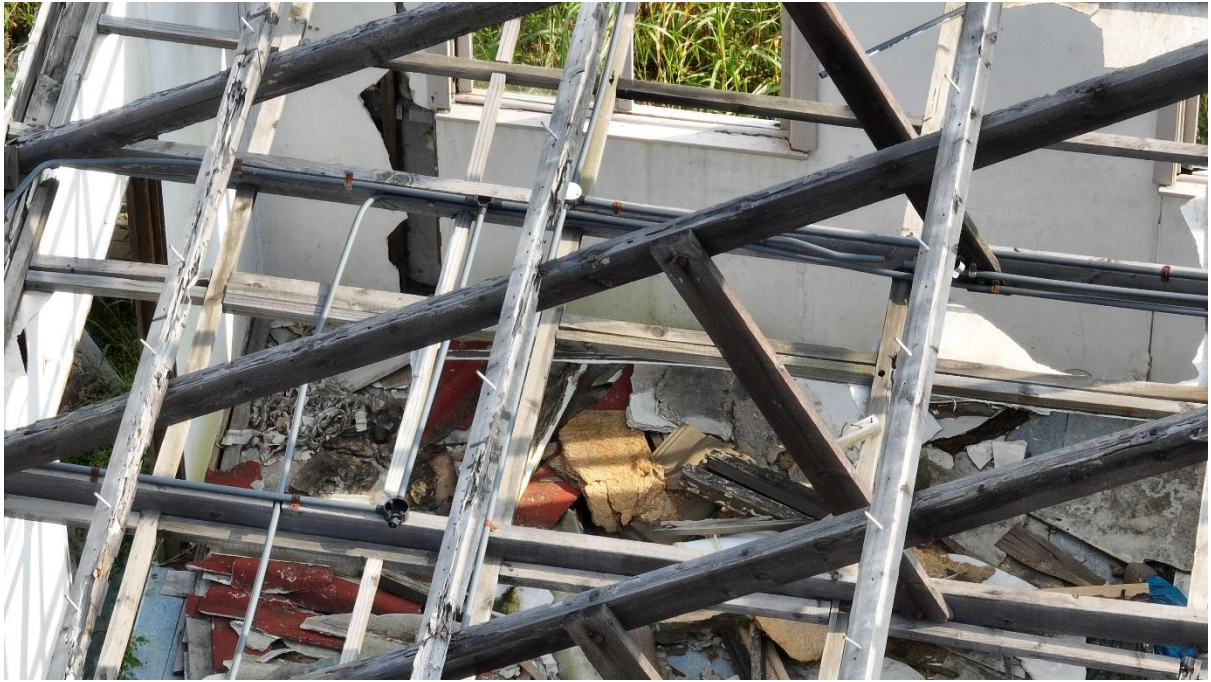
AERIAL IMAGE ZOOMED IN SHOWING DAMAGED ROOF

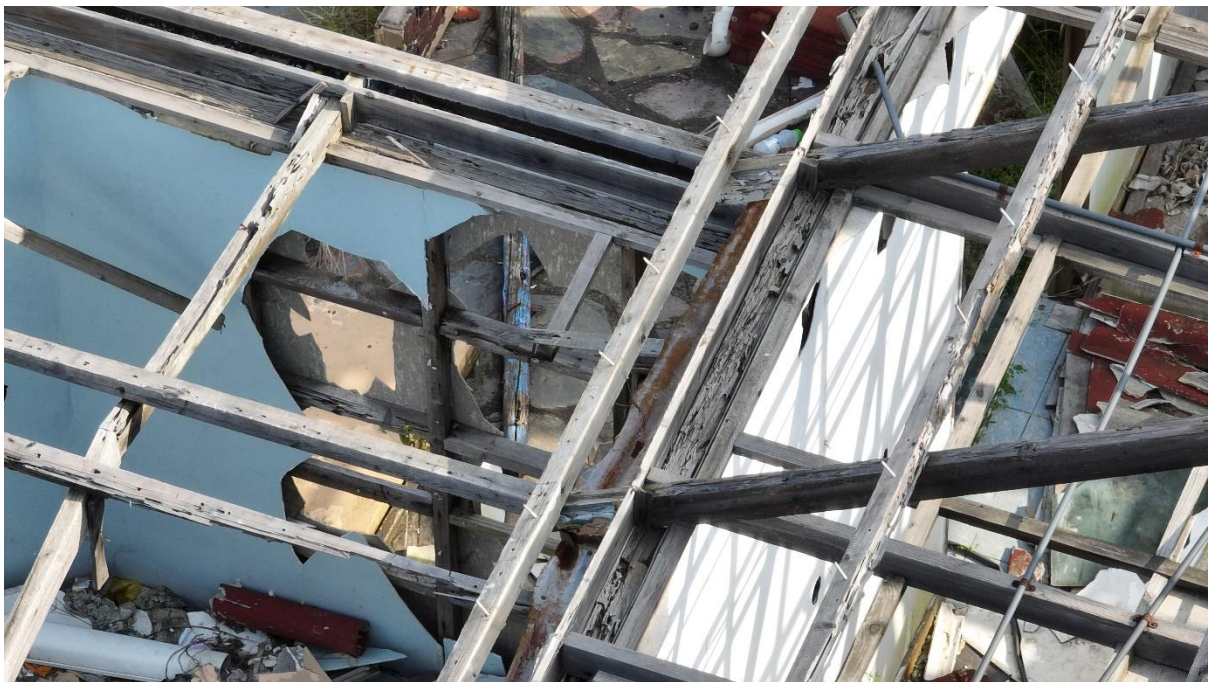
AERIAL IMAGE ZOOMED IN SHOWING DAMAGED ROOF
