HERITAGE IMPACT ASSESSMENT REPORT

**RE: A MOTIVATION FOR PROPOSED ALTERATIONS AND ADDITIONS TO 45 MOUNTAIN VIEW DRIVE,
MORNIGSIDE, DURBAN.**

Lot No	Portion 73 of Erf 230 Springfield
Extents	789m ²
Street Address	45 Mountain View Road
Proposed Works	Alterations and Additions
Zoning	Single Residential (15)
S.G No.	358/1954

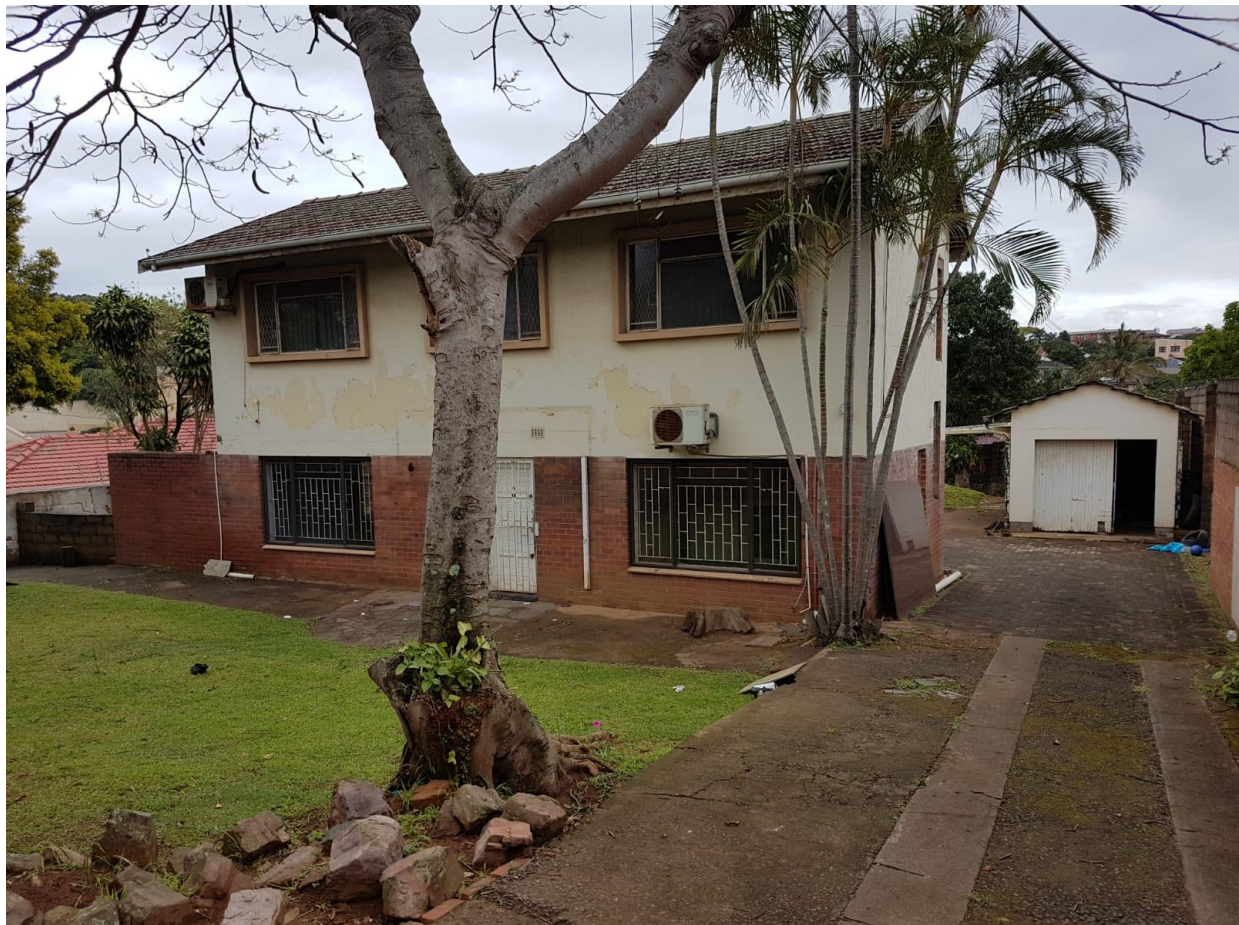
Image 02 – Existing Front Elevation

The building has no sign of any roof leaks or rising damp. There also no evidence of differential settlement cracks on any of the walls. Some of the timber frames on the fenestration require replacement as there are signs of severe wood borer infestation.

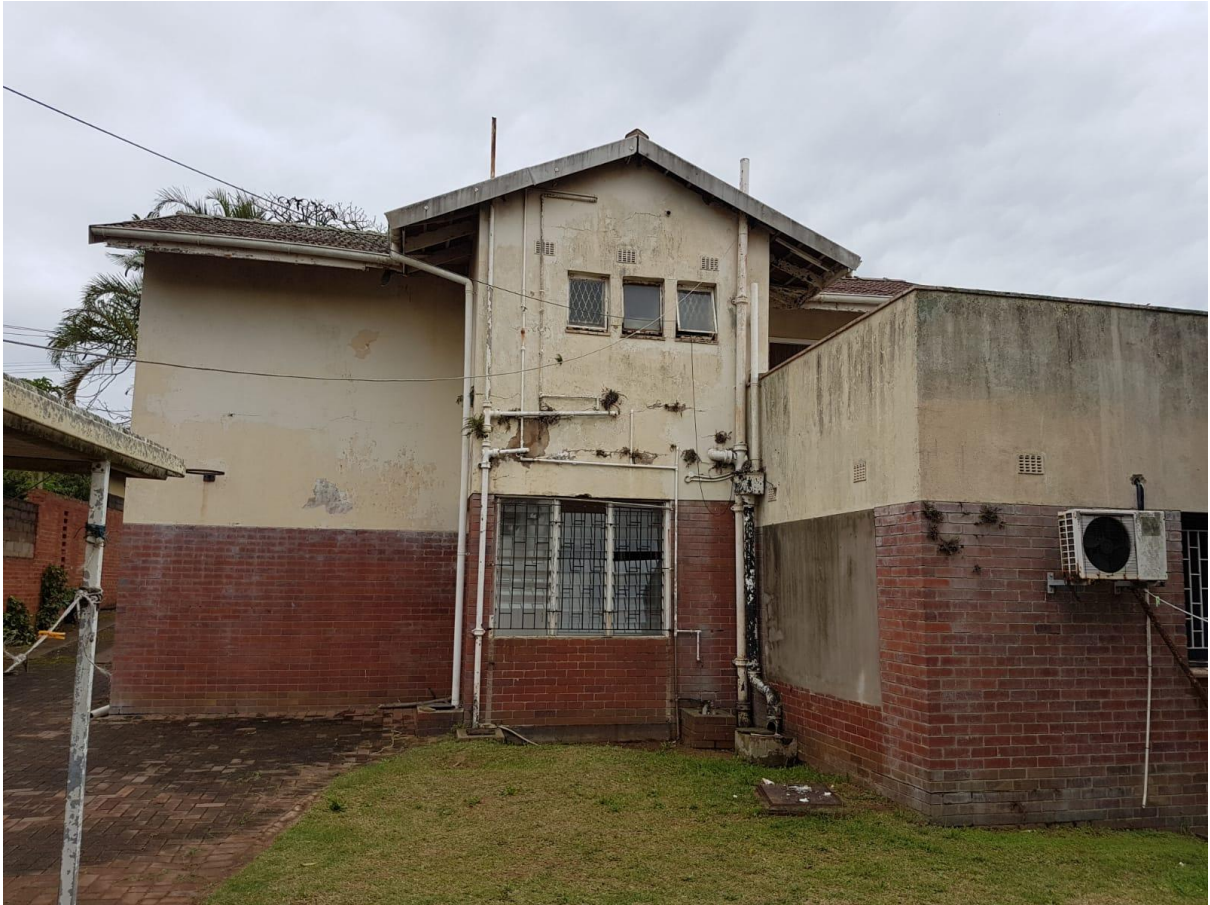
Image 14 – Rear Elevation

Due to soil conditions of the main ridge at Durban being partially that of a large sea dune, the building has settled well into the Berea Red soil however over the last few years the adjoining property at the rear boundary has made 6m sheer excavations which can cause mild erosion to dangerous mudslides. It is our intent to harden the surface around the dwelling so as to prevent any further erosion around the strip footings and foundations. This will be done by casting a minimum of 1m wide concrete aprons right around the building envelope.
