**Report on the Geotechnical Investigation for**

**HYPERAMA PIPELINE**

**REIGER PARK**

Report no.: GWS18217/G00085-F0

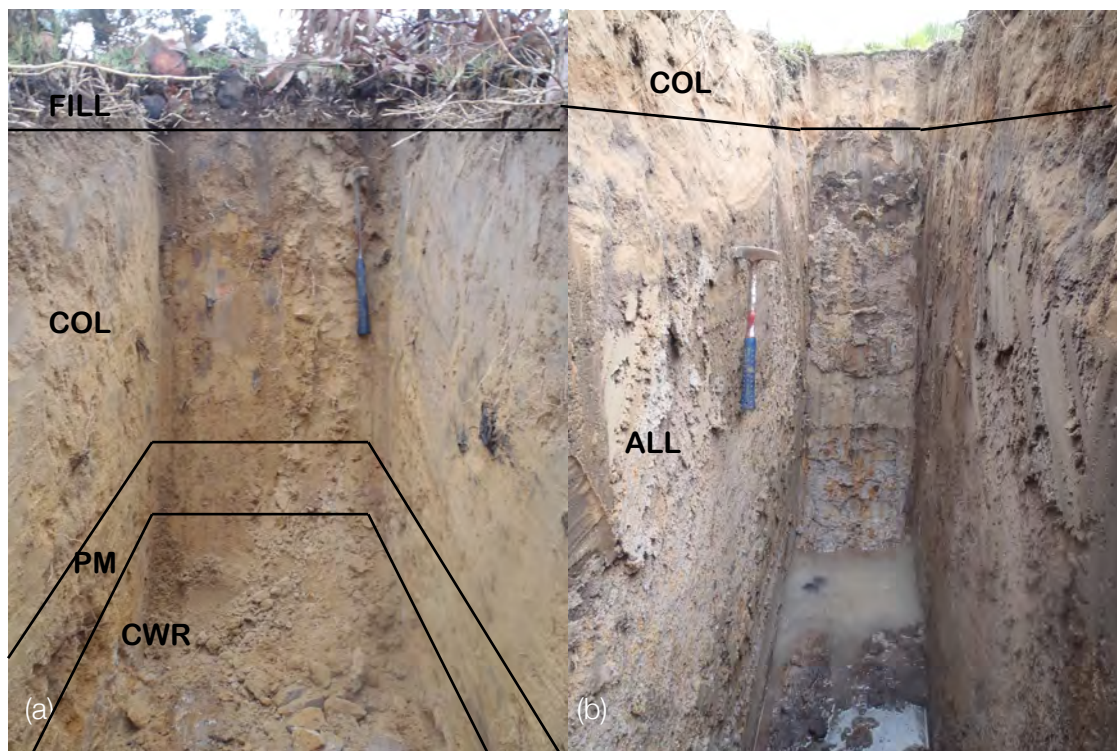
**Figure 3.2 (a) Photograph of typical profile at test pit H RTP2 and (b) photograph of profile H RTP4**

The seven (7) trial pits were excavated until terminated due to water seepage or refusal at a shallow depth using a TLB. The generalised profiles observed in the trial pits excavated at the site are summarised in Table 3.2. No sidewall instability was encountered in any of the trial pits with slow water seepage to wet conditions experienced in three (3) holes in close proximity to the stream. Furthermore, presence of mottling and ferricrete in the soil profiles is indicative of seasonal moisture changes.

- A surficial colluvial or uncontrolled fill layer of medium dense to loose, slightly clayey silty fine to coarse sand with traces of angular gravel and anthropogenic material to an average depth of 0.80 m below ground level (BGL); to a alluvial loose (soft), clayey sand with traces of sub-rounded gravel to an average depth of 1.00 m BGL; which was in turn underlain by

- An occasional pebble marker, found away from the stream, described as loose to medium dense, silty sand with abundant angular gravel and cobbles to an average depth of 1.10 m BGL; underlain by

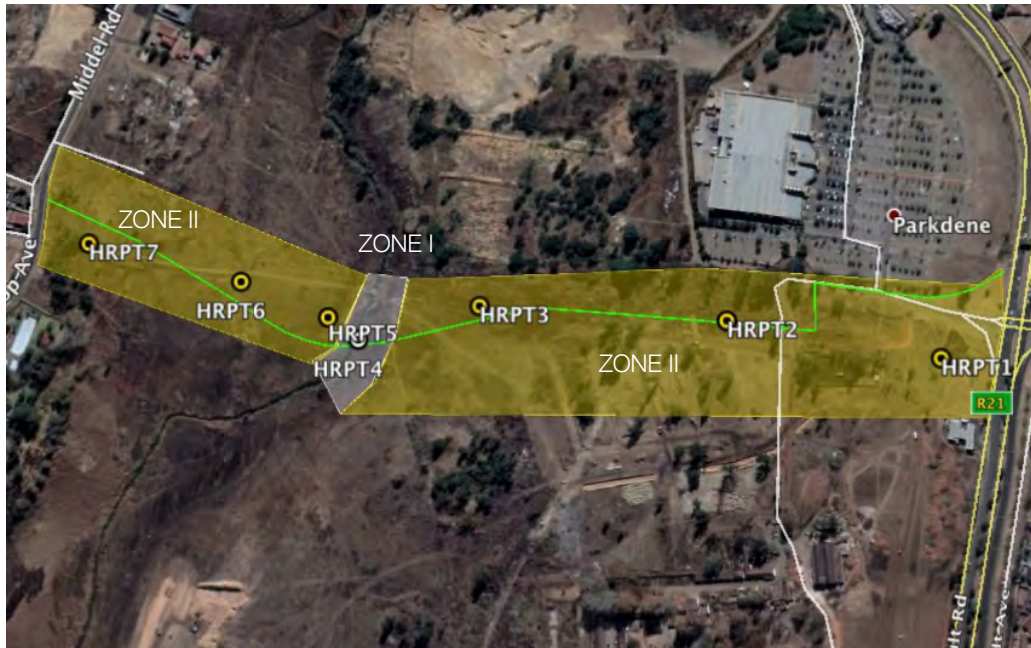
Figure 4.1 Geotechnical zoning map for proposed pipeline

| ZONE | Geotechnical constraint |
|---|---|
| I | Area subjected to flooding<br>Seasonal perched watertable<br>Moderate soil heave potential<br>Materials unsuitable for reuse |
| II | Difficult excavation (shallow bedrock)<br>Seasonal perched watertable<br>Moderate slopes |
