Bo-Kaap Erf 149141, 90 Chiappini Street

Section 34 Application to Heritage Western Cape in terms of the National Heritage Resources Act

Report on Existing Housing Condition and Assessment of Recommended Work on City Owned House in Bo-Kaap.

**Compiled by Dieter Bossow of Architects Associated for the City of Cape Town.
April 2018.**

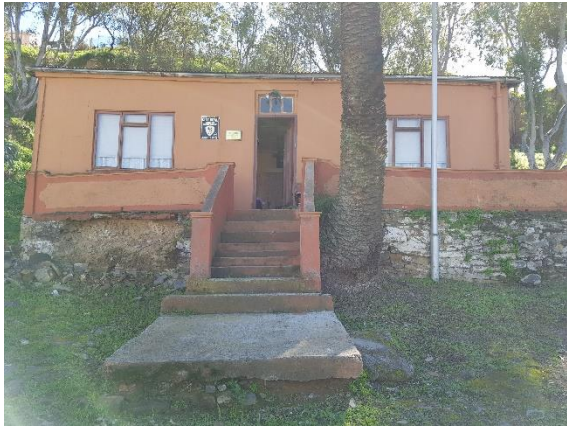
Front façade

Walls are plastered and painted, ditto to stoep walls. Stoep stone retaining wall has collapsed.

Service windows and repaint.

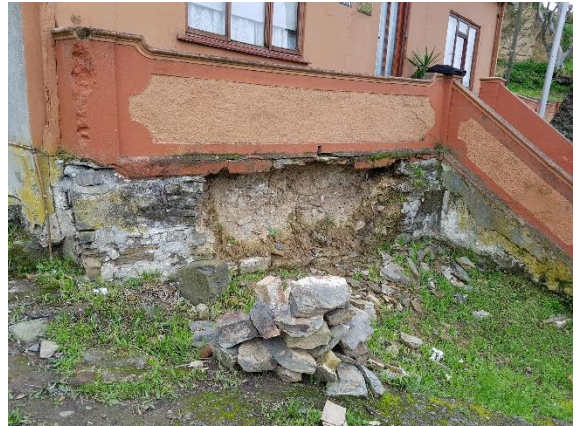
Stoep wall damage

Cast new footing and rebuild stone wall below stoep.

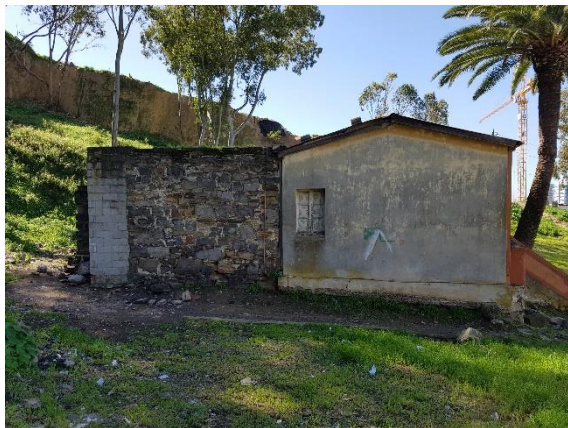
Side façade south

The walls of the main section of the house are plastered, wing walls in stone and blockwork are unplastered. Part of the courtyard has been roofed over with clear sheeting. The courtyard is closed at the rear with a sheet metal structure.

Paint unpainted walls, plaster block walls and stone walls and paint, raise existing toilet walls, fit new window, plaster and paint. Service existing windows and repaint.

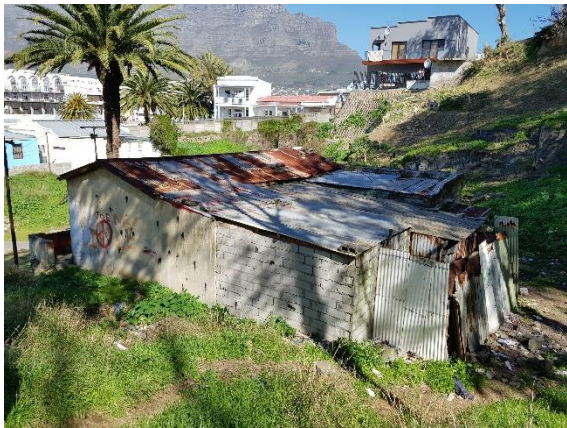
Roof view

Corrugated iron double pitched roof over main part of house with lean-to roofs at the back and a separate roof over the toilet. There are no gutters and downpipes externally.

Check roof for leaks, replace roof if necessary, fit new fascias, gutters and downpipes, construct new roof over wc as per drawings. .

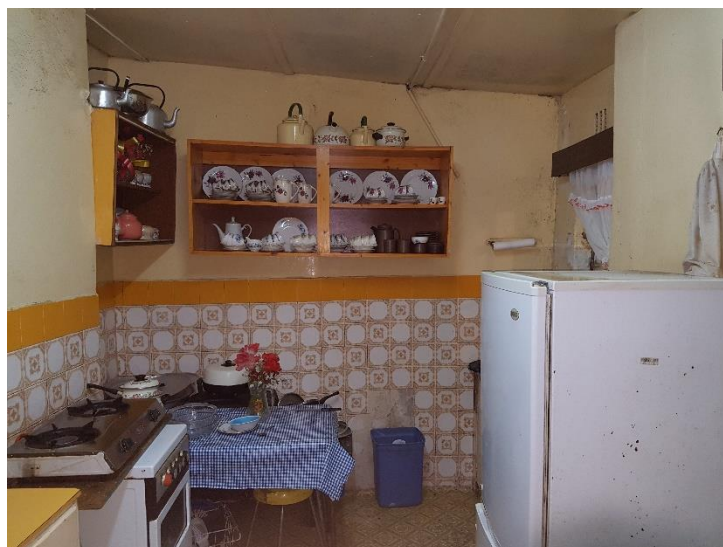
Kitchen

The kitchen has a sink and walls are tiled. The bathroom contains a bath and basin, the toilet is separate.
