2 LION STREET, BO-KAAP, CAPE TOWN

STRUCTURAL REPORT (A0137-R-100 REV A)

JOB No: A0137

18th August 2020

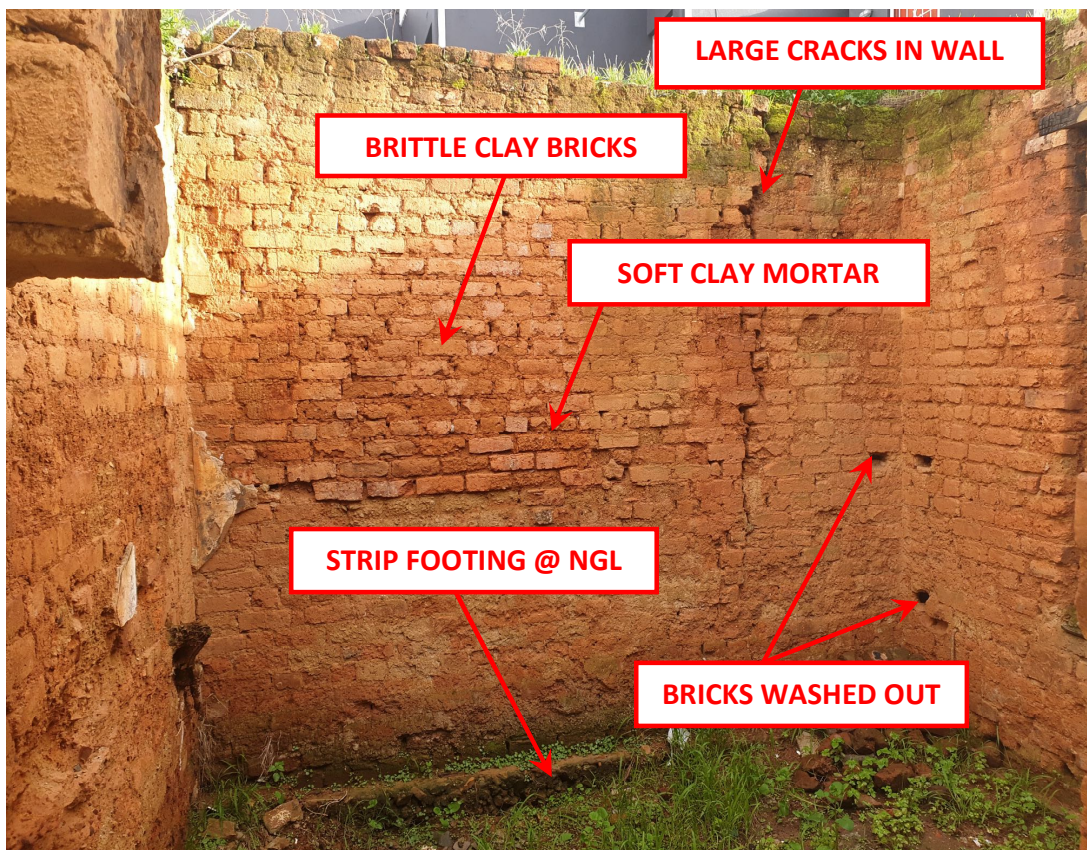
The walls were built off strip footings that were constructed with rocks / boulders, laid in cement mortar and founded at Natural Ground Level (NGL). The compressive strength of the footings is unknown. The walls were constructed using clay bricks and clay mortar. Bricks are brittle, some have washed out and the clay mortar beddings are soft (see photograph 1 & 2 below).

PHOTOGRAPH 1: TYPICAL WALL CONSTRUCTION

The existing walls must be demolished completely and the existing strip footings removed. The propose 3 storey apartment building must be built completely new to suit the client's requirements. The street boundary wall / retaining wall have failed its serviceability and therefore must be completely demolish. The new boundary wall must be built to suit the new building configuration and aesthetics.

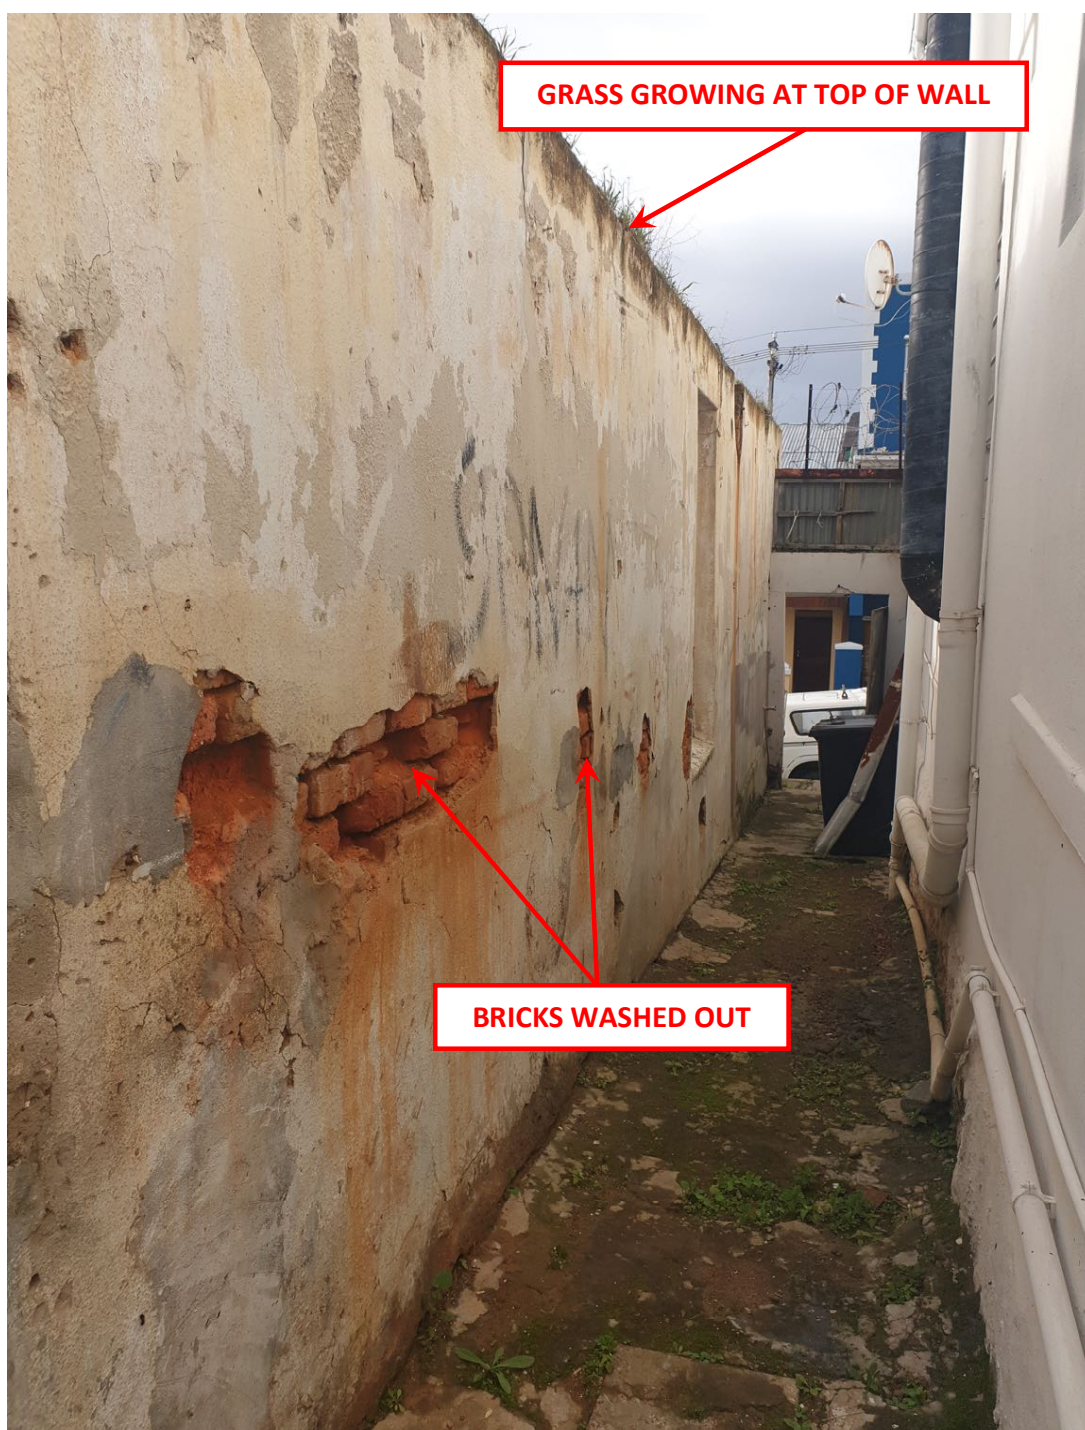
Photograph 2: EXTERNAL WALL ON BACK BOUNDARY

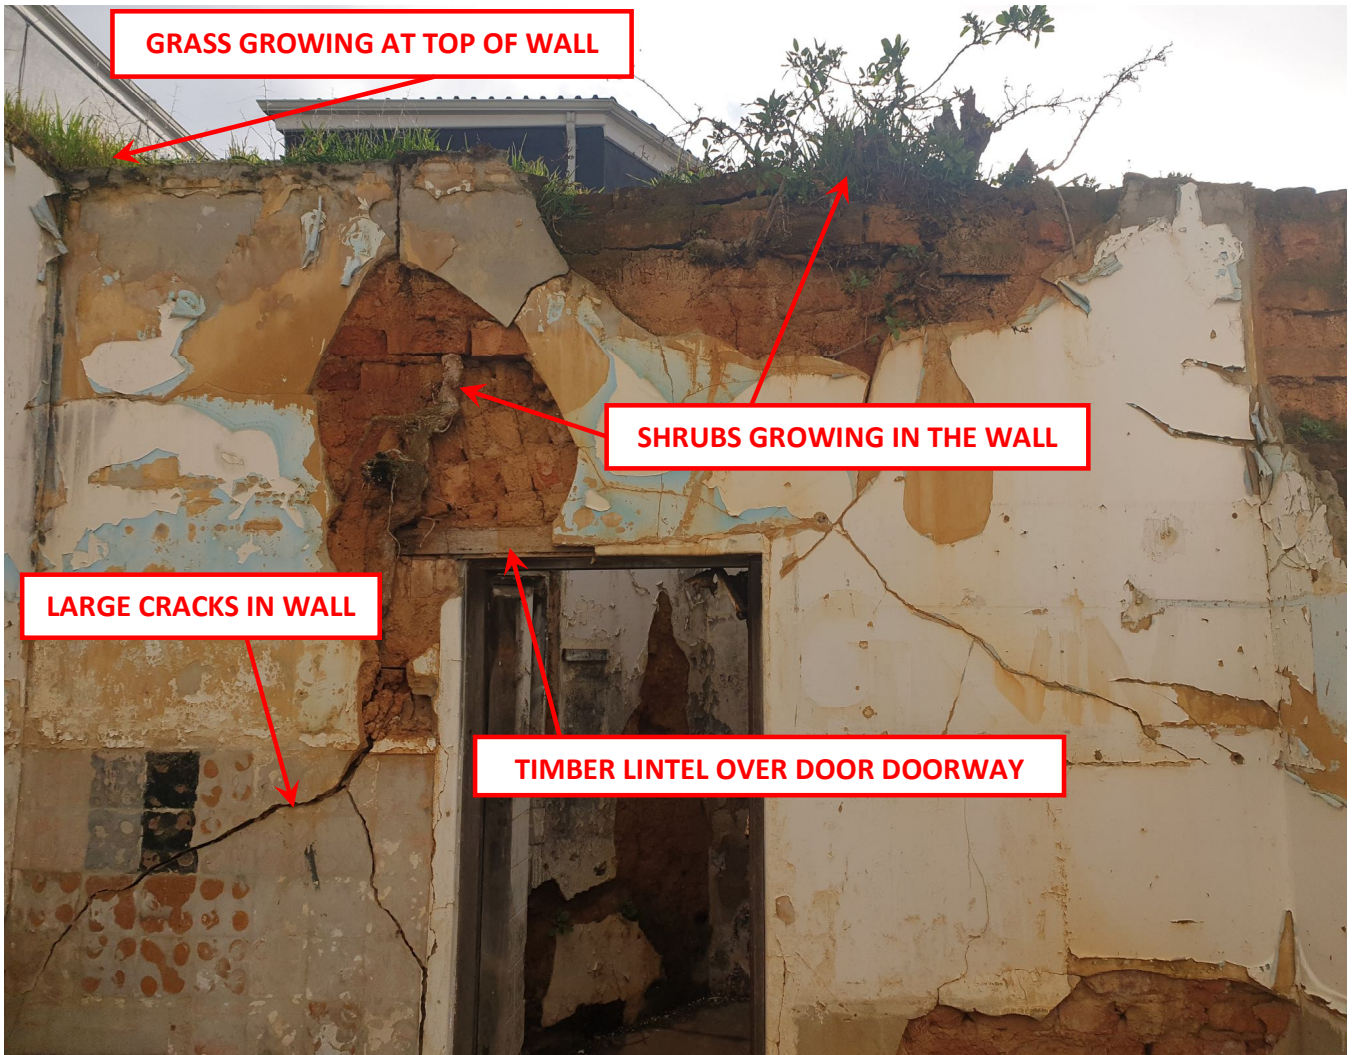
Grass / shrubs are growing from the walls displacing bricks and mortar. Large cracks (greater than 3 mm and for full depth) induced by the heat of the fire run across wall panels. Timber lintels were damaged by the fire (see photograph 4). This is the case in all the walls.

PHOTOGRAPH 3: WALL PANEL WITH DOOR OPENING

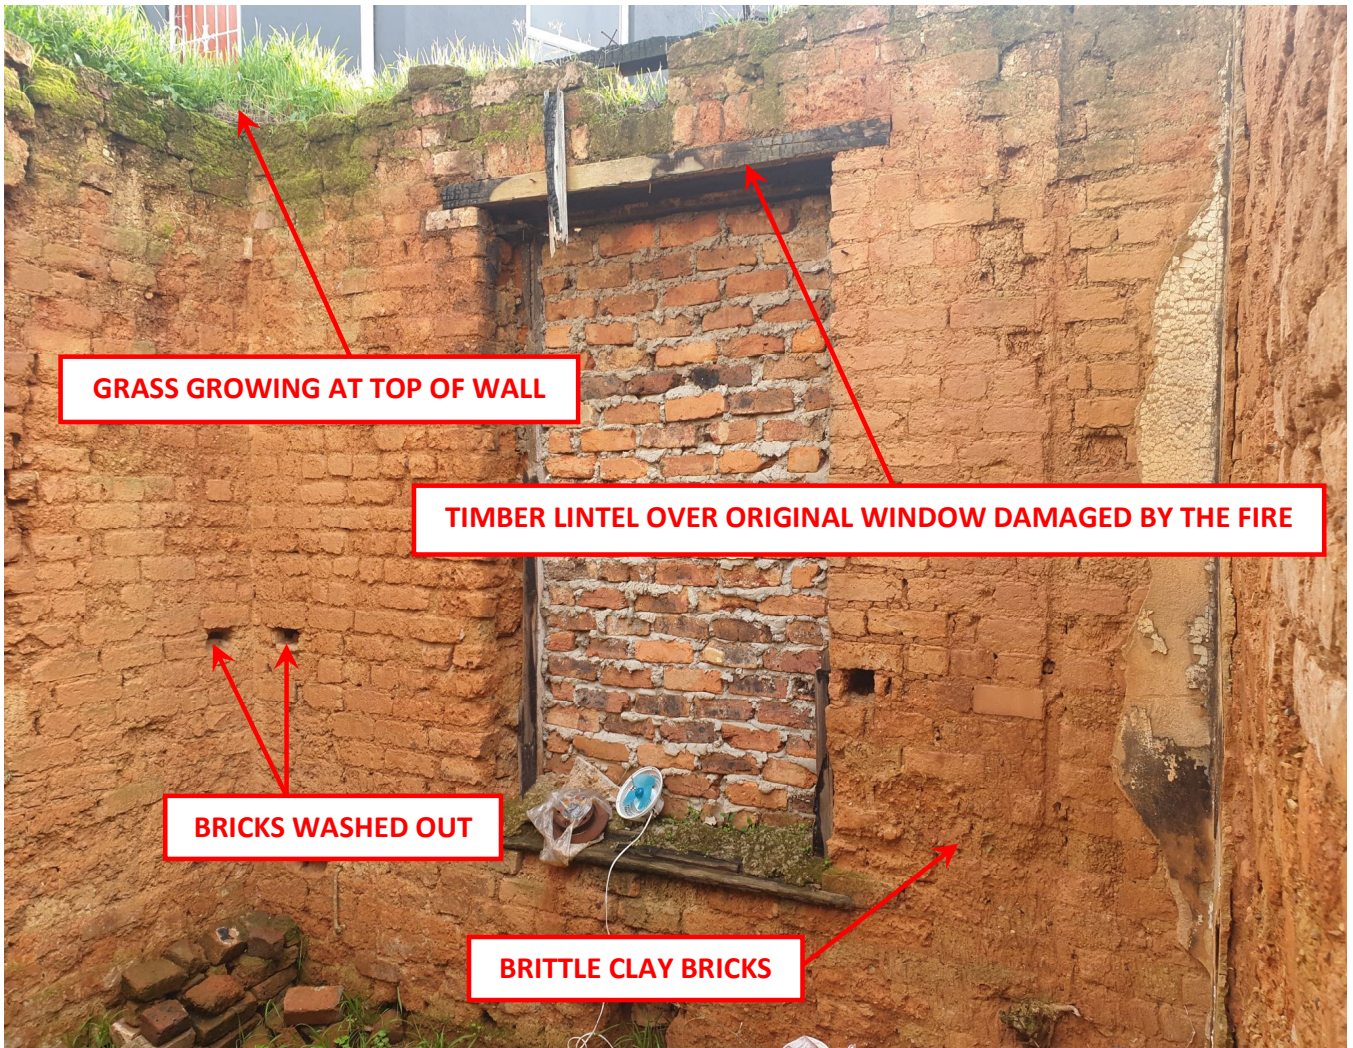
PHOTOGRAPH 4: ORIGINAL WINDOW CONSTRUCTION

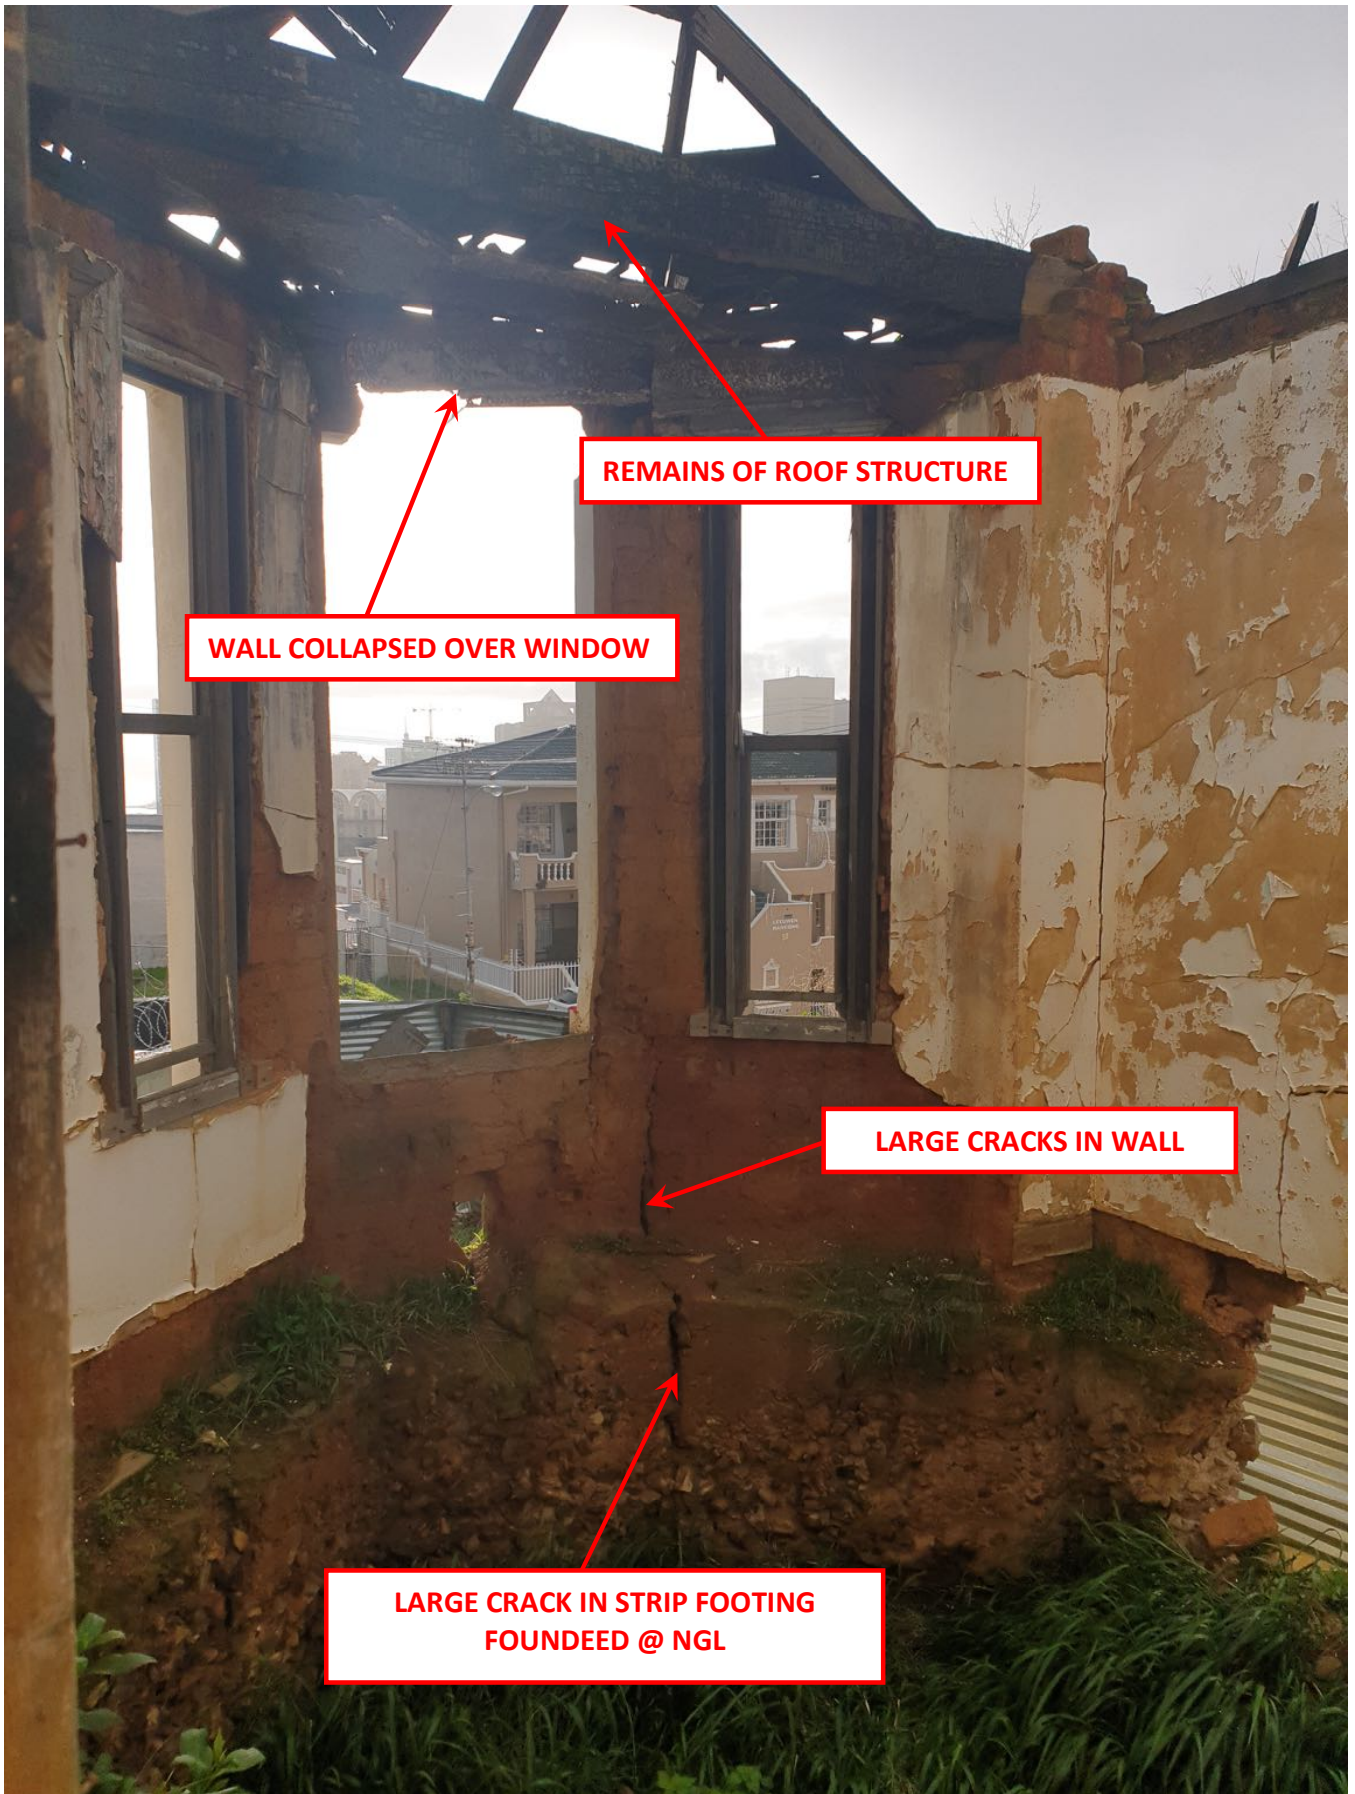
PHOTOGRAPH 5: BAY WINDOW IN LOUNGE

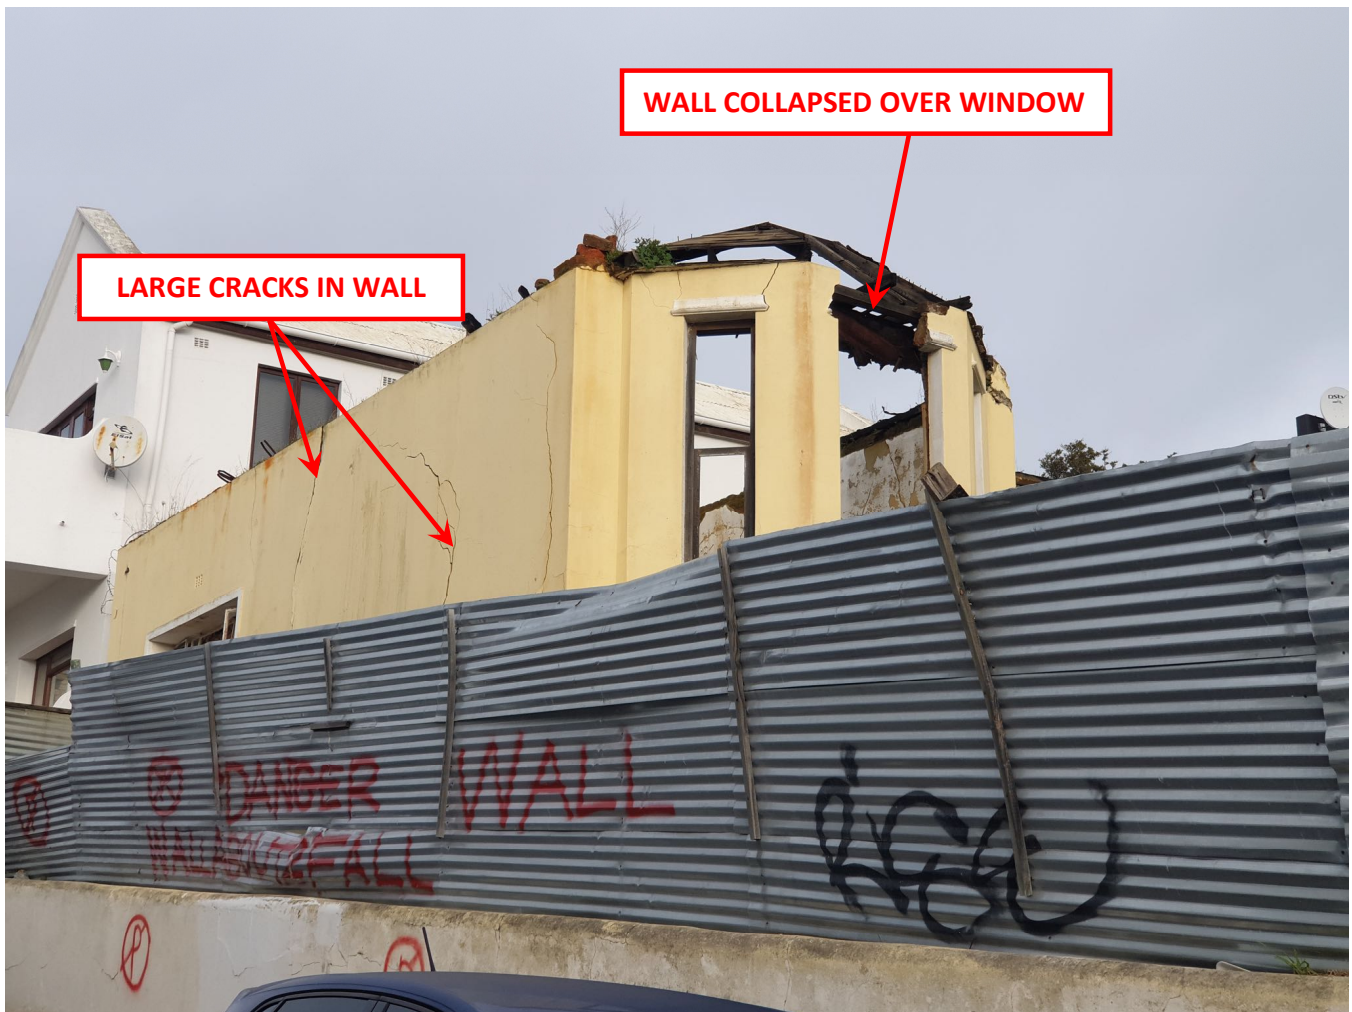
PHOTOGRAPH 6: STREET VIEW

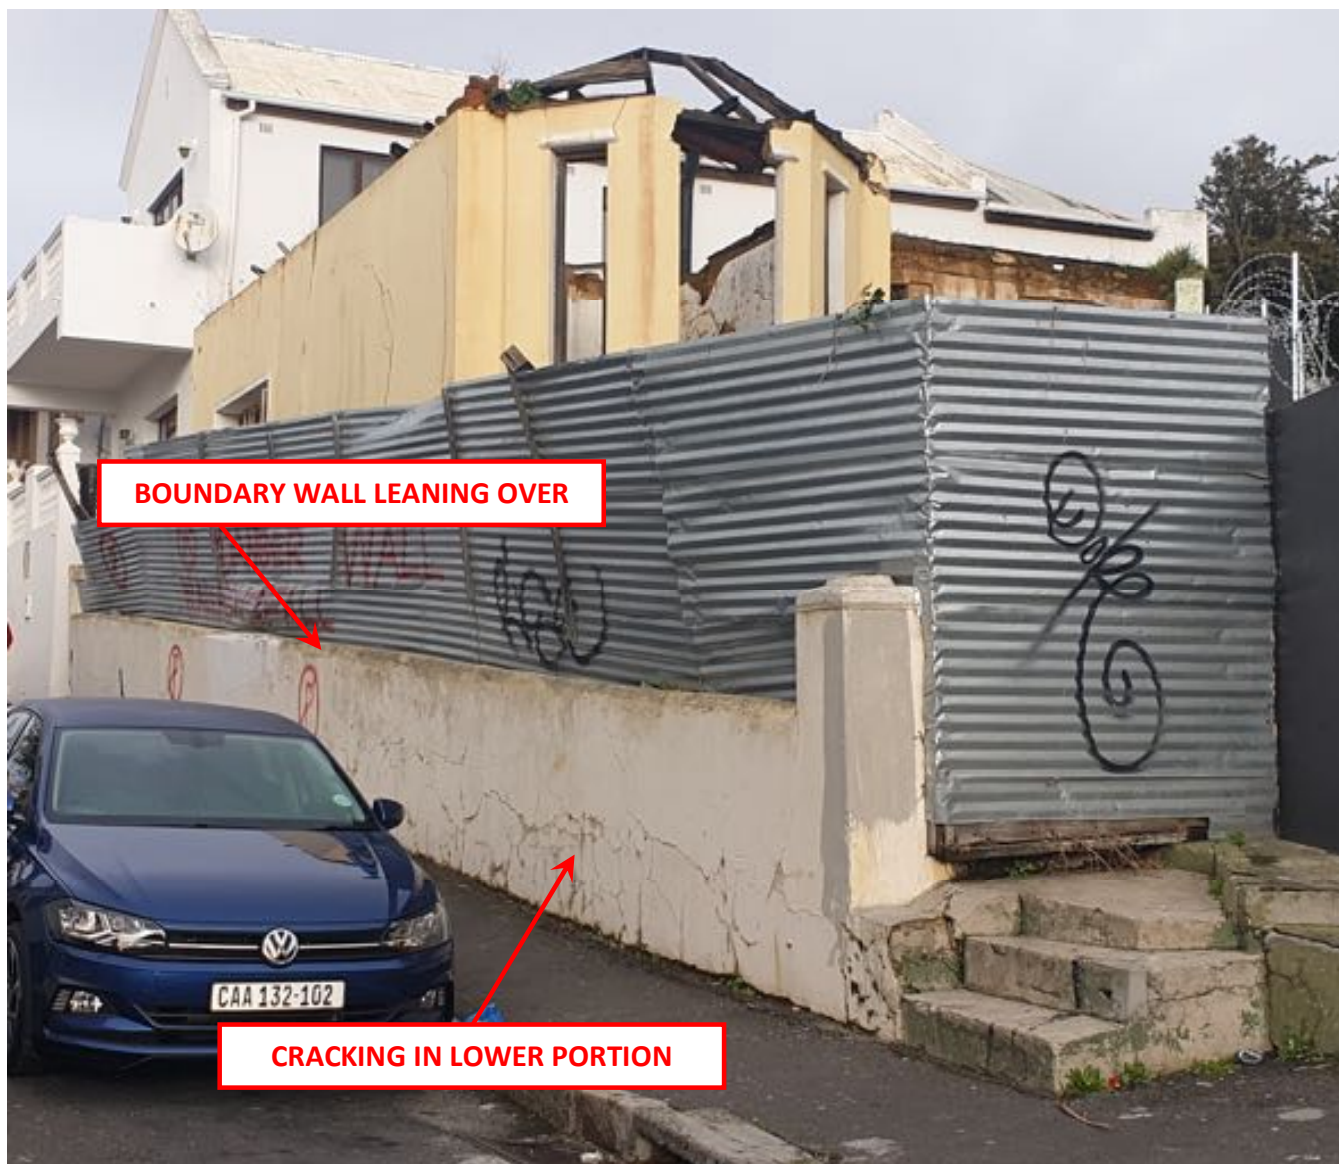
The street boundary retains the grass patch / garden at mid-height. It is cracking at the lower portion of the wall with damp blemishes along the crack lines caused by the water logged ground. The boundary wall is also leaning over towards the street (see photograph 7 below).

PHOTOGRAPH 7: STREET BOUNDARY WALL
