# HONDEKLIP BAY ABALONE PROJECT: REPORT No. 1; HERITAGE IMPACT ASSESSMENT PROGRESS REPORT AND PRELIMINARY FINDINGS

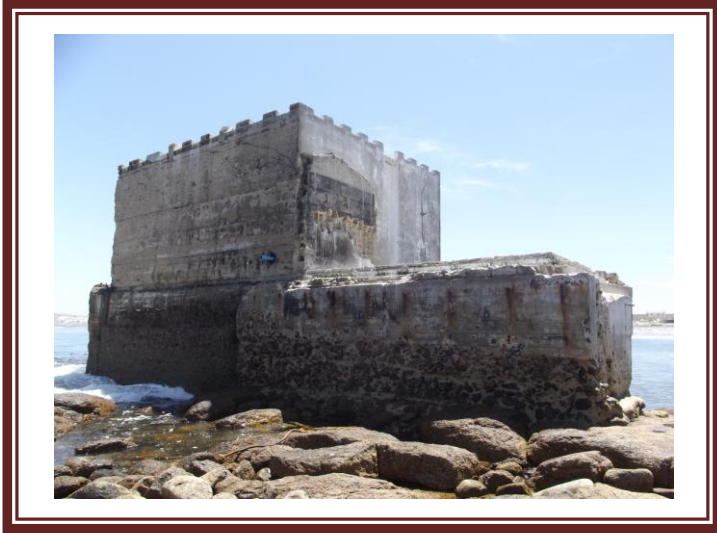
Ice house ca November 2011

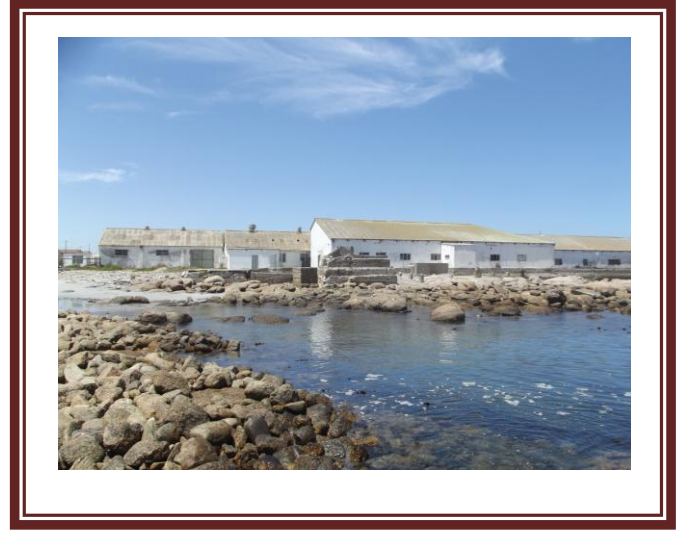
Remains of Jetty and Ice House ca November 2011.

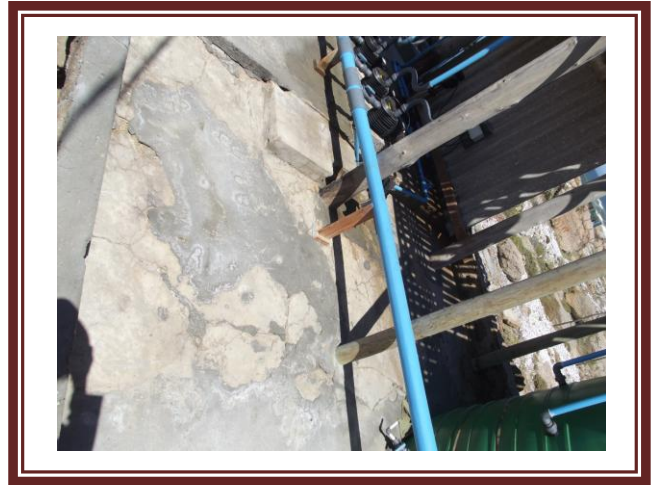
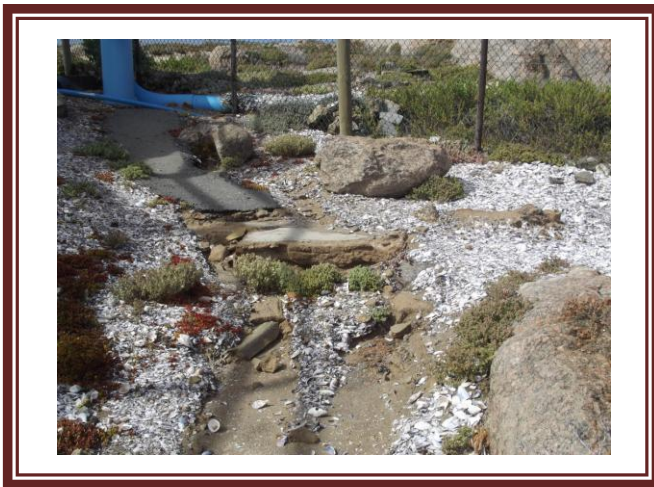
### Site 1

Situated on the small hill overlooking the /Main Building. The current water tanks to store sea water are situated on top of the floor and foundations.

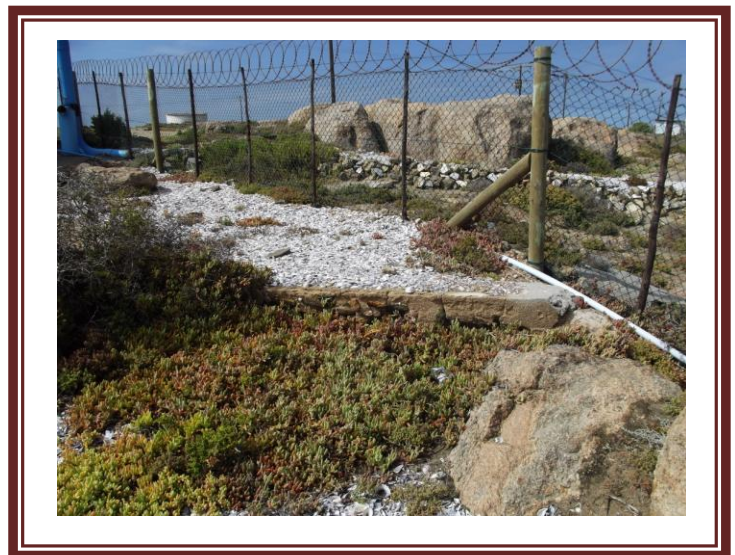
### Site 2

A small section of the remains of a floor is visible towards the seaward side of the water storage tanks and close to the current fence.

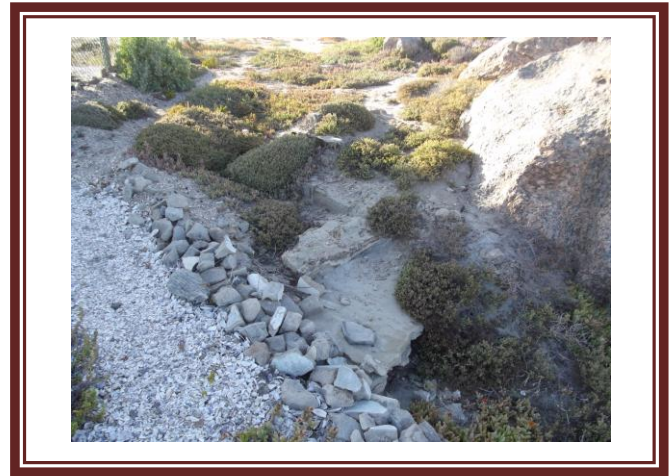
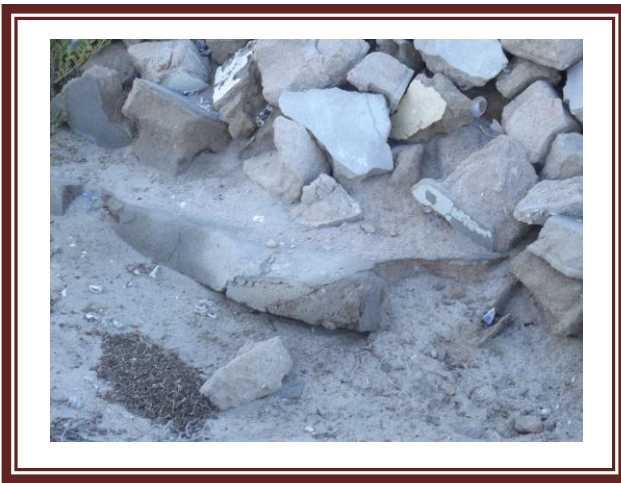
#### Site 4

Situated next to the present pipeline on the southern side close to the fence near the water tanks are the remains of a concrete floor, foundations and the first layer of breeze blocks for the wall of a house.

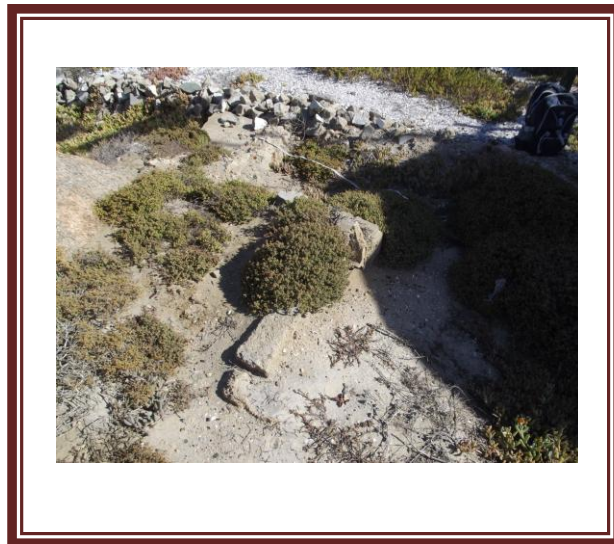
#### Site 5

The remains of a floor underneath the present pipe.

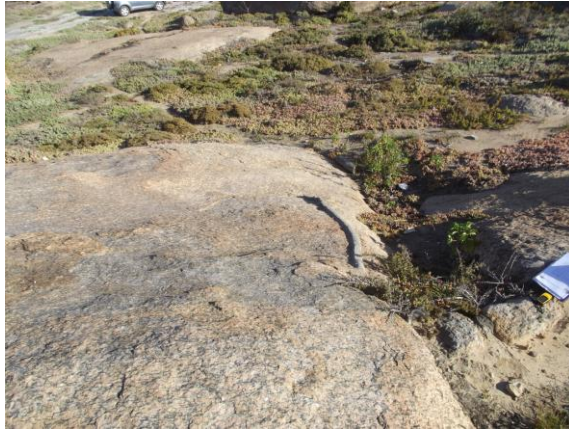
#### Site 6

Foundations and remains of a wall can be seen on the north side of the pipeline.

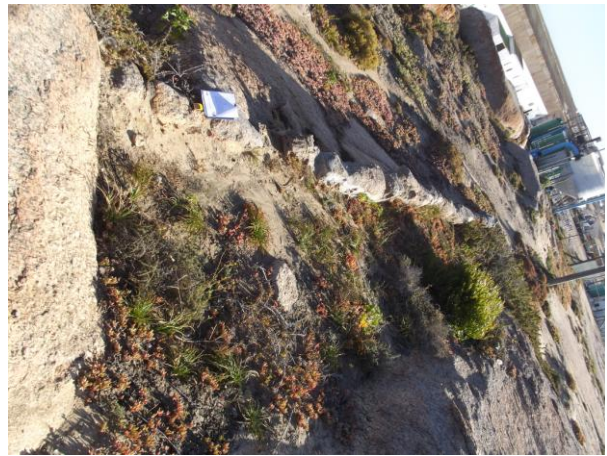
Site 7. Remains of cement channel on rock to channel rainwater into a catchment pond shown below, now silted up. The pond was used by the residents of Ou Lokasie to wash with.

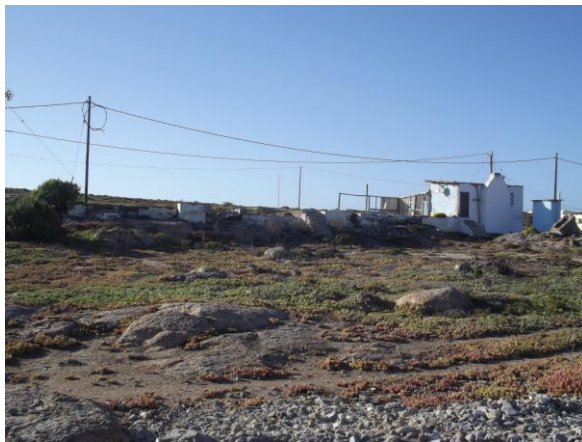
Site 8. Remains of single quarters burnt down ca. 1990's
