**Letter from PGS to Client with Observations and Recommendations
based on Site Visit of 28 October 2014**

OBSERVATIONS AND RECOMMENDATIONS RESULTING FROM A SITE VISIT TO THE DURBAN ROODEPOORT DEEP ON TUESDAY, 28 OCTOBER 2014

PGS Heritage was commissioned to conduct a Heritage Impact Assessment for the proposed development of Goudrand Extension 4 situated on Portions of the Remainder of Portions 1 and 5 as well as Portion 404 of the farm Roodepoort 237 IQ, Gauteng Province.

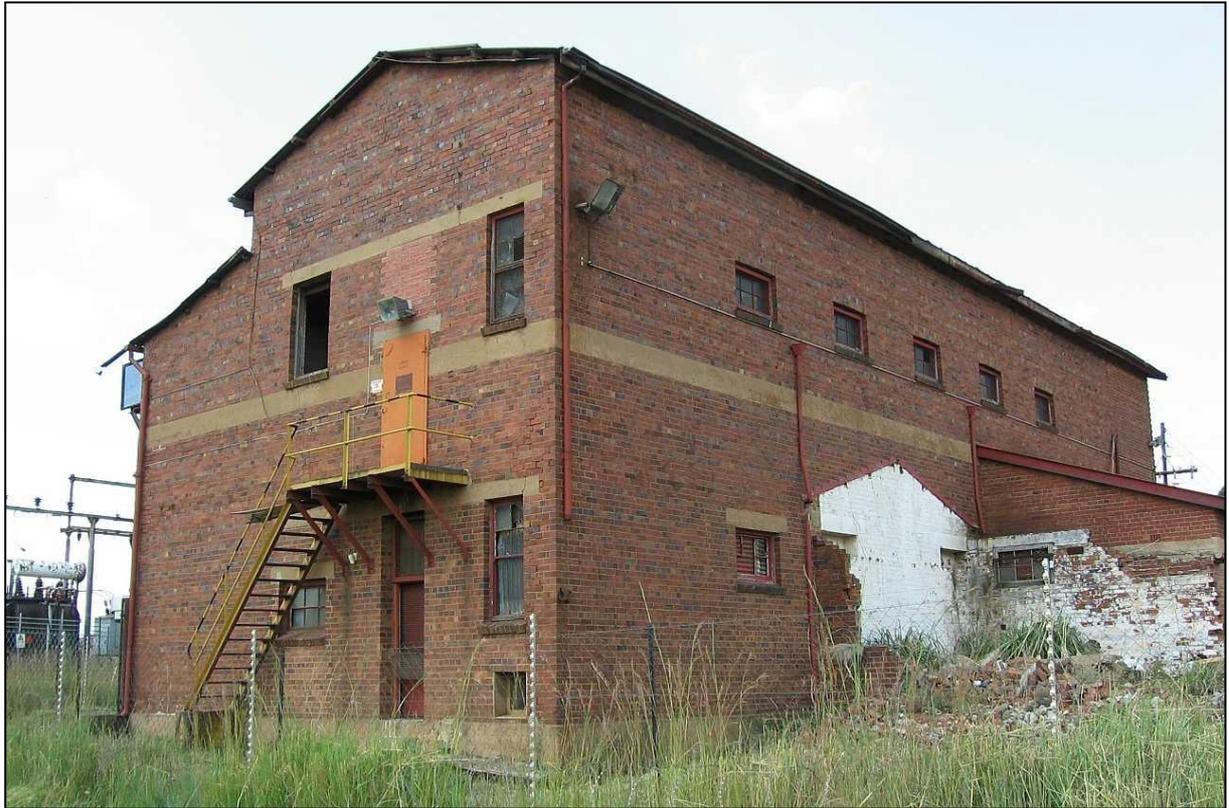
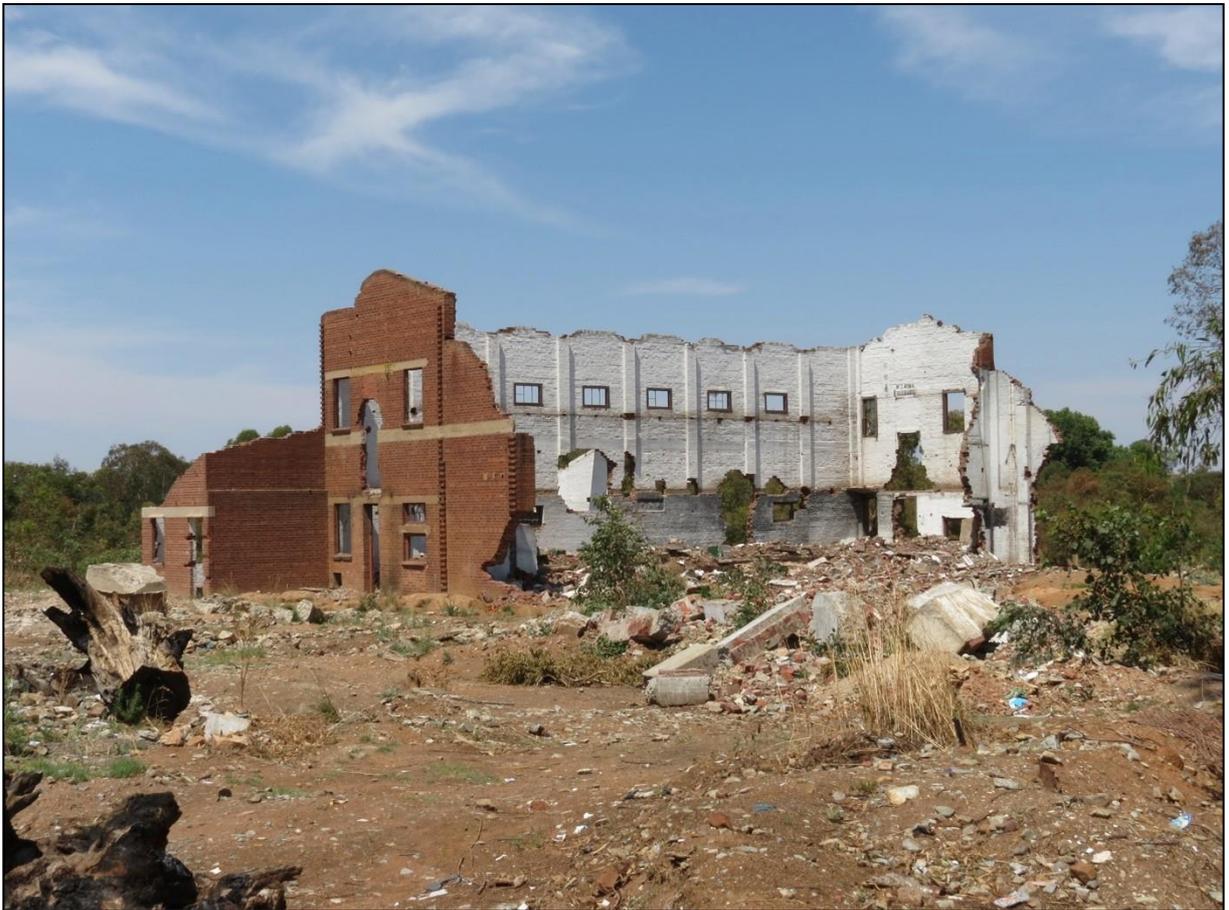
During the site visit of 28 October 2014, it was found that all the buildings from the site had been vandalized to such an extent that very little remains.

Figure 1 DRD 1 – 2013: The top image depicts the site in 2011 with the bottom one in 2014.

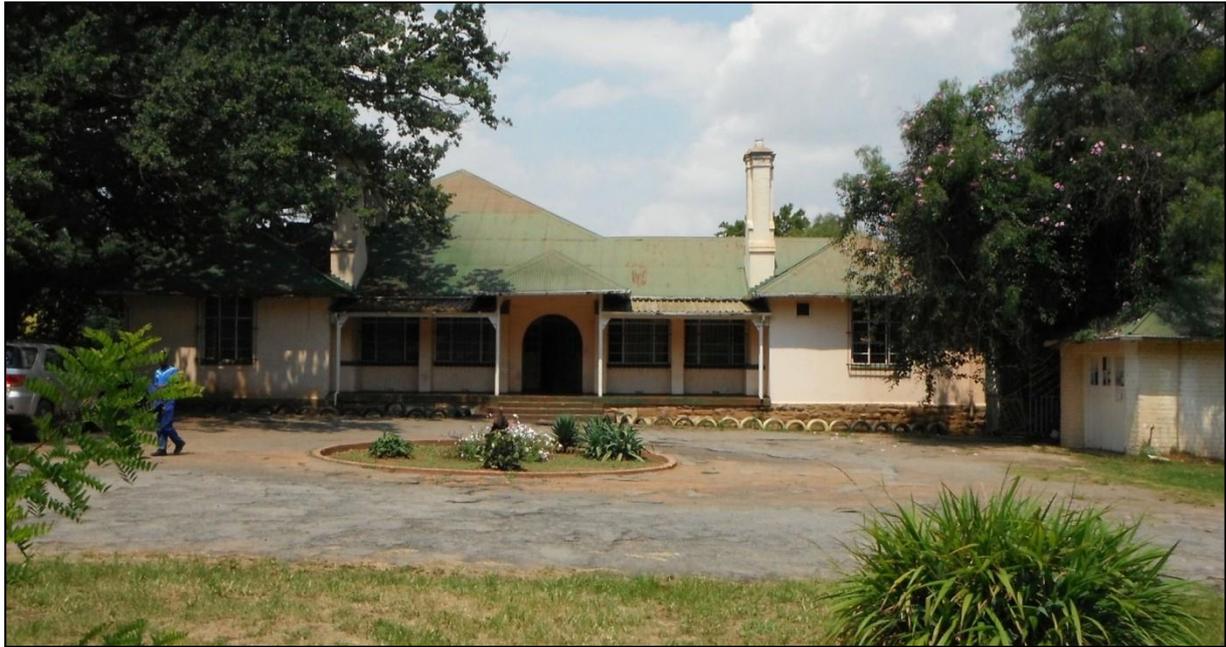
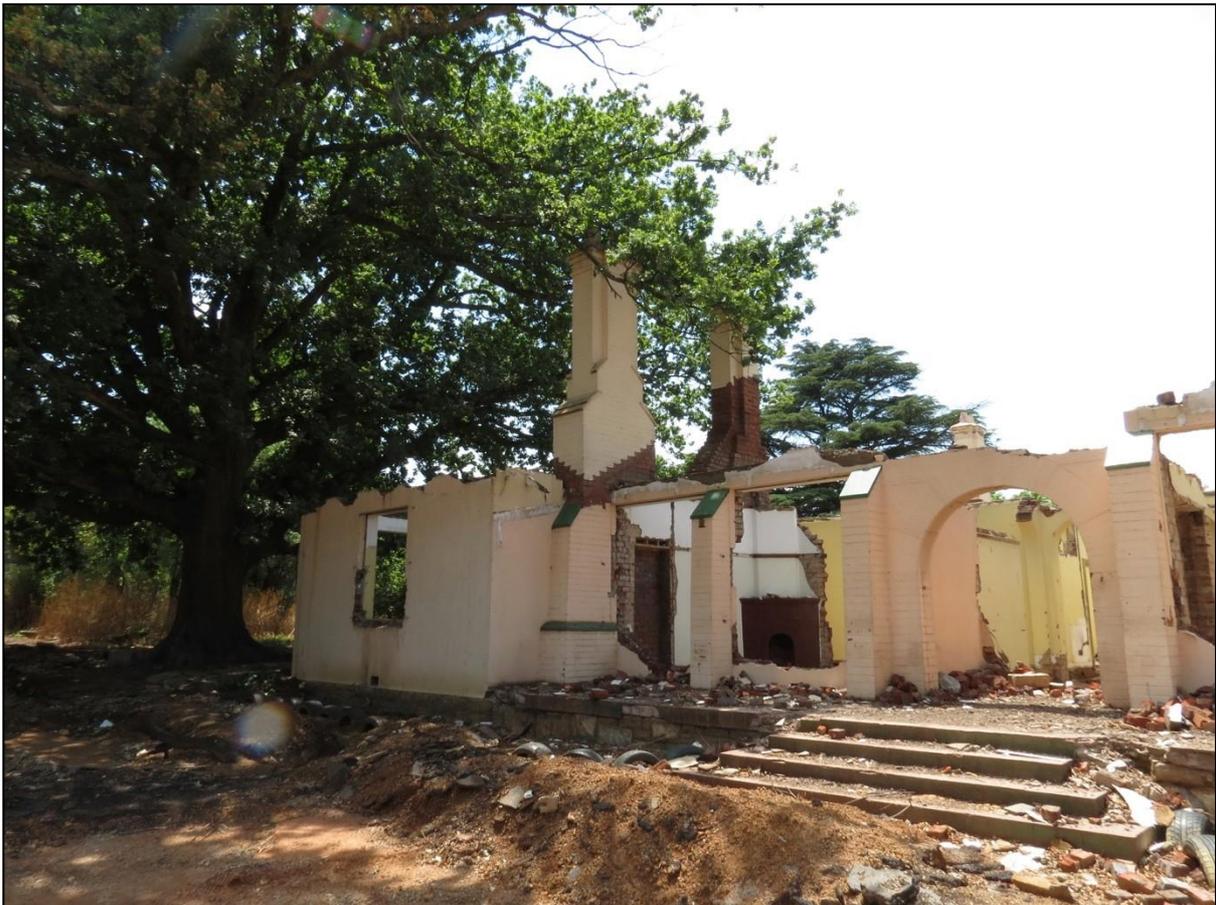
During the site visit of 28 October 2014, it was found that the building has been extensively vandalized with only sections of the walls still remaining. The driveway and parking area in front of the building had also been ripped apart by illegal gold miners. The building is in a very poor condition.

Figure 2 DRD 5 – 2013: The top image depicts the only example of Building Type 28 that was identified within the study area in 2011. The bottom image depicts the same building as seen during the site visit of Tuesday, 28 October 2014.

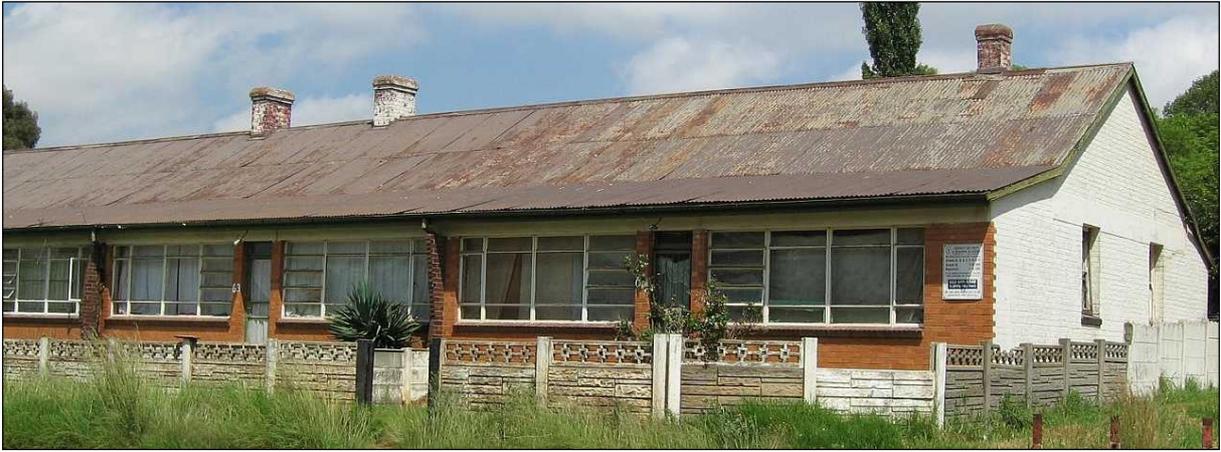
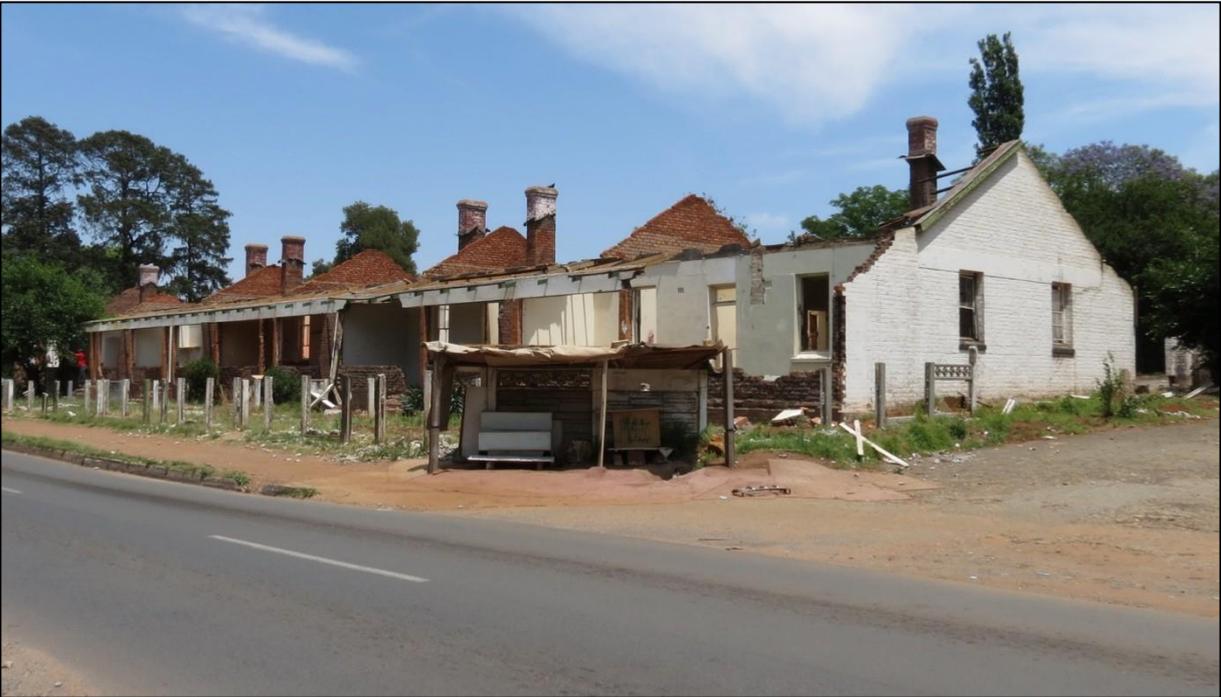
During the site visit of 28 October 2014, it was found that Building Type 27 had been extensively vandalized with only sections of the walling still intact. All examples of Building Type 19 had similarly been extensively vandalized. Furthermore, three of the four examples of Building Type 26 had also been extensively vandalized. The only buildings still in the same state of preservation as what was observed during 2011 are the three examples of Building Type 25 as well as one example of Building Type 26.

Figure 3 DRD 7 – 2013: The top image depicts one of the buildings (Building Type 27) from the site in 2011. The image at the bottom depicts the same building as seen during the site visit on Tuesday, 28 October 2014.

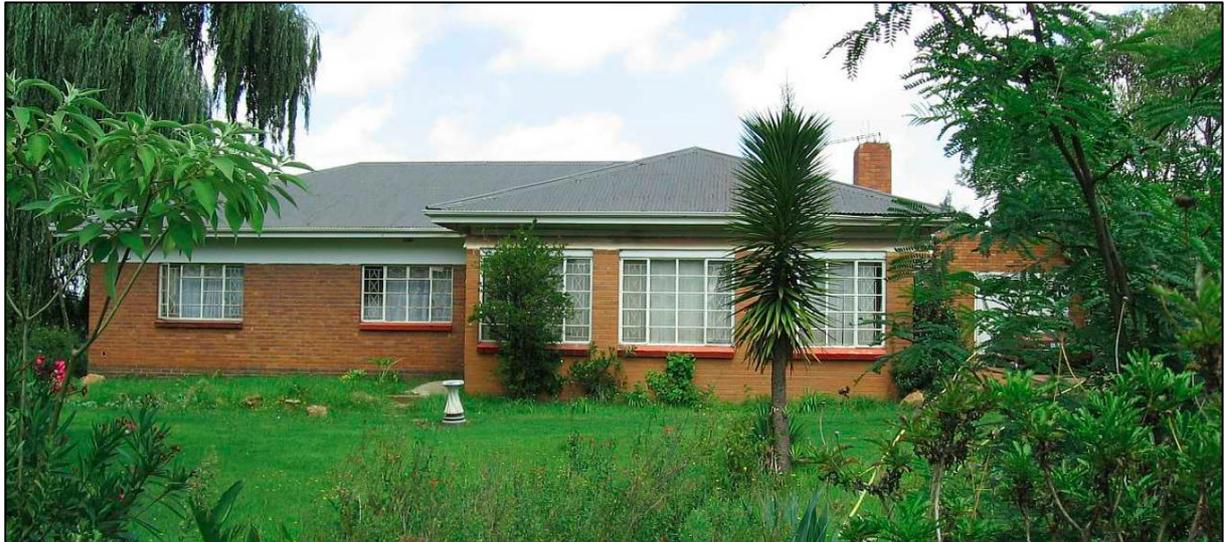
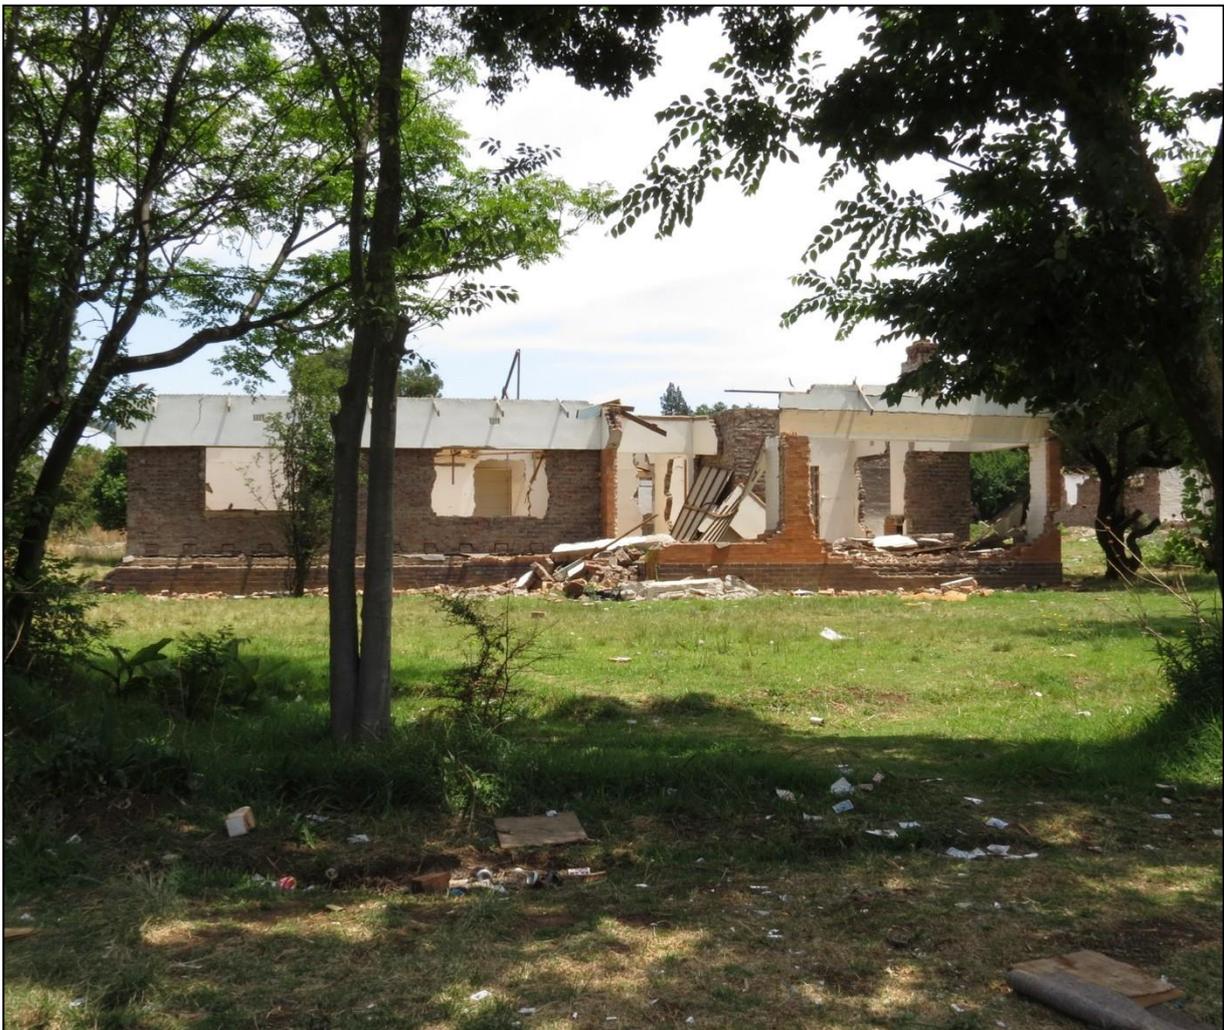
Figure 4 DRD 7 – 2013: The top image depicts one of the buildings (Building Type 26) from the site in 2011. The image at the bottom depicts one of the same buildings as seen during the site visit on Tuesday, 28 October 2014.

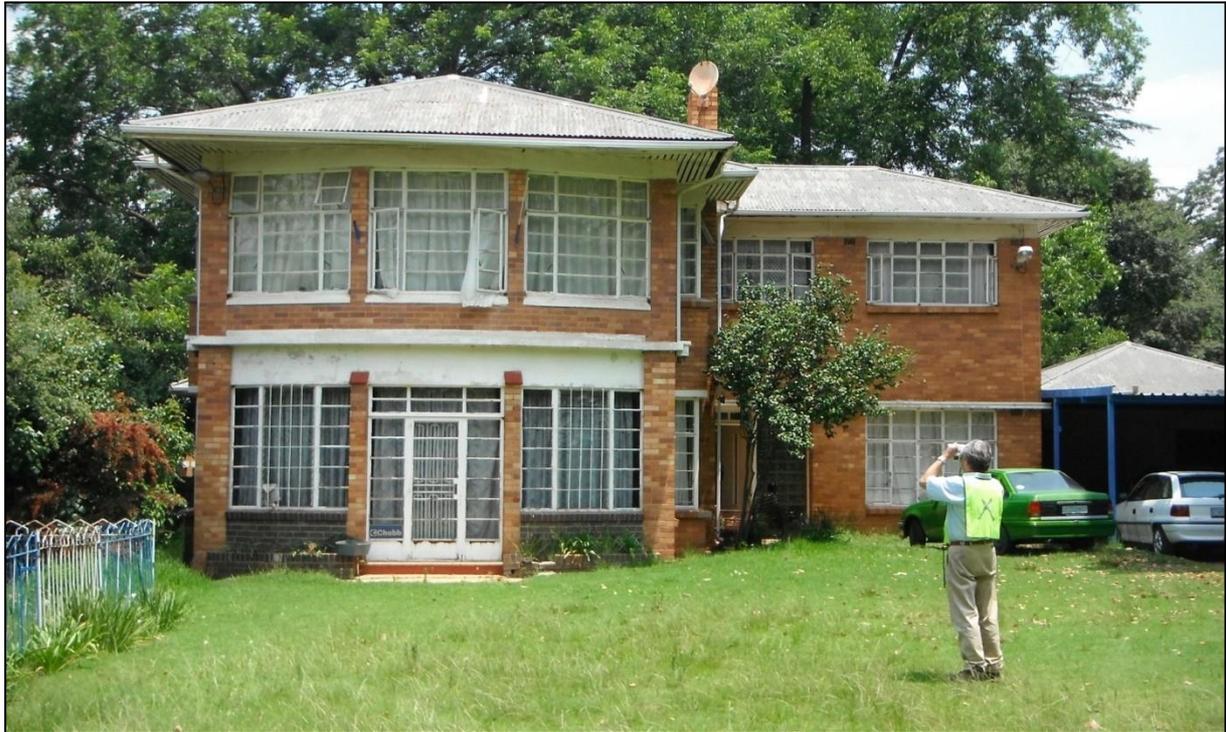
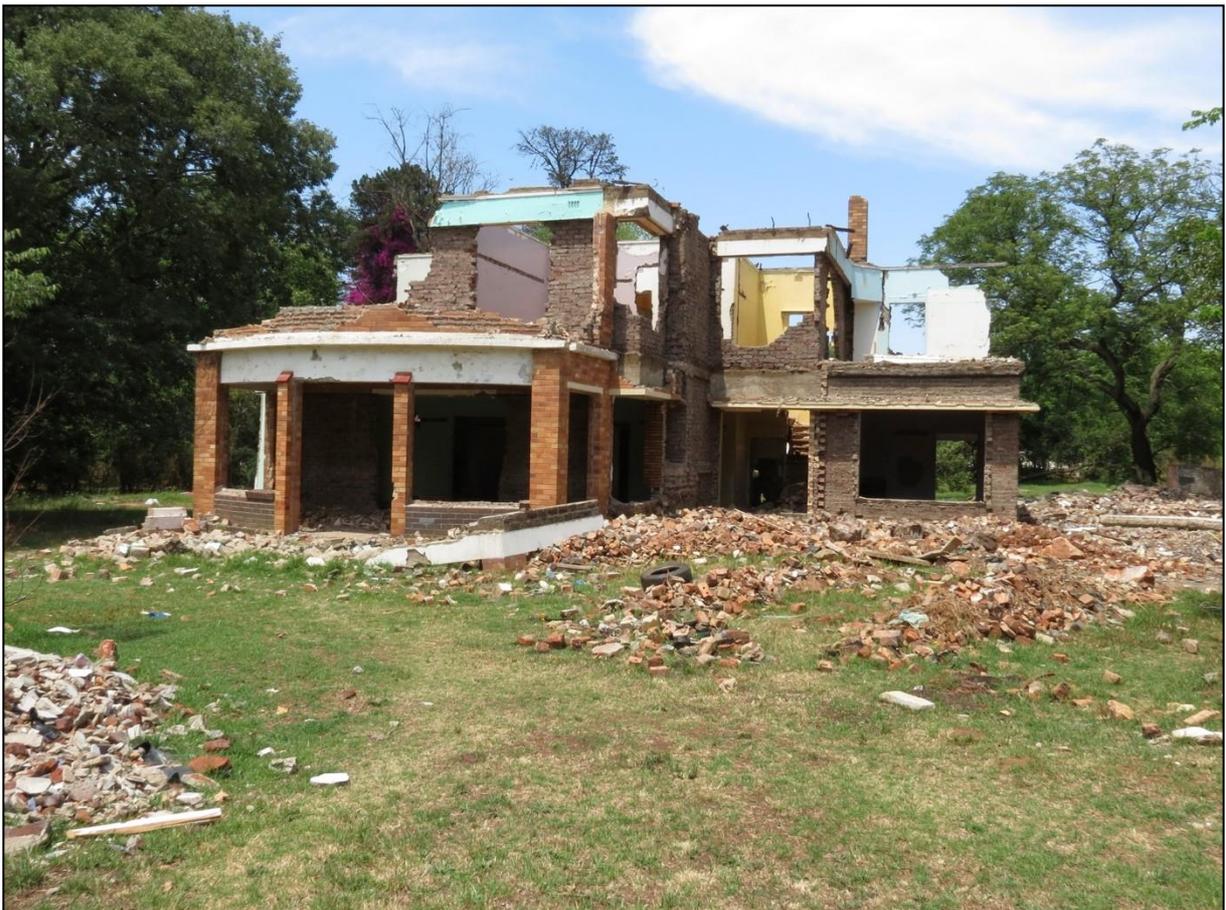
During the site visit of 28 October 2014, it was found that both examples of this building type were vandalized to such an extent that only sections of the walling have remained. The same holds true for the remaining three examples of this building type. This means that no intact examples of this building type still remain within the study area.

Figure 5 DRD 9 – 2013: The top image depicts one of the two examples of Building Type 17 earmarked for conservation. The bottom image shows the current condition of one of these two buildings as seen during the site visit of Tuesday, 28 October 2014.
