# **EXCAVATION OF ARCHAEOLOGICAL FEATURES DISCOVERED DURING CONSTRUCTION WORK AT THE RAILWAY STATION CONCOURSE, CENTRAL CAPE TOWN**

**Magisterial district: Cape Town**

Prepared for  
**Vidememoria**

April 2010

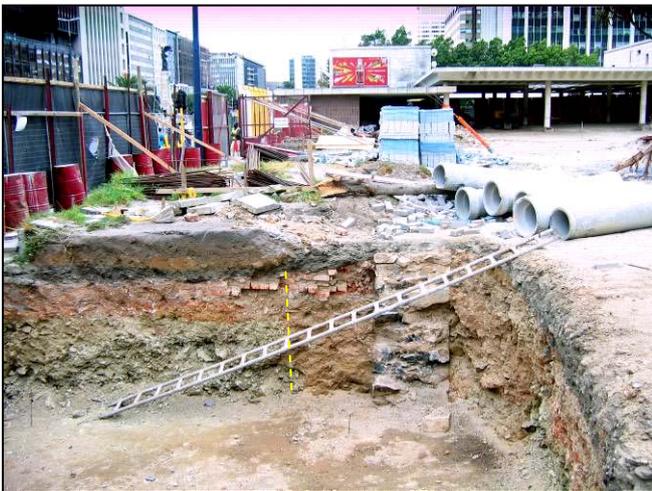
A substantial wall footing of shale blocks held in place by mud mortar had been observed in the north east section during the initial site visit (Plate 1). A break in the layering of the fills to the north west (left) indicates that the wall was built after a land filling event and corresponds to a similar cut to the north west of the wall in hole 3. The stratigraphy of the opposite section indicated that the shale block wall did not extend to that point, although a shallower brick "footing" is on the same alignment (Plate 2). We would liked to have examined the foundation of the larger wall to gauge its relationship to the brick footing opposite, but since a cement base was already cast, this was not possible. After having surveyed the positions of the two stone wall sections, we have established that wall both appear to be in the same alignment, though not of equivalent width. As the brick footing was no longer visible, the position could not be accurately determined.

**Plate 1:** A wall footing made from shale blocks is clearly visible in section with the cut indicated with a dotted yellow line.

- **Wall footings:** The feature has been measured, surveyed and photographed and we do not believe the feature needs to be conserved.

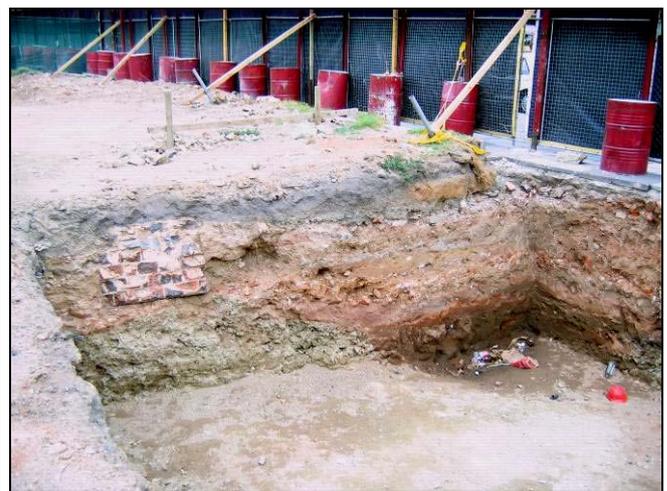
**Plate 2:** The opposite side of the hole showing a less substantial brick footing. Most sediments visible in section consist of introduced fill.

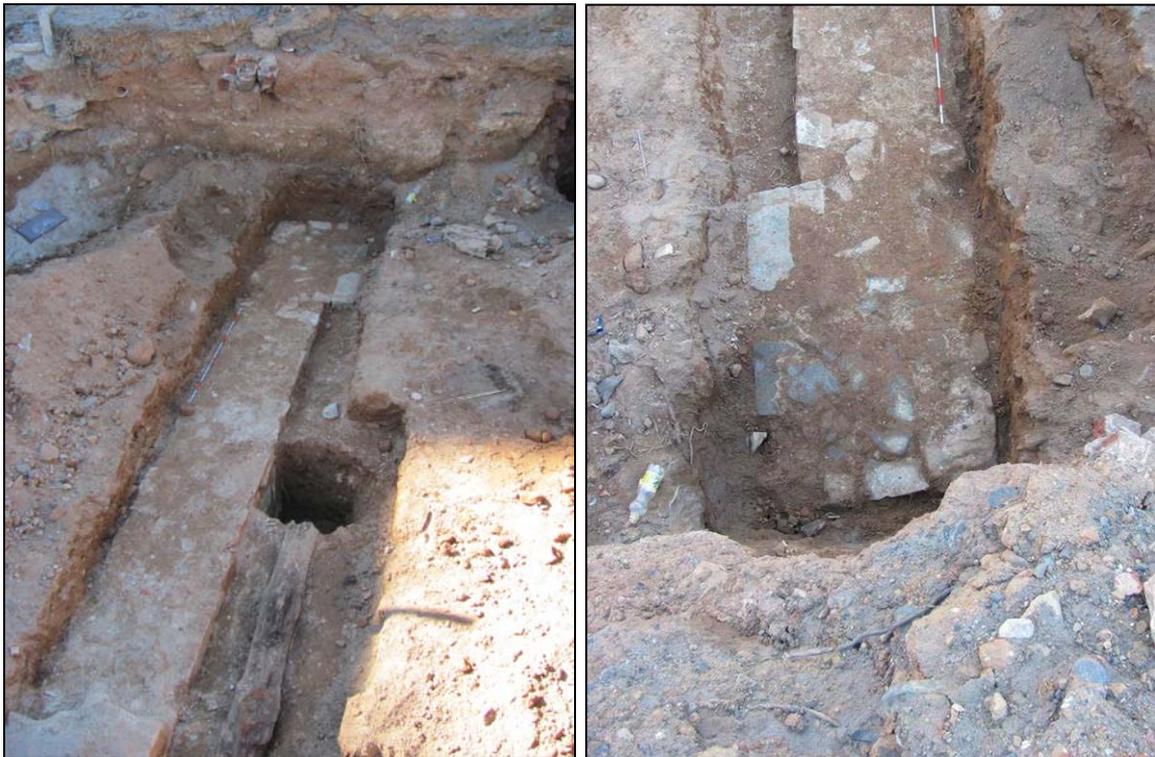
The course of the wall was cleared of soil revealing that it continued to just short of the nw section ending in a broader “plinth” (Plates 3 & 4, Figure 2). No other adjoining walls were observed suggesting that this was the end of the feature. To the south the wall continued into the section that we note runs at a slightly divergent angle with Adderley Street.

**Plate 3:** The remains of the stone wall extended almost all the way across the hole.

**Plate 4:** Looking from above, the wall ended in a broader “plinth”.

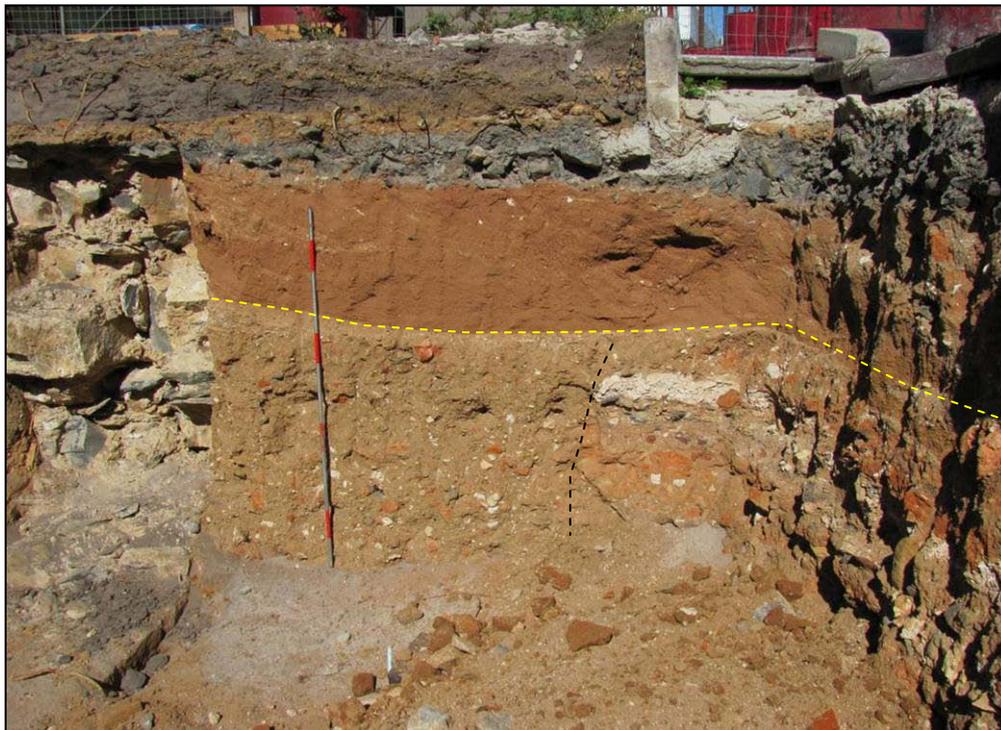
Despite its appearance (resembling a Dutch wall made with dressed shale blocks held in place with shell lime cement) the stratigraphy of the surrounding deposits suggests that the construction dates to the 19<sup>th</sup> century. We have noted glass and distinctive transfer printed “willow pattern” refined earthenware ceramics at the top of the brick and rubble rich deposits at the lower part of the sequence. These deposits appear to be cut by a substantial (>1 meter wide) “trench” to the west of the wall (see Plate 5). A layer of brown gritty sand in turn covered by a layer of brick rubble, does not show evidence of the cut and suggests that it was deposited after the wall was constructed. Deposits to the east are substantially different and appear to post date the wall in their entirety (Plate 6).

**Plate 5:** The section to the west of the wall shows an interruption of the deposit over a meter away from the wall (black dotted line). From the artefacts, we know the deposit below the yellow dotted line dates to the first part of the 19<sup>th</sup> century and suggests the wall is coeval or post-dates that time.

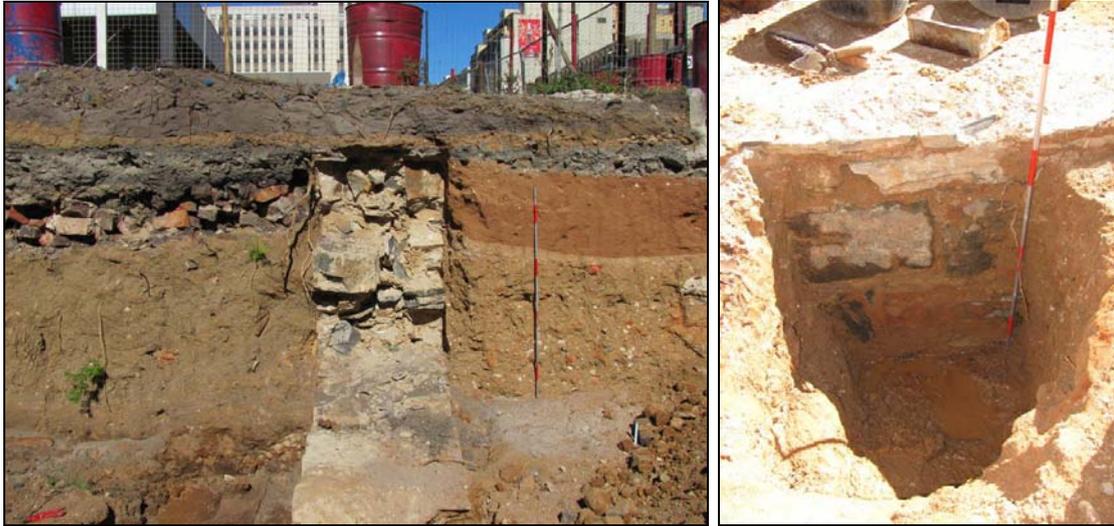
Test holes on both the east and west sides of the wall showed well finished faces on both sides (Plate 7). The test hole on the east side was dug to the water table (approx 830mm below the remaining top of the wall), and a probe was hammered into the ground in 3 different positions to determine the depth of the foundation, where resistance occurred at depths ranging from 530 - 630mm below water table. We were unable to dig into the waterlogged clayey soil to determine the nature of the lower deposits and can therefore not say if the foundation was in *in situ* shoreline deposit or into rubble fill.

**Plate 6:** Deposits at this level to the east of the wall are distinctly different from those to the west and there is no evidence of a cut.

**Plate 7:** A test pit was excavated to the east of the wall revealing a well finished structure that probing indicated penetrated to a depth of 630mm below the water table.

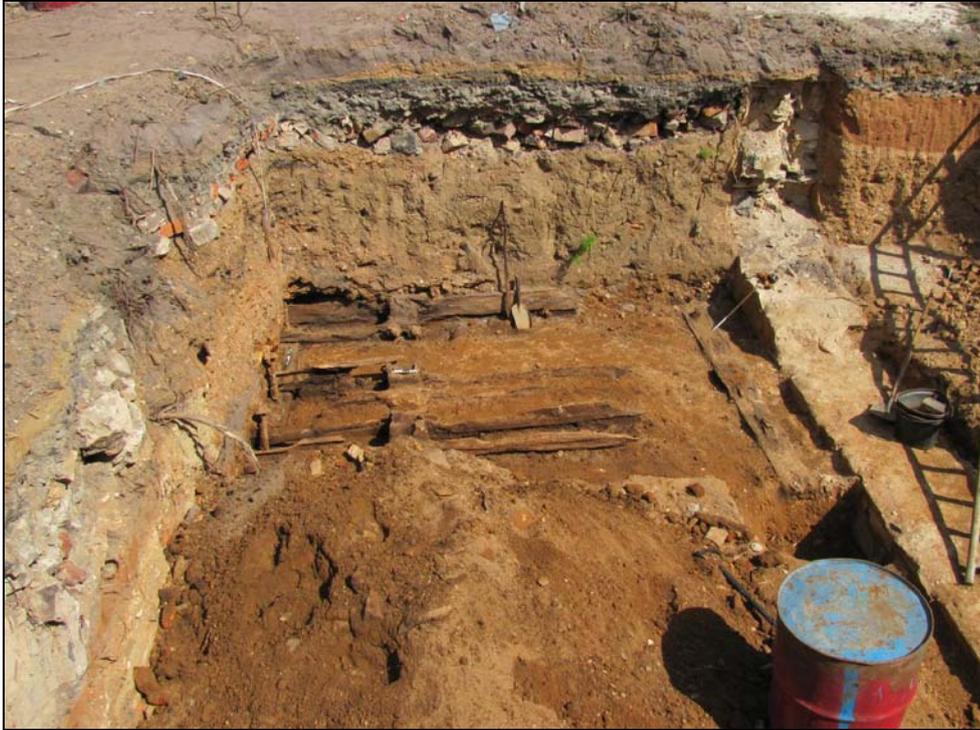
The size of the timber elements along with the associated metal bolts, suggests that all were at one point connected to form a structure (Plates 8 & 9, Figure 3). Considerable wear and degradation of the wood in places suggests that it has been exposed to water. The form of the timbers, wear patterns and context suggests that this was once part of a jetty or slipway.

All the linear timber elements are aligned at 90° to the stone wall and would seem to indicate a direct link between the two features. They were either erected at the same time or the timber alignment took its cues from the wall alignment at a later stage. This being the case, it would seem logical to deduce that the timber structure also dates to the 19<sup>th</sup> century. Also, the use of threaded iron connecting bolts and nuts was more common in the 19<sup>th</sup> century than before when forged and riveted fixtures were more common.

**Plate 8:** The location of the timber features in relation to the stone wall. The timber plank immediately east of the wall lies exactly parallel to it and suggests some acknowledgement and links between the structures.

- **Timber elements:** The feature has been measured, surveyed and photographed. The timber is in extremely poor condition and will not withstand exposure for long. We do not believe that the feature could be conserved.

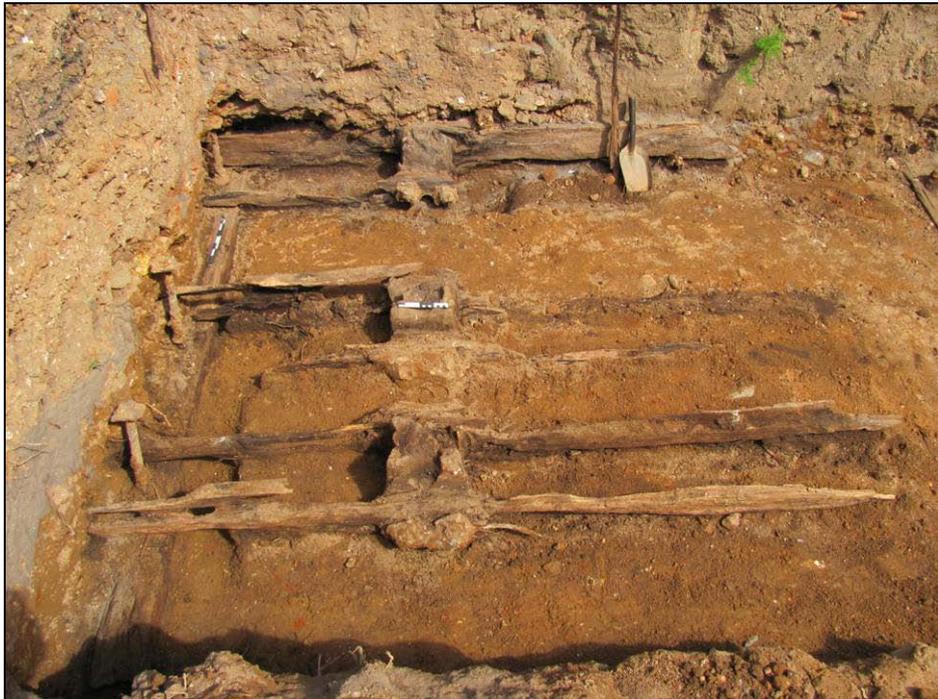
The wood is in poor condition and in places was represented by nothing more than a dark stains in the soil. In places there are marks suggesting that connecting timbers were recently removed, and are likely to be places where the stockpiled timbers were once positioned. We noted that timber continued into the east and south sections where because of the circumstances, we were unable to continue excavating. Three large square posts supported the visible structure Excavation of the bases however showed that they did not penetrate far into the soil, and no dark stains at the base showed that it was not just a case of the wood having rotted off. This was moderately troubling in terms of its use as a jetty as we had expected them to be much deeper set. If however we assume that the shoreline sloped upwards, we may have found the shallowest part of the structure where it lay partially on the shore (for example Figure 4). Truncation of the structure did not permit more observations to

**Plate 9:** Detail of the timber elements and showing metal fixtures.

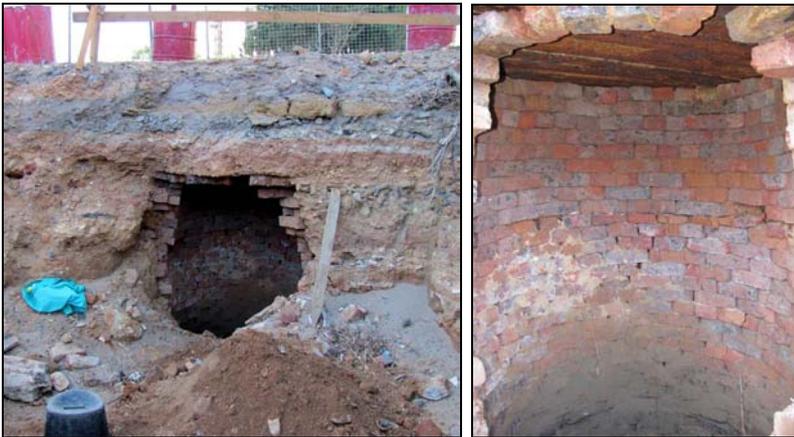
When the well was encountered during the mechanical excavation of the hole, the side of the shaft was damaged resulting in the structure becoming unstable. As it had been capped by a metal sheet (presumably when it was no longer in use) and then covered by approximately a meter of soil, considerable weight was bearing down on the unstable structure and it was therefore too dangerous to contemplate archaeological excavation. Some observations of the structure were however made (Plates 10 & 11, Figure 5).

The walls of the shaft are made from a double course of fired bricks almost certainly of 19<sup>th</sup> century age. With an internal diameter of approximately 1250mm, bricks have a single frogged surface and are held in place by mud mortar. Brick dimensions are 240x105x70mm.

**Plate 10:** The damaged side of the well showing overburden.

**Plate 11:** Detail of the brick structure showing metal cap.

- **The well:** Positioned as it is in the section means that it could be successfully avoided by the proposed building activities. An engineering solution should be found to accommodate the construction activities while maintaining the well into the future as a heritage resource. The engineer will have to resolve possible future collapse of the metal sheet capping in a way that is acceptable to the heritage authority. As this represents one of very few historic elements on the site, some consideration may be given to utilising it as a feature of the redevelopment. Engineering work and/or rehabilitation of the structure should be approved by HWC.
