ANNEXURE TWO

Allee Bleúe: Annotated Photographs

Manor House: Section 7.1.

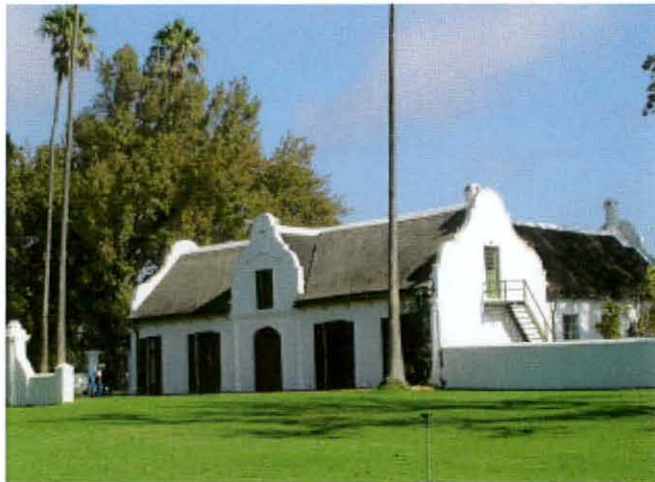
Figure A: Allee Bleúe Manor House with Cape Georgian and Cape Arts and Crafts overlays, and showing the loss of the perimeter fence. The high level of the grassed forecourt and stoep is evident

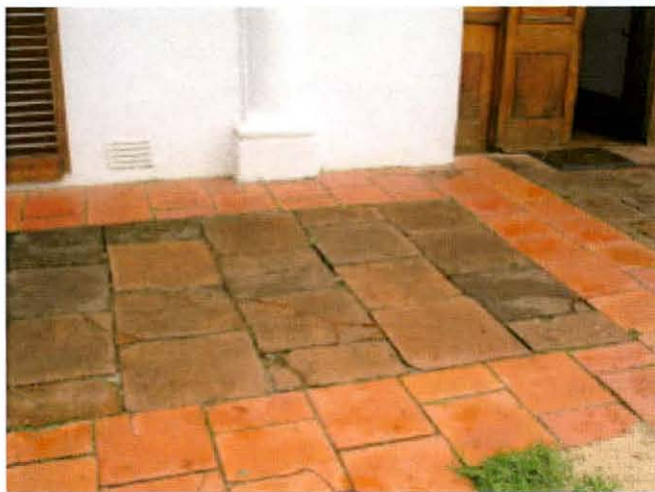
Figure B: Mixture of Batavian tiles (some original) in front of the Manor House, re-laid and damaged by damp

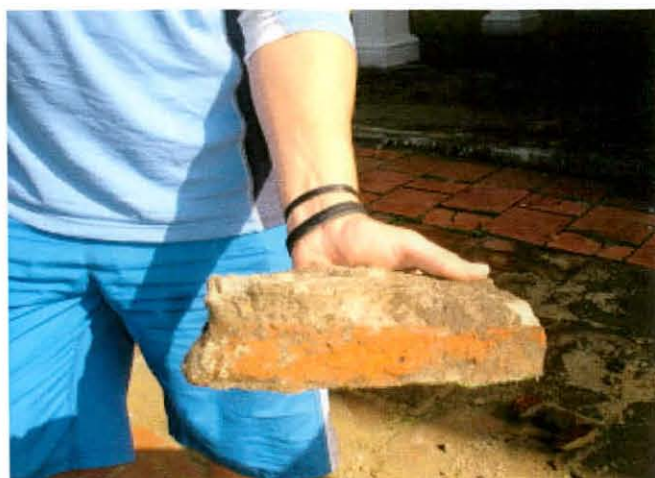
Figure C: Detail of tile, showing the cement base on which it was re-laid.

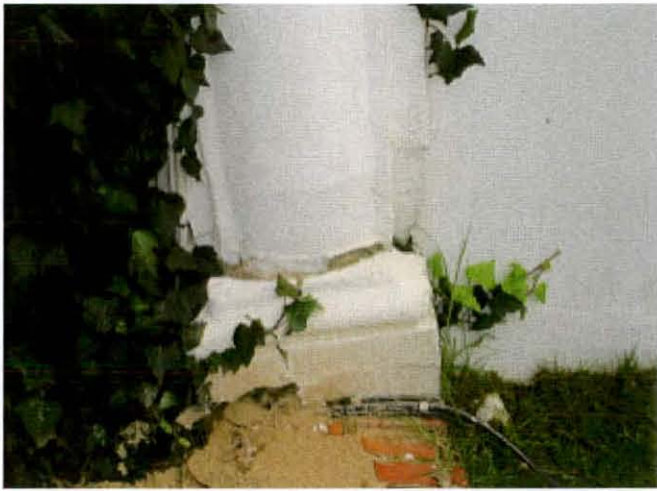
Figure D: Georgian pilaster detail, damaged by aggressive vegetation growth and allowing further water ingress

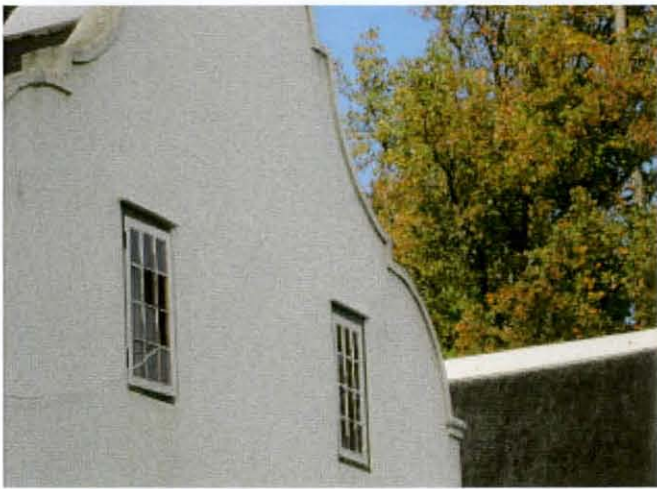
Figure E: Moisture penetration through broken window panes and cracked paint on fenestration at the left upper rear wing of the Manor House

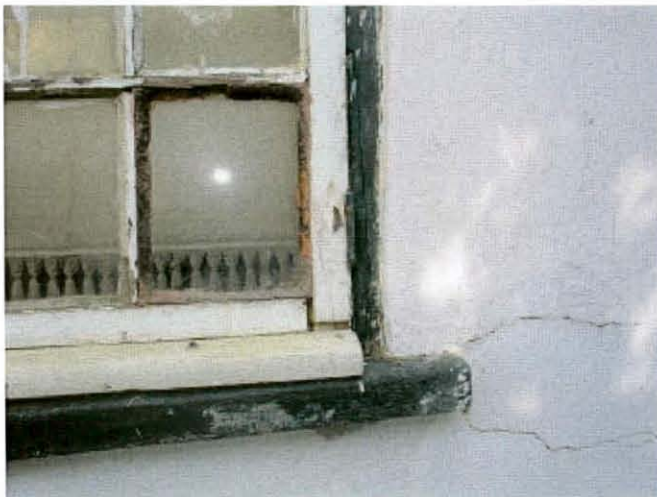
Figure A: Damage cause by damp via lack of woodwork maintenance

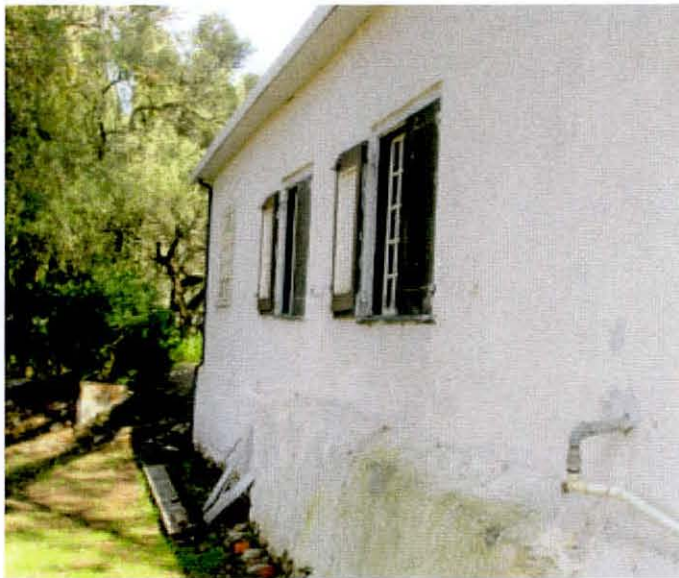
Figure B: Detail showing stone base of original cottage and damp penetration into plasterwork

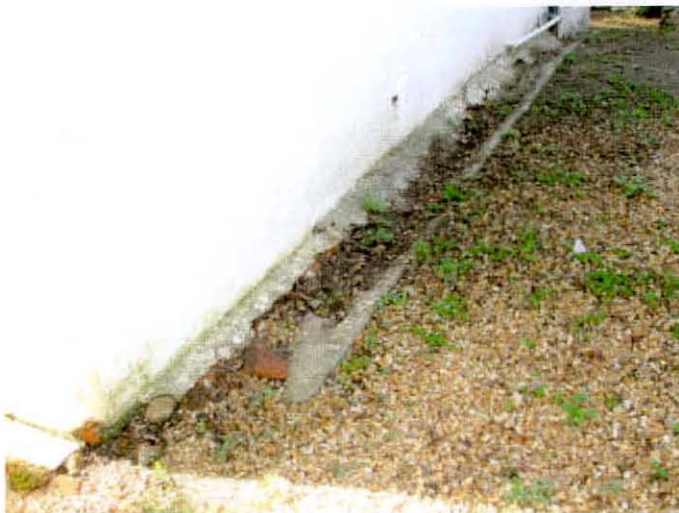
Figure C: Shallow channels with vegetation allowing poor water dispersal

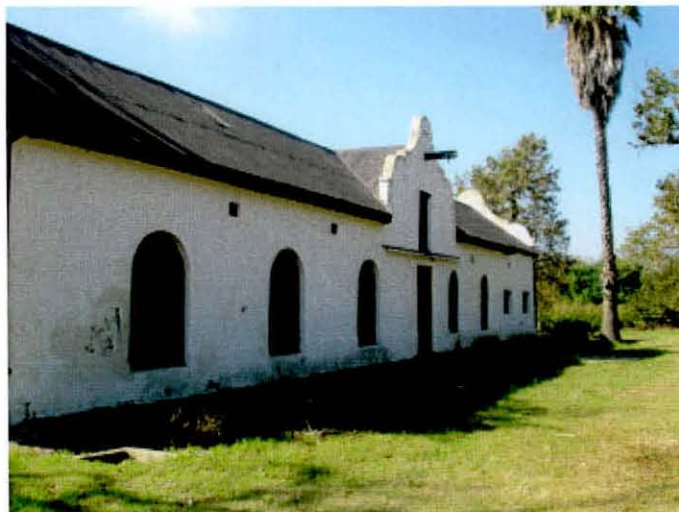
Figure A: The entrance longhouse, showing changes in fenestration and rising damp as a result of shallow water dispersal system

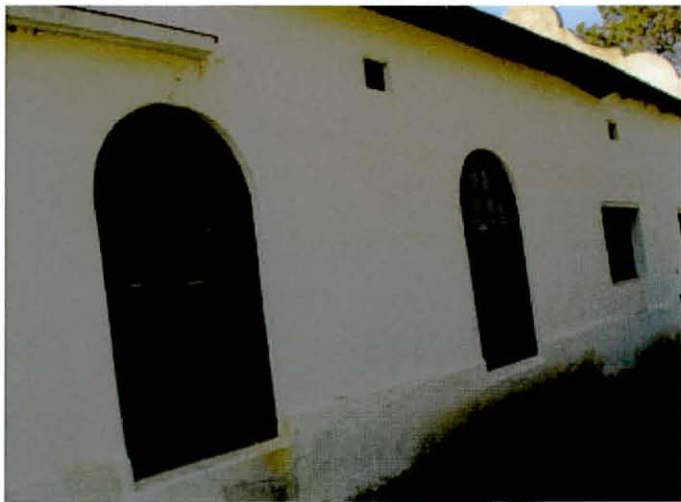
Figure B: Detail showing damage as a result of rising damp and poor condition of wood fenestration

Replacement windows
 1920's windows
 Original late 18th
 house - ~~Pitt~~ workers.
 Pickstone

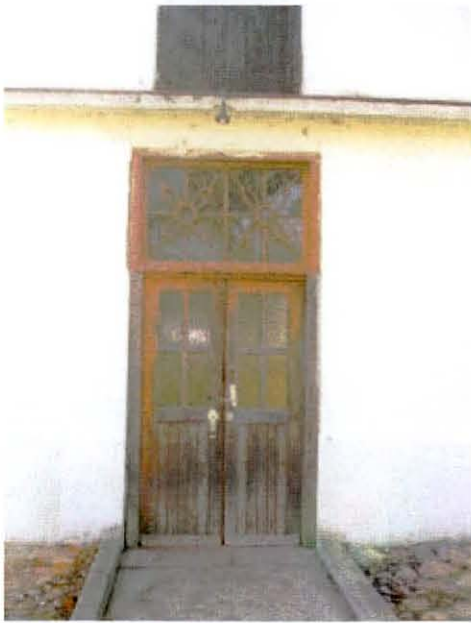
Orig. fanlight

Figure C: Detail showing ornamental fanlight to be conserved

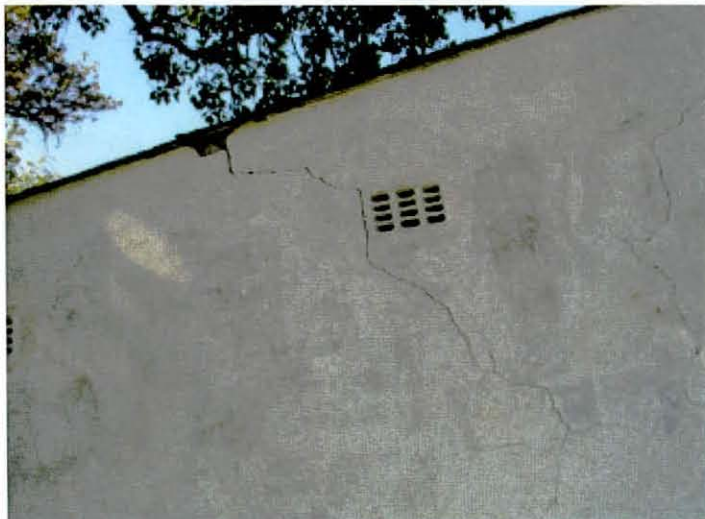
Figure D: Damage as a result of water ingress via unsealed and porous roof timbers

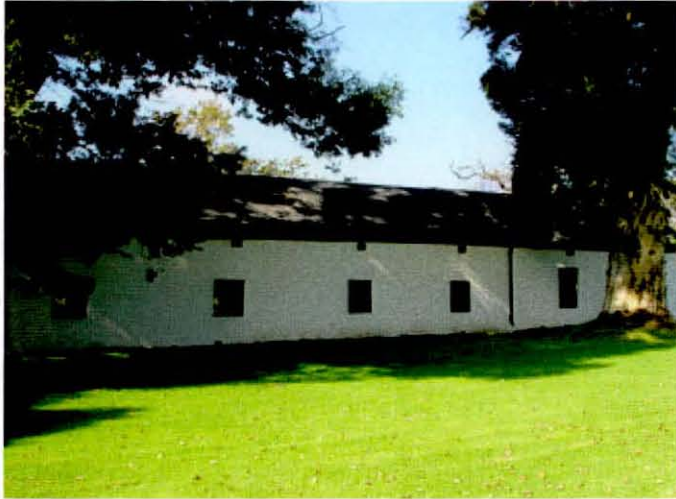
Figure A: Cellar from within the wharf showing high ground levels.

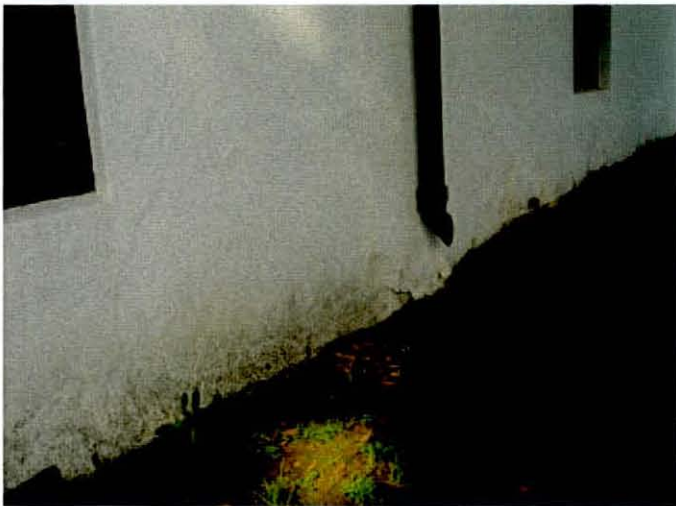
Figure B: Gutters with no dispersal system allowing damp penetration into old and porous walls. Some plaster cracking is also visible

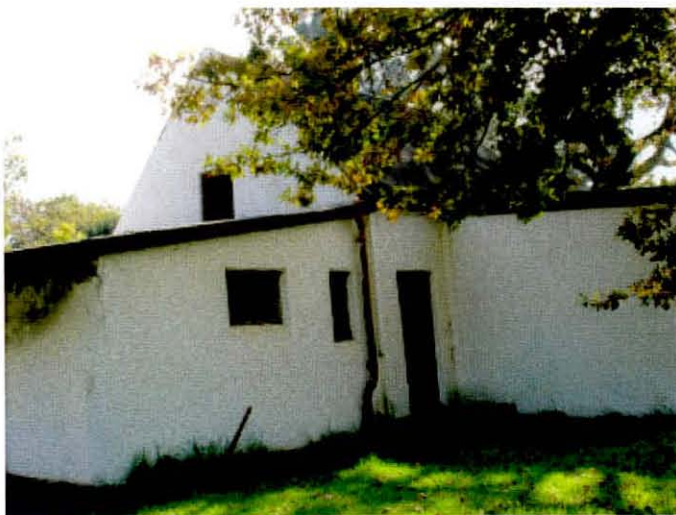
Figure C: Showing lean-to with damp, attached to Mill House

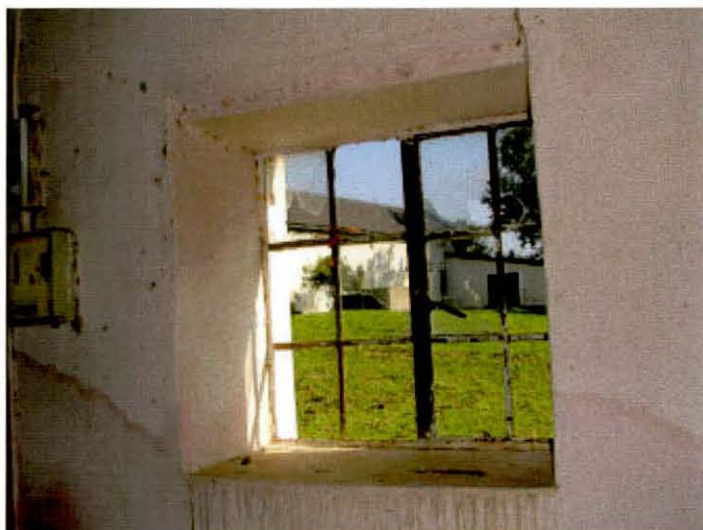
Figure D: Showing wall thickness, inserted metal-framed window and damp from interior of Mill House. Background building is the cellar.

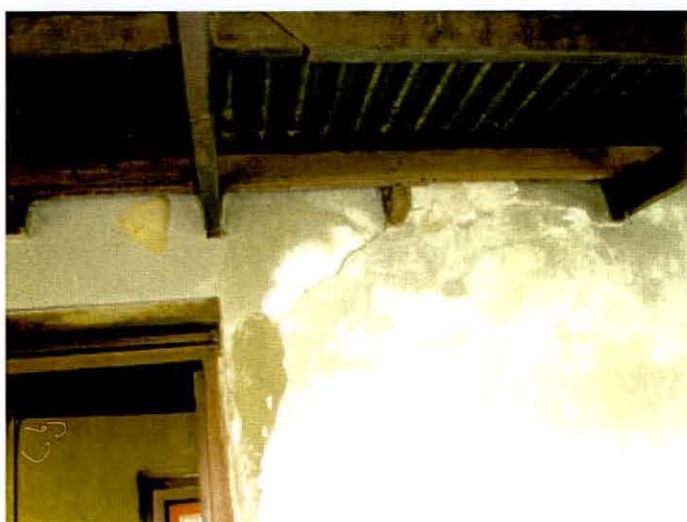
Figure E: Detail of plaster, masonry damage and cracking

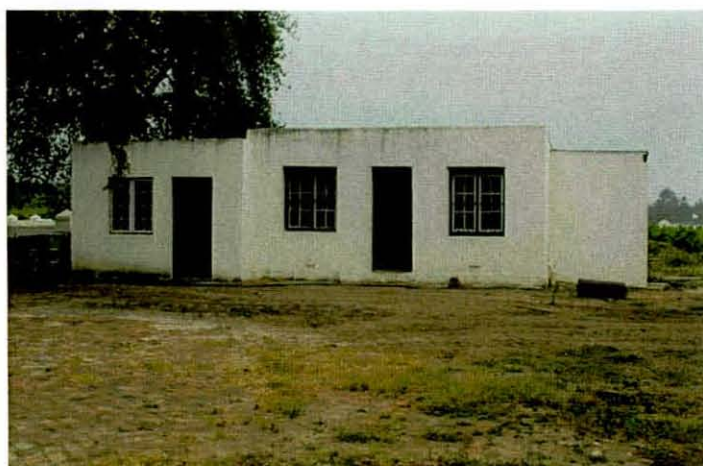
Figure A: Front view of outbuilding proposed for demolition. Building has been erected later and inappropriately place in relation to the manor house

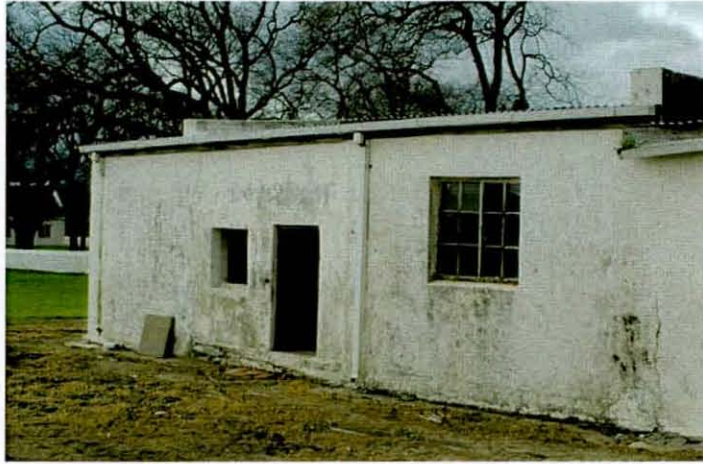
Figure B: Rear view of outbuilding proposed for demolition

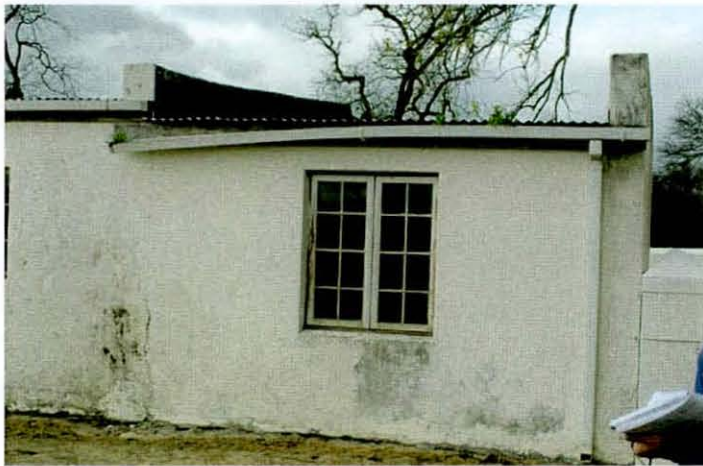
Figure C: Rear view showing masonry deterioration
