Babylonstoren Farm 1268
Archaeological Monitoring Report
Stables Building

14 March 2011

Executive Summary

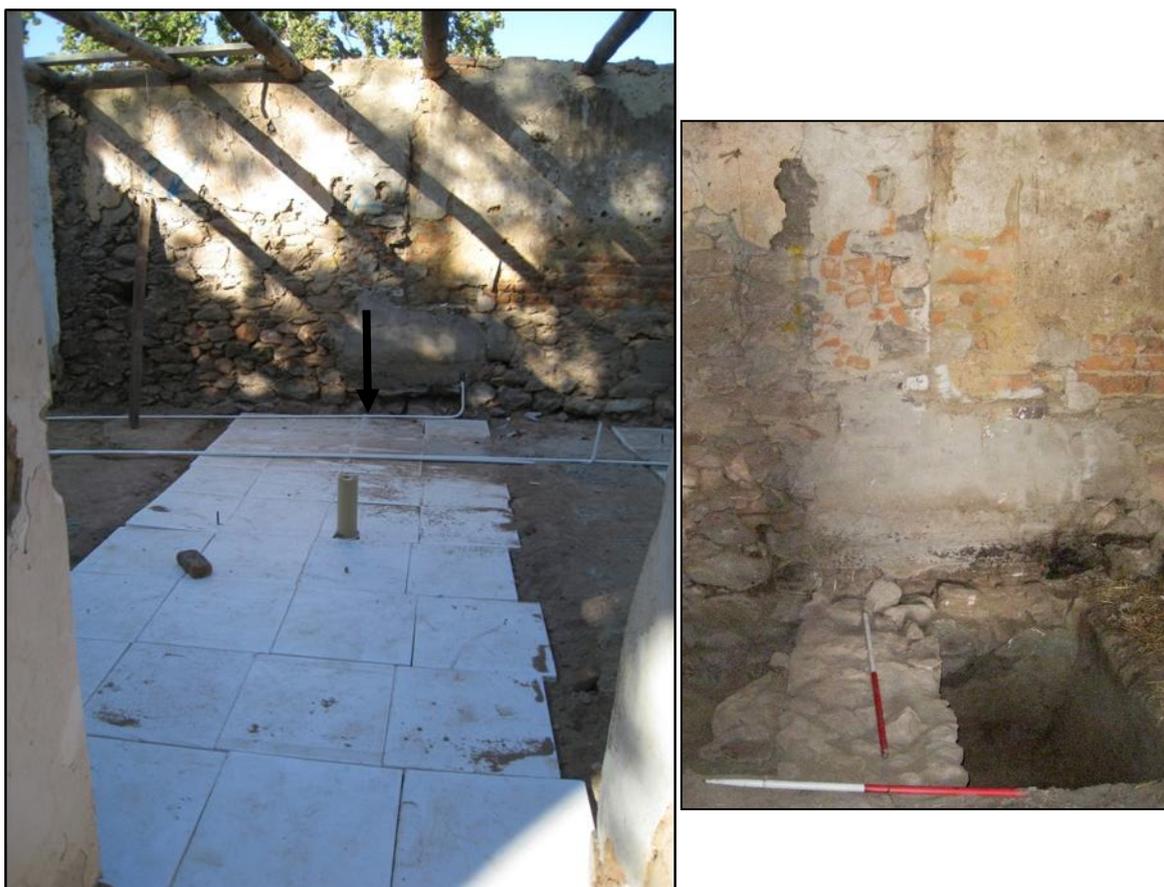
No findings of significant archaeological features were uncovered during the lowering of the floor levels. Existing floor levels were reduced to between 75mm and 100mm and these alterations did not truncate the stratified archaeological deposits. The only exception to this was in the far western part of the building – stables 1,2 and 3 – where floor levels were lowered to accommodate the insulation and electrics for the milk room (see Figs 5a and 5b). This truncated the upper course of the north-south wall exposed in excavations in 2010 (Smuts & Clift 2010: 13-14).

Figure 5a: View of Stables extension with insulation laid along alignment of wall (201) (left). Arrow indicates location of wall. View to south.

Figure 5b: View of wall (201) (right). View to south. (Smuts & Clift 2010: 5)

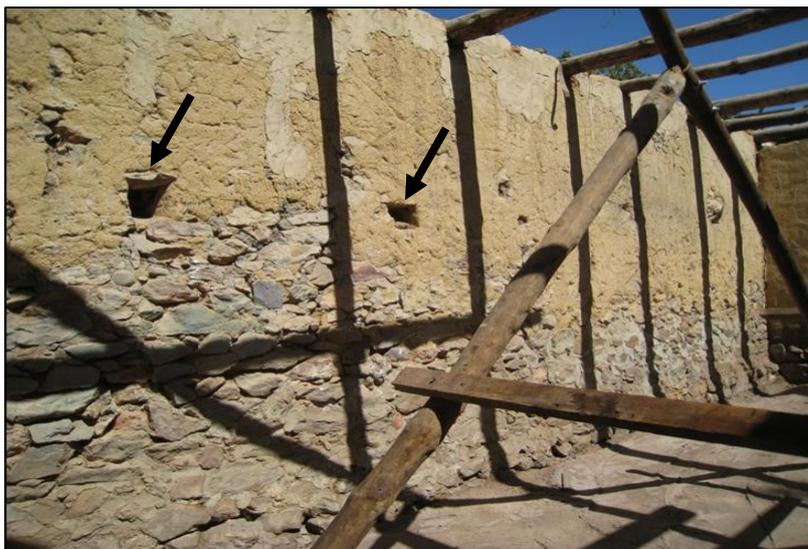
This room had been identified as the wagon room in 2010 (Smuts & Clift: 18). This room has largely been left unmodified. The floor surface has been raised with a bedding layer of cement and finished with an earth floor. This will effectively serve to preserve the wheel ruts discovered during excavation (Smuts & Clift 2010: 17). The possible shelves mentioned in 2010 (Smuts & Clift: 9) will be reinstated on beams utilising the beam slots in the walls (see Fig. 6). The room will retain its function as a wagon house.

Figure 6: Room 1 showing the holes in the wall that are assumed to have housed beams holding shelving. View to southwest.

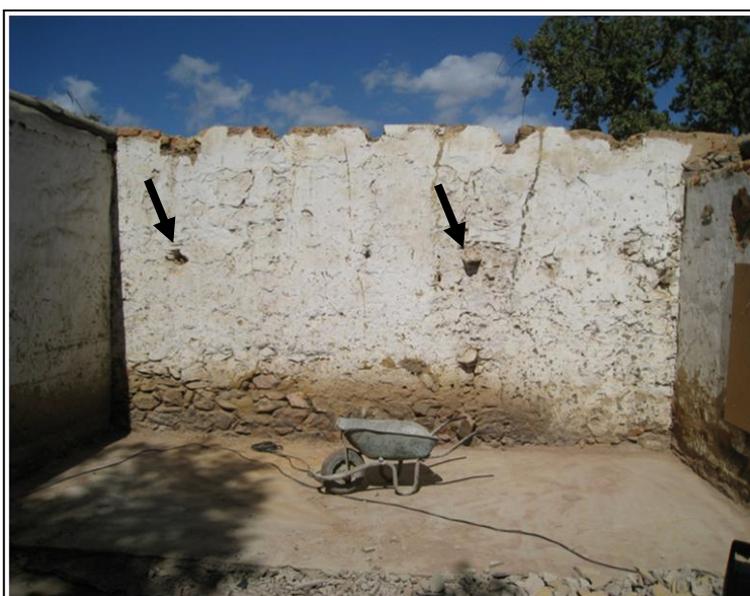
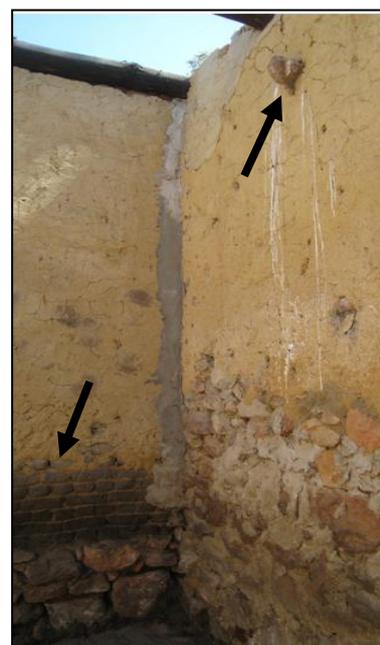
Rooms 2 had not been investigated in 2010 as it was still in use as a store and had a concrete floor that was not lifted at the time. Rebuilding in 2011 involved removing the concrete floor and reducing the floor levels by 100mm. No archaeological material was evident in the removed material or the subfloor layers. The only feature of interest in the room was the presence of further beam slots at the same height as those in Room 1 along the southern wall and three stones protruding from it, one above the other (see Fig. 7a). As these elements are also found in Room 1 (see Fig. 7b), this indicates that these two rooms were once a single space and that the dark brick wall between them is a later phase structure. This room will be used as a bakery.

Figure 7a: Room 2 showing hole to left and protruding rocks to right (left). View to south.
 Figure 7b: Room 1 showing protruding rock; note also black bricks of dividing wall (right). View to northwest.

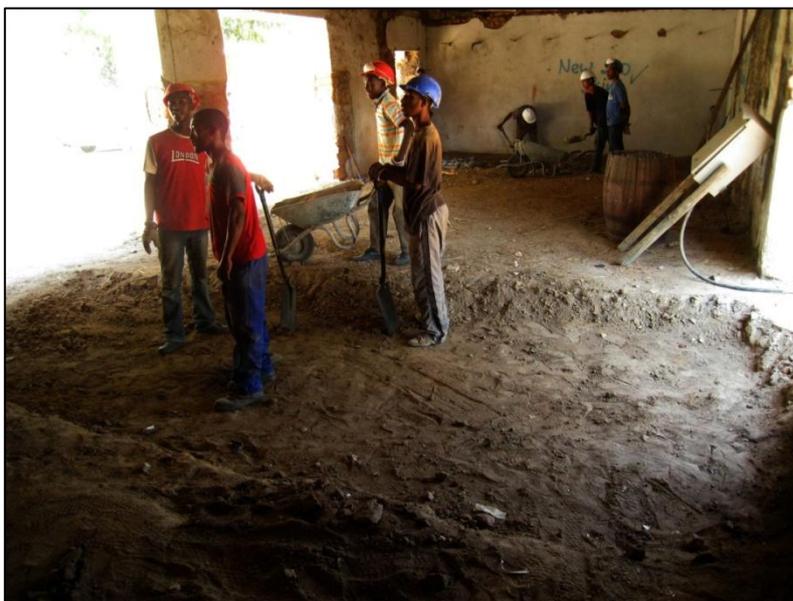
Rooms 3 and 4 were consolidated and are to be used as the smithy. Although several trenches were cut into the floors to accommodate services, wall (228) exposed in 2010 was not directly impacted. All the floor levels in the room were recorded and described in the AIA (Smuts & Clift 2010: 14).

Figure 8: View of consolidated rooms 3 and 4. Alterations to floor levels are visible. View to southwest.

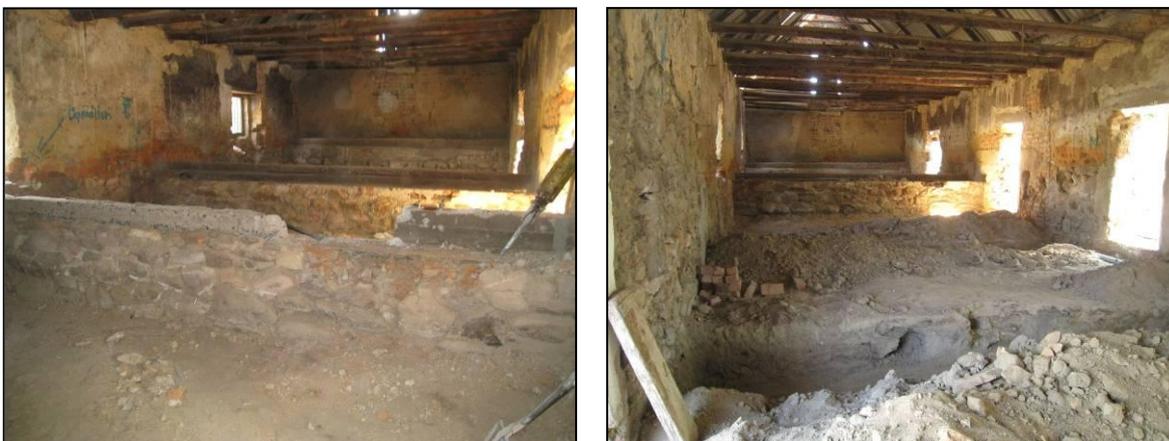
The greatest amount of disturbance to historical fabric took place in the stables extension at the western end of the building. Wall (201) was truncated as described above (see Figs 5a and 5b), and the two easternmost of the four troughs were demolished (see Figs 9a and 9b). These troughs had served to divide the extension into three separate stalls. Two walls are to be built in the same locations as the demolished troughs to divide the space into rooms of similar dimensions to the stalls (see Appendix 1).

Figure 9a: View of the stables extension with troughs in place (left). View to southwest.
Figure 9b: View of the stables extension after demolition of troughs (right) View to northwest.

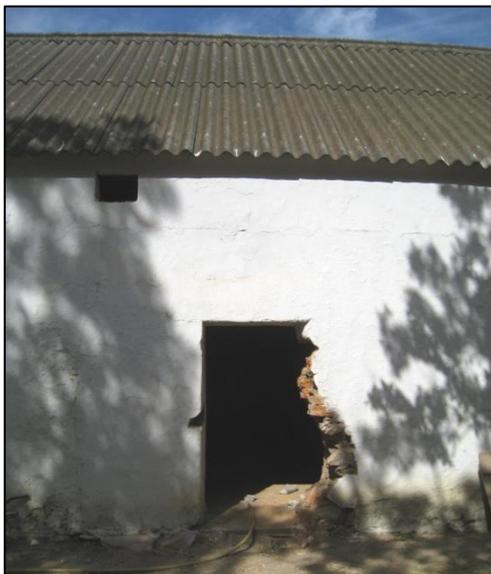
In addition to this demolition work, some of the historic fabric of the northern façade was damaged with the removal of the old stable doors (see Fig. 10). The central stable door is to be partly bricked up and the original central opening, identified in 2010 (Smuts & Clift: 18), will be reopened. The doors are to be replaced with modern facsimiles.

Figure 10: Damage to the northern facade resulting from removal of the historical stable doors. View to south.

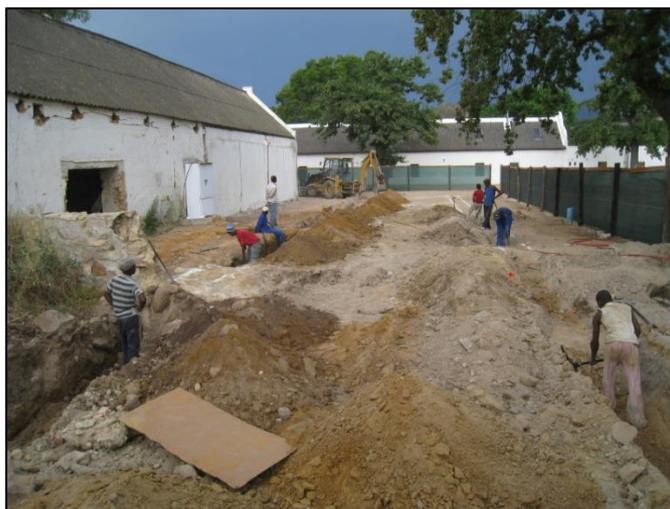
The lean-to southeast of the building was demolished and foundation trenches were dug for the new building to be located there (see Fig. 11). These exposed natural sub-soil deposits and revealed no *in situ* archaeological features.

Figure 11: Trenches being excavated for foundations of new building south of stables. View to east.

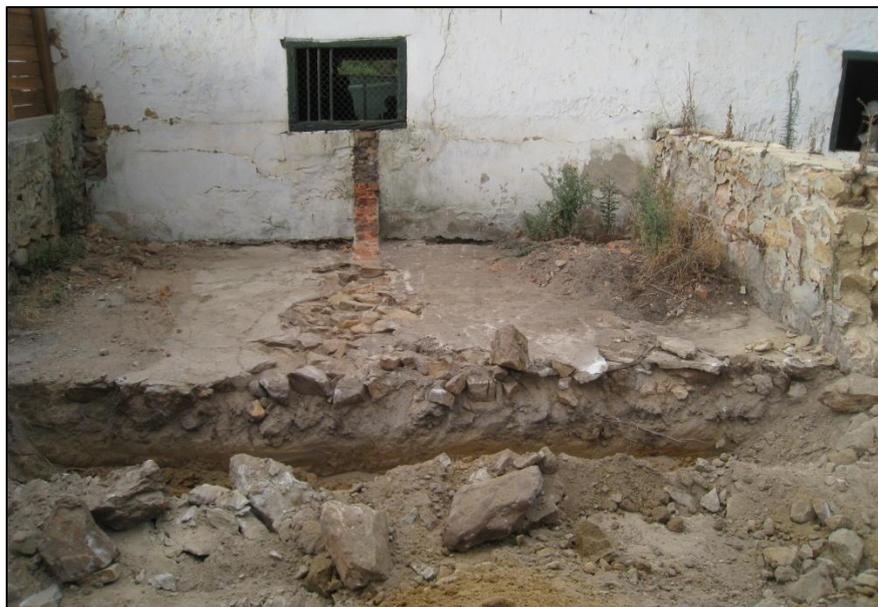
The brick extensions to the stone-built walls at the rear of the stables extension as well as those walls built entirely of brick were demolished; the upper, modern concrete floors in the area were lifted. This revealed large cobbles below the concrete that were also

removed (see Fig. 12). It would seem that the stone walls represent an earlier two-roomed extension to the building that had had a concrete floor laid onto a bed of cobbles. This structure was later transformed into longer, narrow animal pens with the addition of the brick walls between the stone walls which were extended to the south in brick.

Figure 12: Rear of stable showing the demolished brick walling and the cobbles visible below the concrete. The stone walling has been retained. View to north.

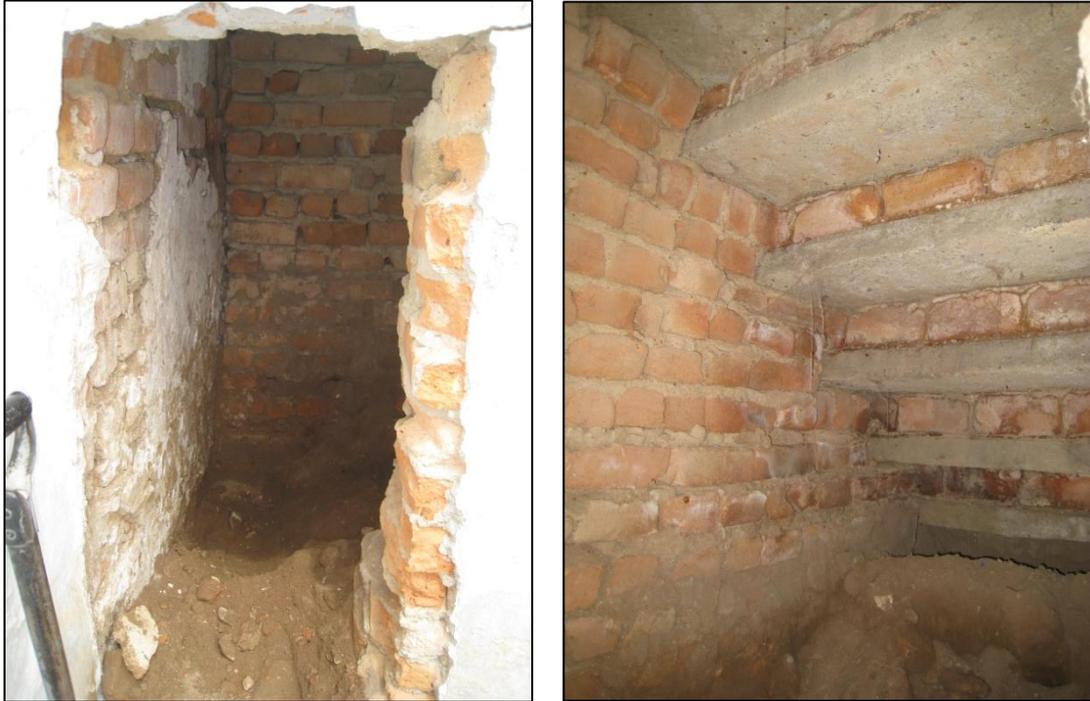
The staircase to the west of the building has been investigated to establish both its age, relationship to the building itself and its stability. The fabric below the steps was dug away (see Fig. 13a). This revealed that the staircase was not keyed in to the western end wall of the stables, but rather was built at a later stage after the western wall had been plastered. This would imply that the staircase was probably only built some time after the stables extension was completed. This later date is confirmed by the presence of concrete mortar between the steps (see Fig 13b).

Figure 13a: Cavity below staircase with render on external face of western stable wall. View to south.

Figure 13b: Underside of staircase from within cavity showing cast cement between steps. View to southwest.

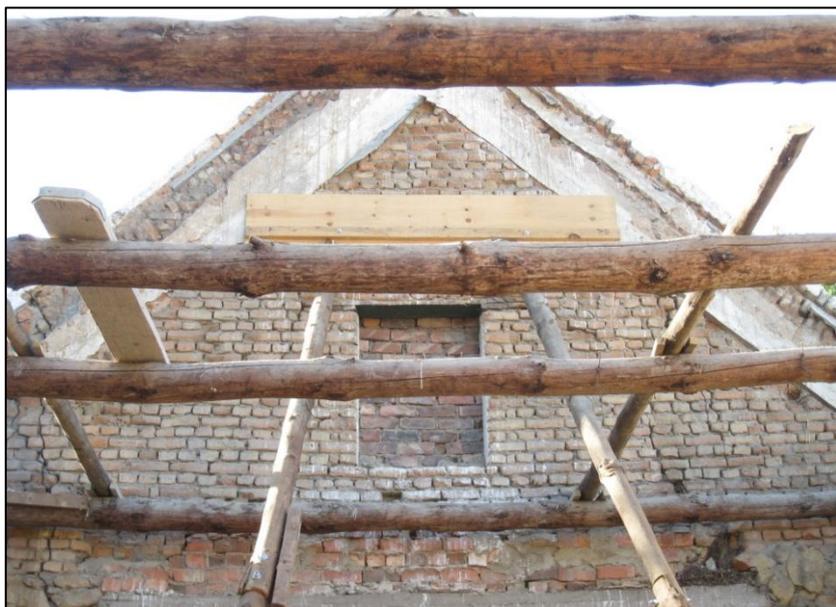
The removal of the corrugated roof and the Victorian clerestory allowed for better inspection of the fabric of the gables (see Figs 14, 15 and 16). We were able to confirm our earlier opinion (Smuts & Clift 2010: 6) that the eastern gable is a phase 1 structure, while the western and central gables are more recent, possibly contemporaneous, additions.

Figure 14: Eastern gable showing small, irregular dark bricks with dark mortar. View to east.

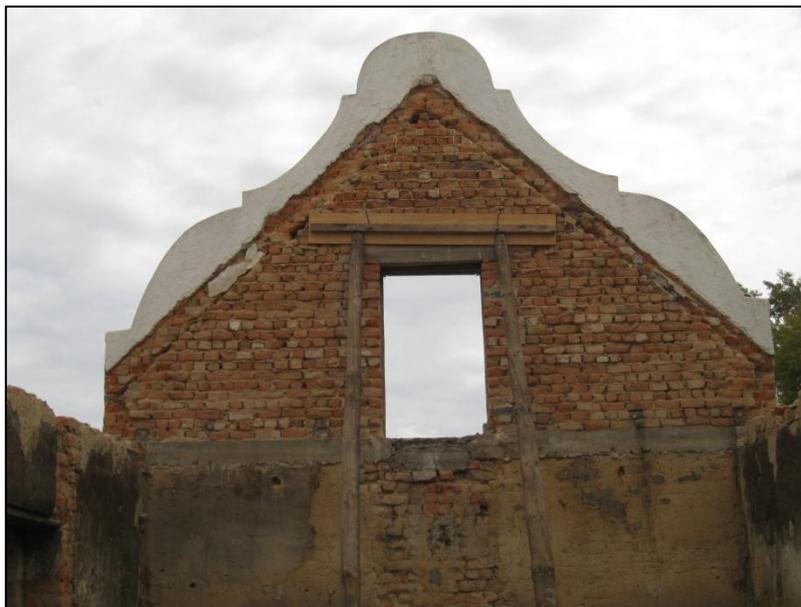
Figure 15: Western gable showing large, regular orange bricks with pale mortar. View to southwest.

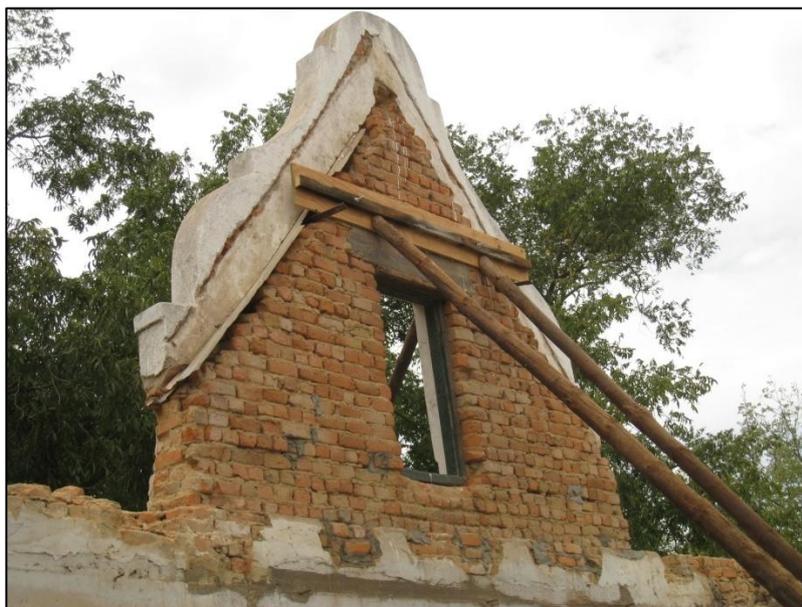
Figure 16: Central gable showing similar fabric to western gable. View to northeast.
