‘Sillery Furrow’

Erf 2274, Constantia

Report Prepared for Doug Jeffrey Environmental Consultants

December 2005

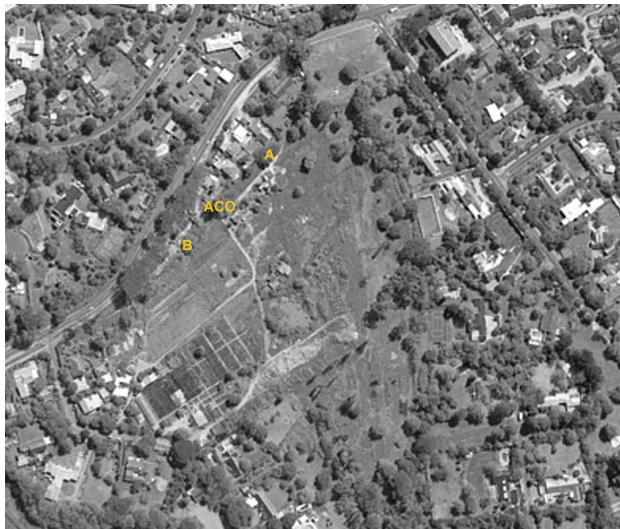
Figure 4: Aerial photograph showing position of the test trenches.

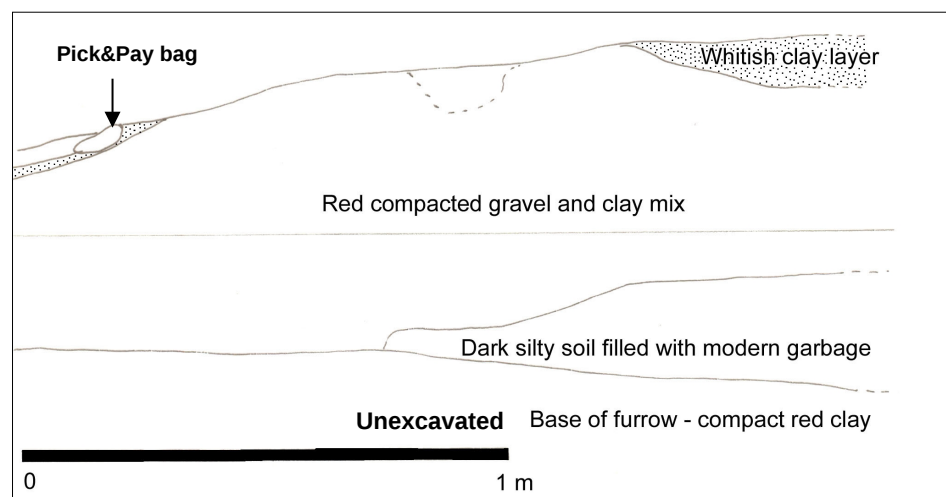
Figure 5: Western section of a portion of Test trench B. (The straight line through the centre of the sketch is the line level.)

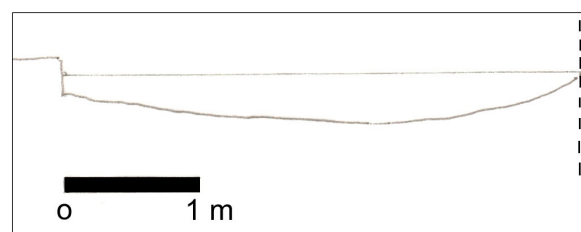
In the northern part of the test trench, the soil was dark and silty and full of modern rubbish; plastic bags, bottles, blankets, a part of a mattress and a 1964 ½ cent coin. Underneath this dark soil, was a red compacted clay. The furrow at this point, formed a rather shallow ditch (Figure 5 and 6). The ACO test trench was covered with a lot more building rubble. The furrow may have appeared more V-shaped owing to the build up of the soil and rubble around it. Mark Smith remembered, as a child, walking in the furrow during summer, when there was little water in it. His recollection was that the furrow was quite shallow near their houses, but deeper towards the Lady's Mile Extension and the Old Sillery farmhouse.

Figure 6: East-west profile of the furrow at Test trench A. The straight line is the line level.

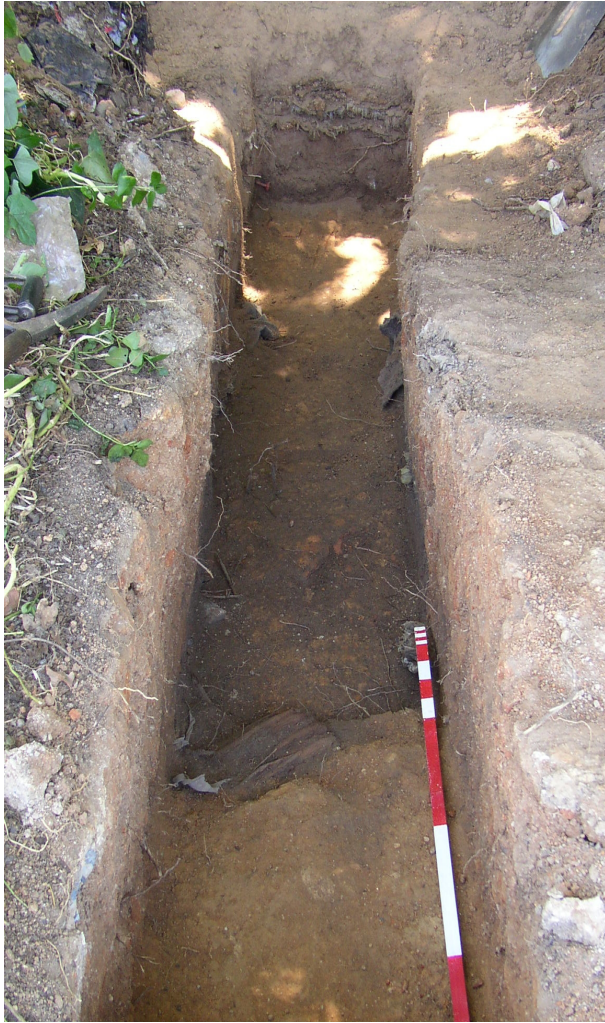
Plate 1: View across test trench, looking northward. The yellow clay at the bottom of the plate is the furrow embankment.

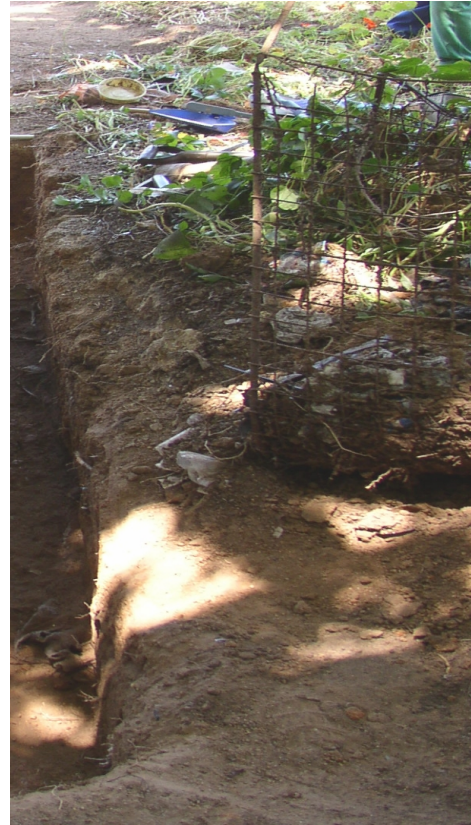
Plate 2: View across test trench, looking southward.

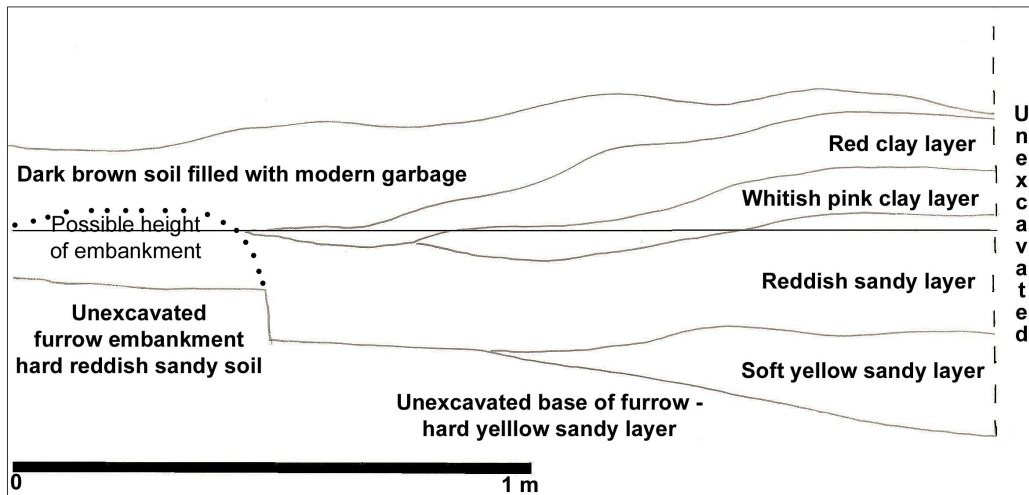
An area just south of the oak tree was cleared of vegetation and loose building rubble. A test trench 50cm wide was then dug. Underneath the loose rubble was a reddish orange clay layer about 10 cm thick. Immediately below this was a whitish pink clay layer. Below these clay layers was a reddish sandy layer about 20 cm thick. Directly beneath it was a yellow silt layer which was only present in the northern edge of the trench closest to the tree, representing the middle of the furrow. The furrow embankment presented as a hard reddish layer of very dry, but fine grained soil. The base of the furrow, underneath the yellow sandy silt, was formed by a hard compact yellow very fine grained soil, again very dry (Figure 7 and 8).

Figure 7: Western section of Test trench B. (The straight line through the centre of the sketch is the line level.)

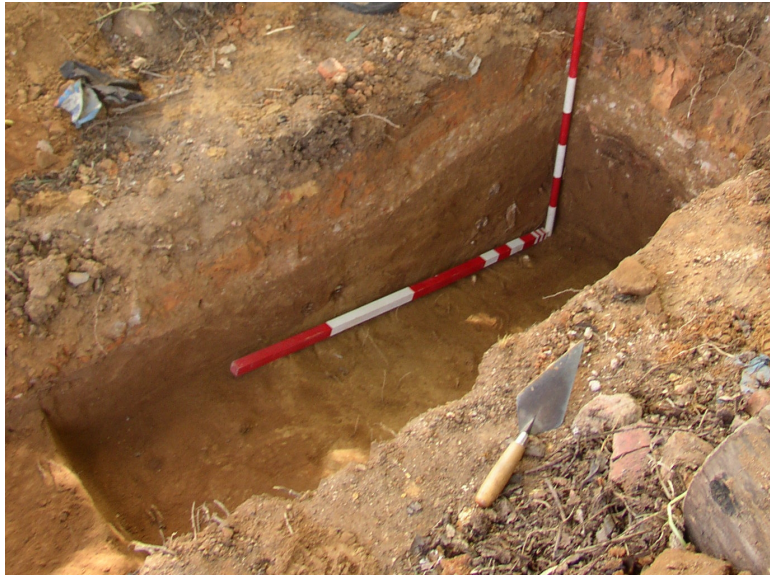
Plate 3: View of the test trench. The furrow embankment is visible on the bottom left of the plate.

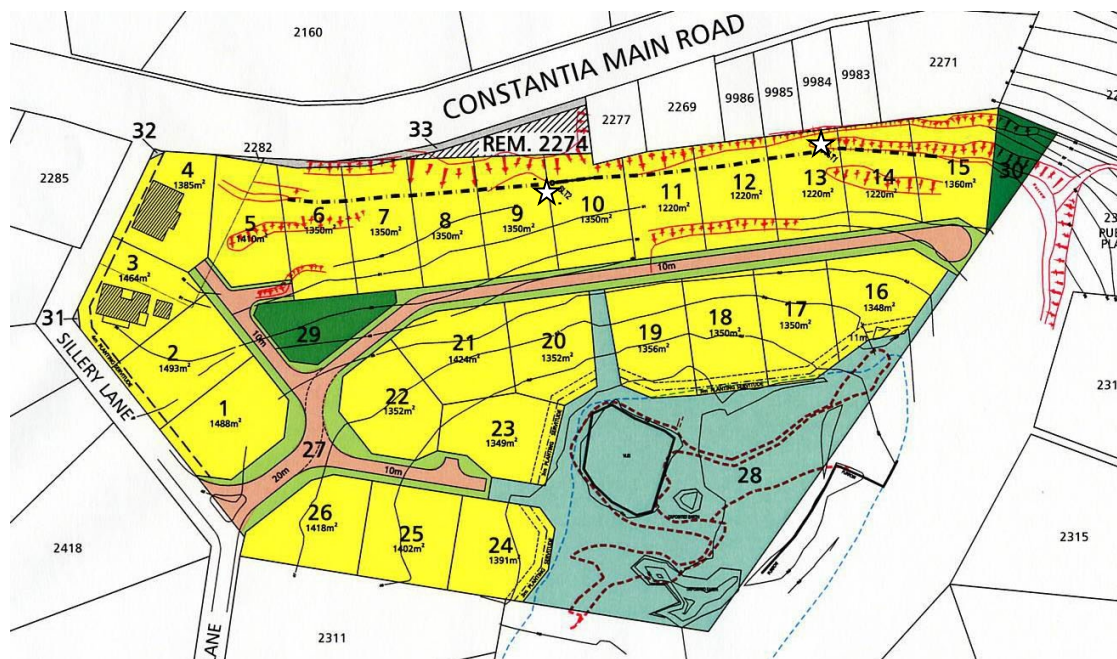
The furrow lies close to the northern boundary of the erf and the oak trees are growing virtually on the northern edge of the furrow. Figure 9 (detail from the Development Proposals Figure 8.1) shows the location of the test trenches and confirms that the dashed line described on the original as the 'approximate alignment of the furrow', is indeed an accurate reflection of the alignment of the furrow.

Figure 9: The white stars indicate the position of the two test trenches (Figure 8.1: Development proposals - Proposed Subdivision of Erven 2274 & 2286 Sillery, Constantia 2004)

Following the recommendation by the Minister of Cultural Affairs, Sport and Recreation, relating to the EIA for the proposed subdivision of Erven 2274 and 2286 (Stali 2005), it has been agreed that a servitude should be registered over the furrow and that it be provisionally protected under the National Heritage Act (25 of 1999).
