**TRIAL EXCAVATION TO EXAMINE STATE OF
HISTORIC FURROW (*LEIWATER*) AT ERF 162247,
SILLERY, CONSTANTIA, SOUTH WESTERN CAPE
PROVINCE.**

January 2004

Archaeology Contracts Office

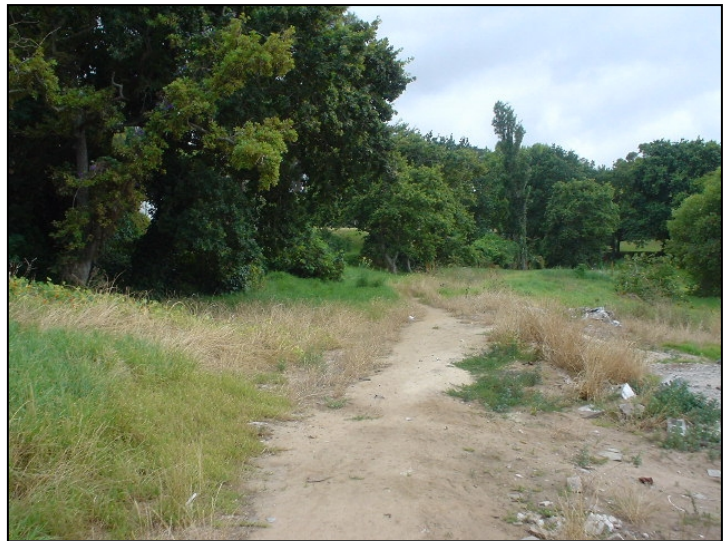
Figure 2

The alignment of the furrow lies roughly on the left hand side of this path along the northwest border of the erf. The furrow remains visible on the border of the property in the distance.

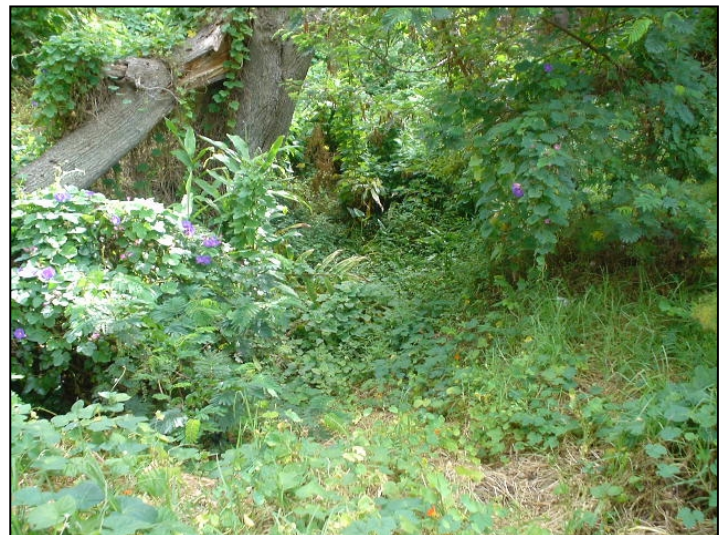
Figure 3

All that is visible of the furrow in the public open space is a sunken area overgrown with vegetation.

- It must be noted that the furrow is visible in Public Open Space. It is however, un-commemorated and choked with vegetation. An option that should be considered is to focus on a portion of the furrow in this area by creating a purpose built path, brush clearing and information signage to explain the significance of the feature (see Figure 3).
- Opening of the furrow within the development area is not a conservation necessity (as the feature is stable while buried) but an option that could be considered by the developer in negotiation with the local community and Heritage Western Cape.
- In terms of conservation of the furrow in its buried state, it is recommended that any future property owners should be made aware of its presence and be discouraged from building foundations across the alignment or establishing services in its immediate vicinity.

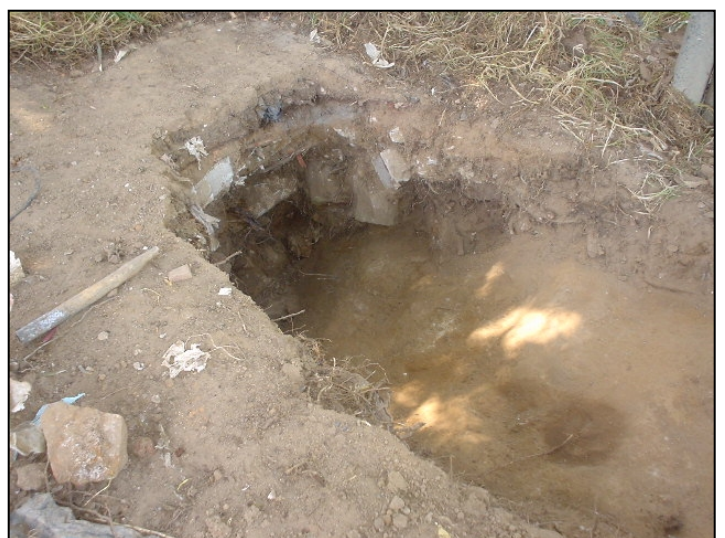
Figure 4

The furrow is a visually unspectacular structure and fairly informal, but is nevertheless very well preserved as a result of its buried state (Figure 4). It is highly likely that aspects of the furrow are present across the northern edge of the proposed

The clay bottom and side of the furrow is clearly visible in the trial excavation. The rubble fill is easily distinguishable.

The furrow is well conserved by virtue of the fact that it is buried. From a long-term conservation point of view this is a desirable situation provided that any services or foundations do not impact the alignment during future development activities.

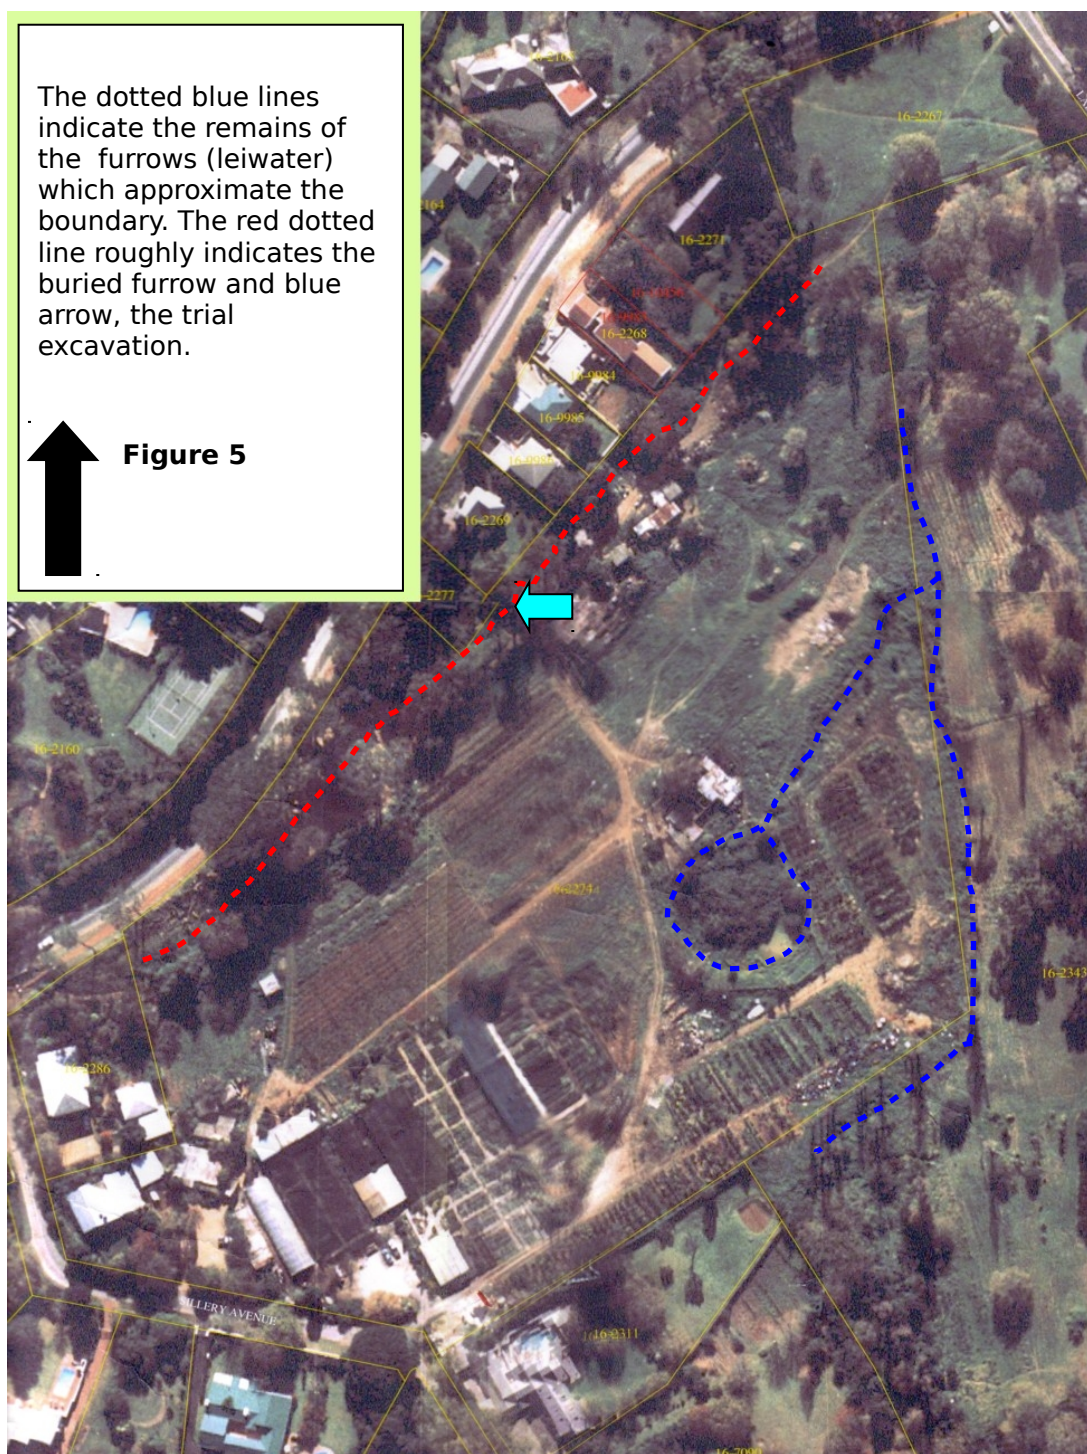
Figure 5

The dotted blue lines indicate the remains of the furrows (leiwater) which approximate the boundary. The red dotted line roughly indicates the buried furrow and blue arrow, the trial excavation.
