HARMONIE FARM 744
PORTION OF VERGELEGEN, SOMERSET WEST
HISTORICAL SURVEY AND STRUCTURAL INVESTIGATIONS
OF THE 18th CENTURY BARN (WORKSHOP)

JUNE 2009

Report Prepared for
NICOLAS BAUMANN & SARAH WINTER
Heritage Resource Consultants
P.O. Box 281 Muizenberg 7950

Prepared by
HENNIE VOS, MA
Historical Archaeologist & Consultant
ARCape Consultancy
P.O. Box 379 Stellenbosch
(082-217-0032 Fax 021 889-8956)

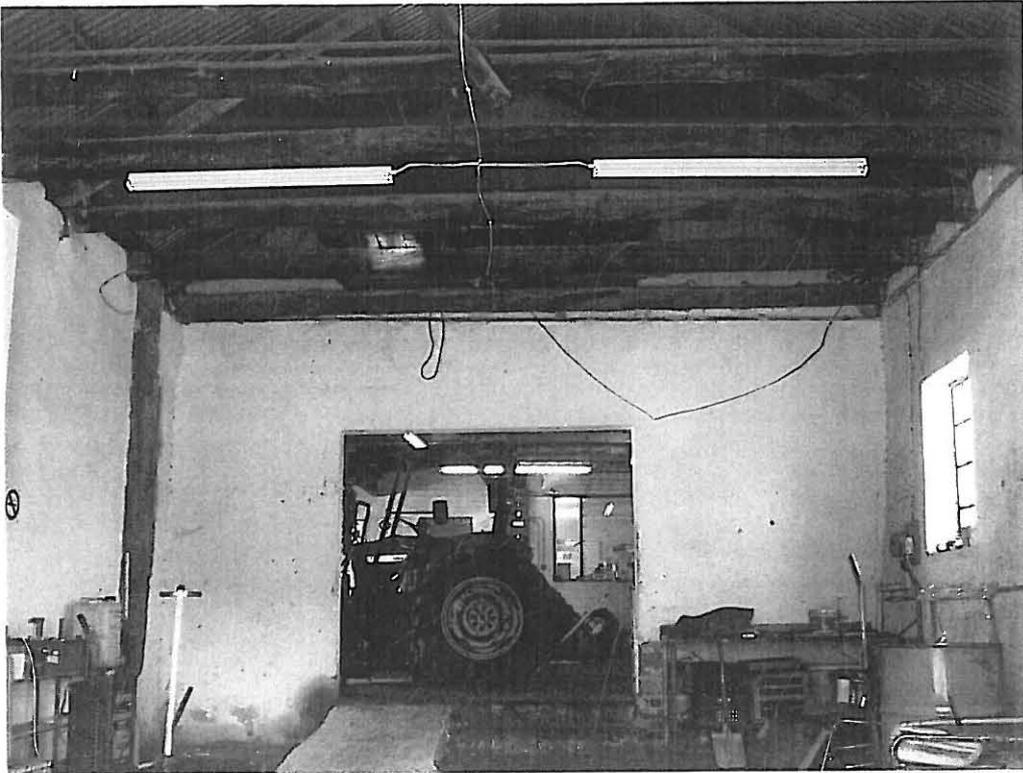
15. Same Room A, looking through a large opening with steps towards Room B. The beams alternate between square hardwoods (18th) and round poplars (19th) (looking S).

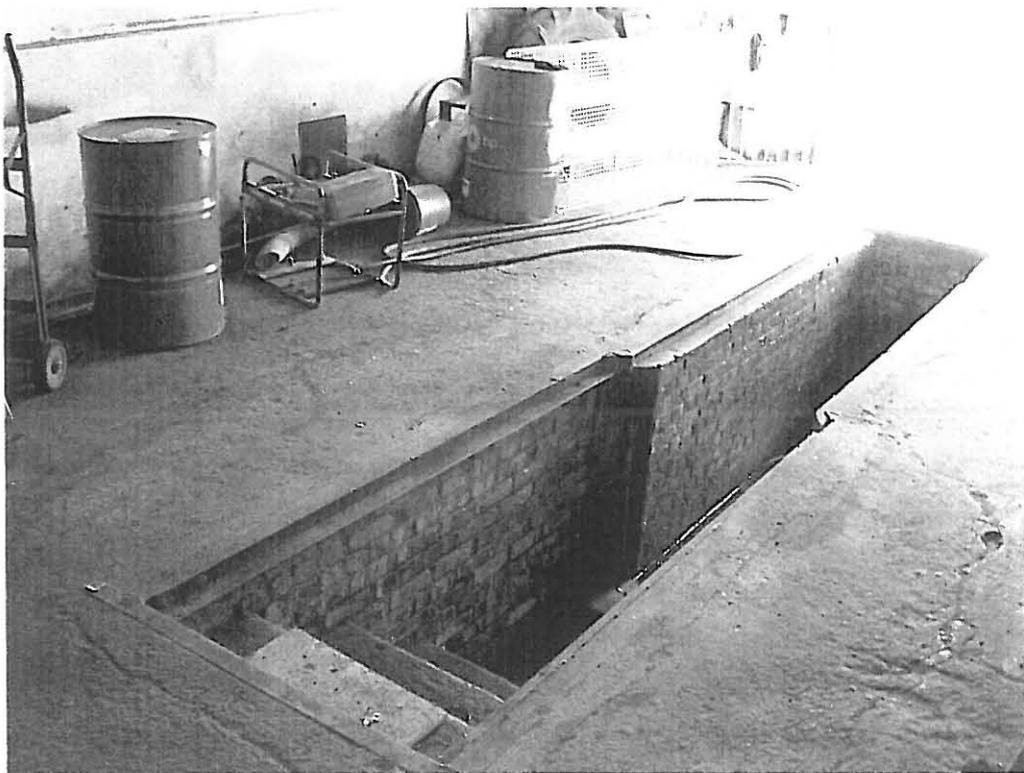
14. The Barn, Room A, with its >1940 oil pit, sunk into the old clay floor, with a cement topping (looking NW) (It can easily be filled in).

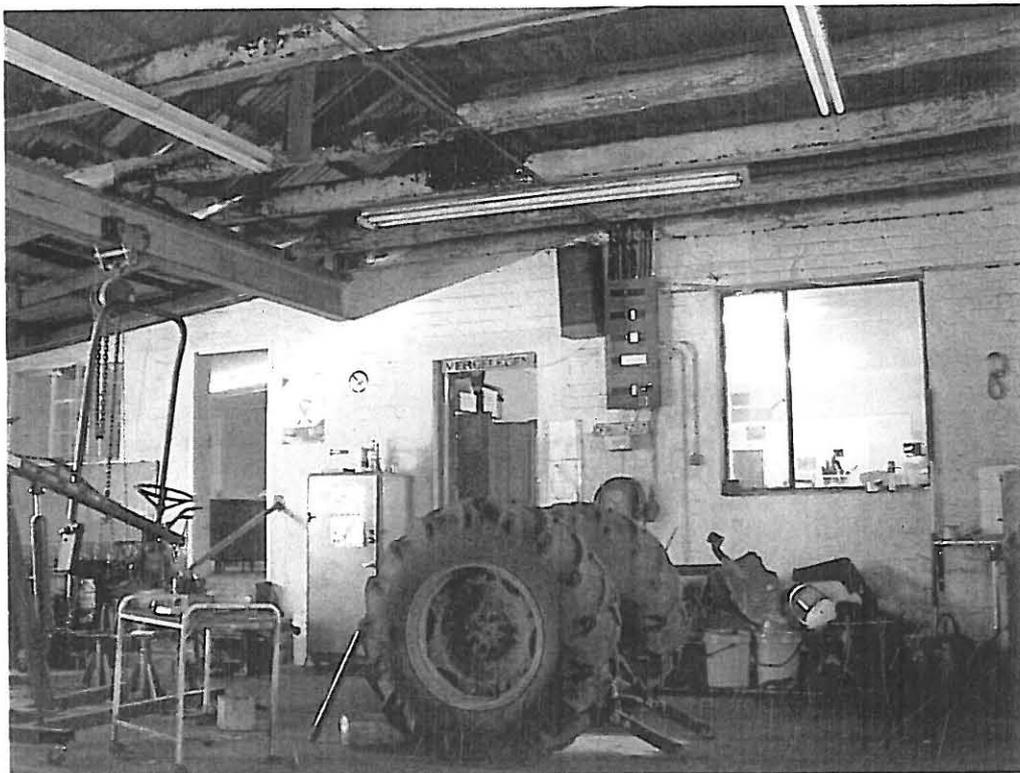
18. Room B has been particularly damaged by the workshop alterations of >1940. Nonetheless, in the rafters the old square and round beams are still in position. The wall (east) has been demolished and replaced by a yellow steel girder (looking S).

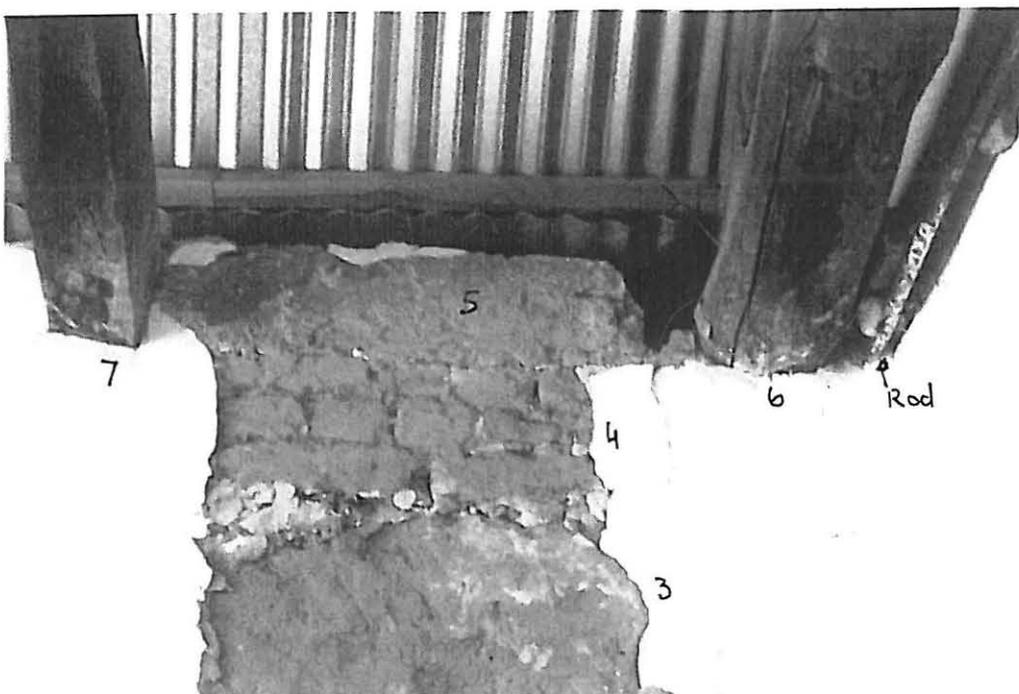
23, 24. In Room A3, corner, a portion of lime plaster was stripped vertically, revealing the:

1. Plinth and cobbling foundation.
2. Dressed sandstone footing (white "lime"/ mould).
3. Ferricrete wall with mud plastering (2 layers, one with white-washed patches).
4. Brick layers in brown mortar.
5. Upper brick layer with yellow mud plaster.
6. Poplar beam with iron rod (>1940) next to it.
7. Square hardwood beam, with soot (scales: 2m, 1m)(looking E).

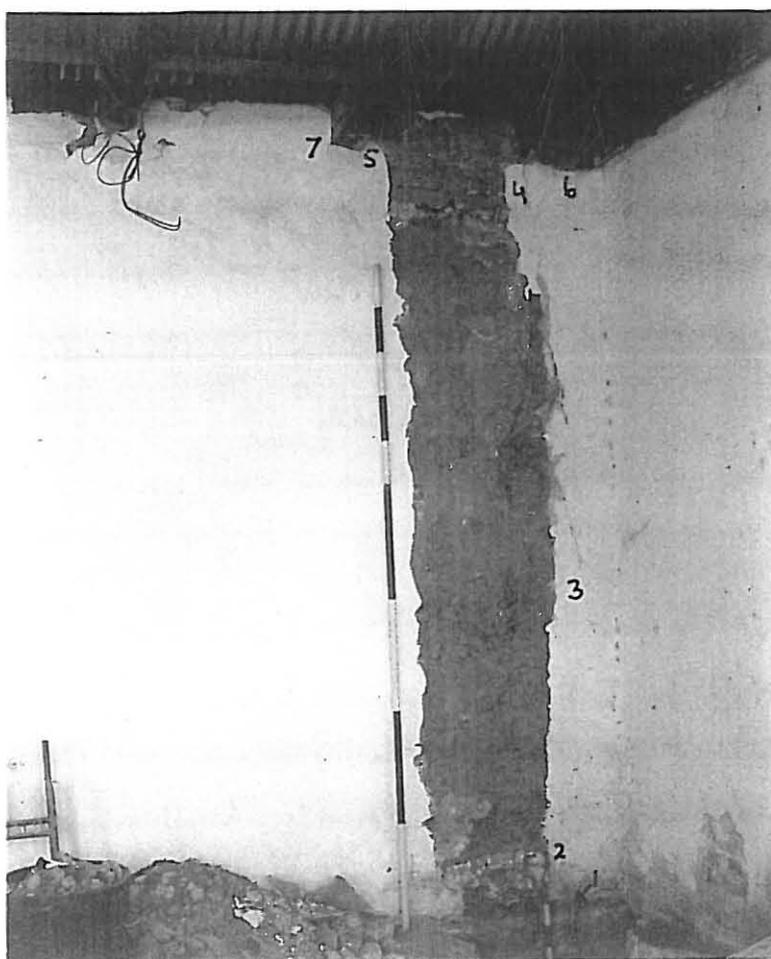
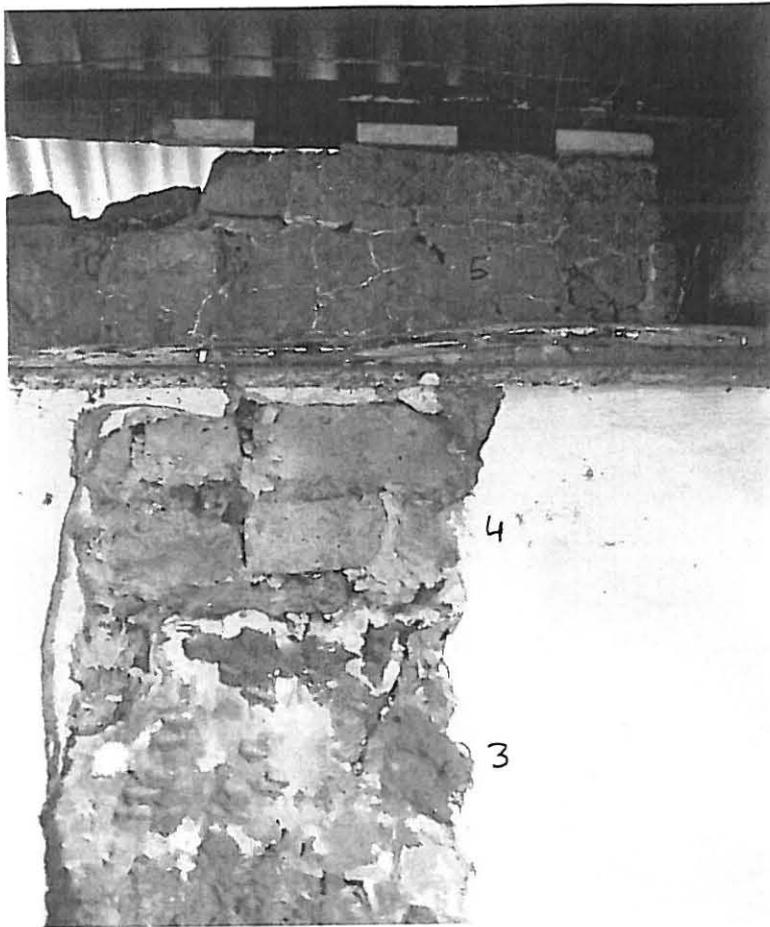
25, 26. In Room A1, a portion of **cement** plaster was chiseled off to reveal a similar constructed wall. 1. Cement floor 2. Sandstone below 3. Ferricrete 4. Bricklayers in brown mortar 5. Upper brick with mud plaster (scales 1m, 50cm) (looking W).

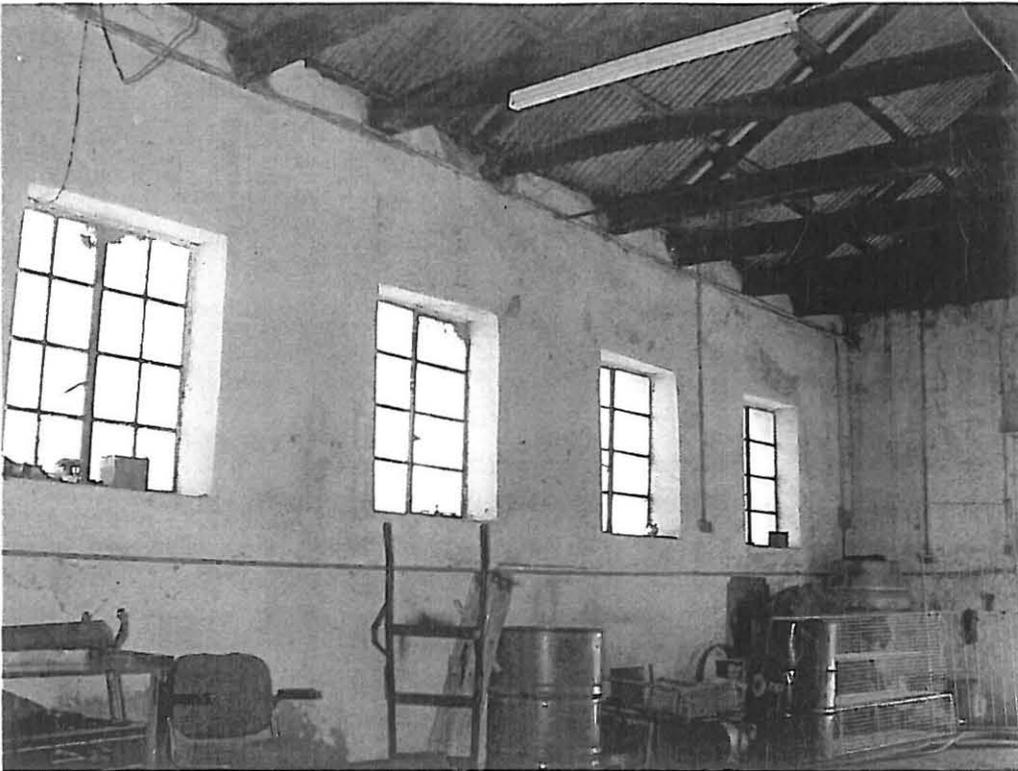
27. In Room A the steel windows (>1940) are regularly spaced in the old 52cm wall, cut into the 18th c ferricrete wall. Earlier openings are likely. Above the alternate beams the ceiling boards are absent (looking NW).

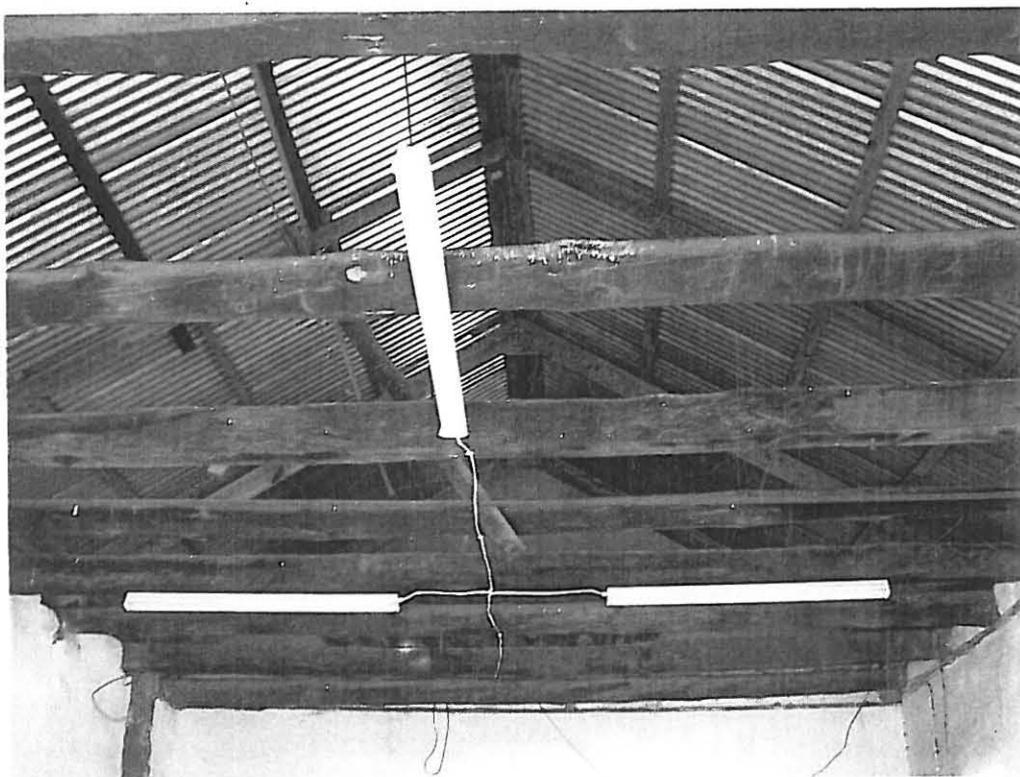
29. In Room A the alternating beams (square and round) give an indication of how intact the old Barn is (looking N).

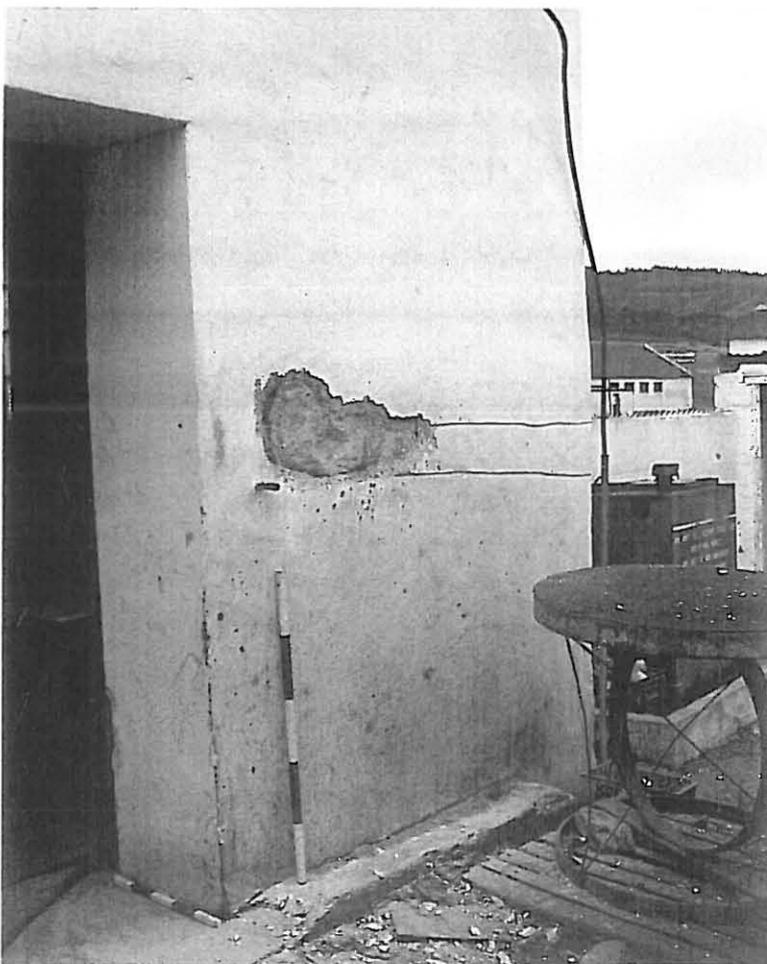
34. Close-up of the right side of the after 1940 door opening. An extremely hard cement plaster, with mesh below, covered the old stone wall. The exposed stone is granite, with modern brickwork as a reveal (scales 1m, 50cm) (looking SW).

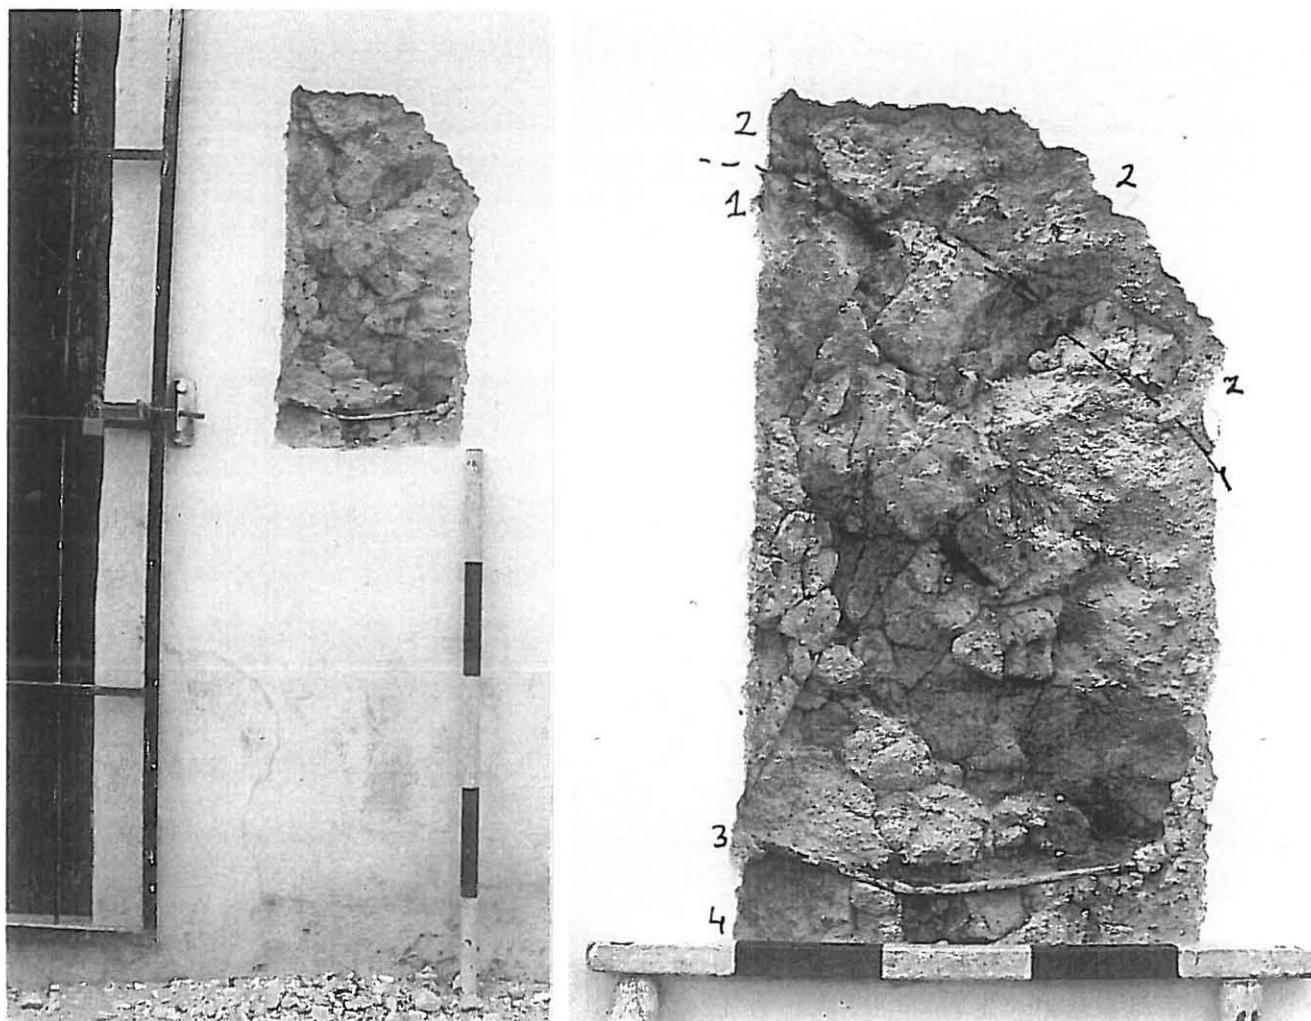
36, 37. Below the plaster, a very brittle clay brick was exposed, laid in an oblique manner, like a relieving arch (1). Ferricrete (2) overlay it. At the base is the iron plate (3), blackened, as is portions of the brown brick. Below the plate, the old oven opening (4) has been filled with modern brick (scales 1m, 50cm) (looking N).

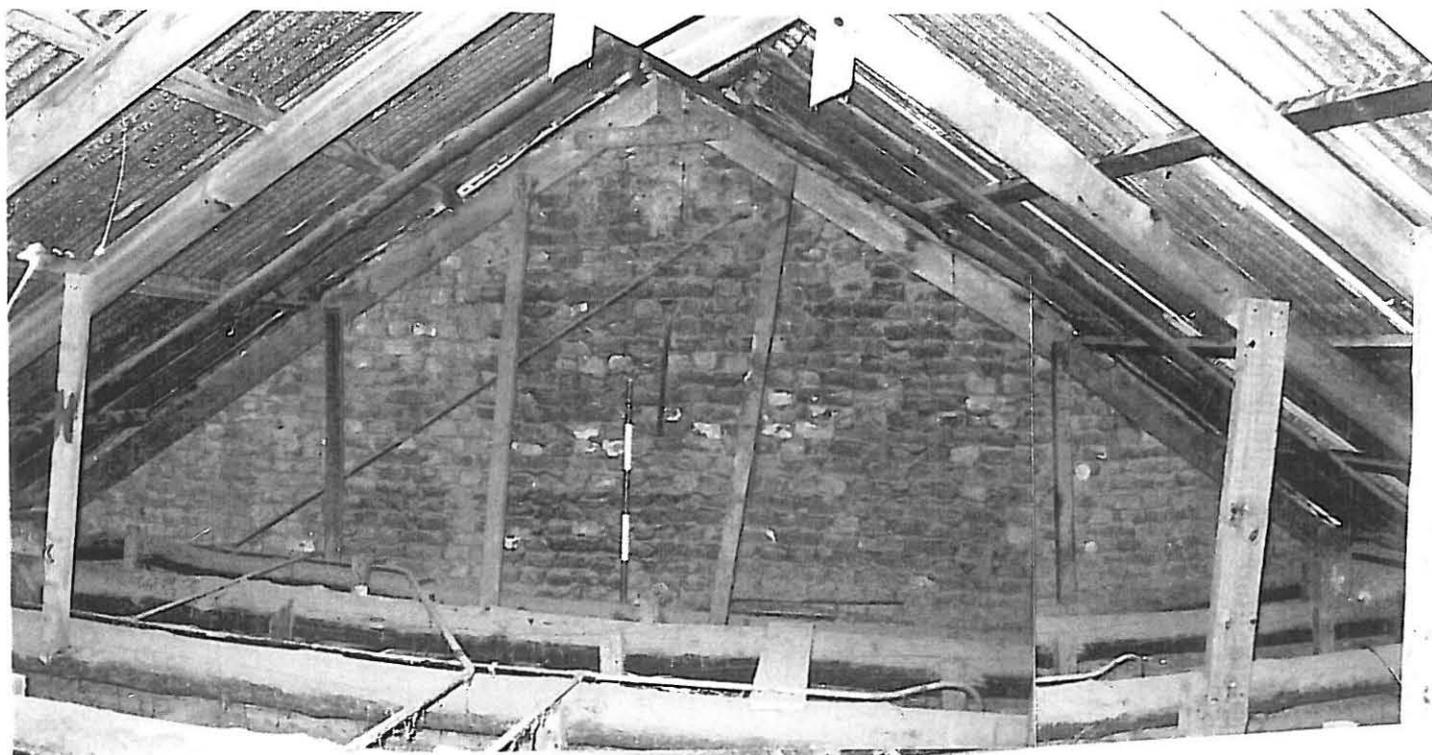
38. A composite view of the interior of the upper gable (south) of Wall EF4. As usual, the inner wall is not plastered, affording the view of a two period brick layer, the earlier below with flatter bricks. All the beams are poplar, overlain with fine grey dust (scale 1m) (looking S).

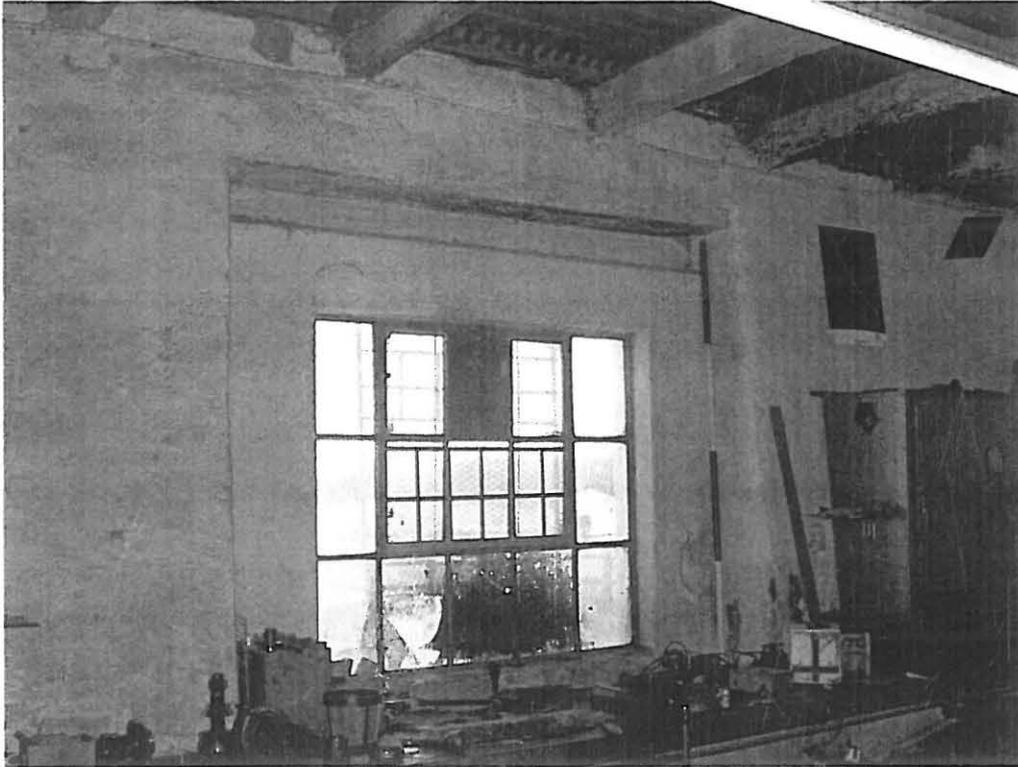
45. The blocked-up coach door of the mid to late 18th century in Room B1 (scale 2m).

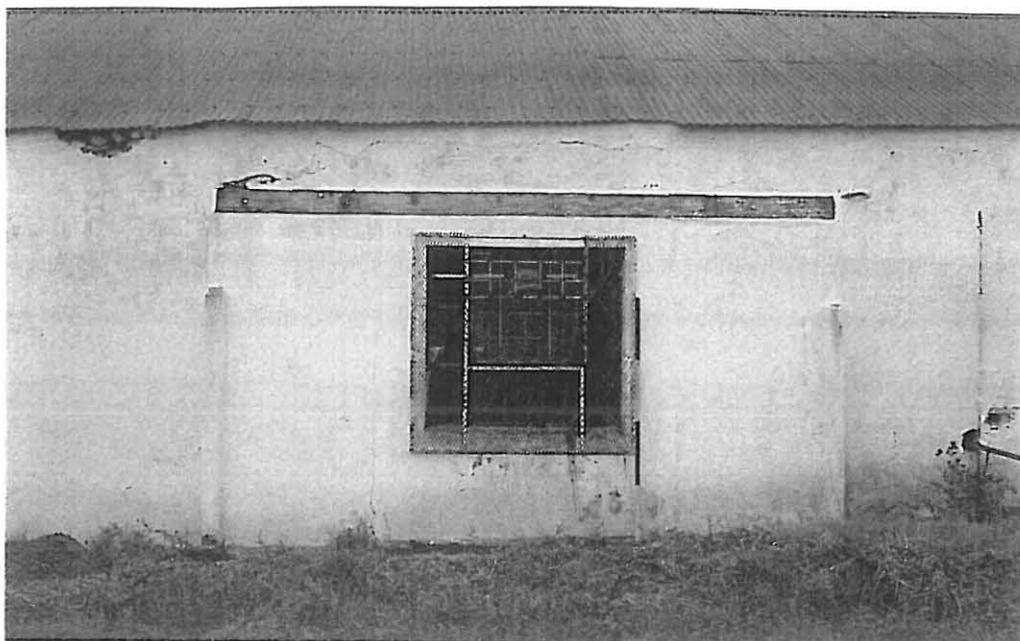
47. On the exterior (B1) the long lintel is obvious. The coach-door (c.1770) has been blocked-up in c.1940 with a steel-framed window (scale 2m) (looking E).

1. In its present state, the Barn is relatively stable, except for **wall B1**, where the coach-doors are situated. As none of the 10 beams are anchored on the eastern side (rest on a c.1990 steel beam), the roof forces are pushing this portion over. The water from the tin roof falls directly against the wall and on the clay soil. Cobble foundations in clay thus are plastic and facilitate movement of the wall. The engineer should make effective recommendations (Gutter, anchoring of beams, slope soil away from building, etc.).

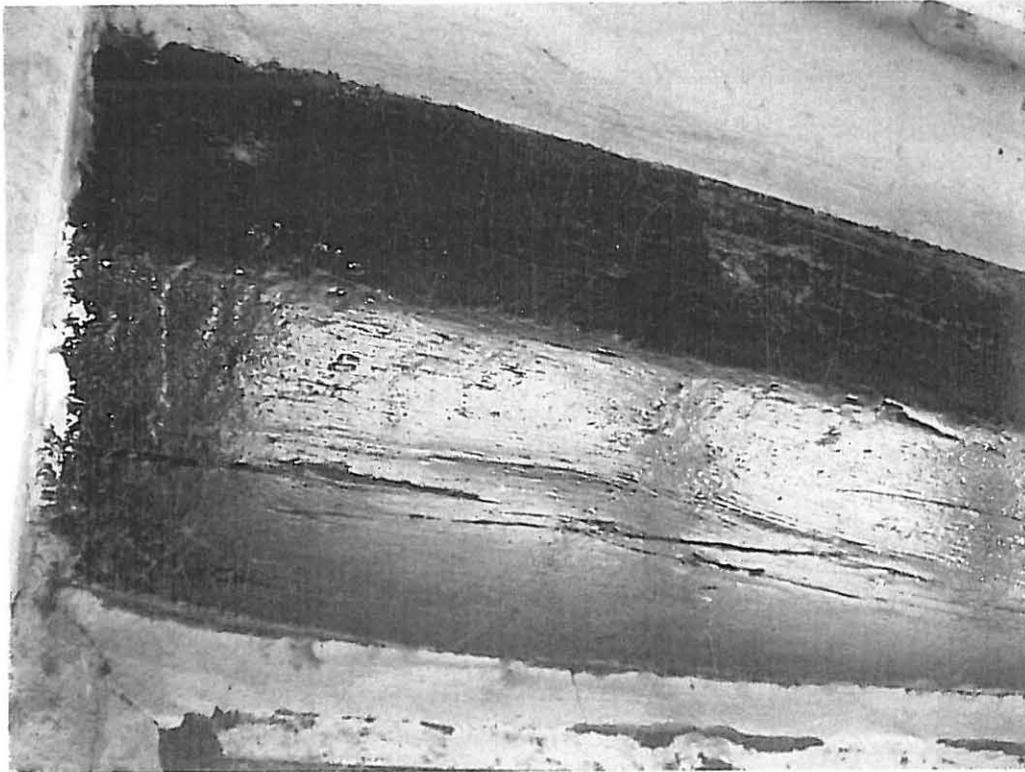
48, 49. In Room D1 another old, plain lintel (18th c) is to be seen above a steel window. Whether the lintel is *in situ* can be determined by plaster stripping (looking W).

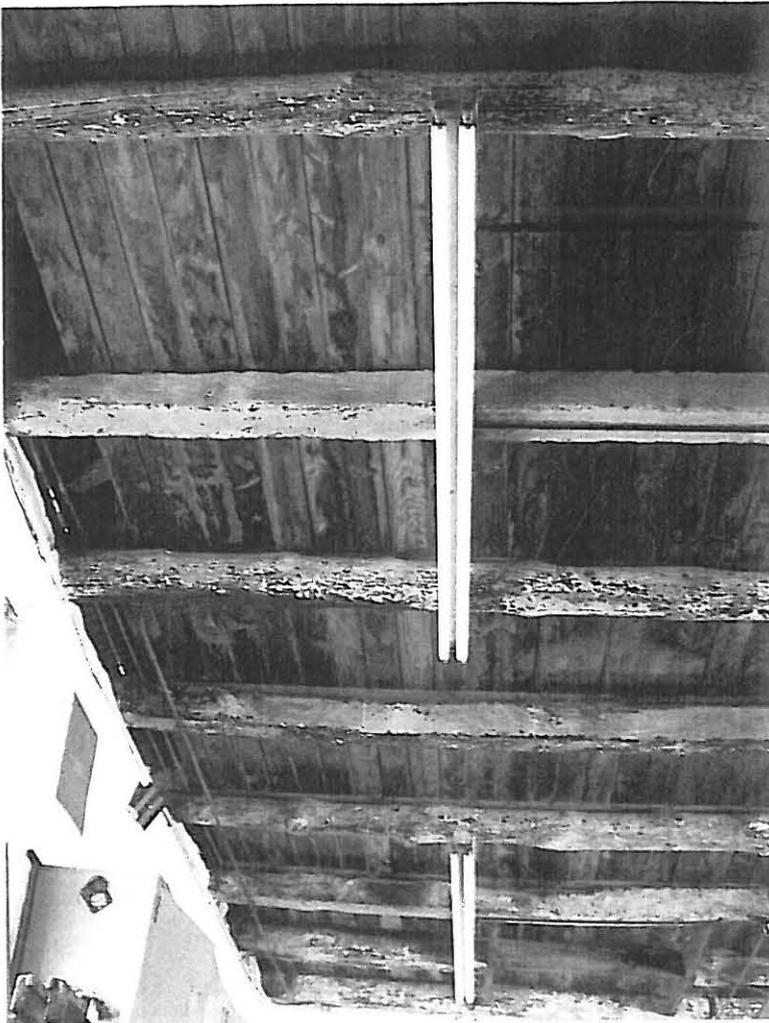
50. In Room B the loft (razed by an earlier fire) has been replaced with pine boards of the 20th century. Note the alternating poplar and square beams, all showing signs of fire soot (looking N).

51. End piece of a poplar beam, but loosely resting on the steel girder (Room B).

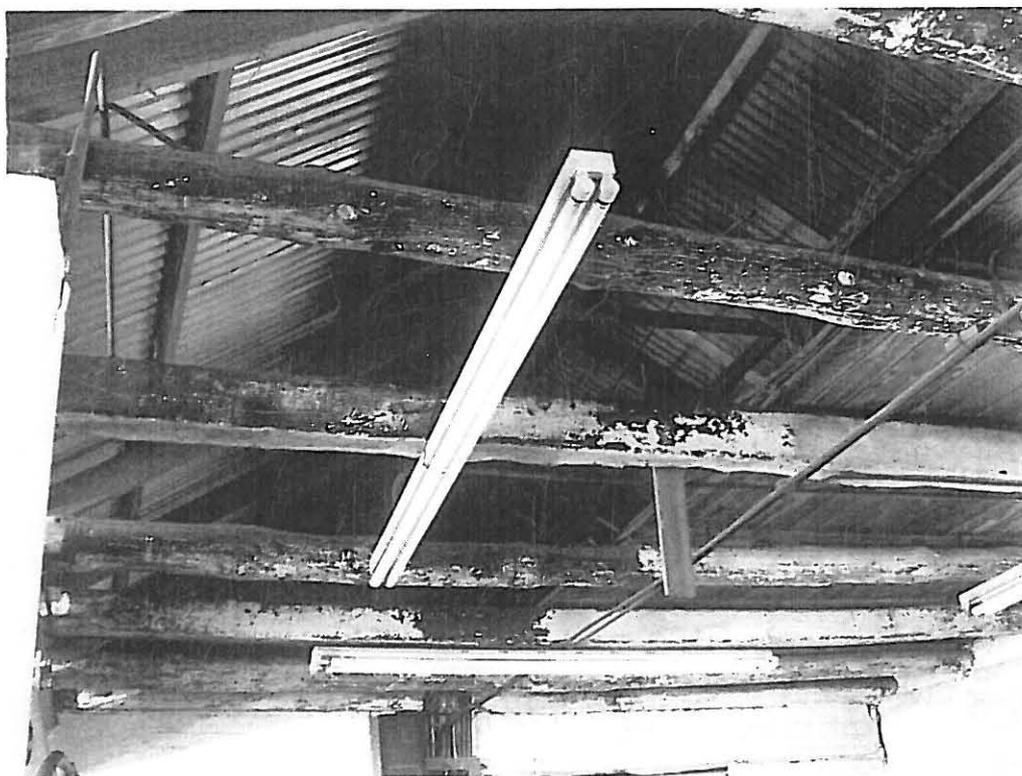
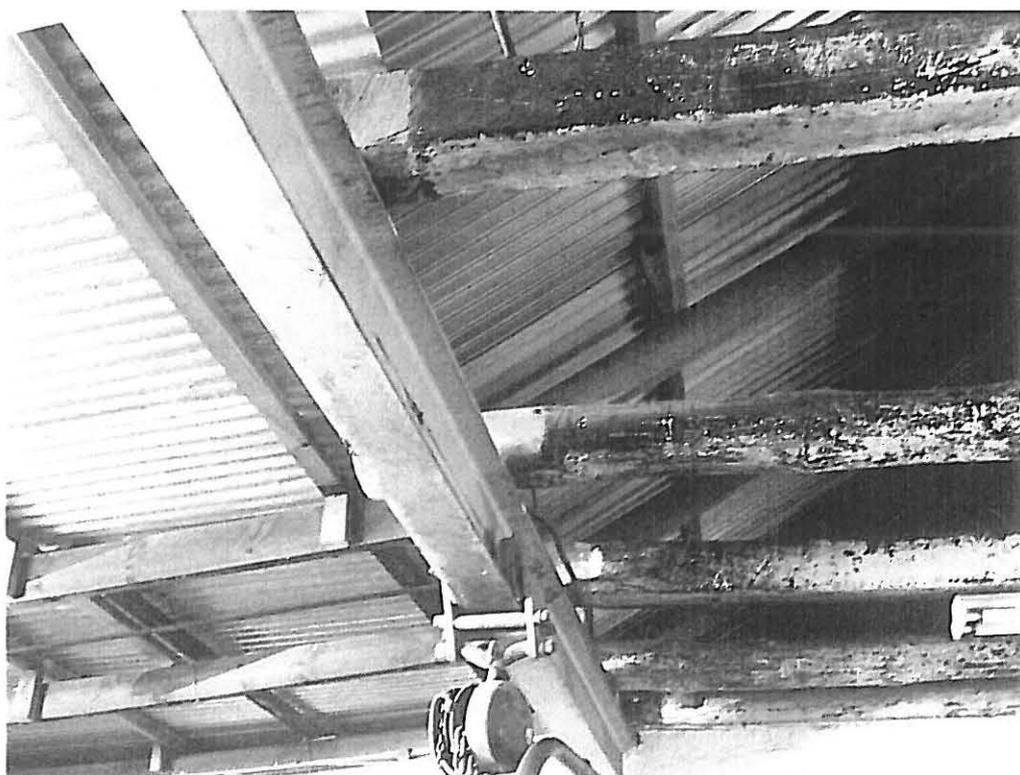
52, 53. In Room B, the eastern side of the beams is fire-crazed and black, which were once lime-washed in white to disguise the carbonized beams (looking S).

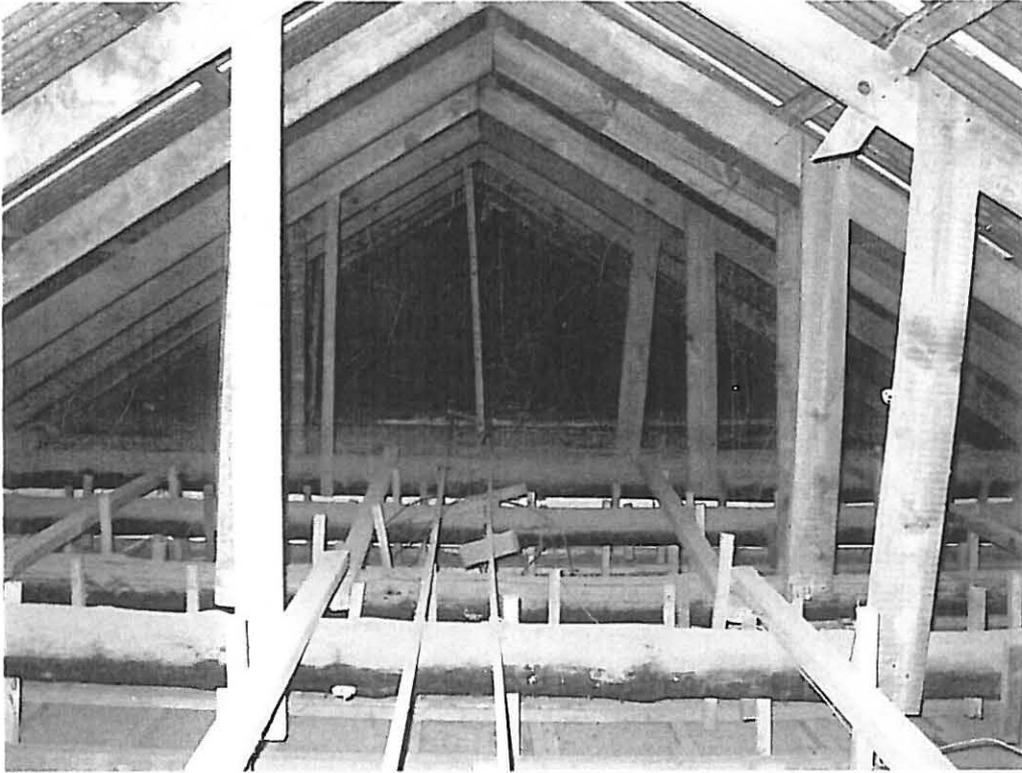
54. In the loft above Rooms DEF, the large and thick (c.25cm) poplar beams are discernable (looking S).

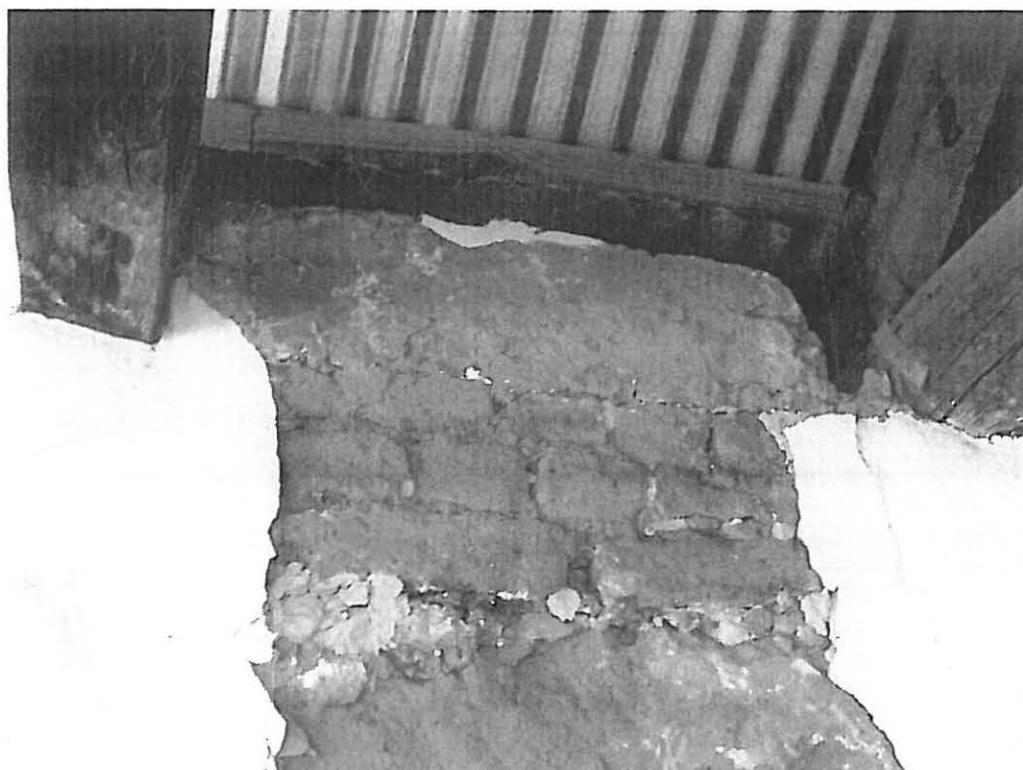
56. During the early 19th century the upper portion of the eaves were raised in brickwork, possibly in 2 stages, to accommodate the earlier square beams & the later (c.1820) poplar beams (Room A3) (looking E).

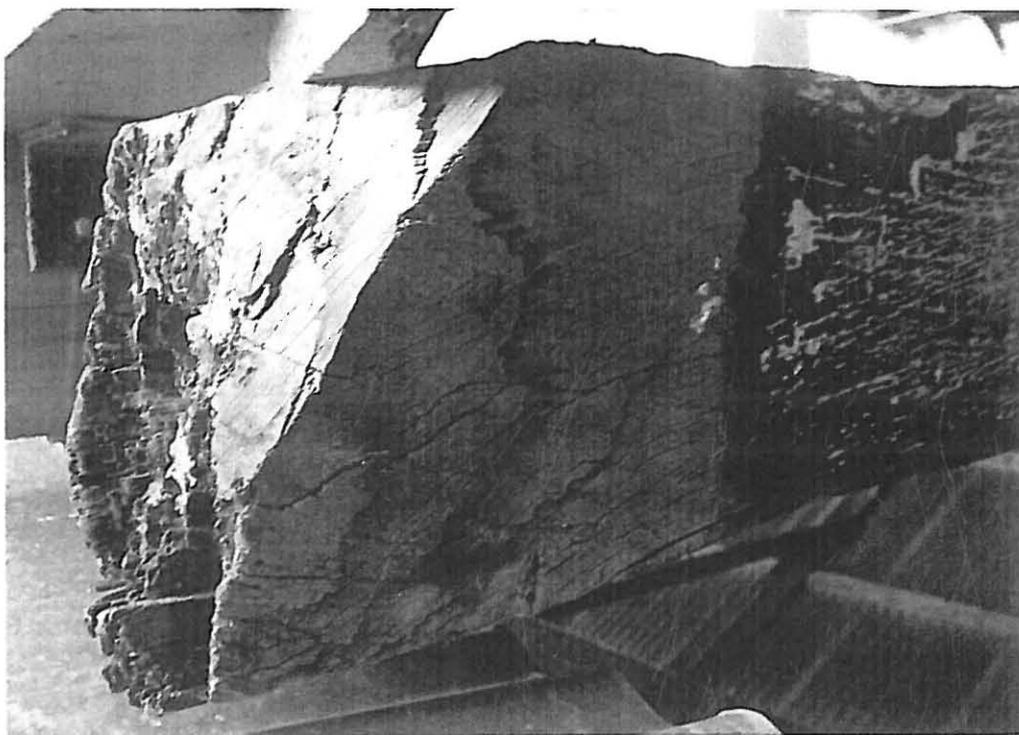
57. Close-up of a square beam with its hardwood showing distinct signs of carbonized, but only on the surface (Room B).

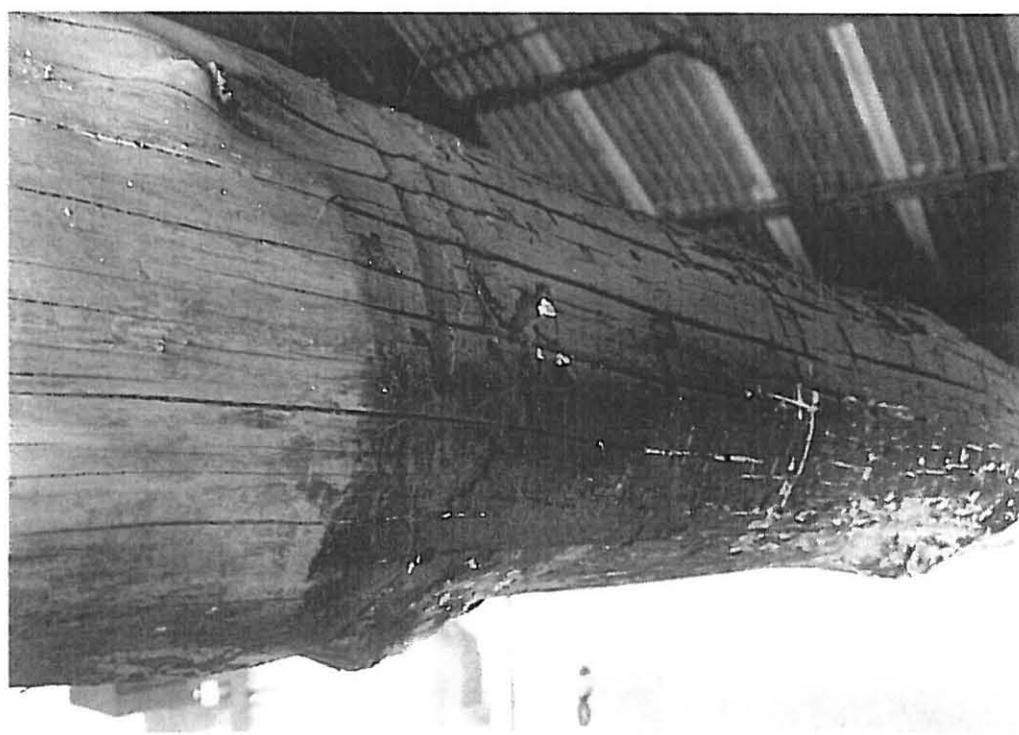
58. Similar close-up of a poplar beam (Room B).

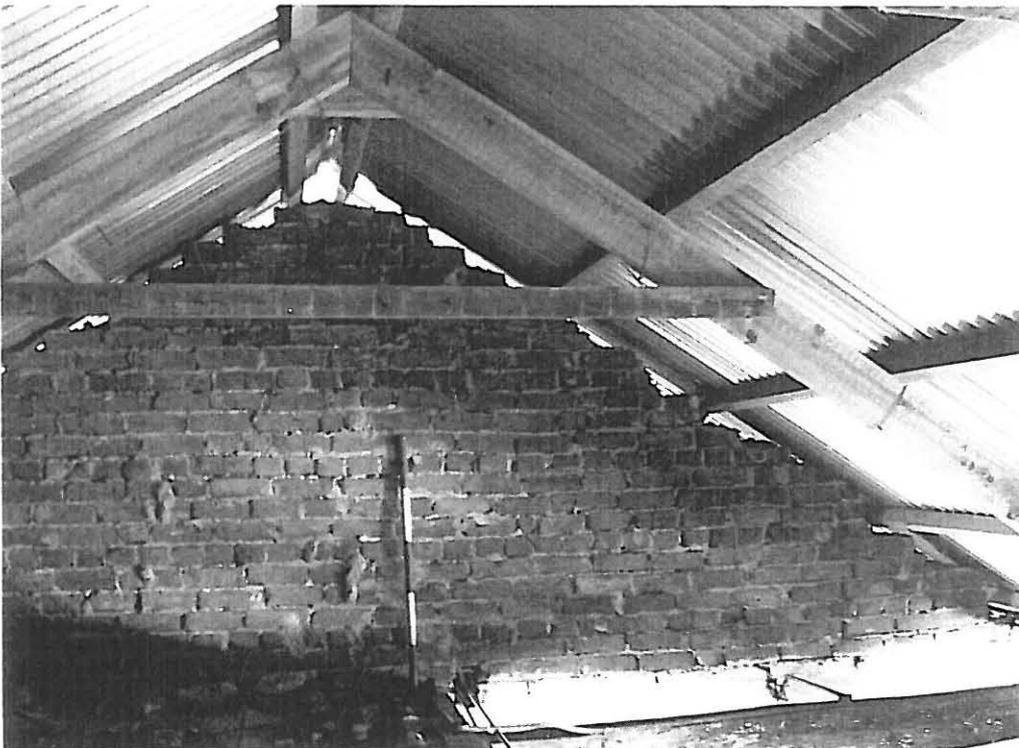
68. The upper gable of B2 was also built about this time (looking N).

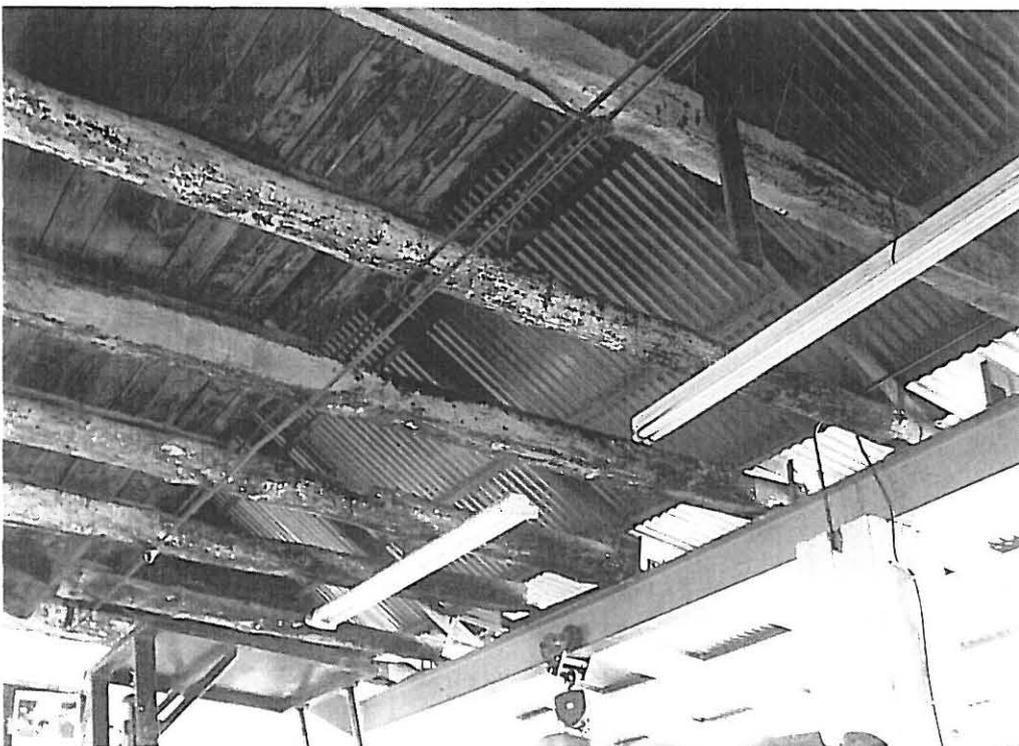
67. In Room B3, the exterior wall was demolished, and the beams placed on a steel girder in the 1970s (looking N).

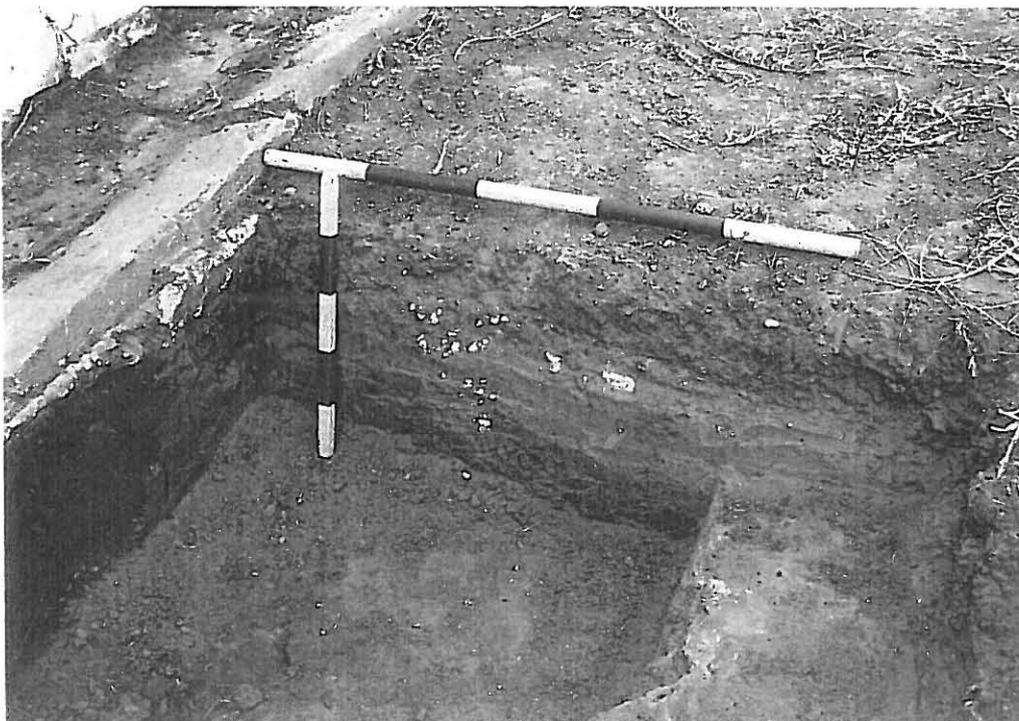
69. Test section B1 on the exterior, is in relation to the gutter furrow and next to the blocked-up coach-door (scales 1m, 50cm) (looking SE)(Vos).
