**ARCHITECTURAL DESIGN SERVICES:
CONDITIONAL ASSESSMENT FOR THE MOTOR LICENCING BUREAU BUILDING
(MLB)**

CONDITIONAL ASSESSMENT REPORT

BY RMA ARCHITECTS

APRIL 2022

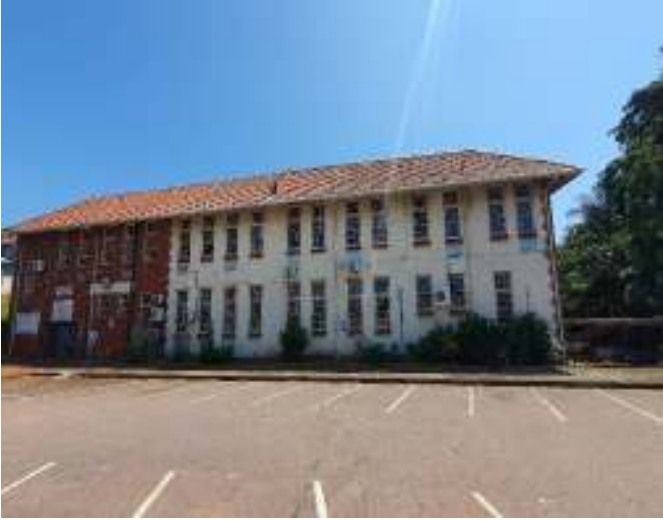
<p>The exterior of the building is structurally sound and in a good condition.</p> <p>The building needs to be repainted and the facebrick</p> <p>Needs to be cleaned as per the scope of works on the Architects drawings.</p> <p>All steel plates to be removed, bricked up and plastered and painted.</p>

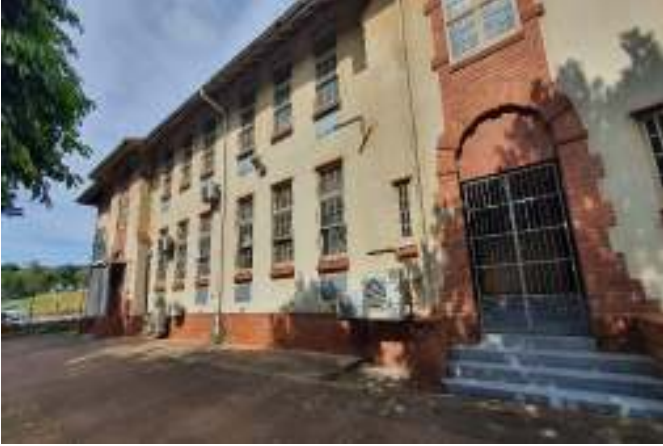
<p>The building does not comply with SANS 10400 PART S.</p> <p>A ramp to be added to the exterior of the building of the parking lot, to accommodate for wheel chair access.</p>

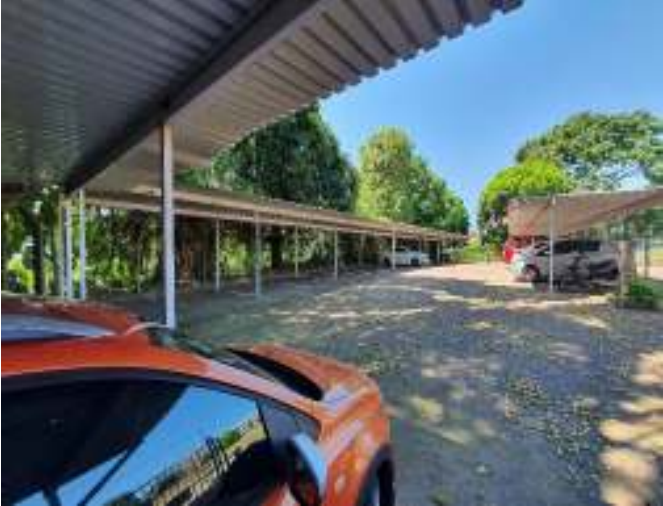
<p>All carports are in a good condition.</p> <p>The sheeting and steel frame structure to be cleaned</p>

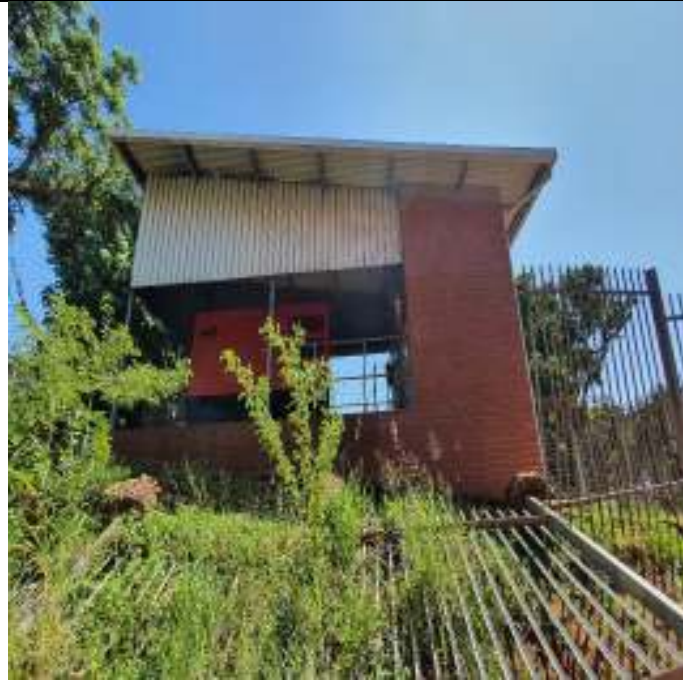
The Generator room is in a good condition, Electrical Engineer to advise.

The facebrick and sheeting to be cleaned.
The Generator needs to be serviced

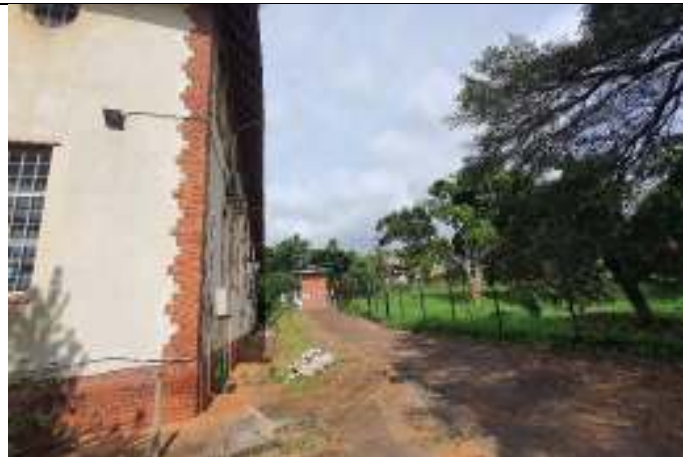
The road is to be made good as per the recommendations of the Engineers

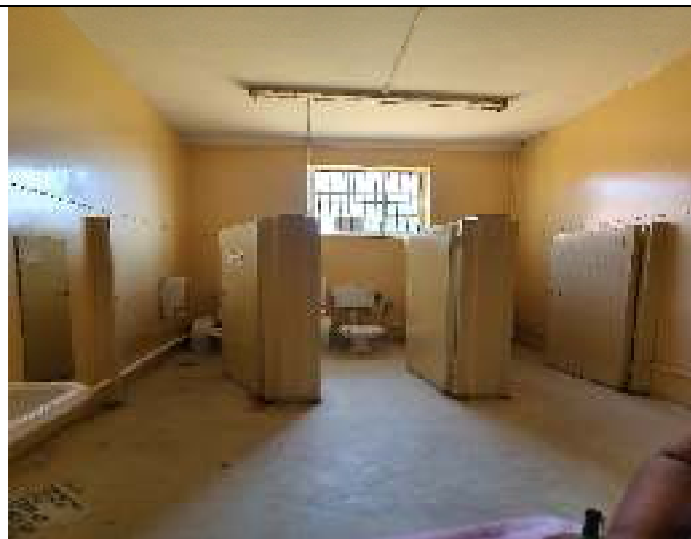
All sanitary fixtures to be removed and replaced with new.
Ex vinyl tiles to be removed and replaced with ceramic tiles.
Partition and door to be removed and replaced.
Ceiling boards to be removed and replaced with new fibre cement ceilings.
All light fittings to be removed and replaced as per Electrical Engineers report.

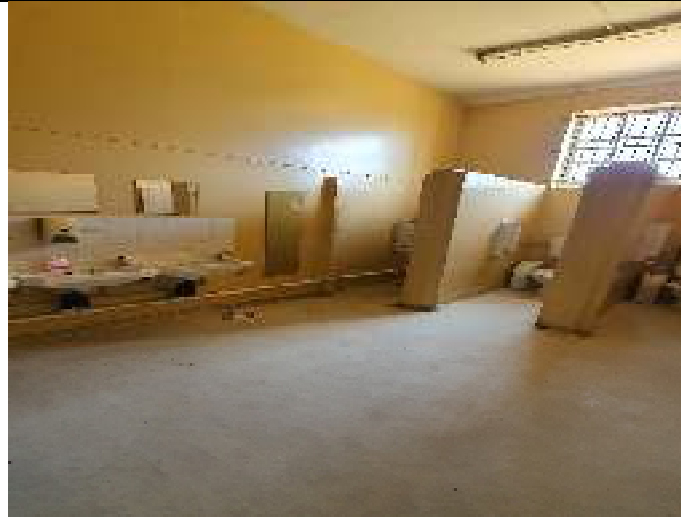
All Whb's to be removed and replaced with new.
All splashbacks to be removed and redone.
Mirrors to be replaced with new.

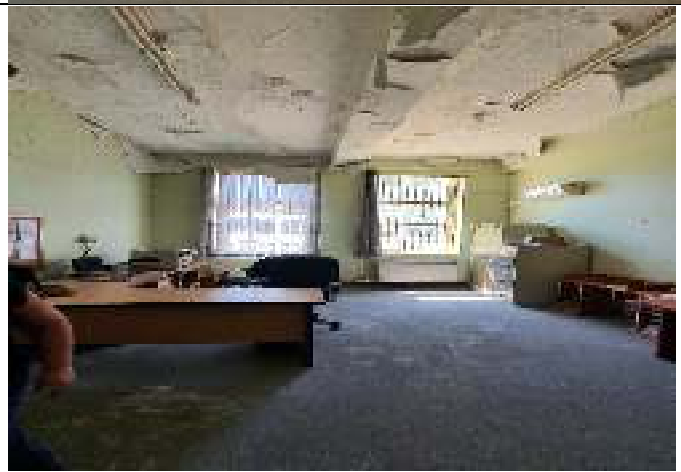
All light fittings to be removed and replaced as per Electrical Engineers report.
Carpet tiles to be removed and replaced with new porcelain tiles
Ex timber Windows to be removed and replaced with new Aluminium windows.
Ceiling and cornices to be redone

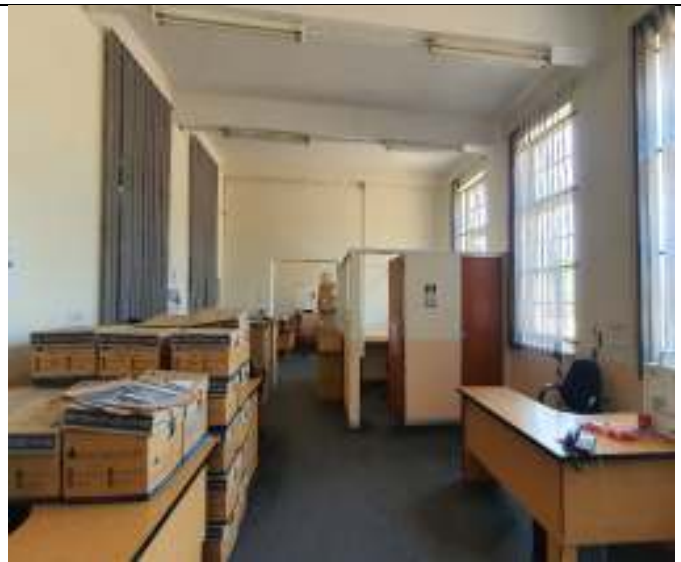
All light fittings to be removed and replaced as per Electrical Engineers report.
Carpet tiles to be removed and replaced with new porcelain tiles
Ex timber Windows to be removed and replaced with new Aluminium windows.
All blind to be removed and replaced with new.
Ceiling and cornices to be redone.
Ex loose furniture to remain.
All ex partitions to be removed.

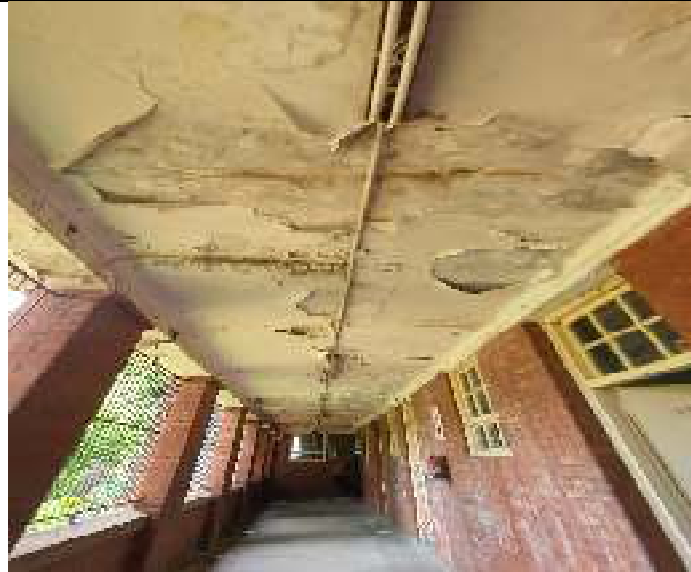
All light fittings to be removed and replaced as per Electrical Engineers report.
Concrete floors to be repolished
Ex timber Windows to be removed and replaced with new Aluminium windows.
Ceiling and cornices to be redone.
All ex facebrick to be cleaned as per Architects scope of works.

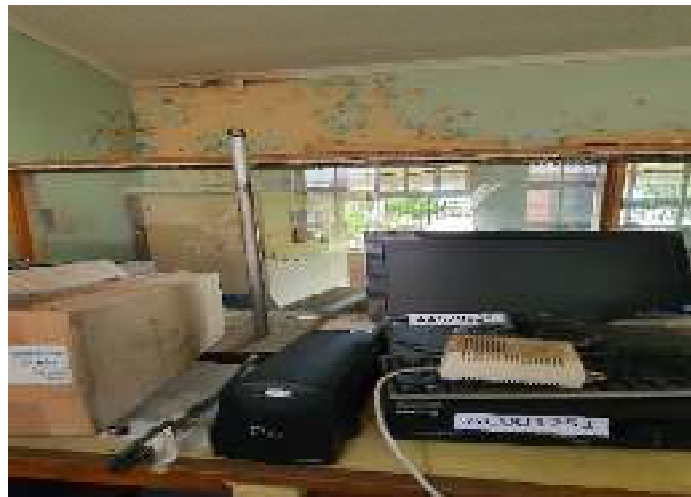
All light fittings to be removed and replaced as per Electrical Engineers report.
Ex timber Windows to be removed and replaced with new Aluminium windows.
Ceiling and cornices to be redone.

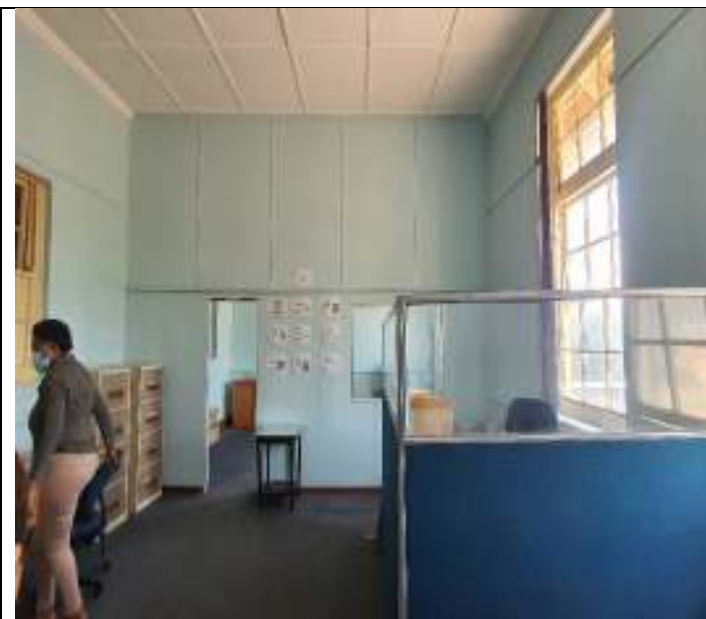
All light fittings to be removed and replaced as per Electrical Engineers report.
Carpet tiles to be removed and replaced with new porcelain tiles
Ex timber Windows to be removed and replaced with new Aluminium windows.
All blind to be removed and replaced with new.
Ceiling and cornices to be redone.
Ex loose furniture to remain.
All ex partitions to be removed.

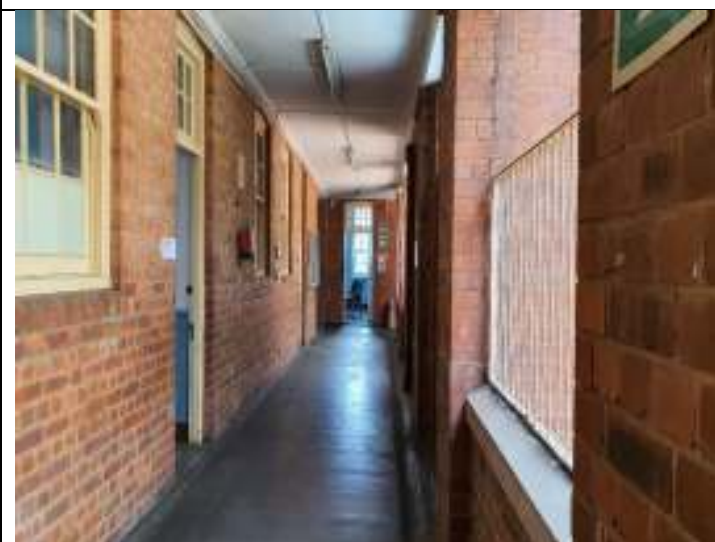
All light fittings to be removed and replaced as per Electrical Engineers report.
Concrete floors to be repolished
Ex timber Windows to be removed and replaced with new Aluminium windows.
Ceiling and cornices to be redone.
All ex facebrick to be cleaned as per Architects scope of works.

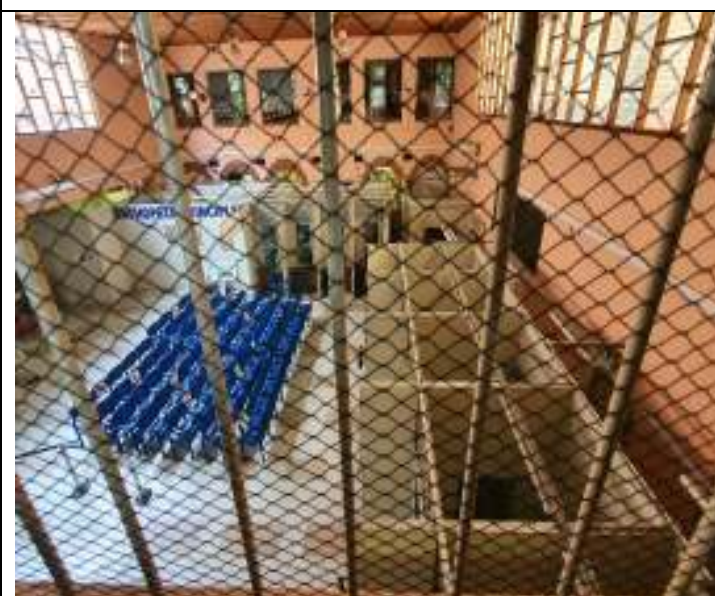
Ex banking hall- all partitions to be removed.
The client to provide the new layout.
Ex vinyl tiles to be removed and replaced with new porcelain tiles.
Ex High level timber windows to be removed and replaced with aluminium windows.
