County of Pembroke

Shipwreck Report

Vanessa Maitland

**Port of Ngqura
Eastern Cape
South Africa**

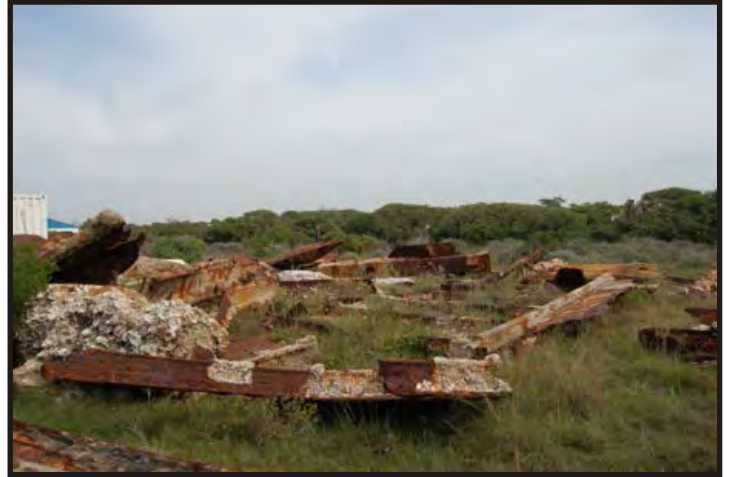
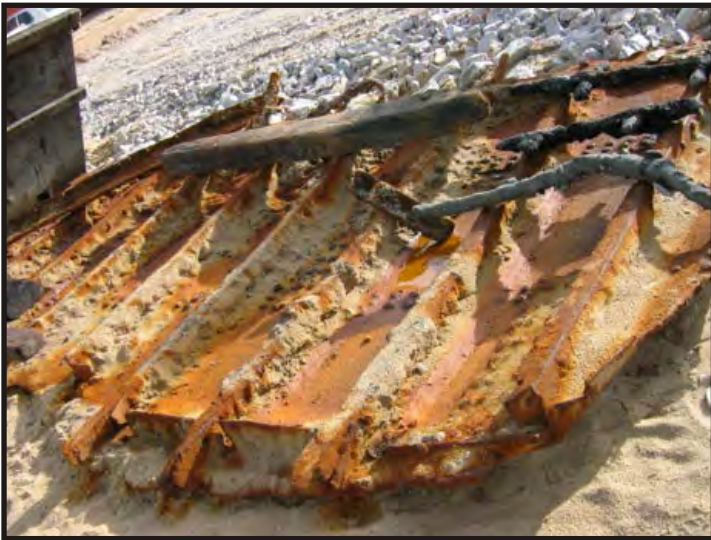
Figures 35 - 36: 2007 - Dump site from the Debris Removal Project was moved to the veld next to the Transnet site office. The following photographs document the deterioration the artefacts have undergone during the last three years. Rust and humans are the main agents of destruction. (Photos V. Maitland)

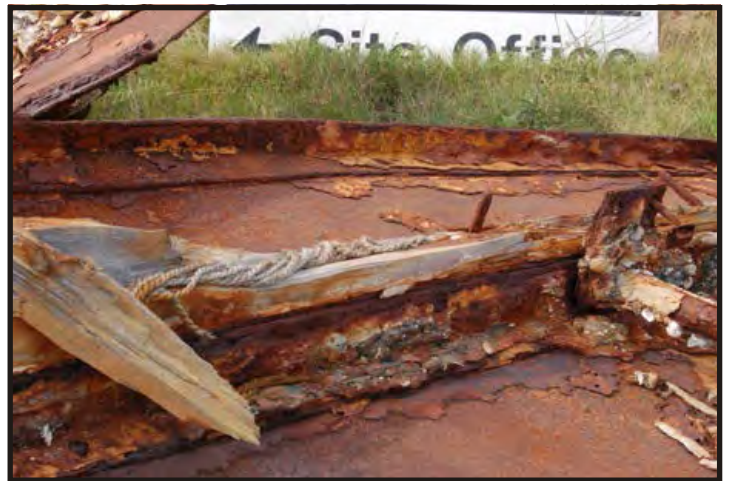
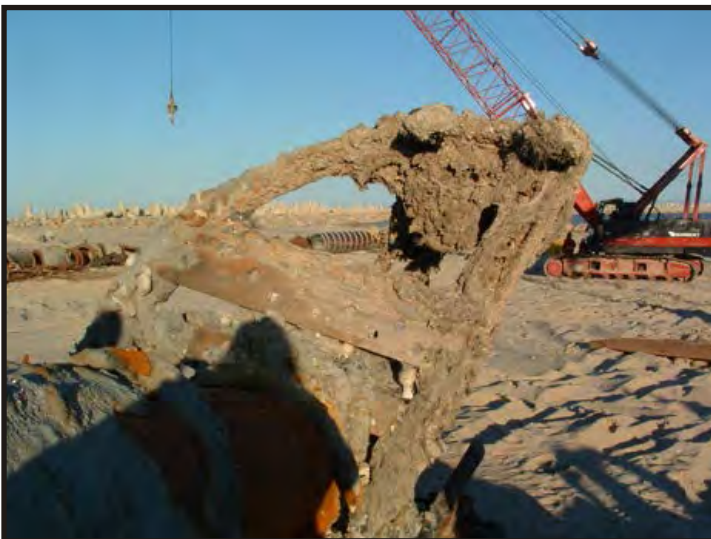
Figures 37 - 38: While the materials appear to be as coated with rust in 2004 as they are in 2007, in 2004 it was a light layer over an unaffected core. After three years the rust had eaten into the iron and is corroded the core. The onion-peel look bears this out. In addition, all the dead-eyes have been removed by persons unknown. (Photos V. Maitland)

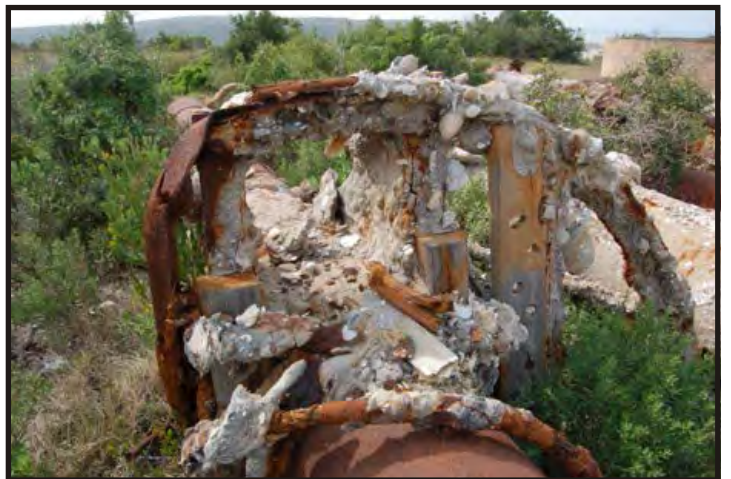
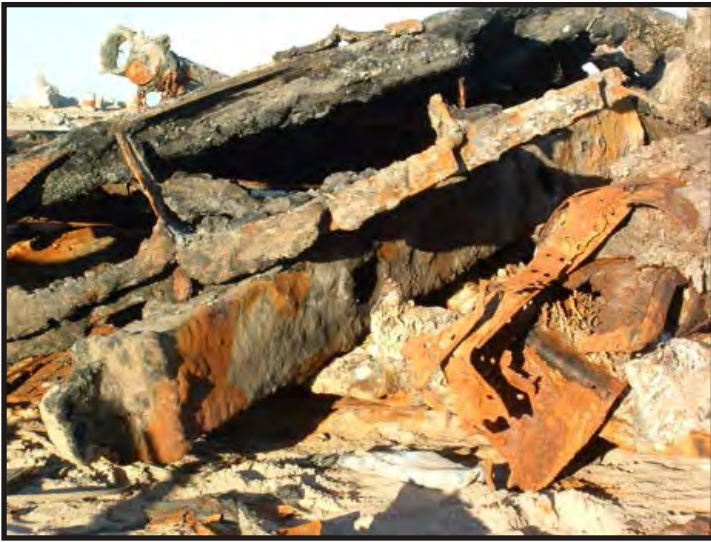
Figures 39 - 40: The mast top has deteriorated substantially. In addition to rust, damage was sustained when the artefacts were moved. The wood has dried out and is warped and cracked. (Photos V. Maitland)

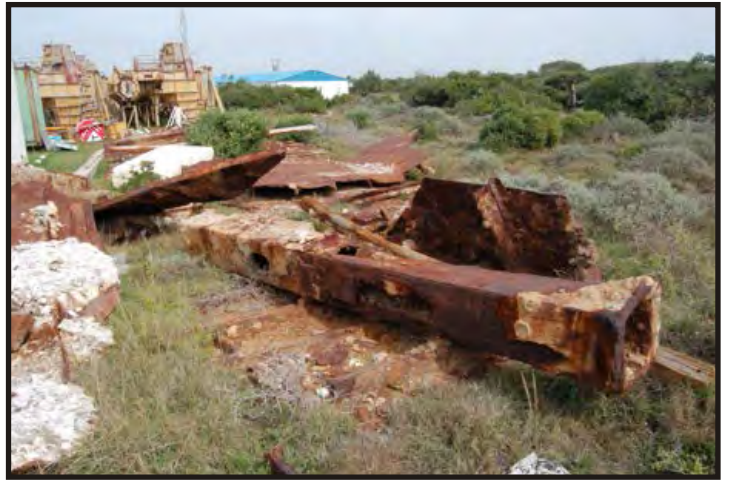
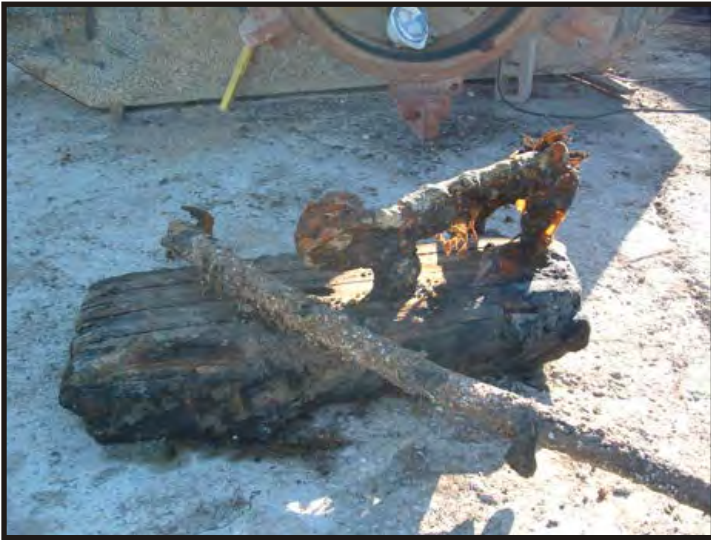
Figures 41 - 42: Corrosion has damaged the head beam further. As it is a fairly substantial piece of iron, human factors have fortunately affected it little. (Photos V. Maitland)

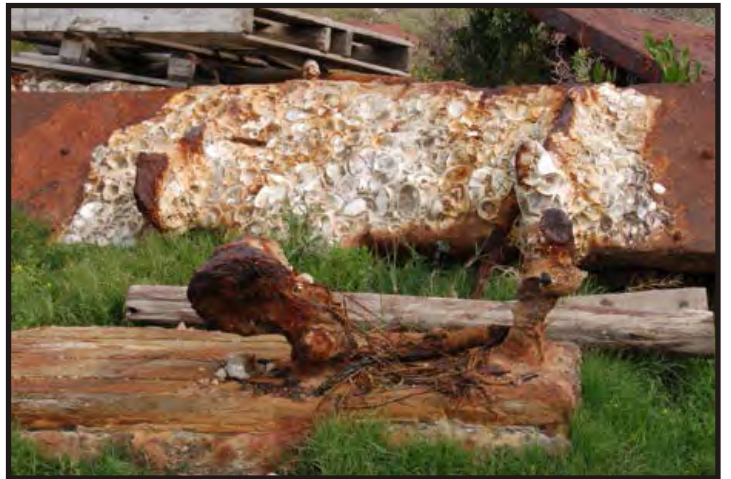
Figures 43 - 44: This rigging gear has become severely damaged in the last three years. It collapsed in places as the rust ate into the core metal. (Photos V. Maitland)

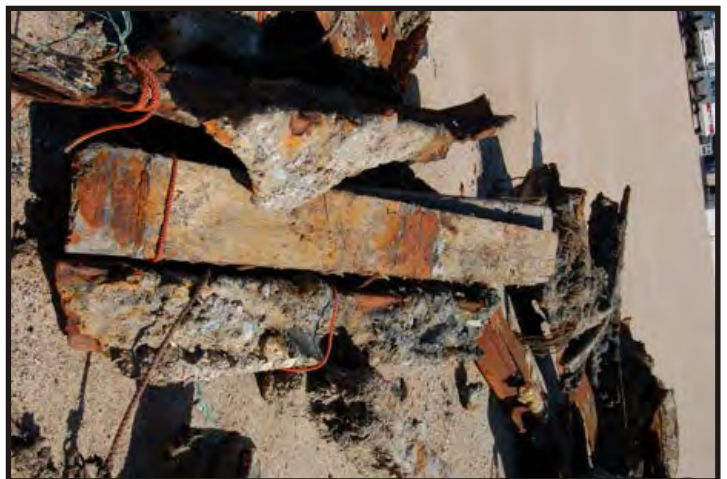
Figure 216: Bottom of a deck plank. Corrosion from the beams is visible. (Photo V. Maitland)

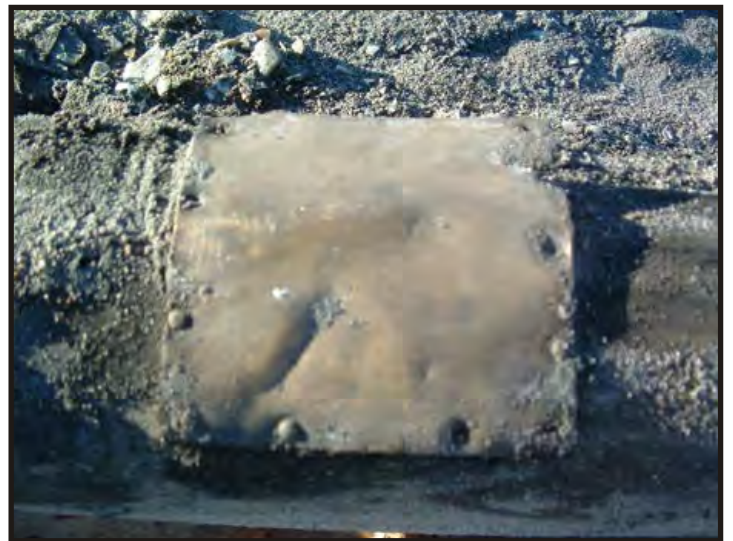
Figure 227: Top of gunwale. Repairs were made to the wood and covered with a copper sheet. (Photo V. Maitland)

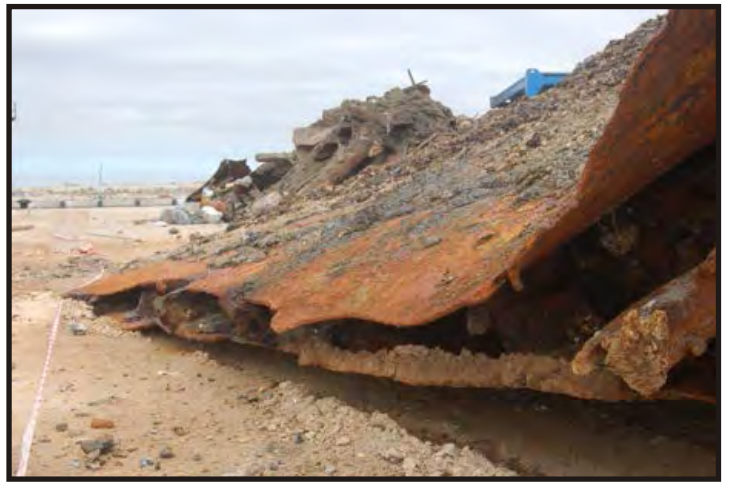
Figure 265: A close-up of the missing keel. This may be the part that was damaged during the wrecking of the barque in 1903. The Eastern Province Herald (24-03-1904) mentions that 17 feet of her keel was ripped away, presumably when she grounded on the limestone rock. (Photo V. Maitland)

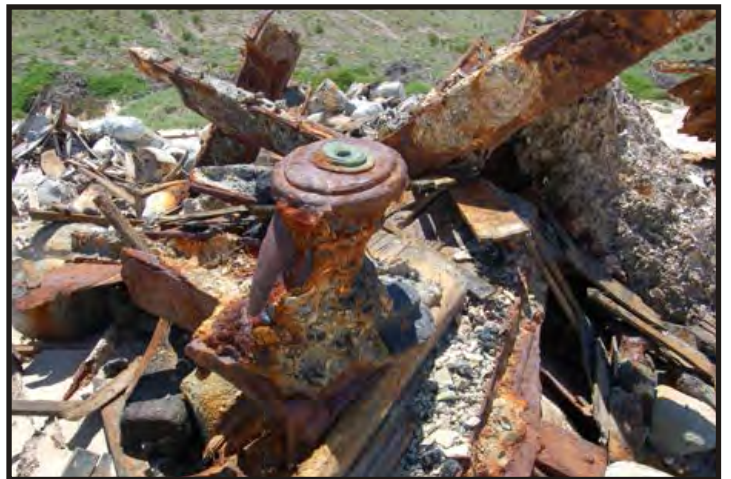
Figure 317: A different type of bollard, broken in half. While this bollard is also made of cast iron, it has a square brass bolt and 'washers' on top. (Photo V. Maitland)

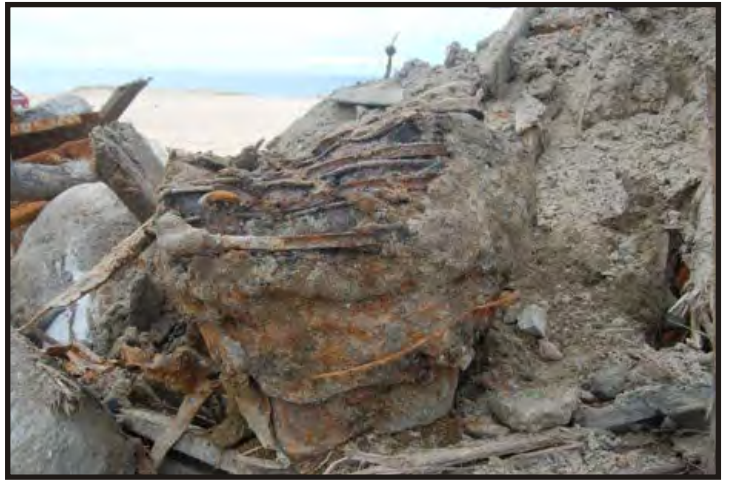
Figure 418 - 419: Metal buckets corroded together. (Photo V. Maitland) Bisset (1958:201) discusses the *County of Pembroke's* buckets in the following extract, "...the hold was filled to the deckhead, with 1,000 tons of guano, rammed into every corner and packed tightly around the two iron fresh water tanks. These, as in all sailing vessels, were set amidships in the hold, abaft the mainmast, and water was drawn from them into buckets by a hand pump on deck, for our whack of three quarts per man per day."

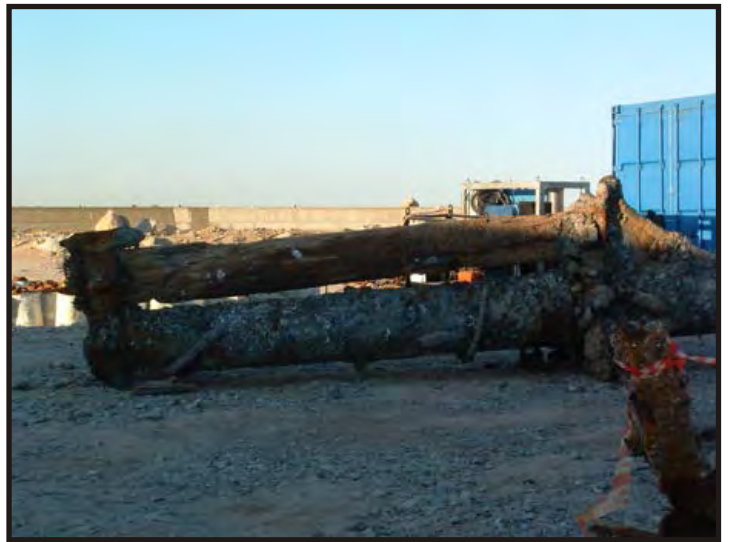
Figure 450: Doubling of the lower iron mast and the wood top mast. The iron trestle trees are still there, but the top is missing. (Photo V. Maitland)
