**1st Phase**

**CULTURAL HERITAGE RESOURCES IMPACT  
ASSESSMENT FOR HARMONY GOLD MINE,  
EVANDER.**

**September 2010**

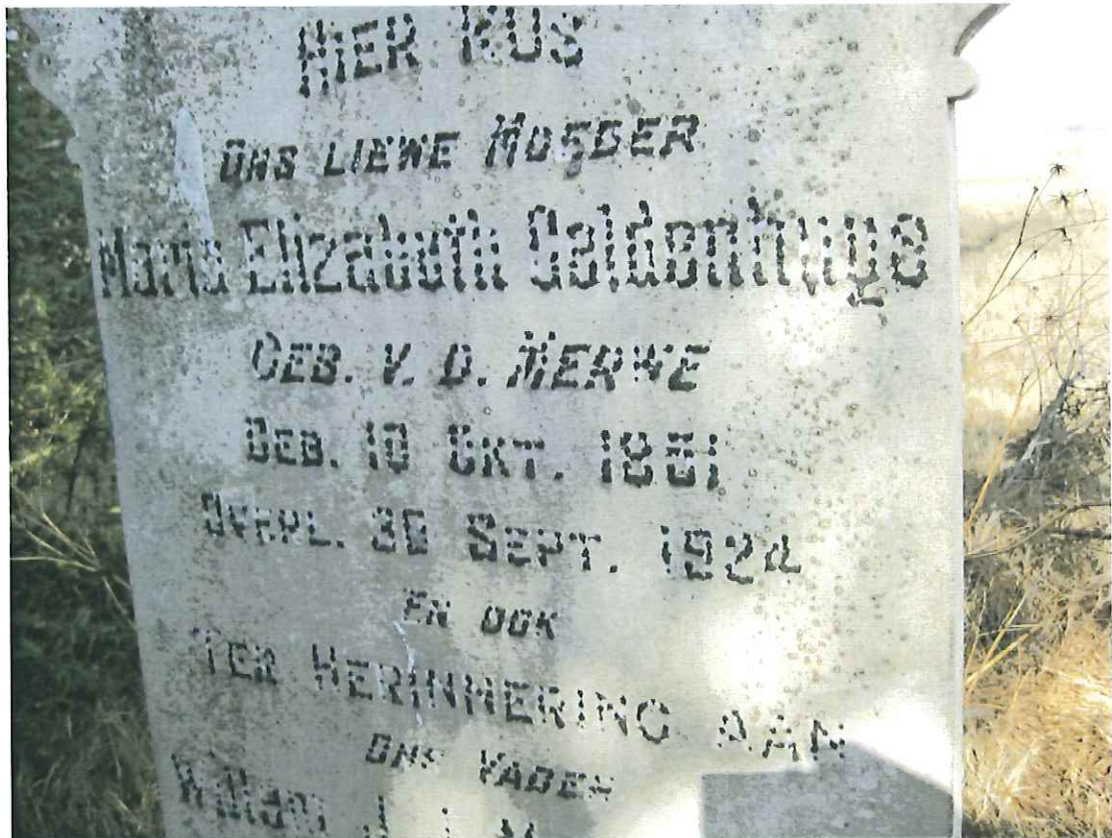
*Figure 1. Typical gravestone in Graveyard 1. Also buried here are Lombard people.*

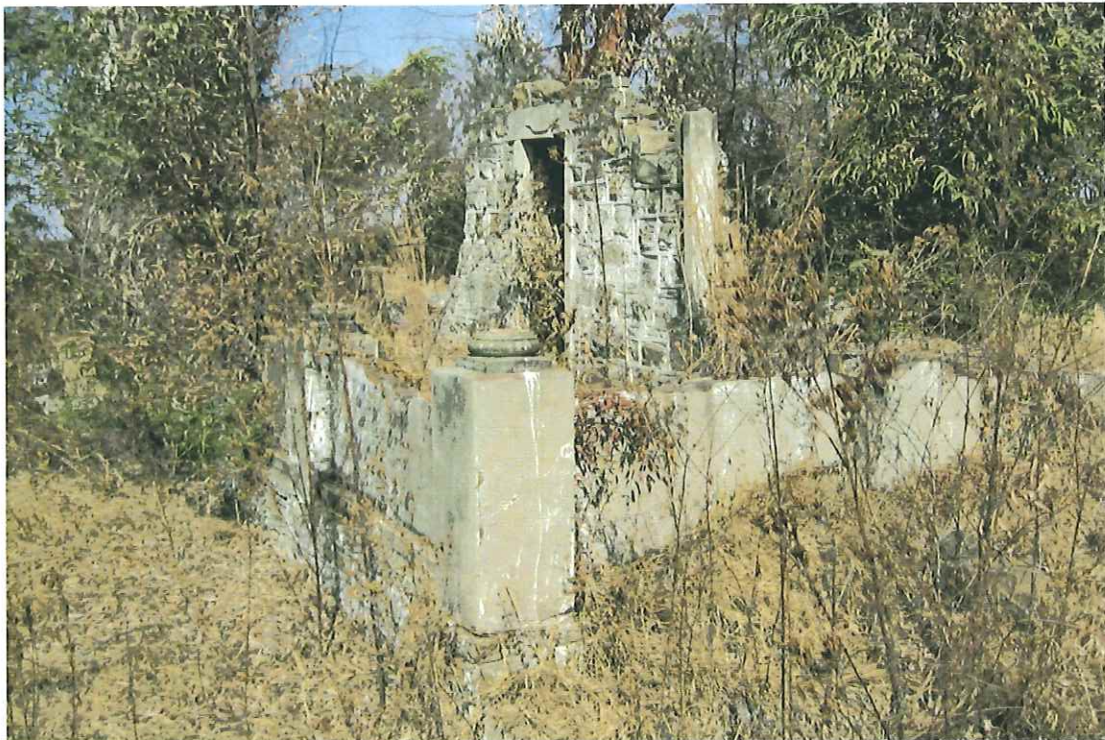
*Figure 2. Remains of a farmhouse near graveyard 2. There are rumours of another graveyard located to the west of this house but owing to vegetation the site could not be found.*

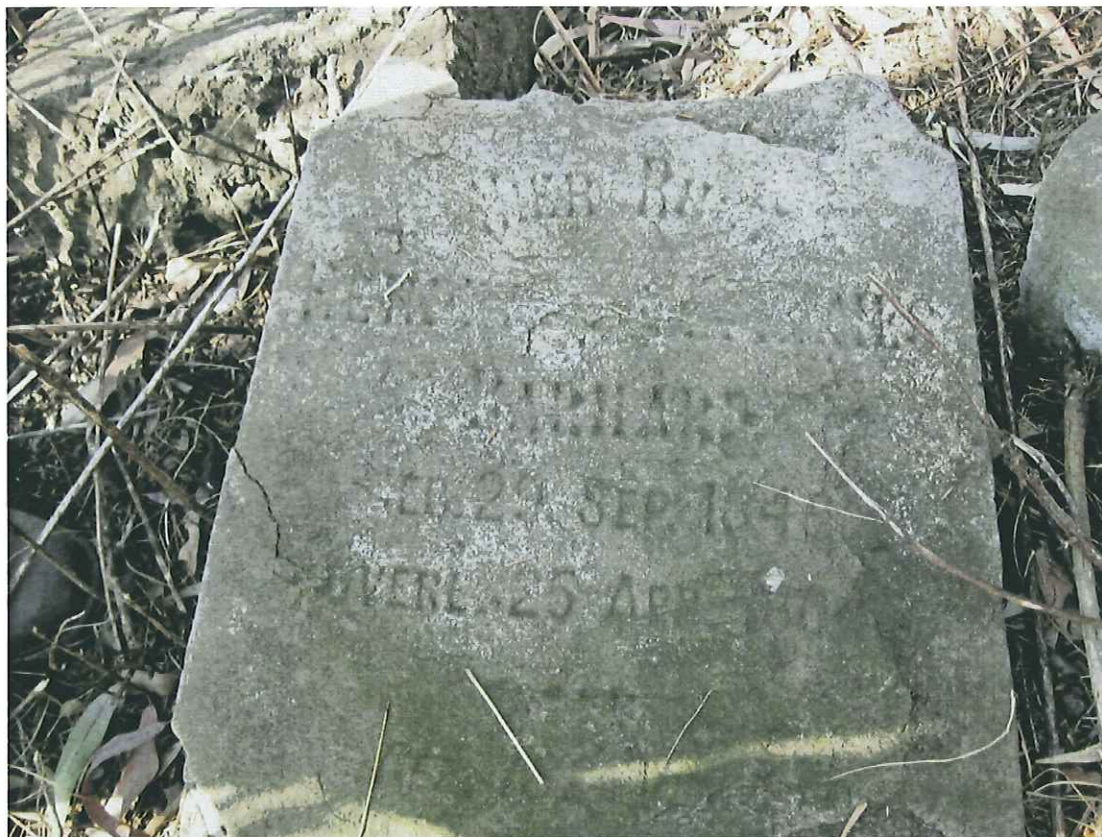
*Figure 3. Typical gravestone in graveyard 2. This burial ground was seriously damaged and it also appears as if a grave, or graves may have been desecrated.*

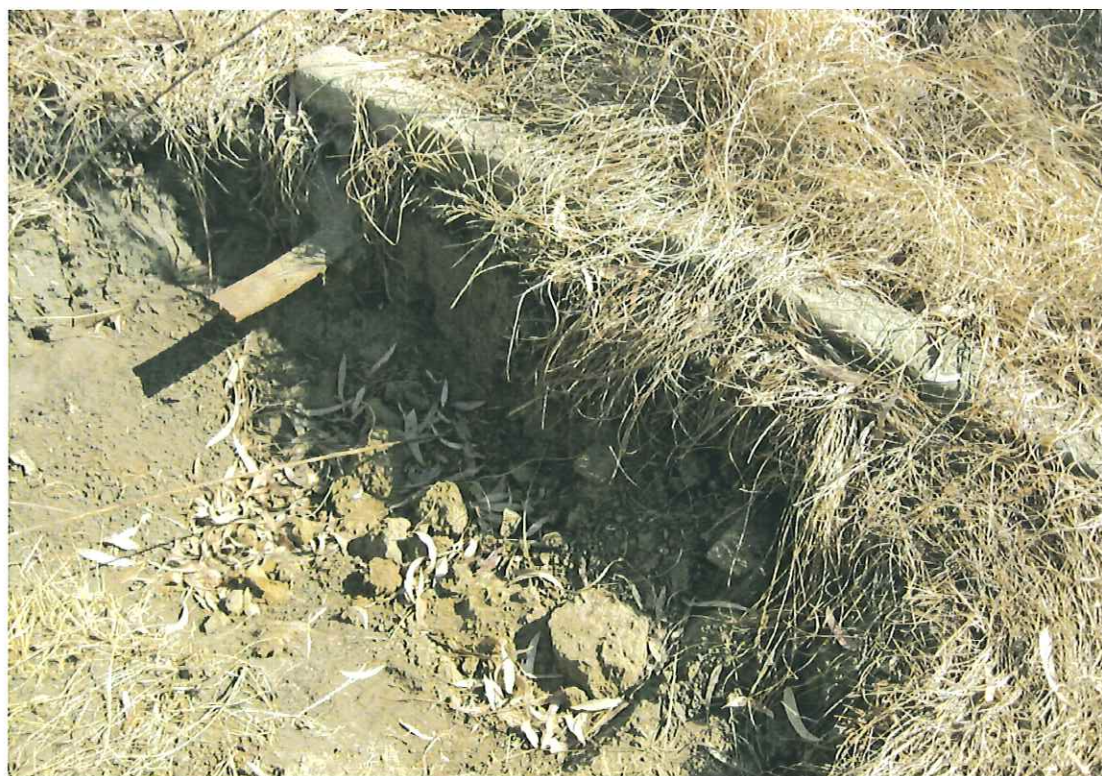
*Figure 4. New excavations in graveyard 2, which is presumably the work of grave robbers.*

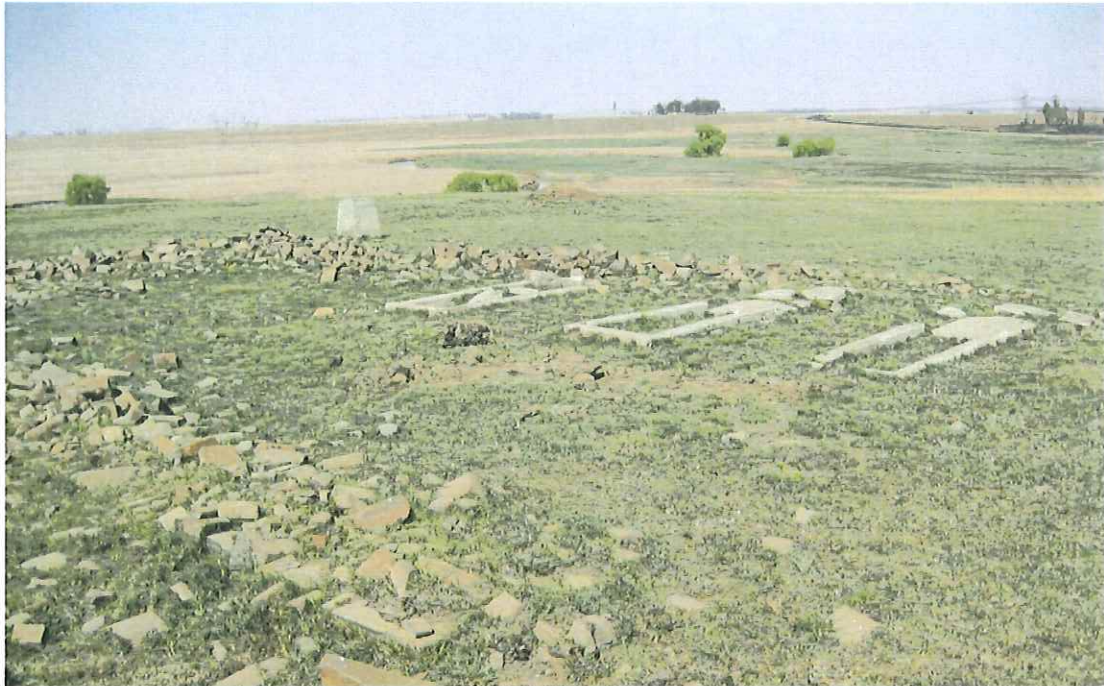
*Figure 5. Graveyard 3 was previously walled but the stone was ‘recycled.’*

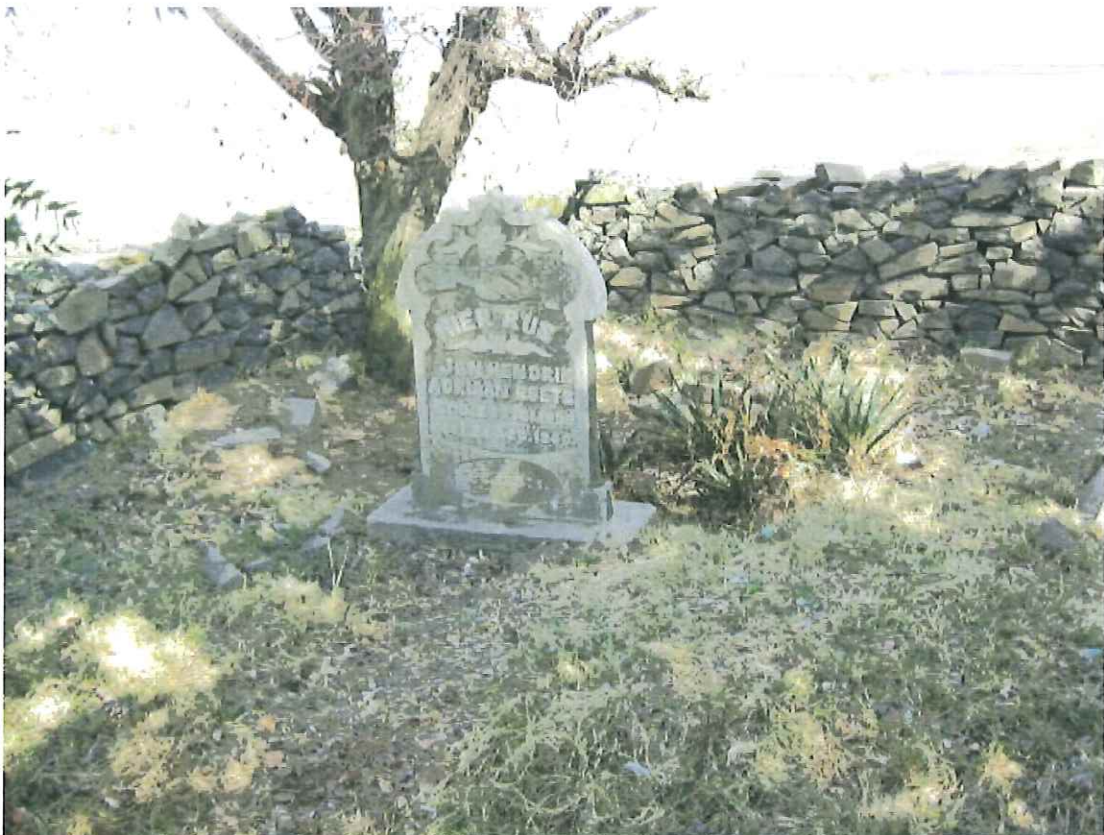
*Figure 6. The Roets family cemetery, graveyard 4. This is the only headstone that survived extensive ‘grave robbing’.*

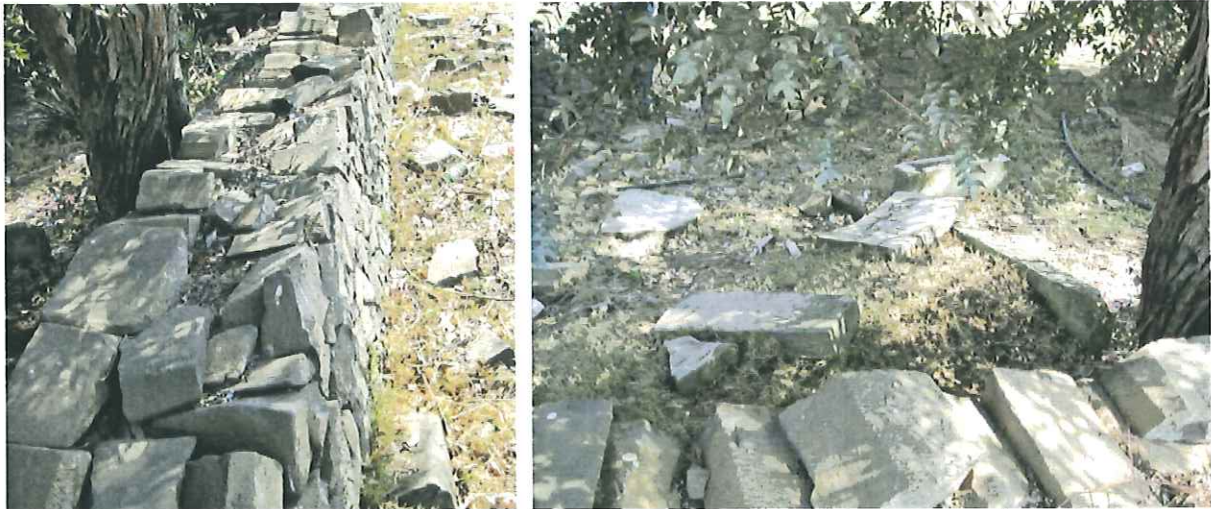
*Figure 7. The Roets family cemetery. Note the masonry in the wall and the desecrated graves.*

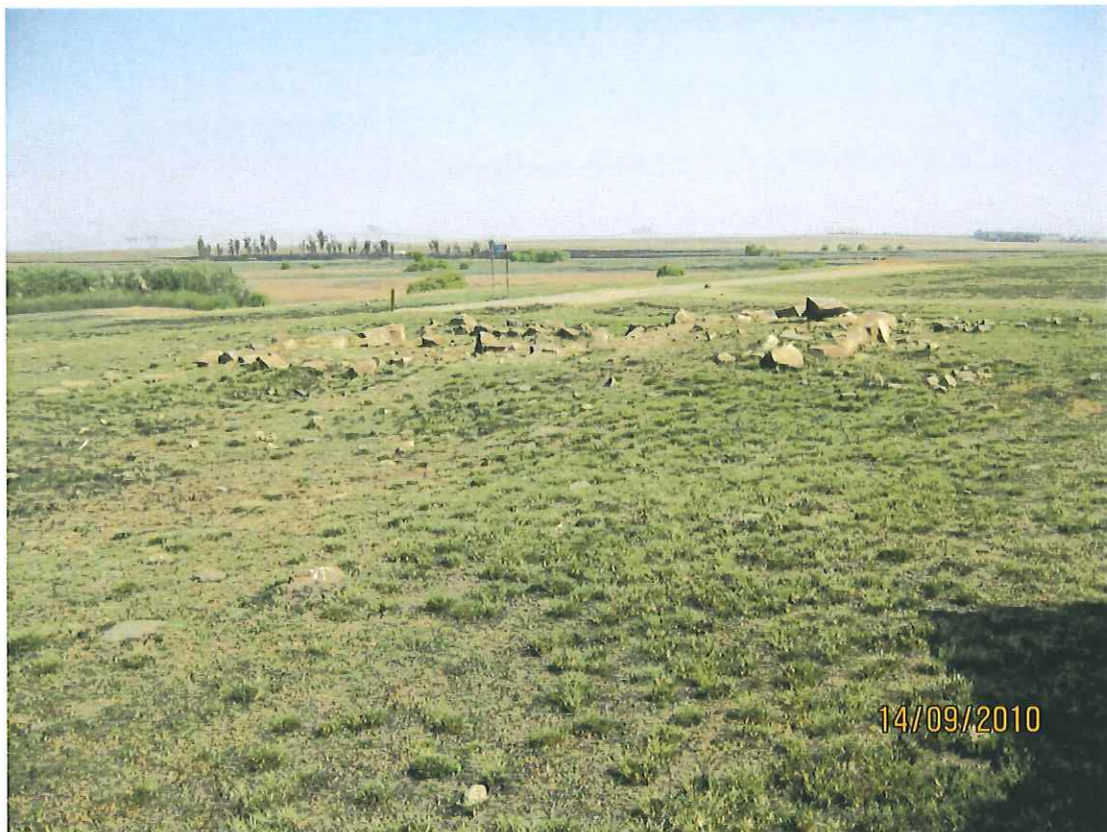
*Figure 8. Remains of farmyard structures near graveyard 4, presumably that of a byre.*

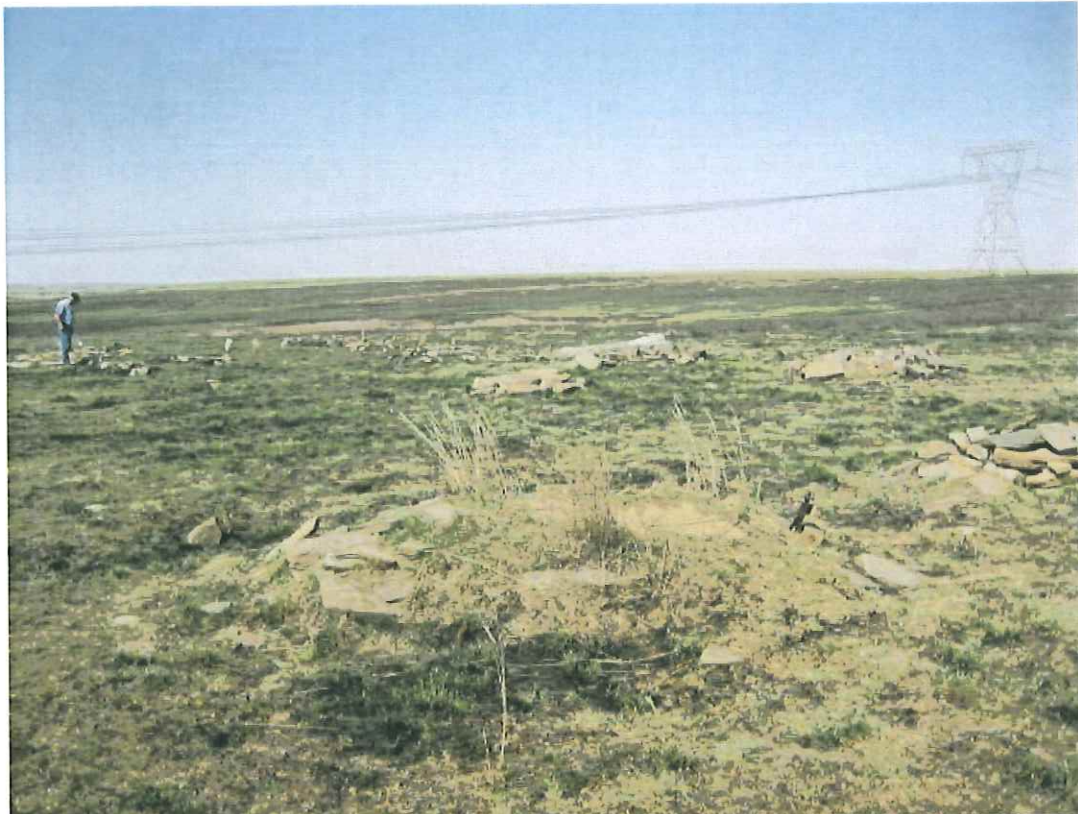
*Figure 9. These graves are collectively known as graveyard 5 in this report. It is difficult to estimate the number, as some appears to be disturbed.*

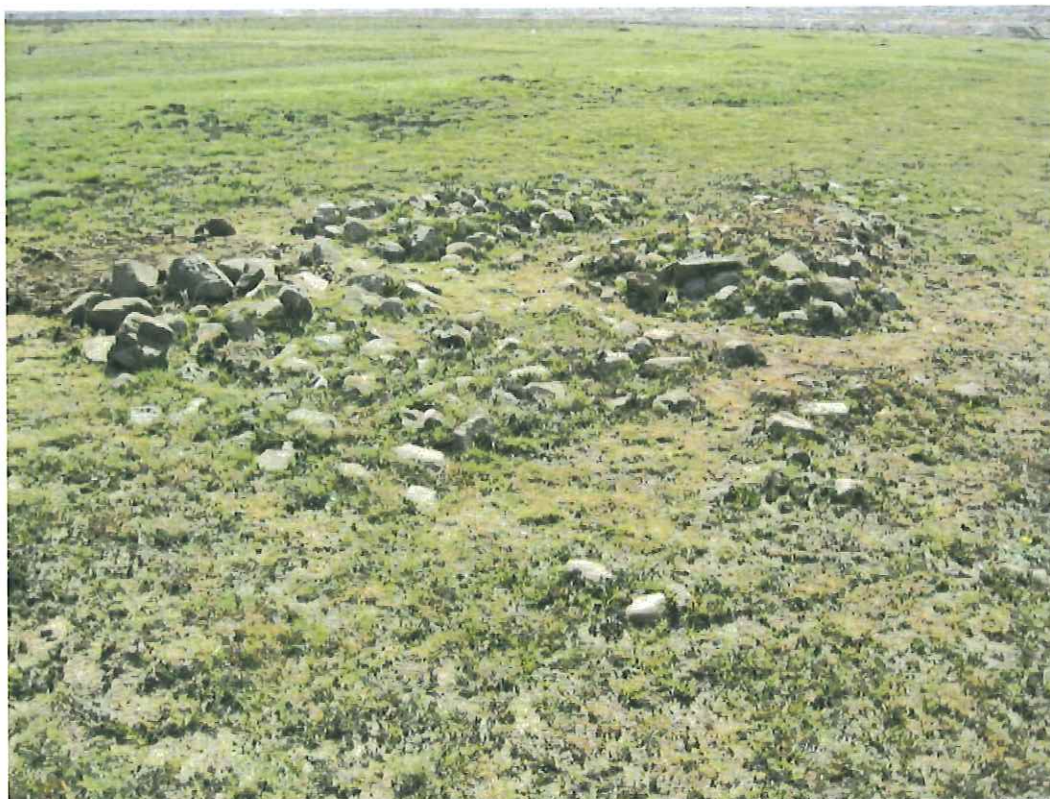
*Figure 10. These graves are collectively known as graveyard 6 in this report. It is difficult to estimate the number, as some appears to be disturbed. Note figure 10*

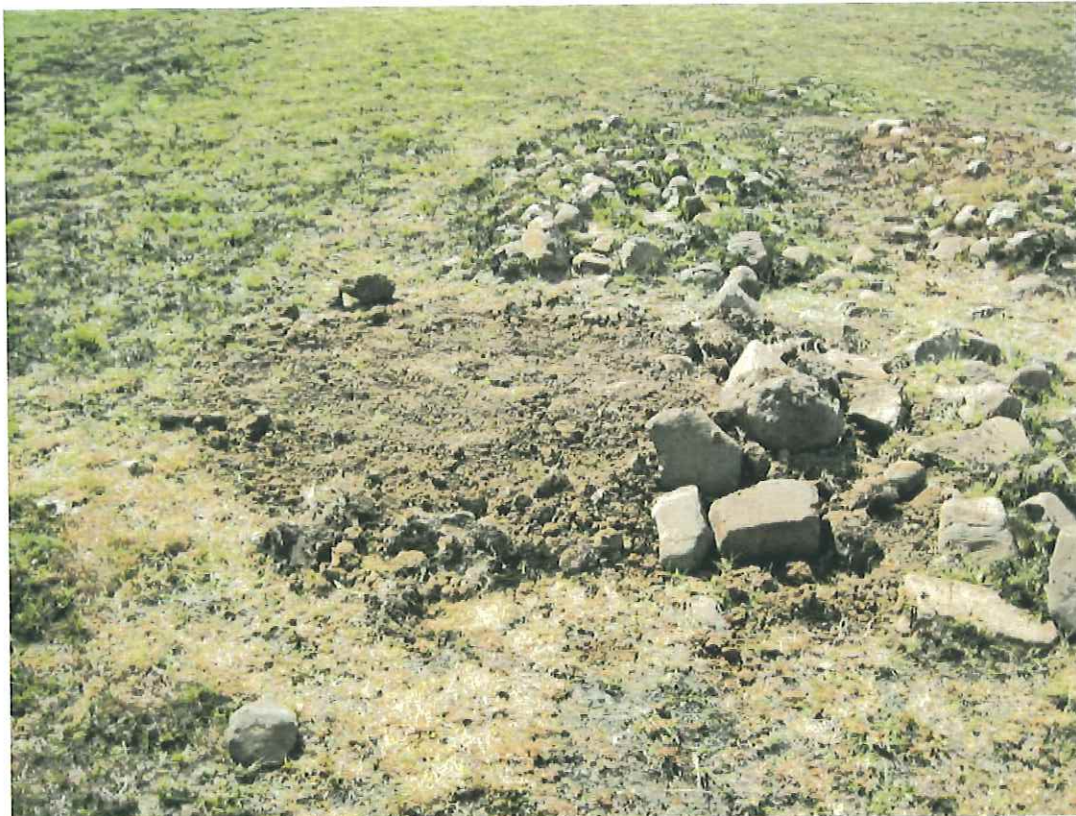
***Figure 11. This grave has clearly been opened, the remains removed, and then again been filled in shortly before the site visit. This is a disturbing practice as we know that trading in human parts is highly illegal.***

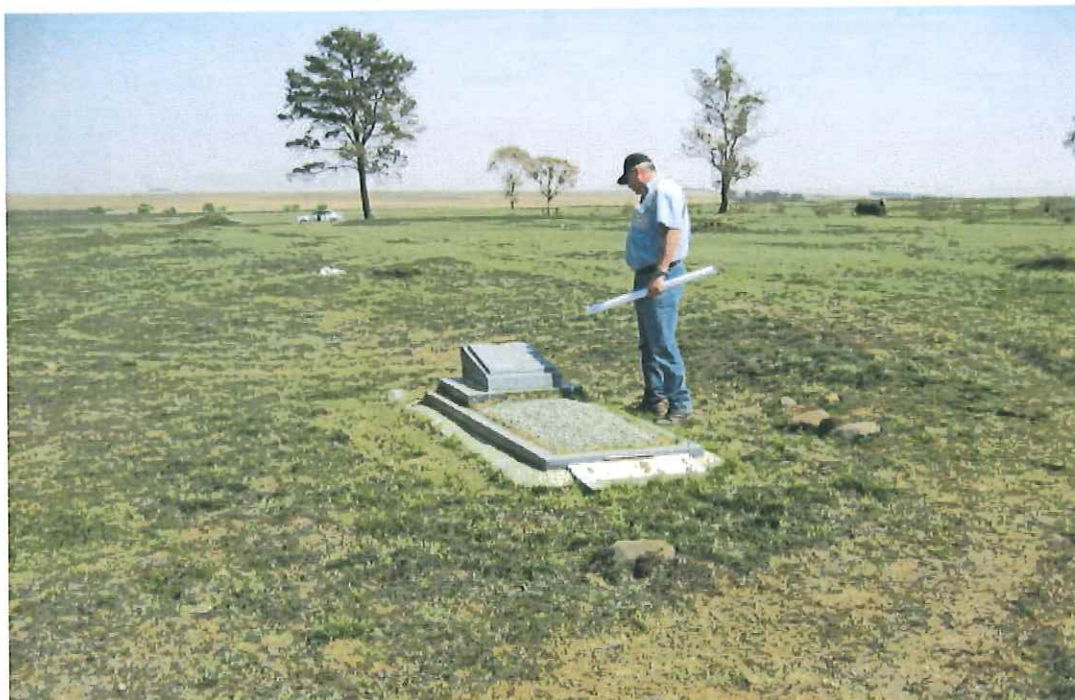
***Figure 12. The placement of 'new' grave markers in 'old' cemeteries is often associated with illegal land claims. Several of these were noticed during the survey. In the background there can also be seen the remains of an old farmyard.***

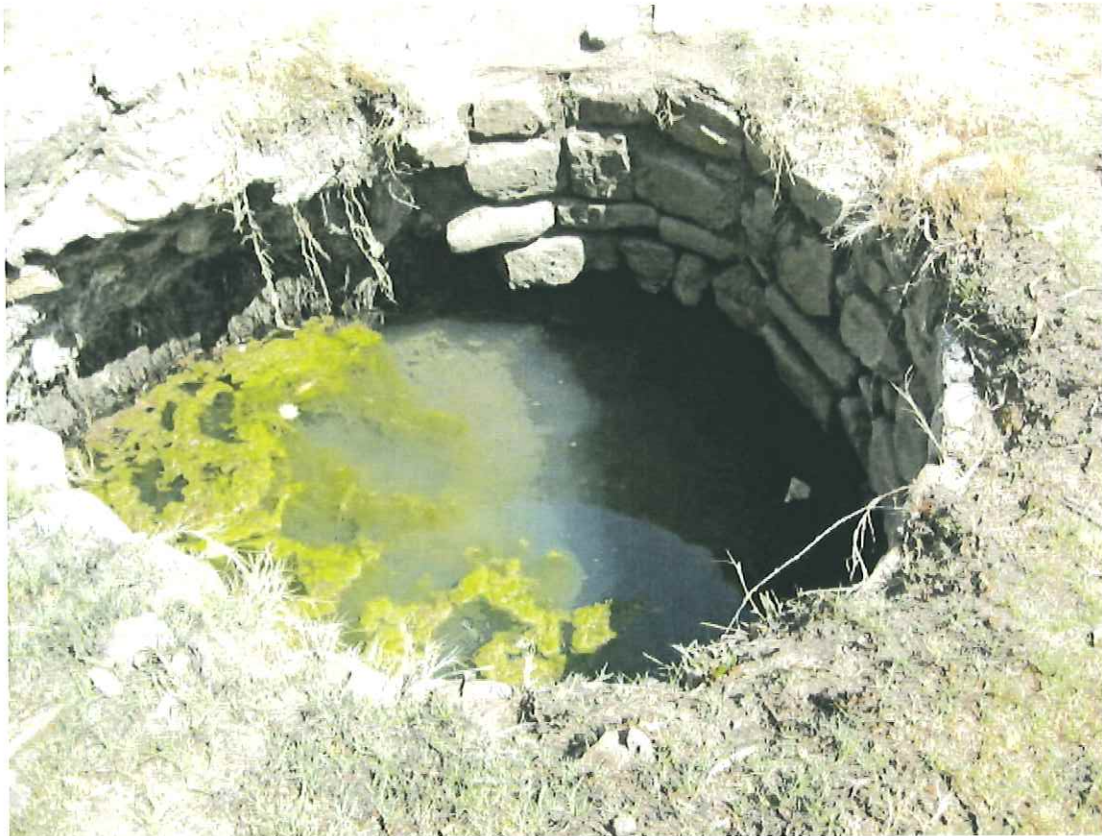
*Figure 13. A well associated with the remains of an old farmyard. This well is still in use for the illegal recovery of gold.*

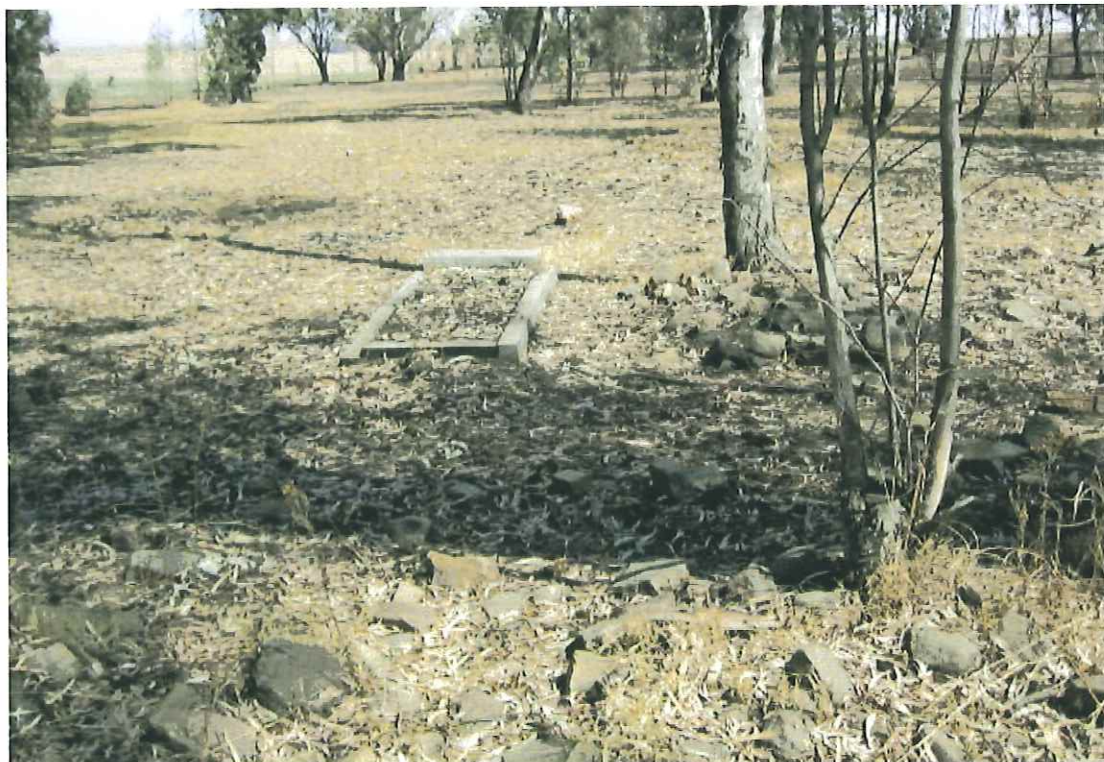
*Figure 14. Graveyard 7 contains approximately 15 graves and is possibly associated with the farmyard containing the well.*

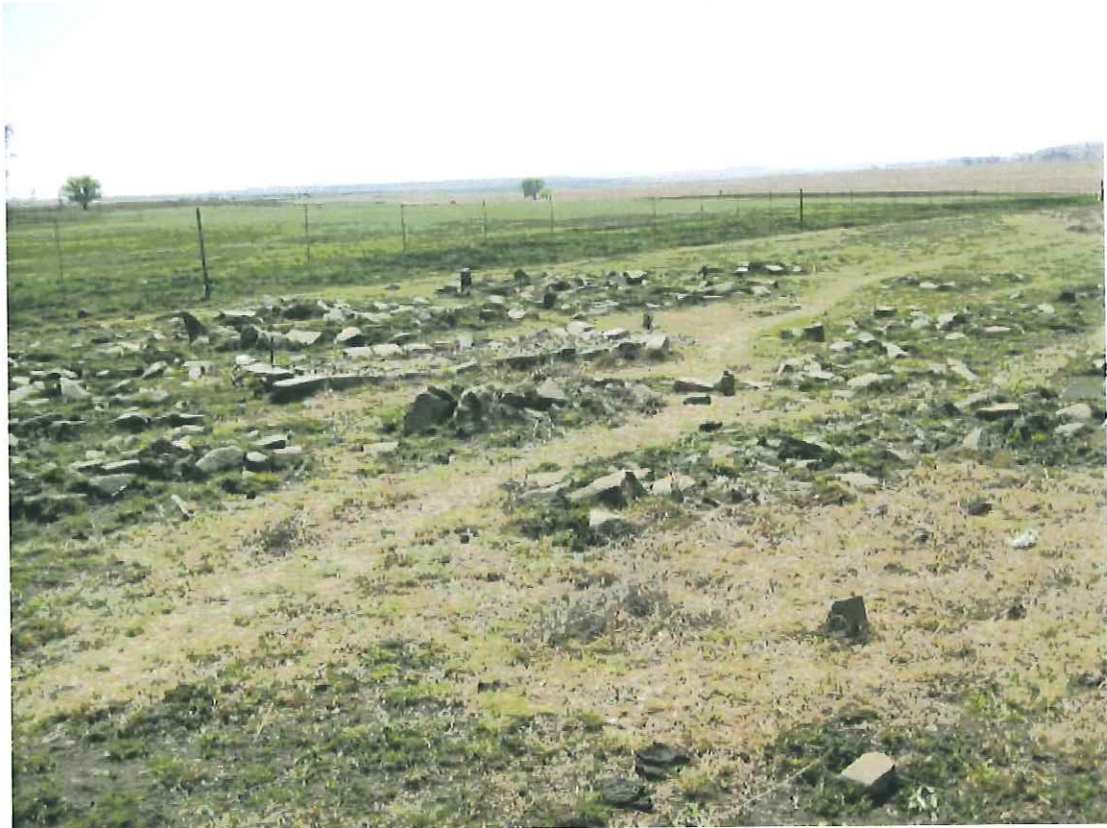
*Figure 15. Graveyard 8 contains a number of strangely elongated graves. The graves appear to be associated with an existing farmyard, but the farmyard does not fall into the study area. (To the left of the fence in the photograph.)*

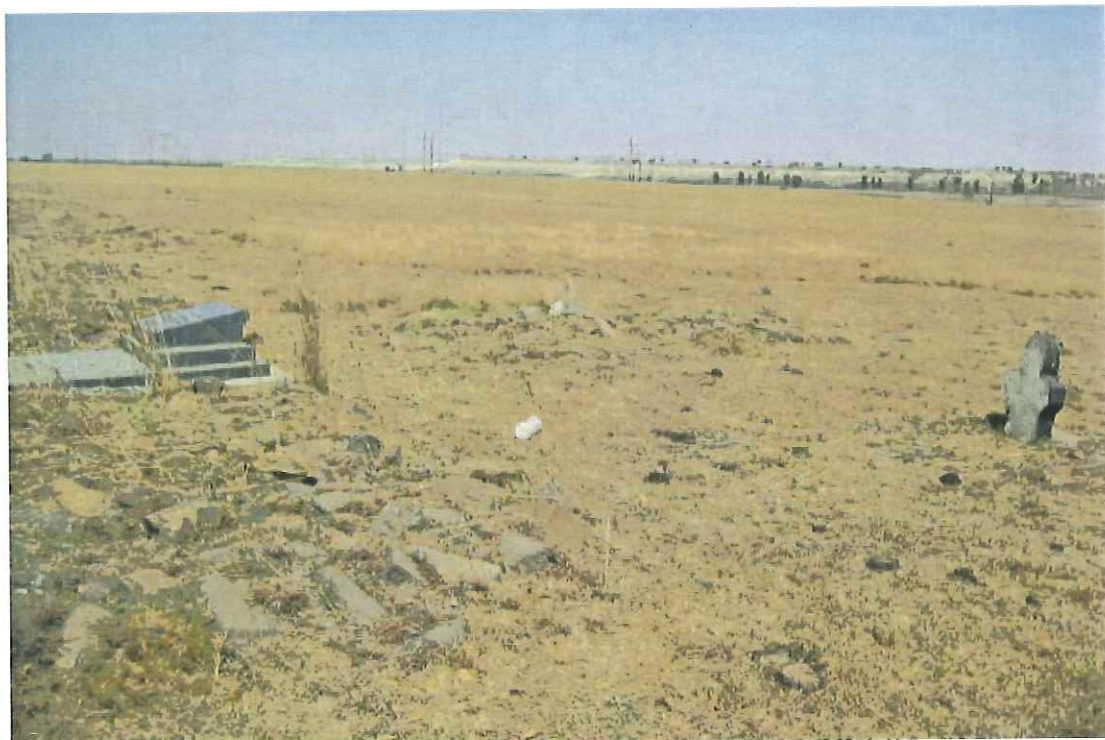
*Figure 16. Graveyard 9 is associated with the remains of an extensive township that was possibly evacuated with the advent of the mine in 1958.*

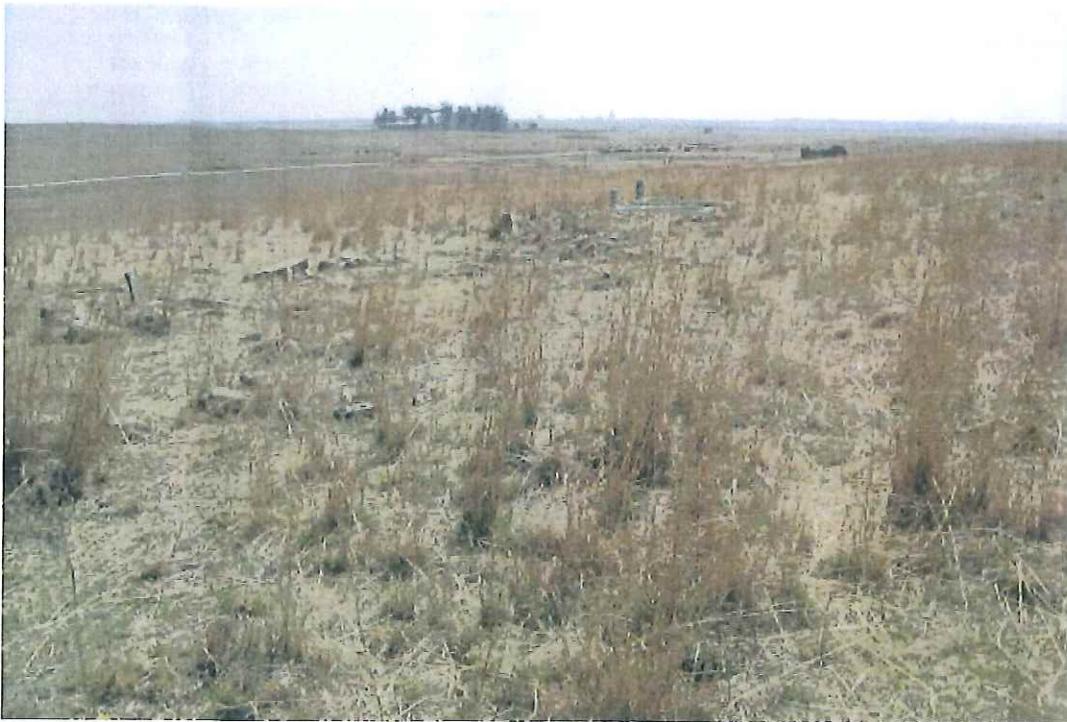
*Figure 17. Graveyard 10 is also associated with the remains of an extensive township that was possibly evacuated with the advent of the mine in 1958.*

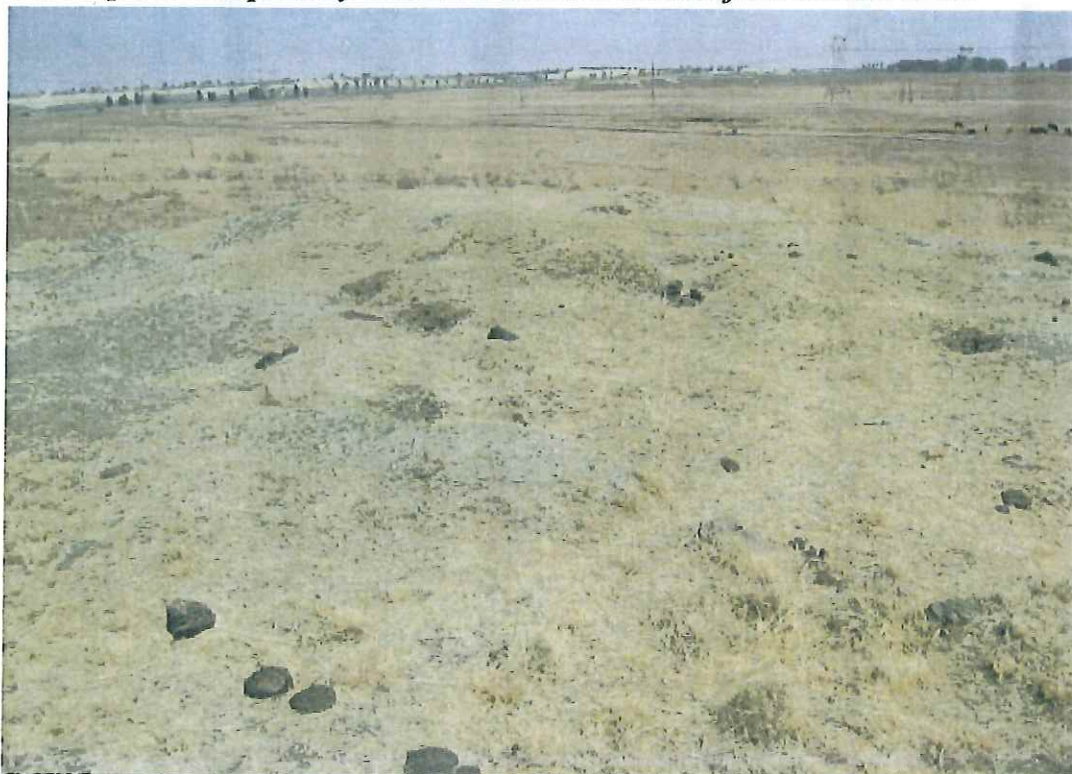
*Figure 18. Several extensive middens are all that remain of a small village. The archaeological investigation of this site may be an interesting exercise to undertake as an 'experimental' process.*

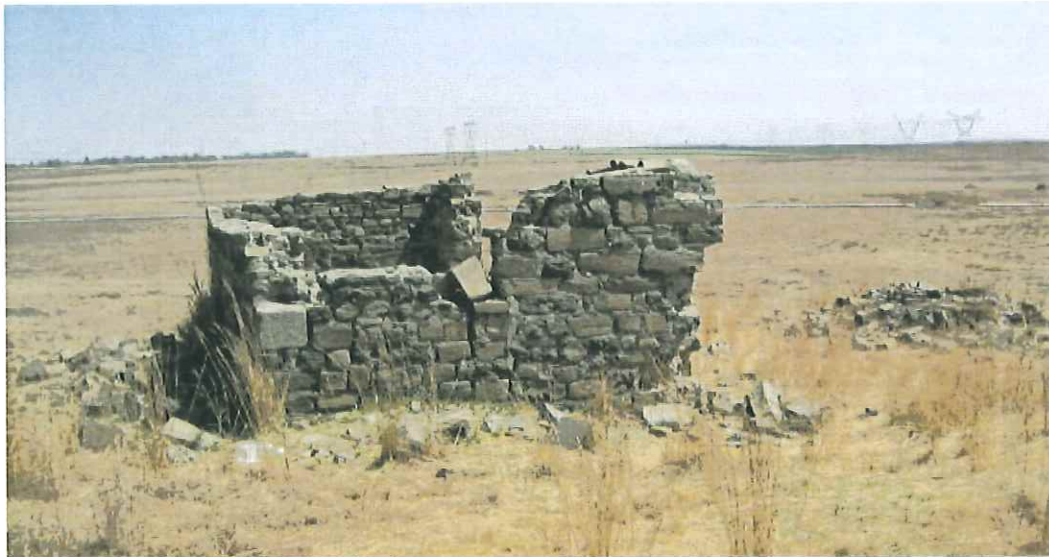
*Figure 19. Local communities use this building (of unknown origin) as an initiation centre. The fact that an amicable relationship exist between mine management and the local community can only be recommended.*

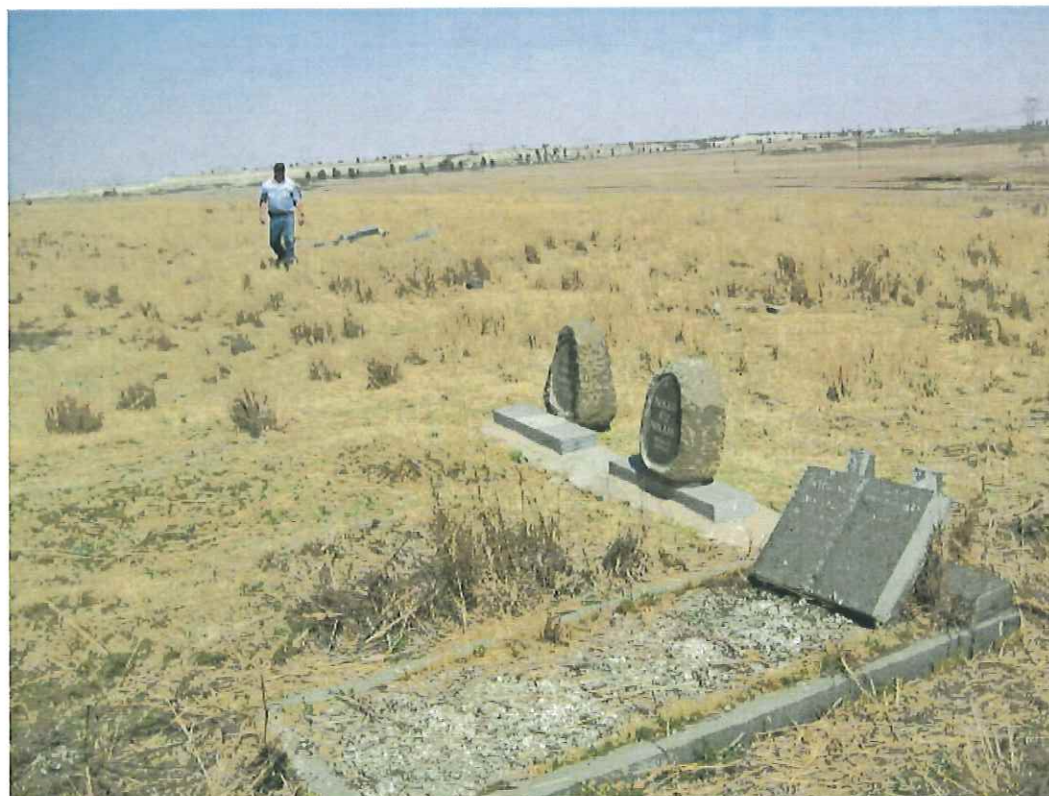
*Figure 20. Apparently graveyard 10 is still in use, albeit not approved by mine management. The reason for this being that modern amenities exist for formal modern burials.*

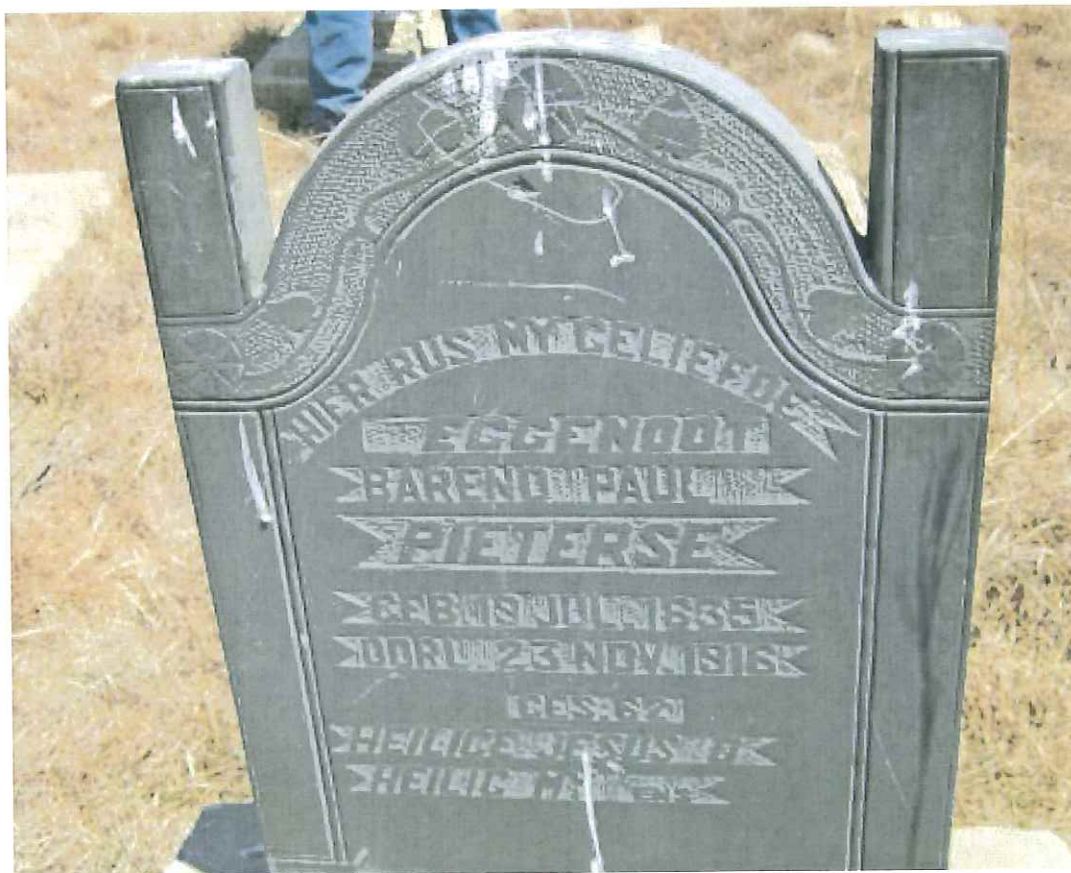
*Figure 21. The Pieterse cemetery (Graveyard 11) contains 9 remarkable graves and headstone. Even here the grave robbers did not shy away.*

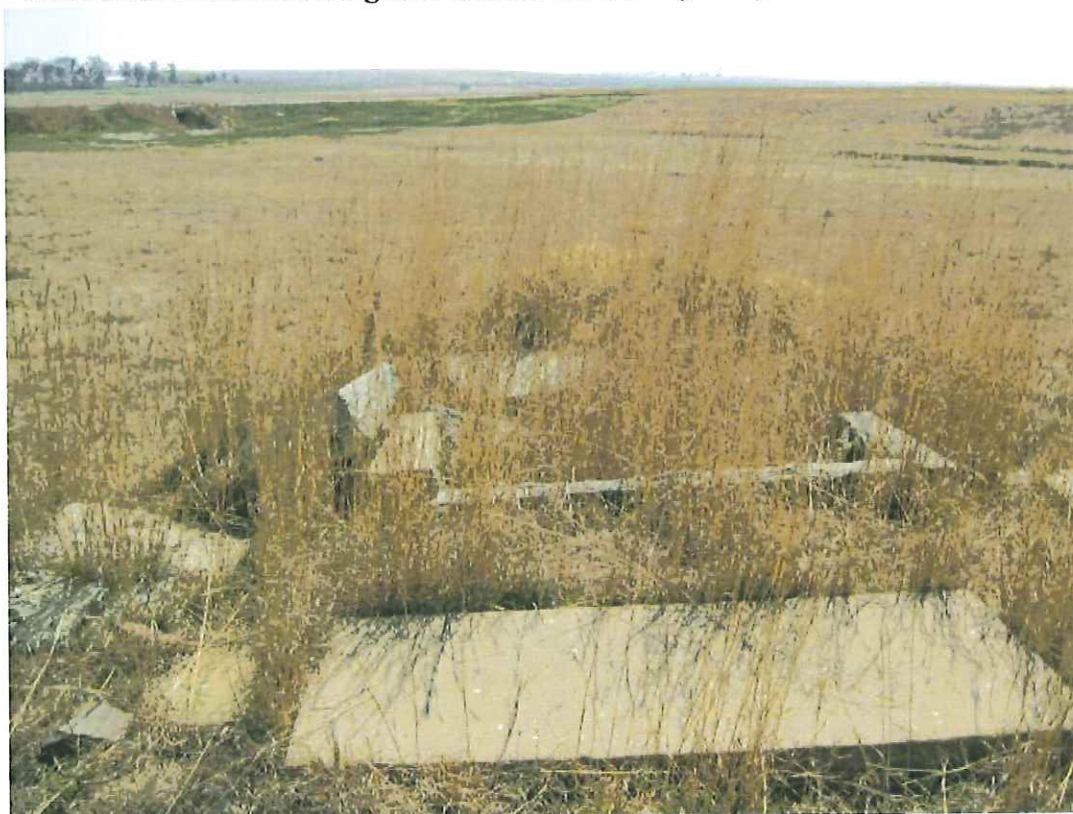
*Figure 22. Two graves were desecrated as can be seen above in graveyard 11.*

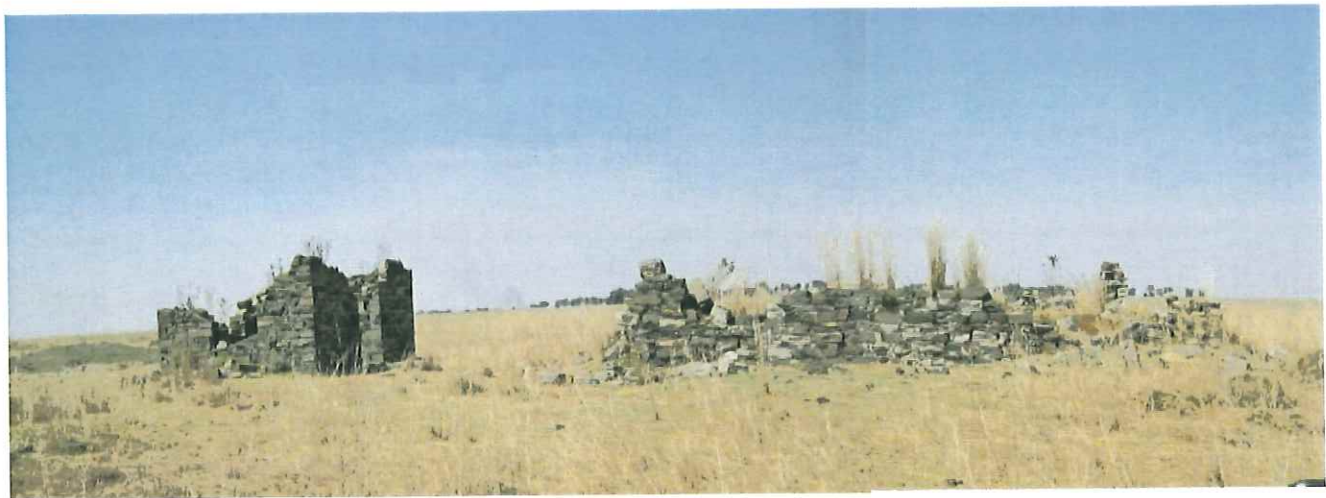
*Figure 23. Remains of the 'Pieterse' farmyard*

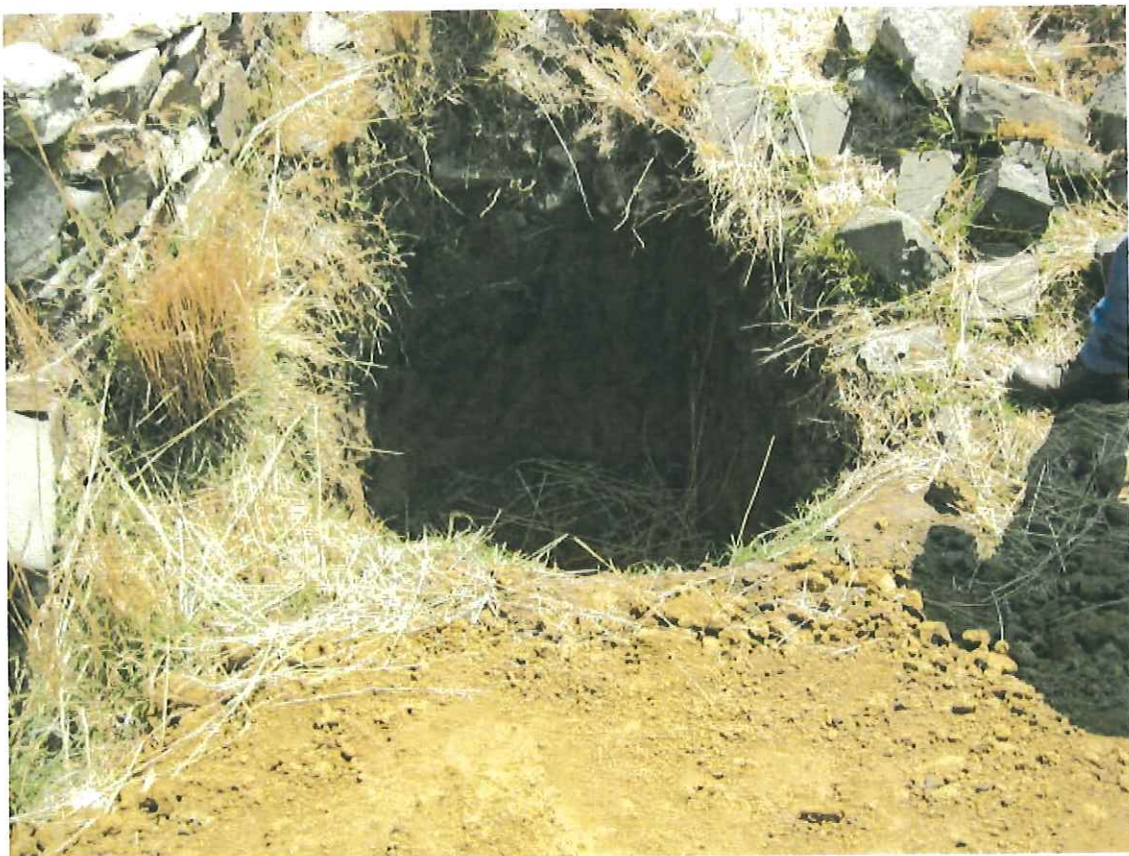
*Figure 24. Large excavation in foundations of 'Pieterse' homestead is typical of 'fortune hunters'.*

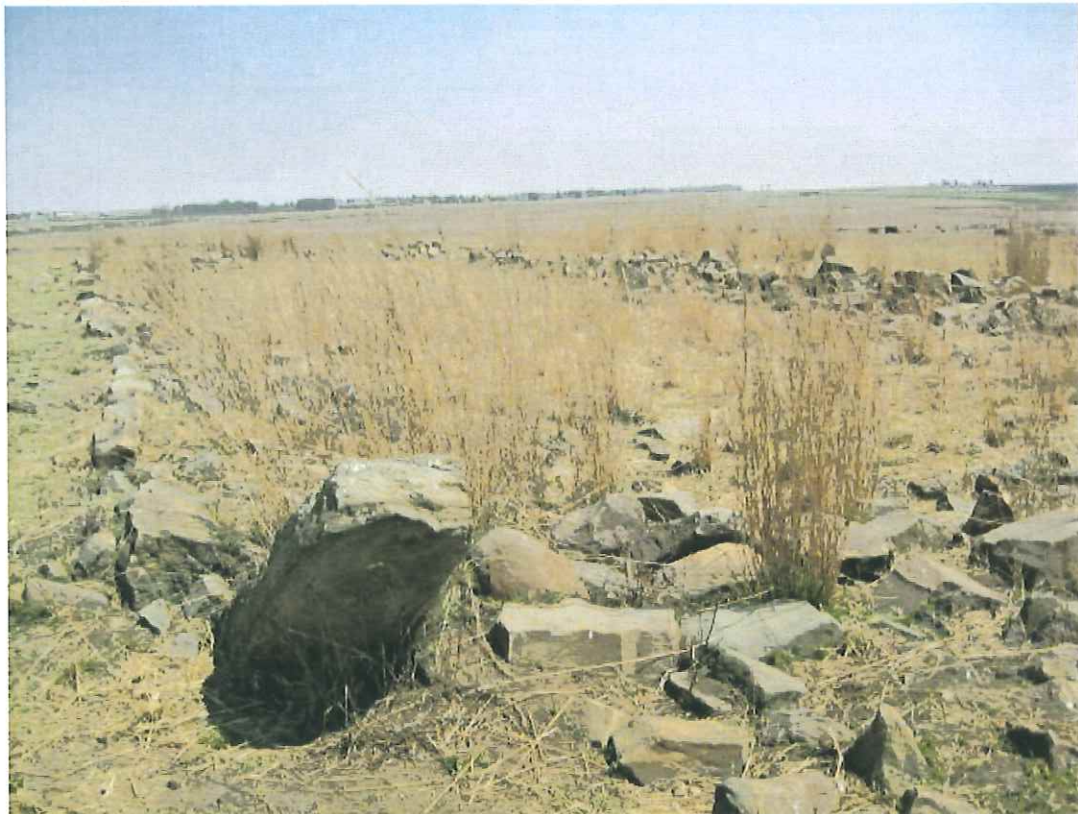
*Figure 25. Remains of byre on 'Pieterse' farmyard.*

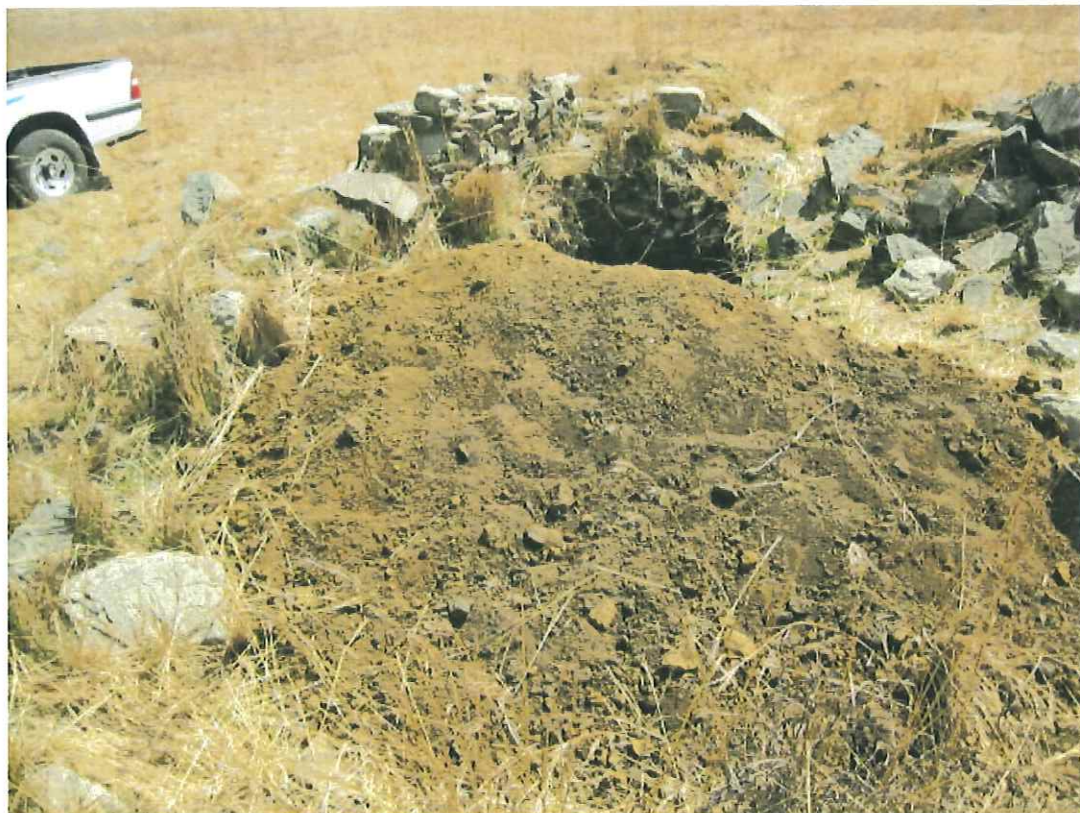
*Figure 26. The extent of the excavation in the 'Pieterse' farmhouse.*
