**1st Phase**

**CULTURAL HERITAGE RESOURCES IMPACT  
ASSESSMENT FOR HARMONY GOLD MINE,  
EVANDER.**

**September 2010**

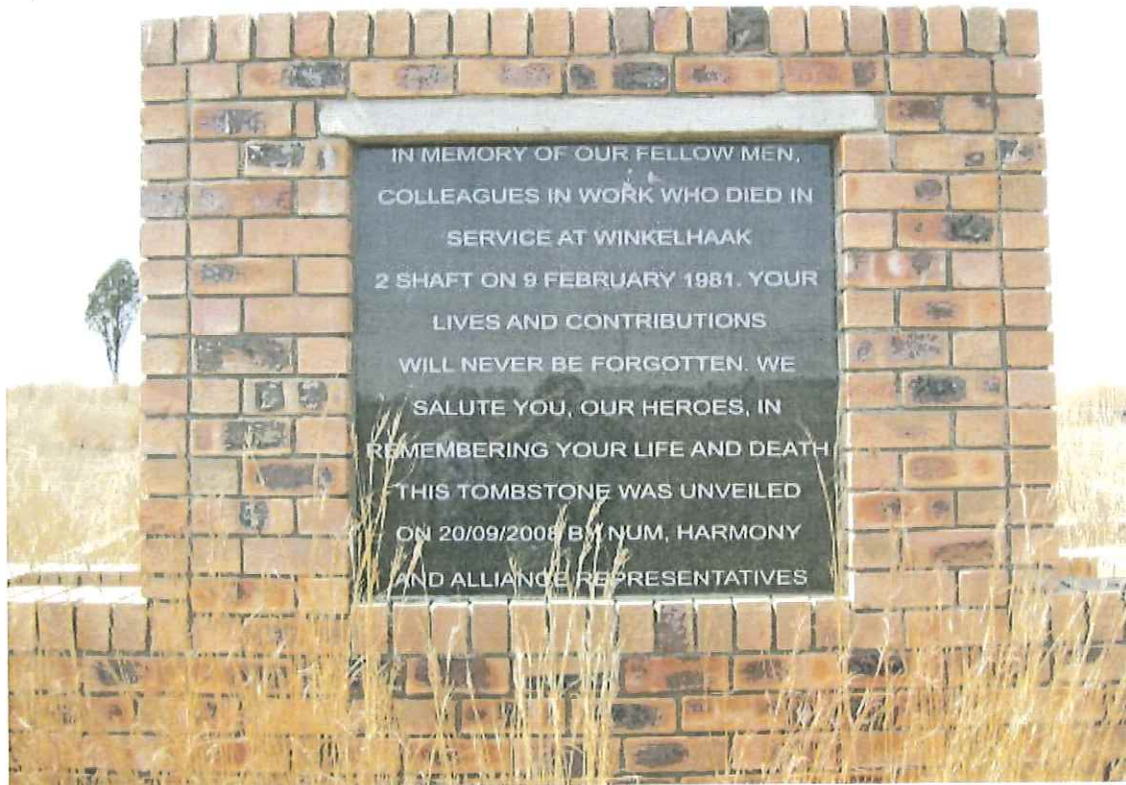
*Figure 27. Memorial plaque for the 1981 disaster at no 2 shaft in the extensive 'official' cemetery that contains several hundreds of graves.*

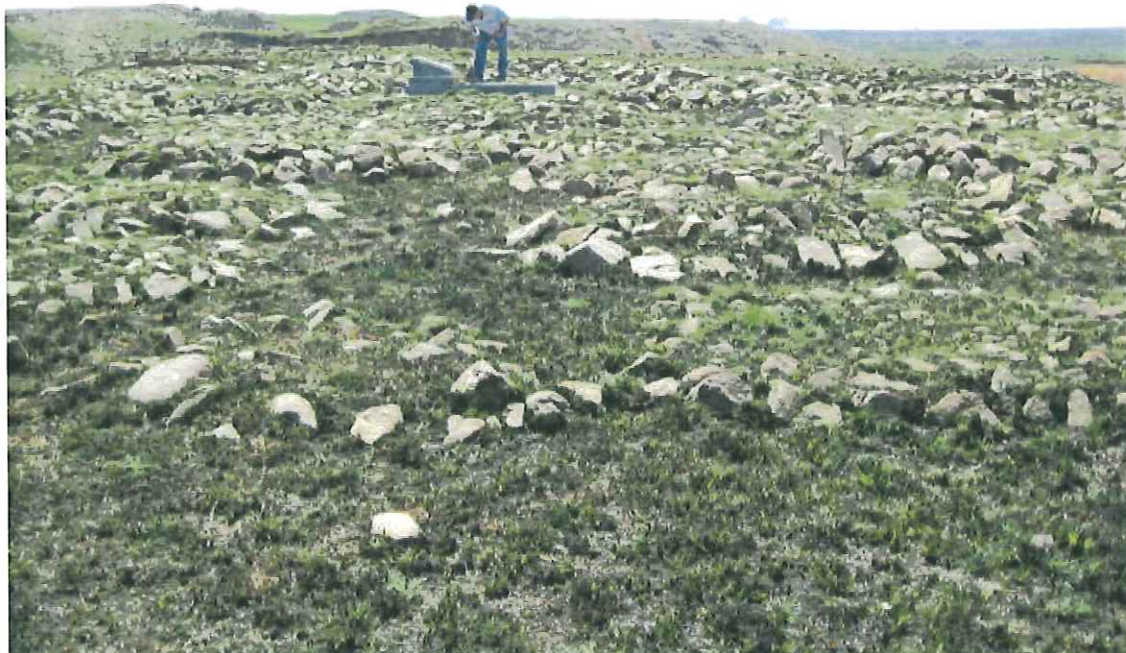
*Figure 28. Graveyard 13 is located on the edge of a large quarry. The way in which the grave stones are placed is indicative of a cultural preference. See next photograph.*

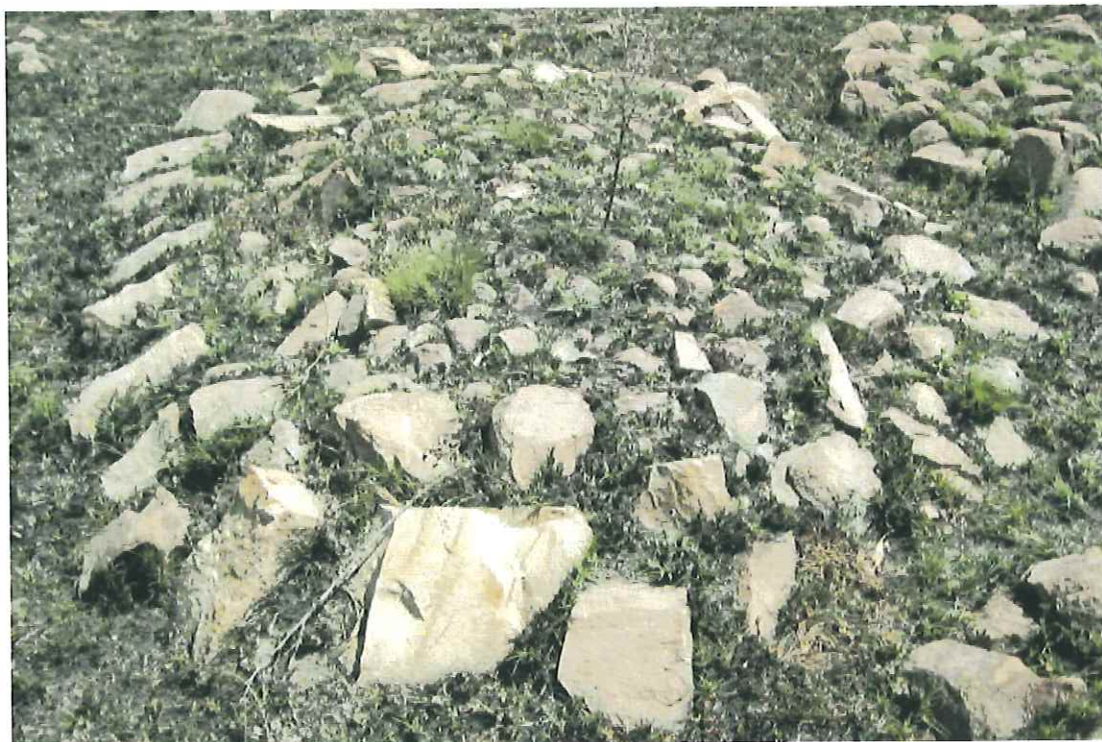
*Figure 29. Typical grave from graveyard 13.*

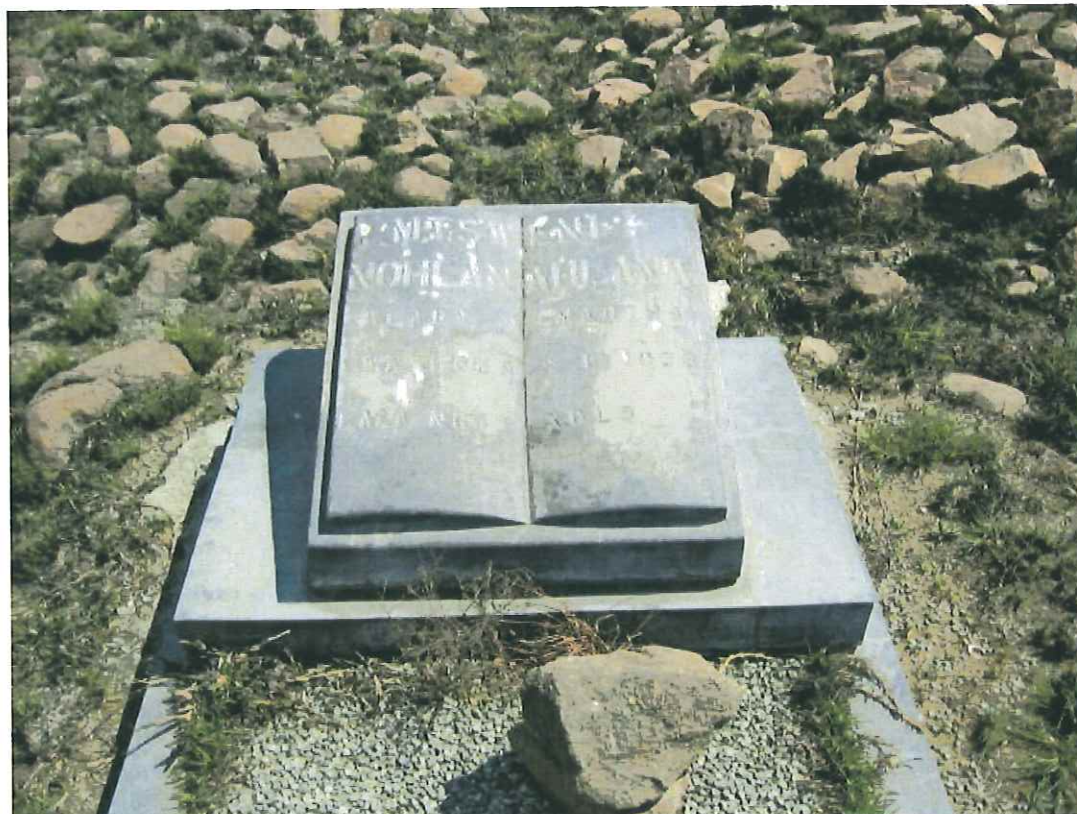
*Figure 30. 'Modern' headstone placed in graveyard 13.*

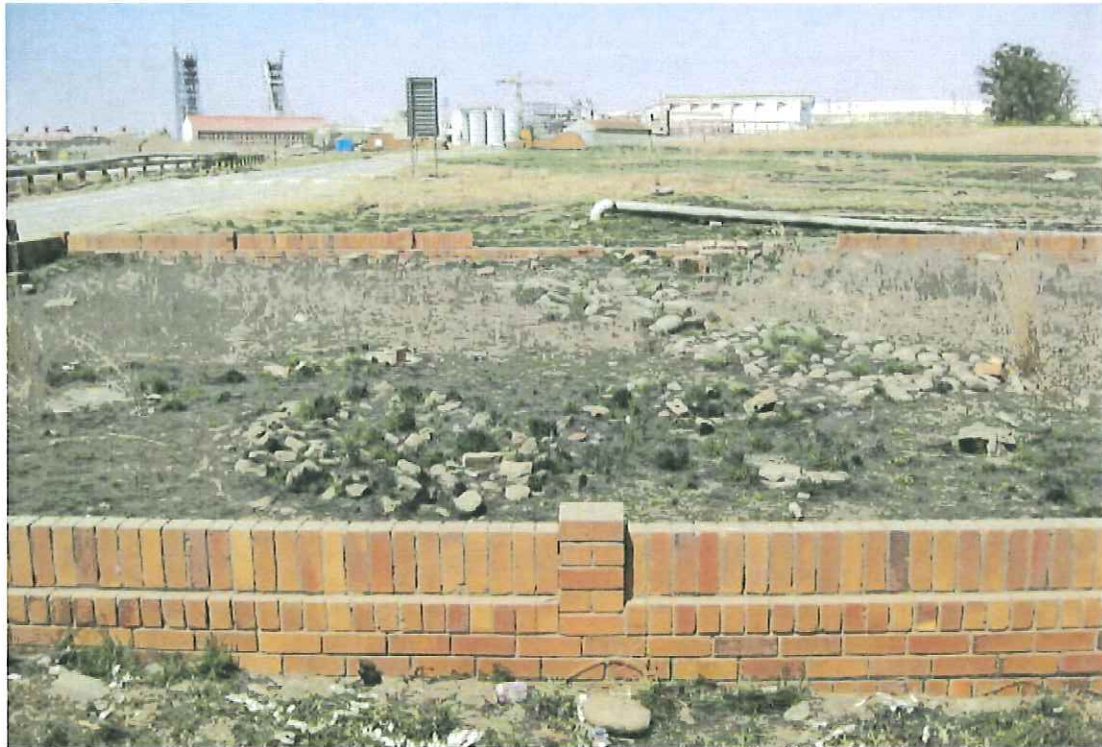
*Figure 31. 'Modern' brick wall surrounding 11 graves in graveyard 14. The ironwork built into the wall was removed by thieves.*

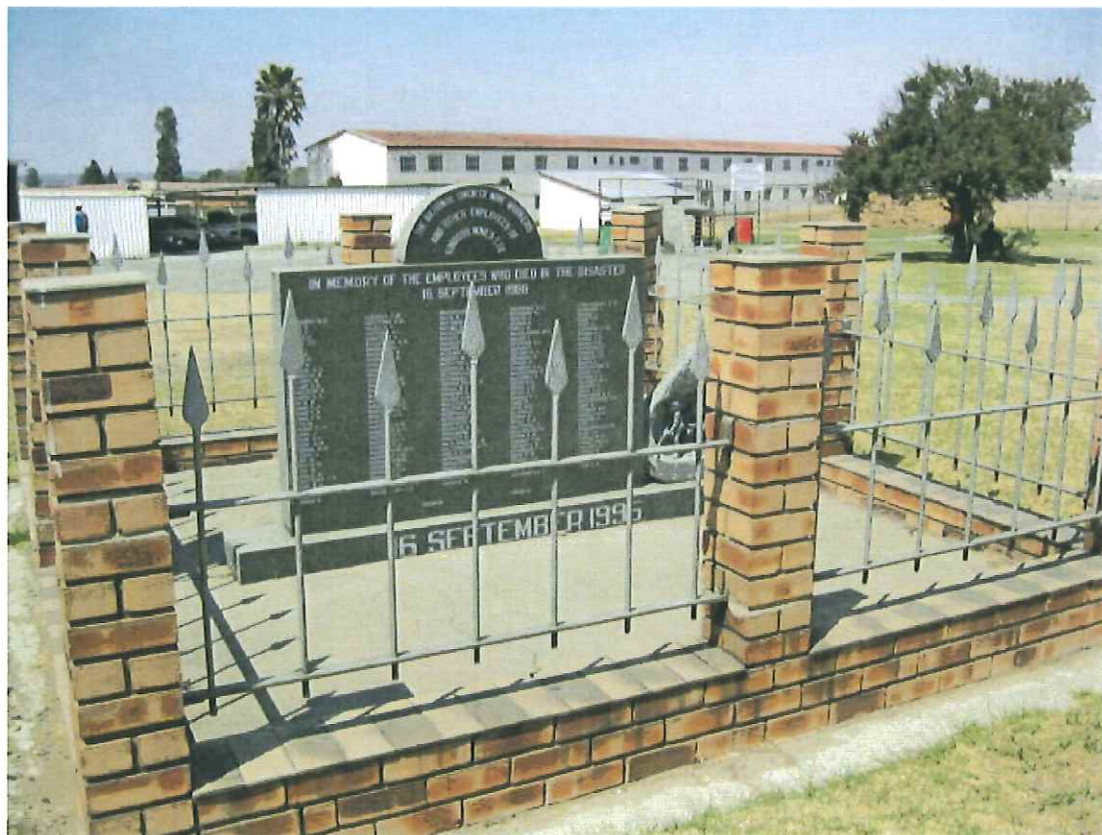
*Figure 32. Memorial plaque at no 8 shaft.*
