**ASSESSMENT OF THE IMMEDIATE SURROUNDINGS OF THE OLD BUILDING AT THE VOORSPOED
DIAMOND MINE AS WELL AS THE WIDER CULTURAL LANDSCAPE**

Version 2.0

14 February 2014

CLIENT: De Beers Consolidated Mines Limited

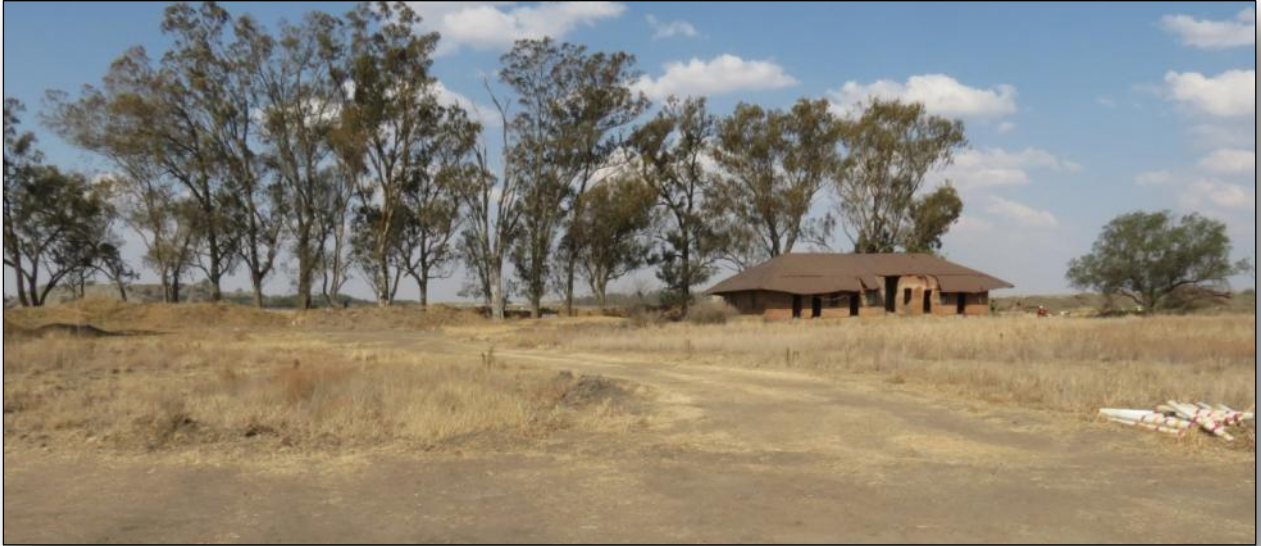
Figure 6 General view of the immediate surroundings of the old building as seen from the north-west.

All heritage features that could be identified within the direct surroundings of the site were recorded on the archaeological site layout plan and were included in the archaeological mitigation of the site. As a result no further mitigation measures would be required.

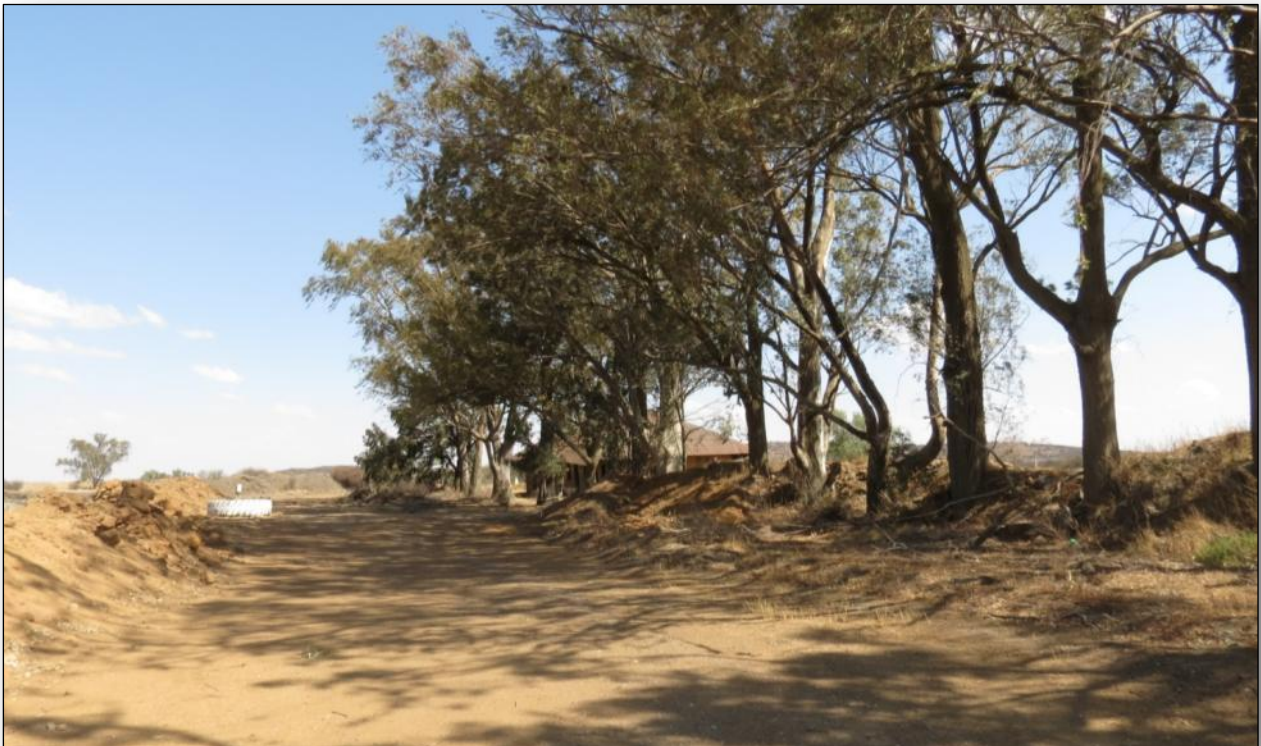
Figure 7 Another general view of the old building as seen from the north.

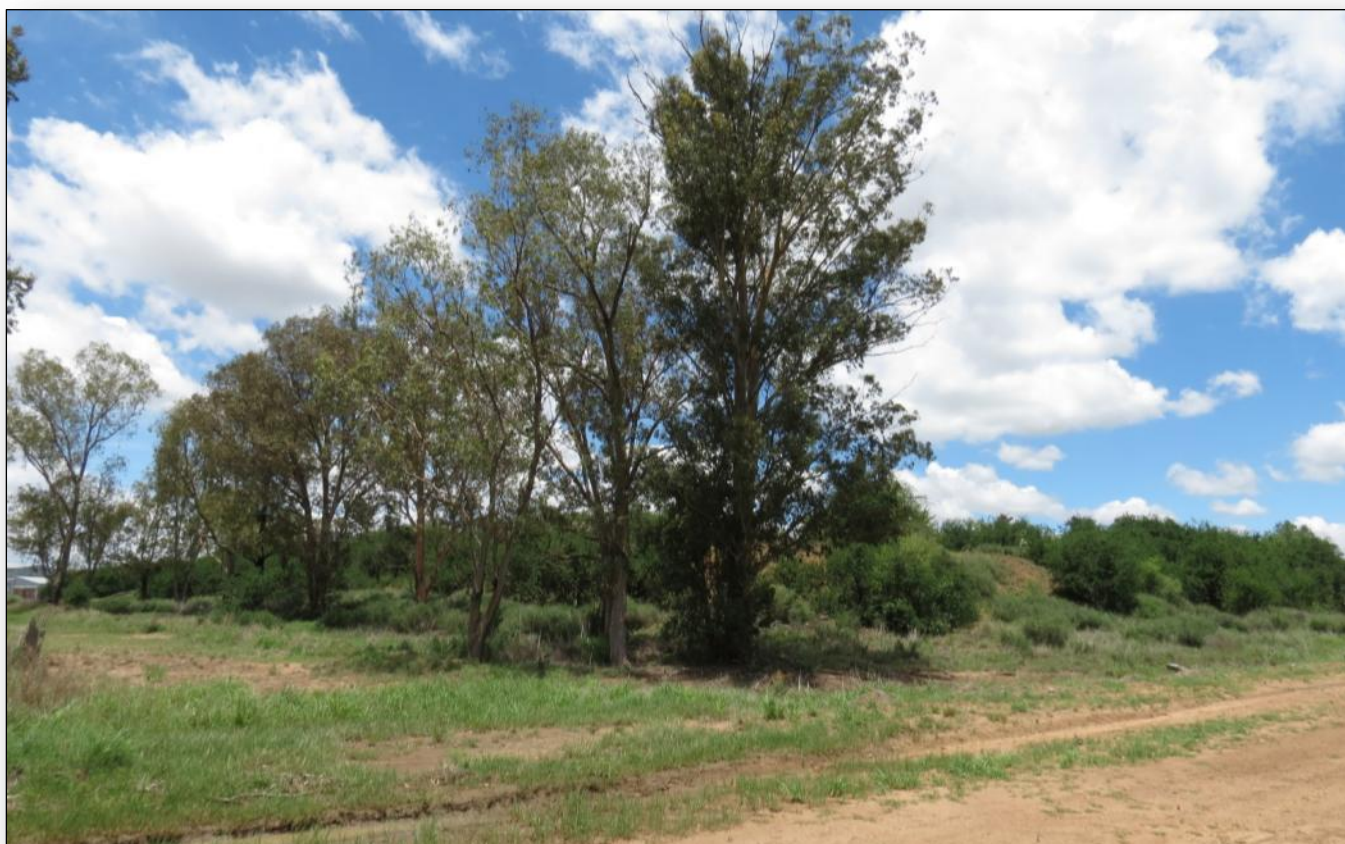
The old water reservoir is located some distance north-west of the old building under discussion. It is located in proximity to existing mine buildings associated with the current mining activities. The site comprises an extensive rectangular structure which would in all likelihood have had a clay core with stones packed along the sides to strengthen the structure. The condition of the structure is still good and its centre is currently used as a scrap metal dumping area.

The site is reasonably unique in that it represents an early engineering work which can be associated with early mining activities. The reservoir also represented a key component in the early establishment of the mine in that the mine would never have been established was it not for the supply of water provided for by this structure. As a result the structure is of Medium to Low Significance.

Figure 14 The north-western corner of the water reservoir can be seen behind the avenue of trees.

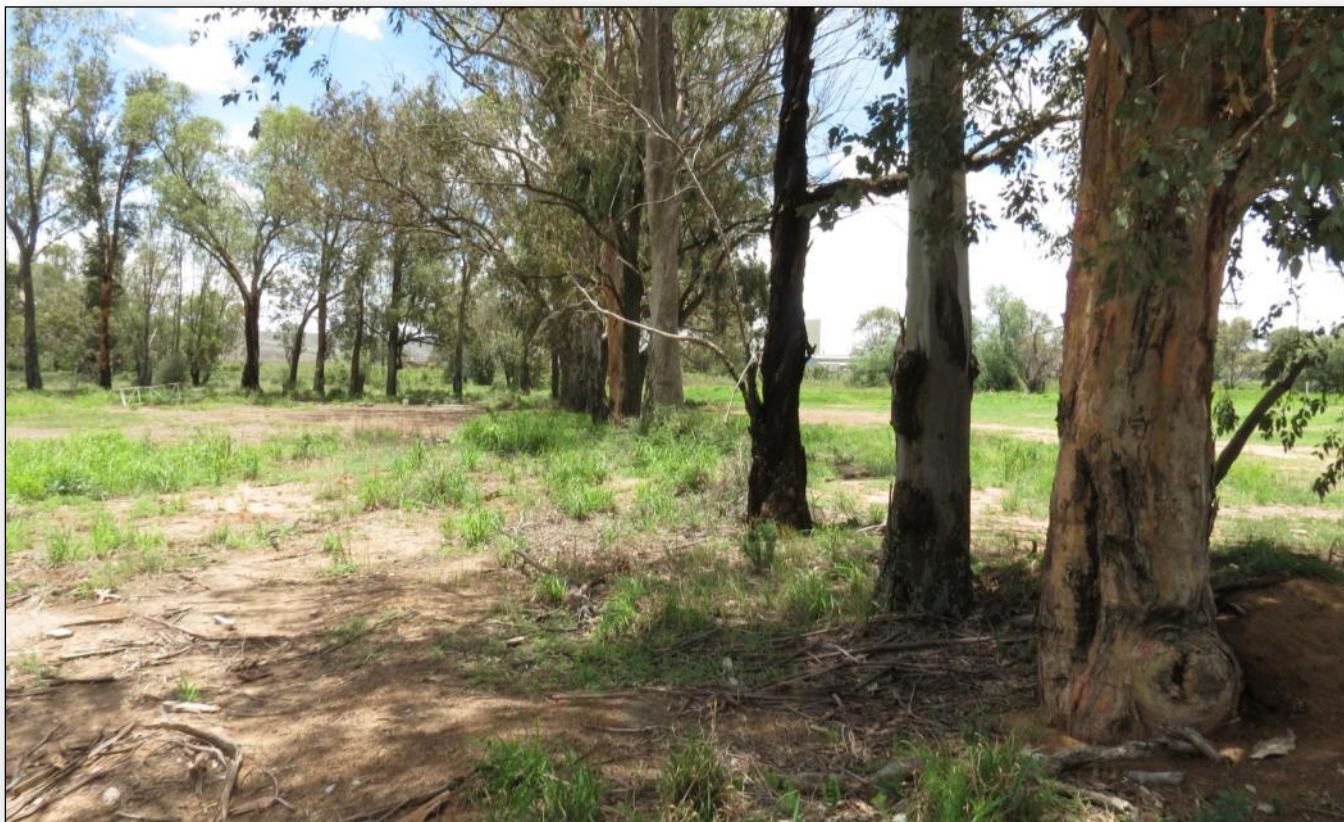
A short distance north of the water reservoir the tree-lined site of the old school yards was identified. While no complete buildings could be seen within this area, a close inspection revealed at least one section of a rectangular stone foundation. From archival evidence it is possible to indicate that this foundation structure represents a later use of the school. As highlighted in the discussion on the aerial photographs, various changes have taken place to this site during the period covered by the aerial photographs, namely from 1951 to 1983. In some instances buildings were added and then removed again over time.

The site is in a poor condition and due to the re-use of the site over the years very little of the original school appears to have remained. Furthermore, the original school building depicted on the 1911 plan appears to be currently located underneath a road which passes through the school yard site. However, the boundaries of the original school yard are preserved to this day in the layout of the trees surrounding the site. Although the school site itself is of Low Significance, the trees surrounding the site can be considered to be of a Medium to Low Significance.

Figure 15 A section of the trees defining the old school yard can be seen. This view is along the inside of the eastern boundary of the site.

While no tangible remnants of the original school building appears to have been preserved, the eucalyptus trees surrounding the school yard defines a tangible link with the original school and school yard. The architectural study has showed that these eucalyptus trees are not associated with the original school. However, it is recommended that they be replaced on a tree-for-tree basis by indigenous trees and by doing this the delineation of the original school yard can be preserved.

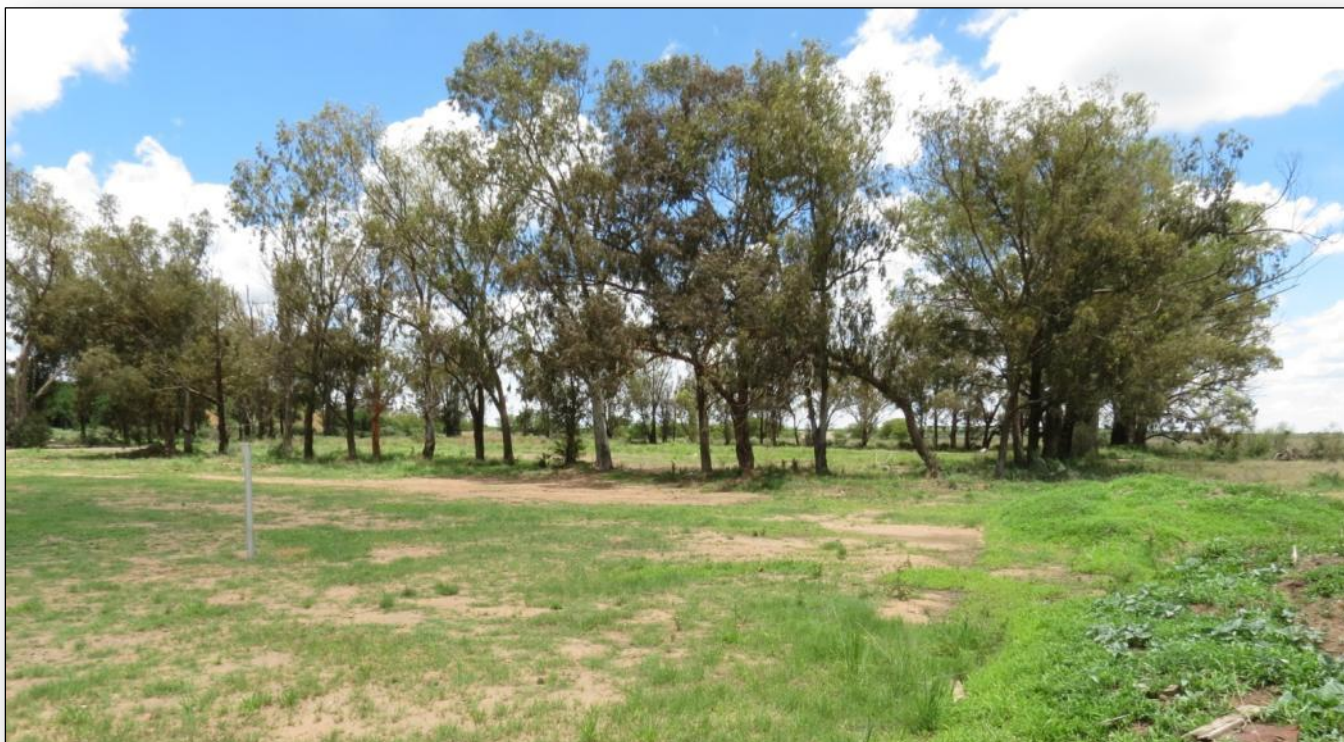
Figure 16 A section of the trees surrounding the old school yard as seen from the north-east.

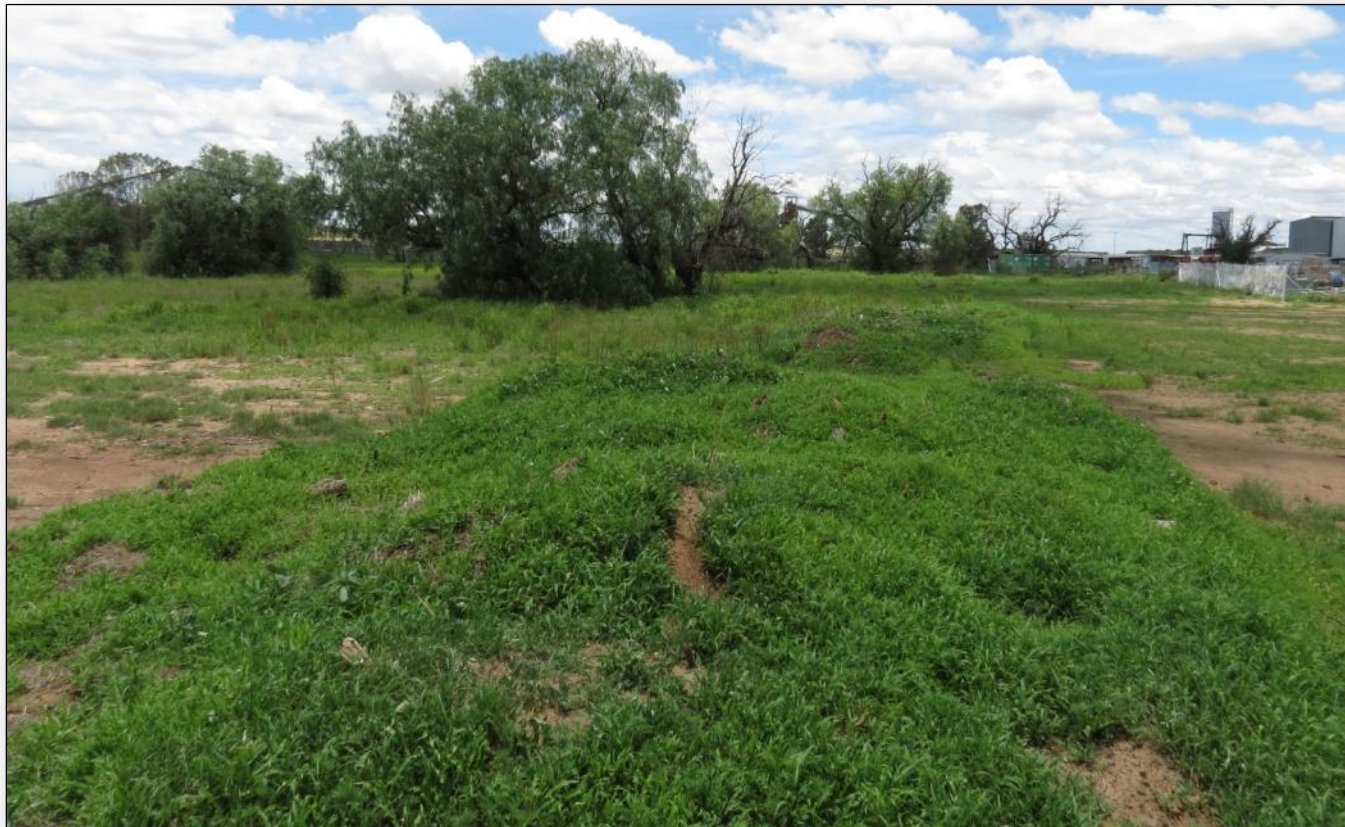
To the east of the school yard and north-east of the water reservoir the remnants of the old mine village is located. Very little of the original mine village has remained preserved, with the only tangible evidence for the old village that could be observed was in the form of some trees as well as historic and archival data. The area was briefly walked through on foot and no historic middens or structures could be observed.

The site is in a poor condition and due to its re-use from the 1960s to 1980s very little of the original village has remained. The only tangible feature identified on the site comprises the presence of some trees. Without the presence of archaeological middens the site would be of low significance. However, the potential does exist for such middens and features to be located here. As a result, the site is deemed to be of Medium Significance.

Figure 19 *This photograph depicts a section of the site where the original mine village was located.*

No tangible remains of the original mine village could be observed. However, it is still possible for subterranean middens and archaeological features to be present at the site. As a result, should any impacts be expected within the demarcated site boundaries, archaeological mitigation and permitting would be required.
