PARLIAMENTARY PRECINCT: OLD ASSEMBLY BUILDING: CAPE STORES: STRUCTURAL REPAIR WORK

C2567 / 31058-REP-001 REV 0

CONCEPT & VIABILITY REPORT

MAY 2016

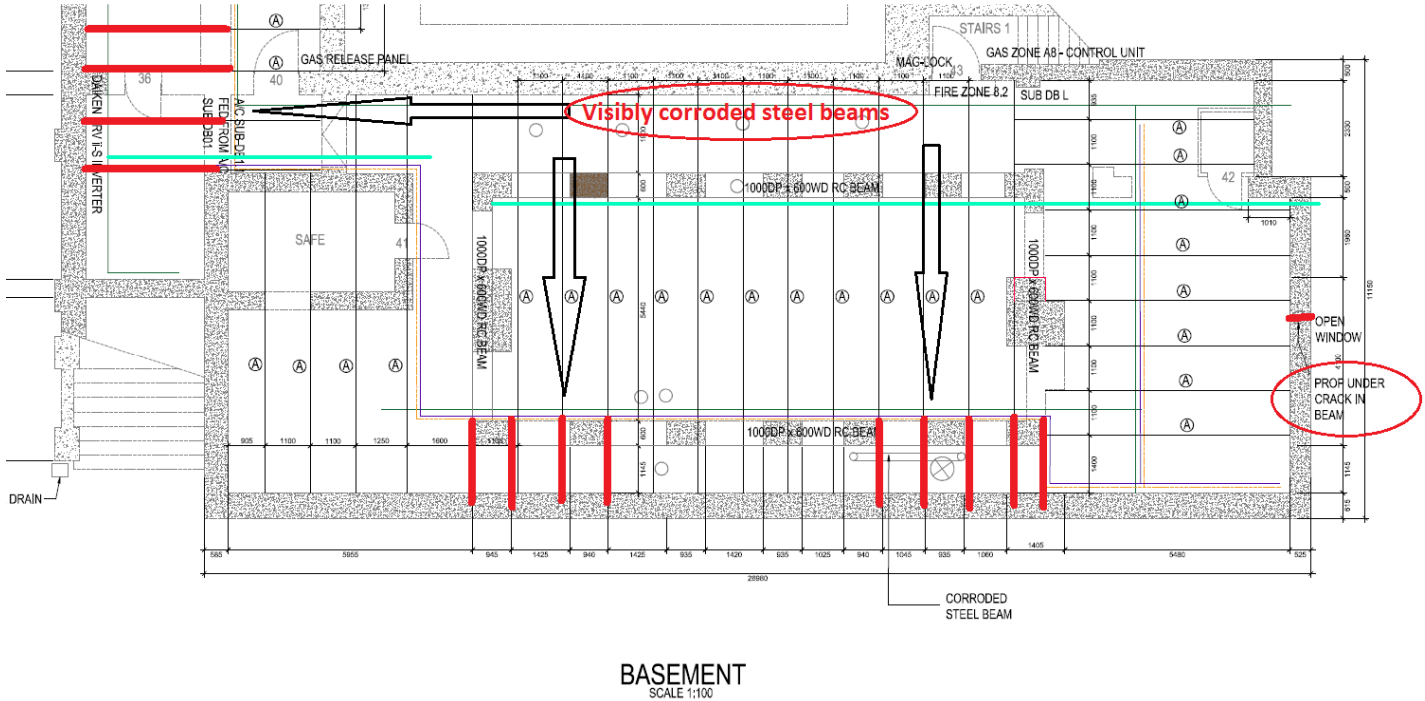
3 locations in the basement were identified where very acute corrosion of the steel beams were visible. Only about 2mm of steel material (a 3rd of the original steel beam) remains in some instances.

Figure 4.1.2: Location of severely corroded steel beams inside the concrete slab in the basement identified on site.

<p>4. Permanent reinforcement of the Cape Stores soffit.</p>	<p>Repair of the corroded steel beams will be very difficult and laborious, as they are encased in the concrete.</p> <p>The 3 area's that have severely corroded steel beams to be propped and the corroded beams to be replaced with galvanized elements, and the concrete to be made good.</p> <p>Application of a migratory corrosion inhibitor to limit the future corrosion of the existing steel beams is also to be done.</p> <p>The services in these area's to be temporarily diverted and reinstated afterwards, where possible.</p>
<p>5. Proper waterproofing, sealing, painting and proper defects repair work</p>	<p>The following measures will have to be applied to remedy defects like cracks, damage and dampness. The basement needs to function as a class 4 basement, and inside and outside waterproofing with an additional storm water and sub-soil drainage system around the perimeter is to be implemented.</p> <p>Installing a sub-soil agricultural drain around the perimeter of the basement slab which is to be connected to the existing underground storm water system, to drain the ground water from the area. (awaiting surveyors data to verify final levels)</p> <p>Waterproofing on the outside of the basement walls that are exposed during the excavations for the new underground services.</p> <p>Rainwater down pipes running underground next to basement to get serviceable storm water catch pits which are to be connected to the new storm water system.</p> <p>Lifting of granite and waterproofing of concrete structure underneath. Resealing of all granite joints.</p> <p>Re- applying a waterproofing membrane on the balcony area's above the basement and also waterproofing the inside surfaces of the basement (floors and walls & ceiling)</p>

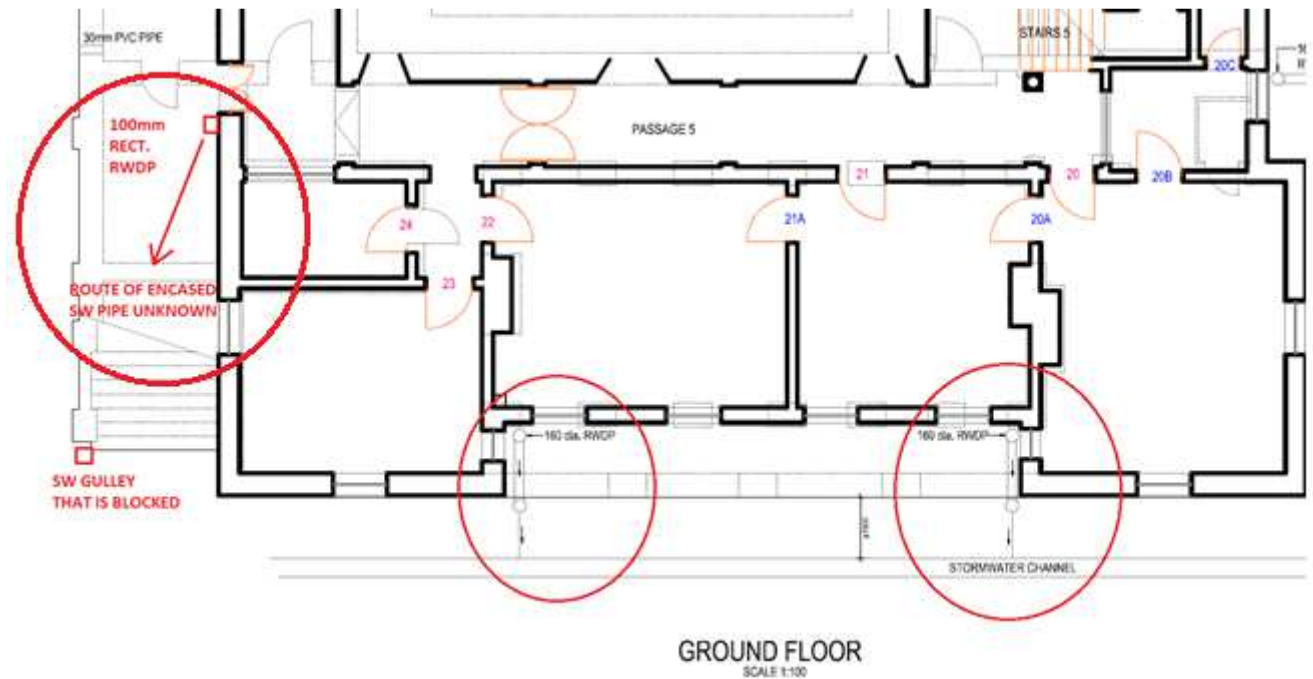
Figure 4.1.3: Location of rainwater down pipes from the roof, which are routed sub-surface, which most probably are related to the observed corrosion.

Where severe corrosion of the steel beams have been observed, a direct correlation with rainwater down pipes going sub-surface has been identified as the potential driving factor of the corrosion. Installing lined rainwater catchpits that are serviceable at the bottom of the rainwater down pipes should reduce the risk of water ingressing into the basement slab. Ensuring proper drainage to the newly installed storm water system, should alleviate the problem in future.

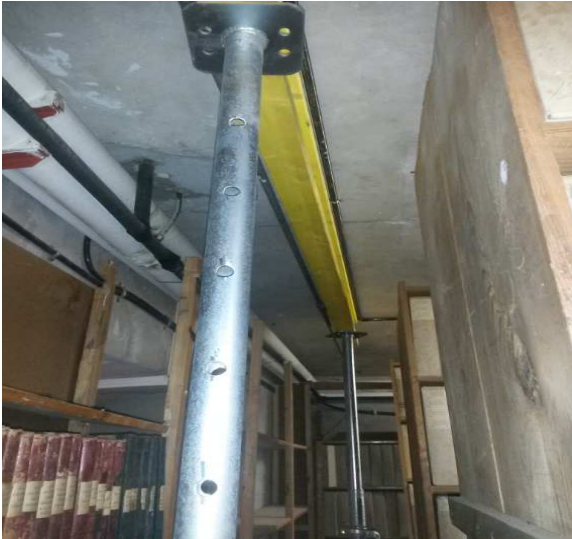
Photo 4.2.1: Existing props and spreader beams in basement

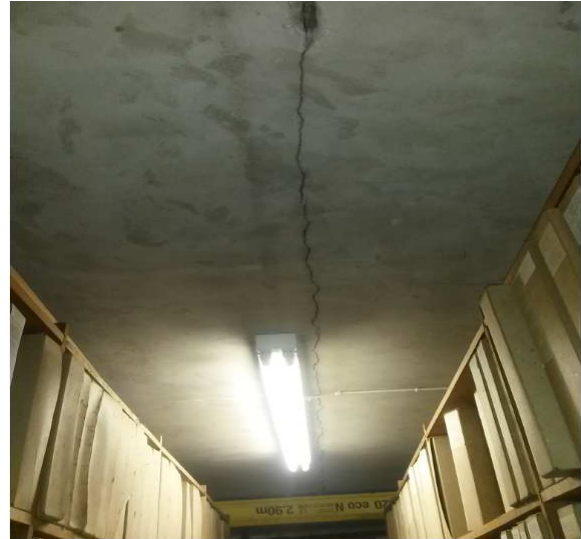
Photo 4.2.2: Typical cracks in plastered finish of slab overhead

The majority of plaster cracks in the bottom of the slabs at the location of the internal steel beams are deemed not of a immediate structural concern, but they appear unsightly and undesirable.

Scope of works	Remedial measures
1. Sealing of cracks 1.1 Cracks in slab	<p>The majority of the +/-400m of cracks in the soffit of the slab are not of structural concern, as the steel beams are the main structural elements, spanning between brickwork supports. The concrete between the webs of the steel beams act as a simply supported elements spanning between the steel beams. As there is no continuity of the concrete, these separate elements behave independently under loading and other varying influences like humidity and temperature. As the plaster at the soffit of the slab was applied continuously, the independent behaviour of the concrete slabs resulted in stress cracks in the plaster.</p> <p>Treating these areas by introducing a straight joint in the plasterwork underneath each beam which must also be sealed with a polysulphide sealant, will reduce the visibility of these unsightly cracks in the plasterwork.</p> <p>Dehumidification of the air in the basement will also retard the rate of corrosion on the existing beams in future.</p>

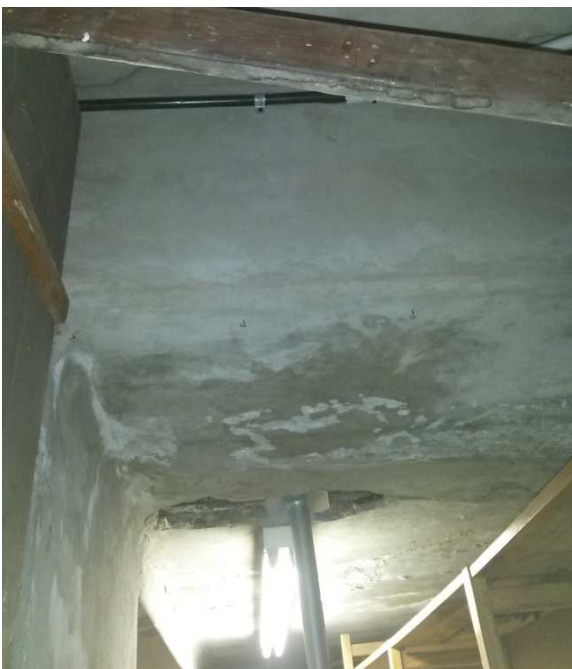
Photo 4.2.3: Portion of slab against far wall below outside balcony that is 500mm lower than rest of the slab

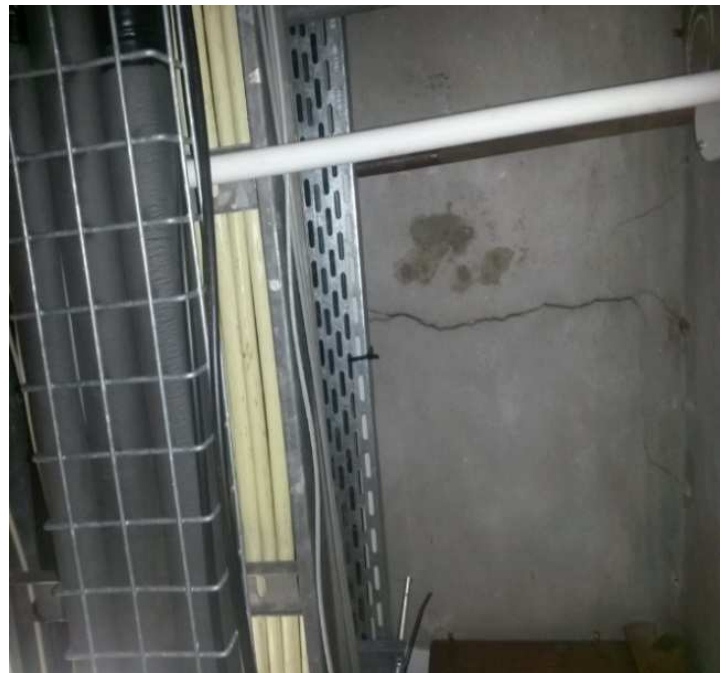
Photo 4.2.4: Services in cable trays with cracks in floor above

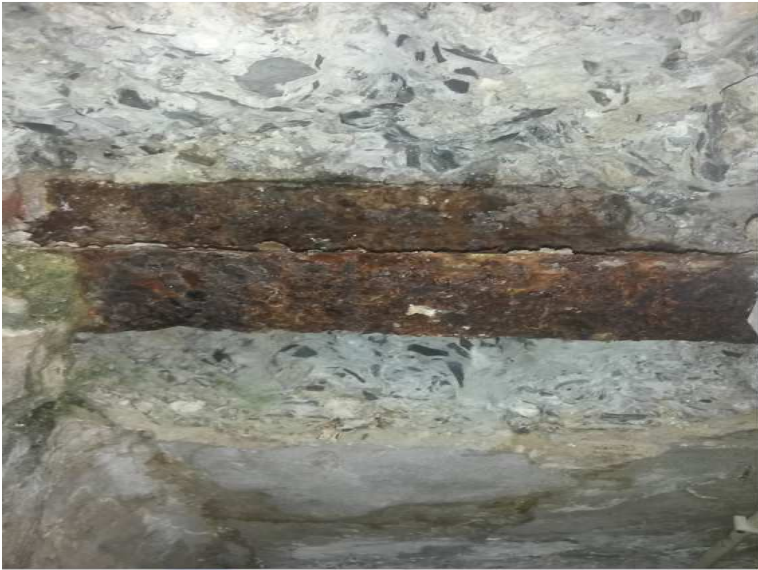
Photo 4.2.5: Steel beam inside concrete floor that is severely corroded

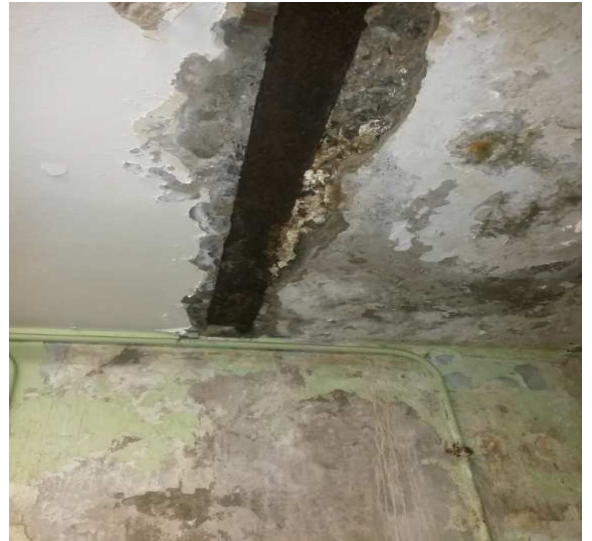
Photo 4.2.6: Another visibly corroded steel beam

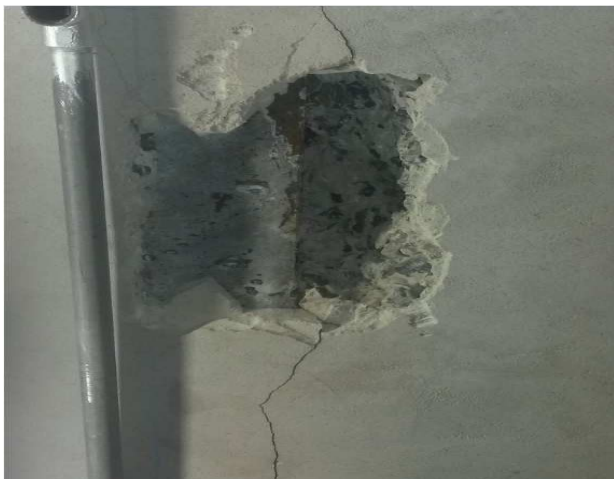
Photo 4.2.7: Crack in slab with bottom flange of steel beam visible, no visible corrosion

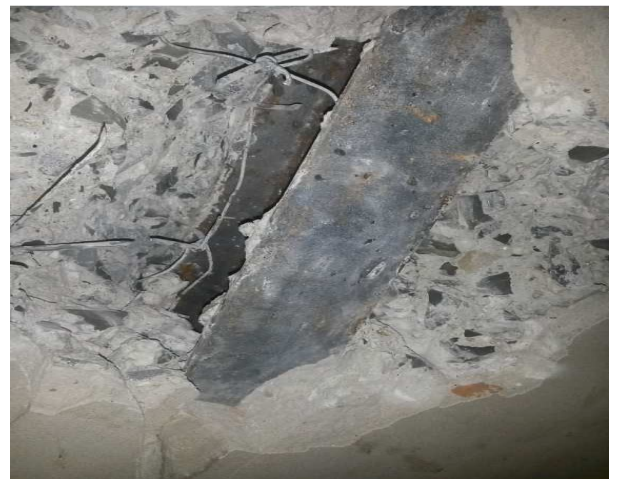
Photo 4.2.8: Another steel beam with little to no corrosion some with reinforcing mesh visible

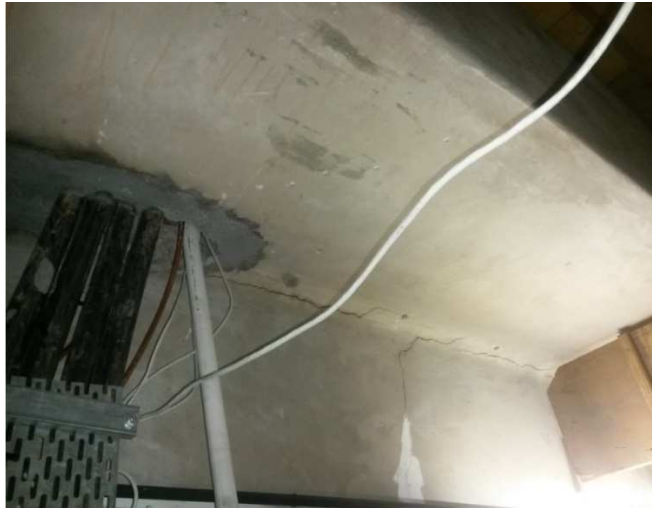
Photo 4.3.1: Crack along slab/beam interface

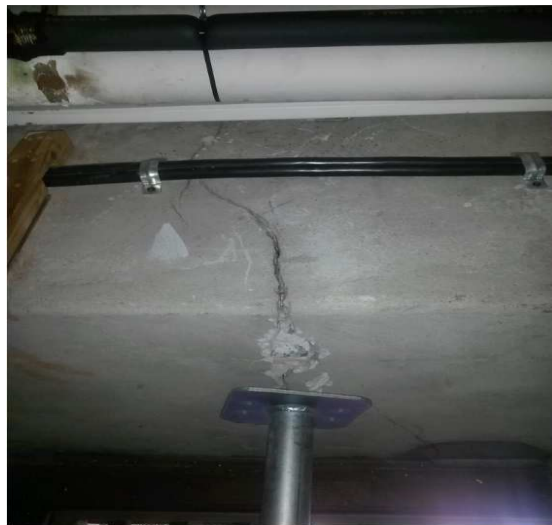
Photo 4.3.2: Vertical cracks through down stand beam, following line of crack through slab

Where these cracks however propagate to the unreinforced concrete downstand beams, they impact on the structural durability of the structure. These beams act like mass concrete arches, spanning between the supporting columns and a shear failure of these arches could result in localized structural collapse.

1.2 Cracks in beams	<p>The down stand beams in the basement appear to be unreinforced concrete and brick beams with aggregate up to 70mm in size and concrete poorly compacted. As there is no observed steel reinforcing in these beams they must act as flexural beams spanning between the supporting walls, contrary to modern-day reinforced concrete beams that function structurally in bending.</p> <p>Some of the plaster cracks in the slab propagates into these beams, and as such these minor cracks are now causing cracks which is undermining the structural stability of the building.</p> <p>Propose that these cracks in the beams be filled with high pressure epoxy repair system, and that steel support beams be introduced underneath these beams where head height clearances are not required.</p>

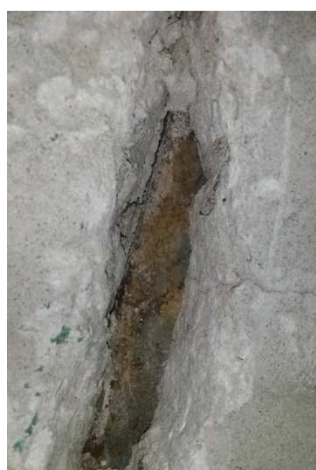
Photo 4.4.1: Exposed Steel beam edge with slight surface discoloration visible

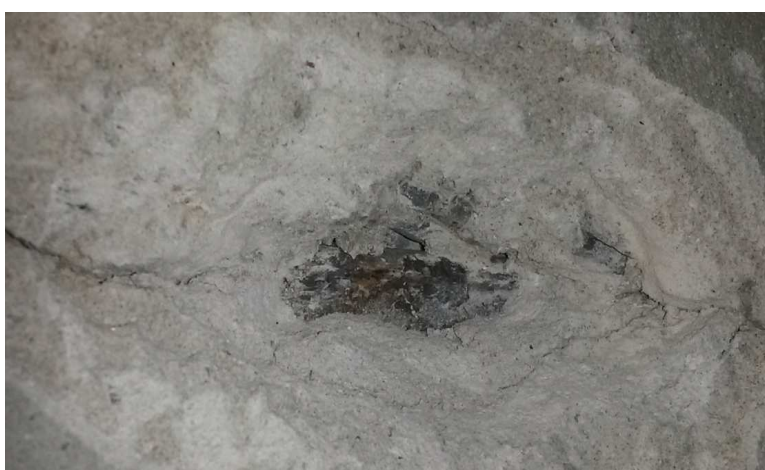
Photo 4.4.2: Another Exposed Steel beam with slight surface discoloration visible

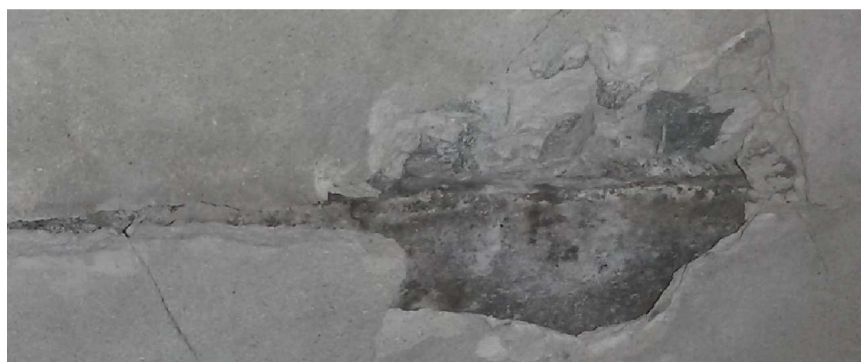
Photo 4.4.3: Exposed steel beam with almost no visible corrosion

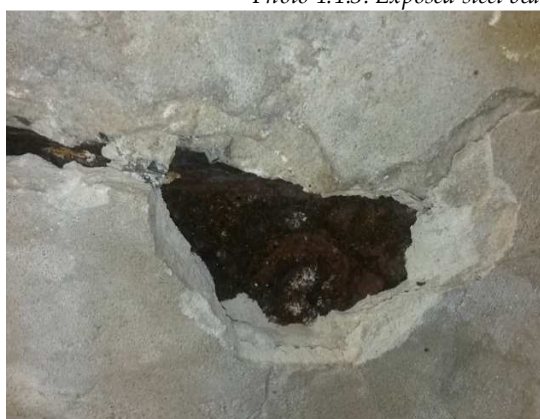
Photo 4.4.4: Exposed steel beam with severe surface corrosion visible

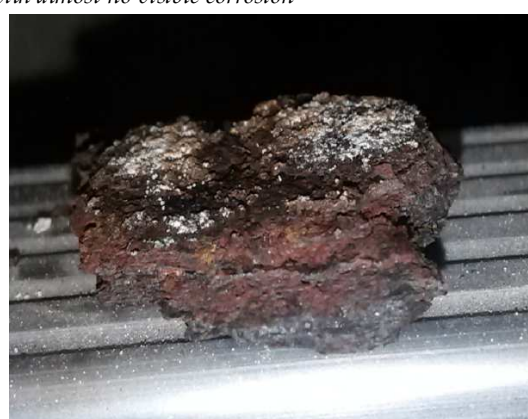
Photo 4.4.5: Portion of corrosion chipped off of beam

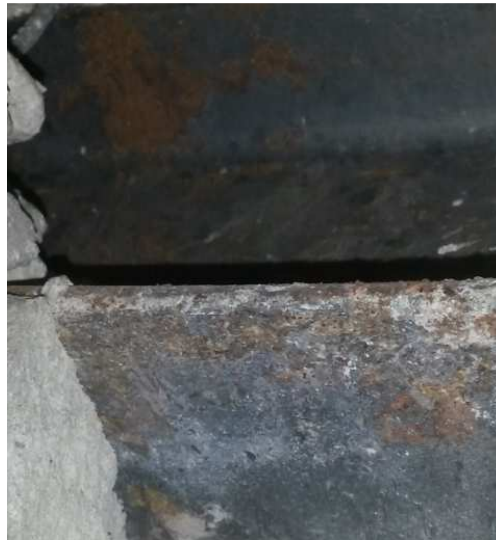
Photo 4.4.6: Bottom flange of beam that has almost no visible corrosion (+/- 6mm thick steel flange)

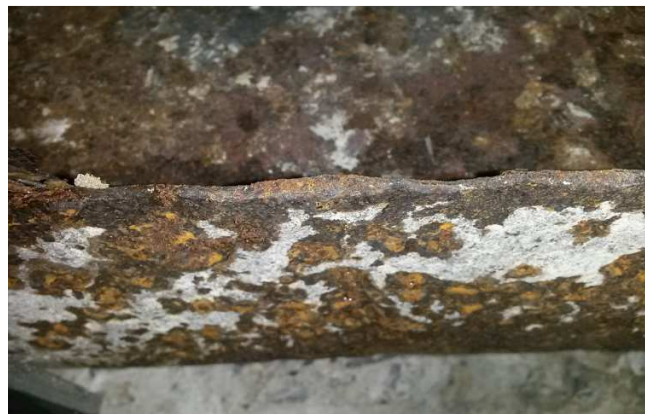
Photo 4.4.7: Bottom flange of beam that has extensive surface corrosion (+/- 4mm thick steel remaining)

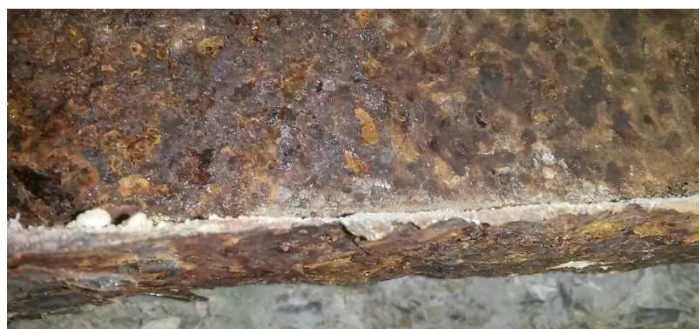
Photo 4.4.8: Bottom flange of beam that has extensive pitting corrosion (1-2mm rusted material remaining)

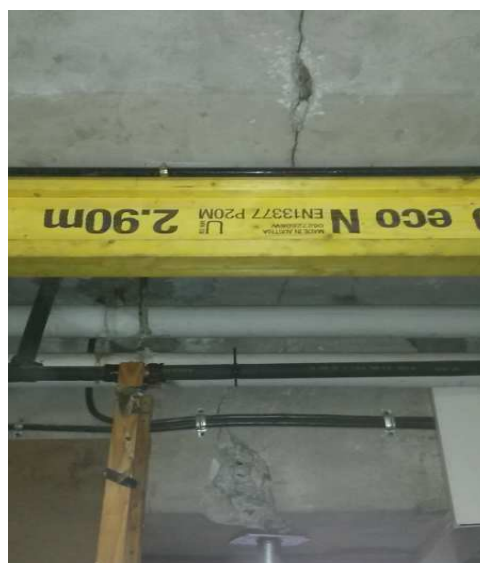
Photo 4.5.6 Exposed beam, with crack from slab visible propagating through beam

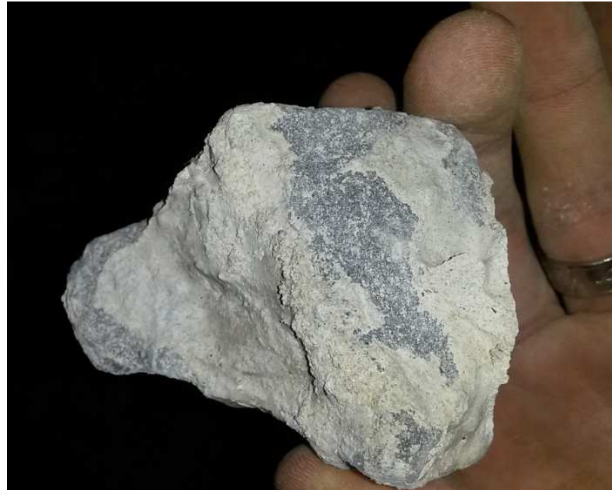
Photo 4.5.7 Aggregate size of 75mm was used during construction of the beams. Modern day concrete used in concrete beams is made up of 19mm stone. 75mm aggregate is normally only used in mass concrete fill underneath foundations.

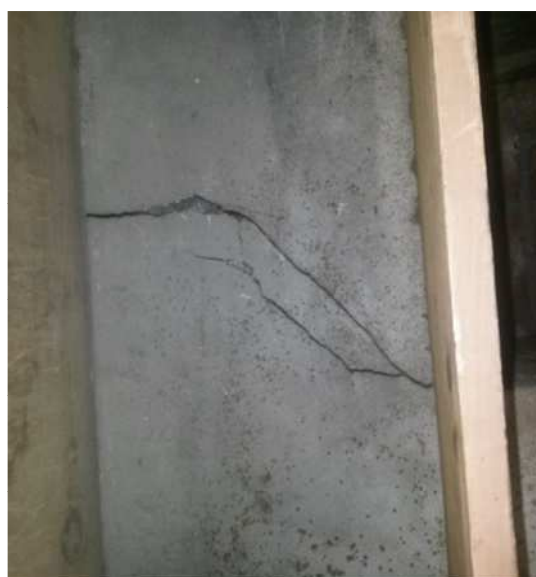
Photo 4.5.9: Horizontal crack in wall element next to plant room of Assembly chamber

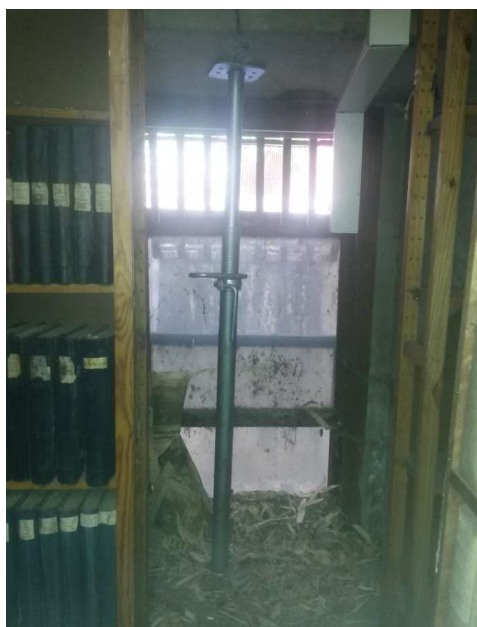
Photo 4.6.1: Open window behind supporting prop

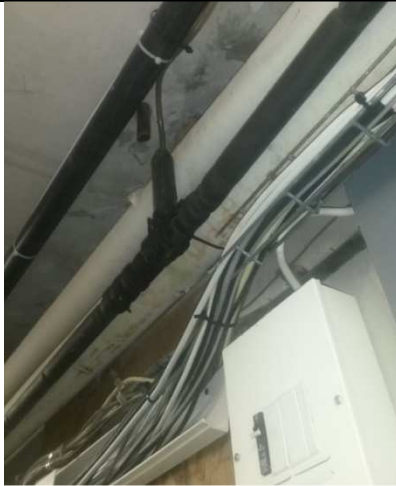
Photo 4.6.2: Overhead Mechanical services where water is leaking from

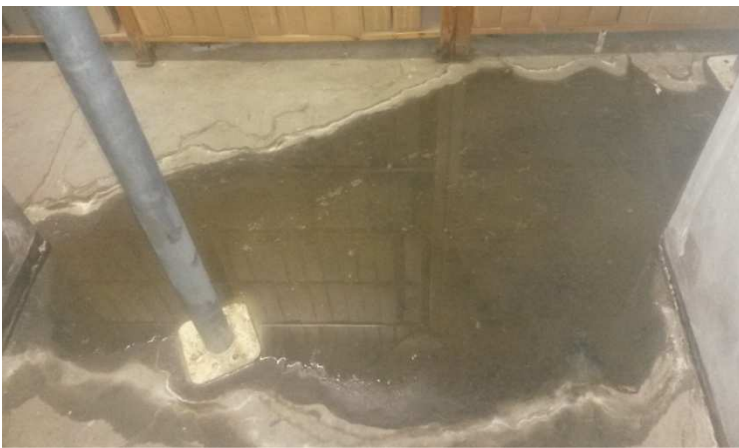
Photo 4.6.3: Standing water inside basement next to existing prop

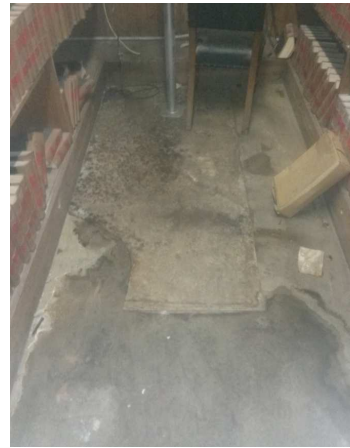
Photo 4.6.4: Water mark from previous water leak elsewhere in basement

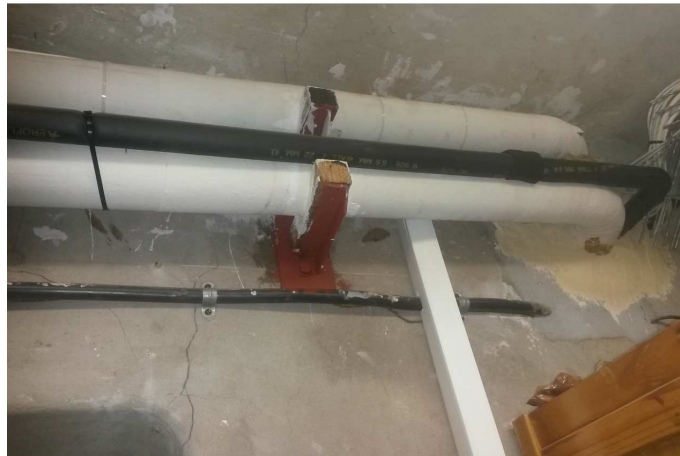
Photo 4.5.35: Overhead services with cracks in beam visible

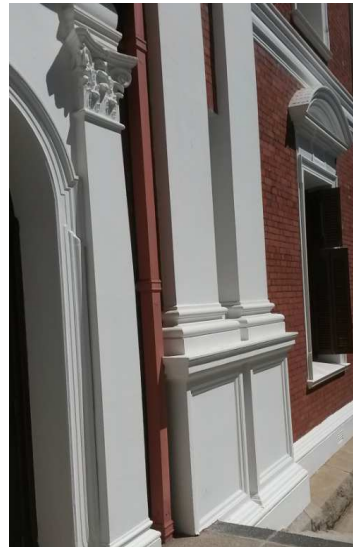
Photo 4.6.2: Rainwater downpipe going into staircase structure, probably resulting in observed corrosion due to water leaking out from encased pipe.

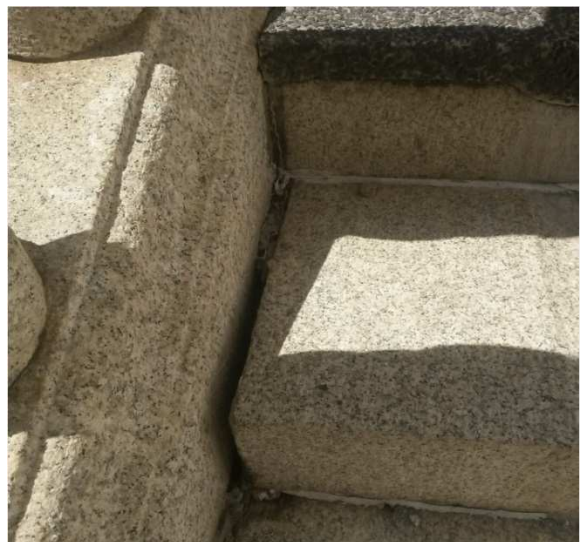
Photo 4.6.4: Joint sealing damaged on edges of granite step

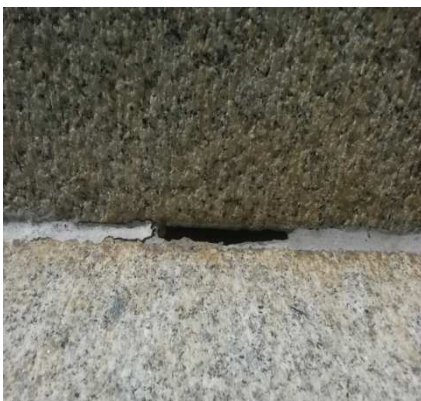
Photo 4.6.5: Joints between steps with visible gaps

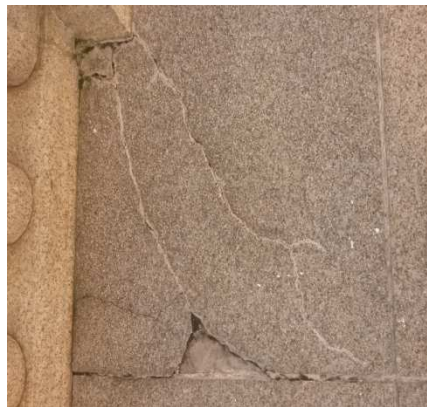
Photo 4.6.6: Damaged granite panel on balcony

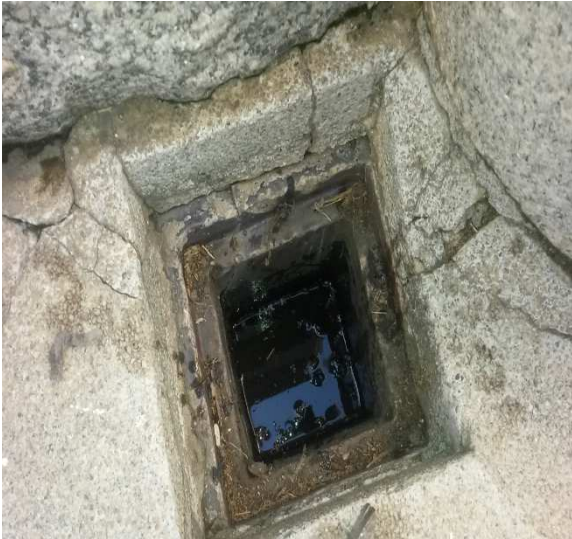
Photo 4.6.7: Blocked storm water drain at bottom of steps

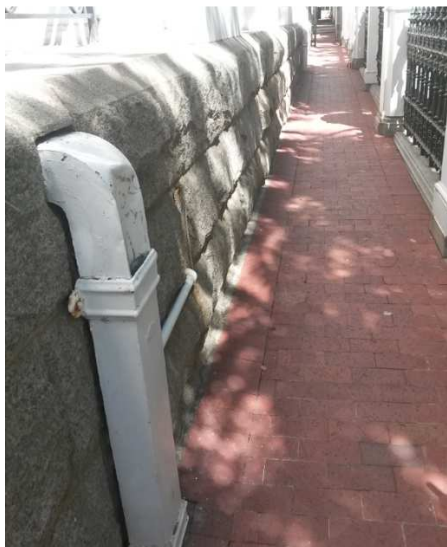
Photo 4.6.11: Position of Rainwater downpipe from roof correlates with position of severe corrosion of steel beams in basement.
