Maintenance of the Voortrekker Monument Wagon Laager Wall

Needs assessment and technical report

Project file and report number: ES/3/3/3/7
SAHRIS case ID: 13832

29 May 2019

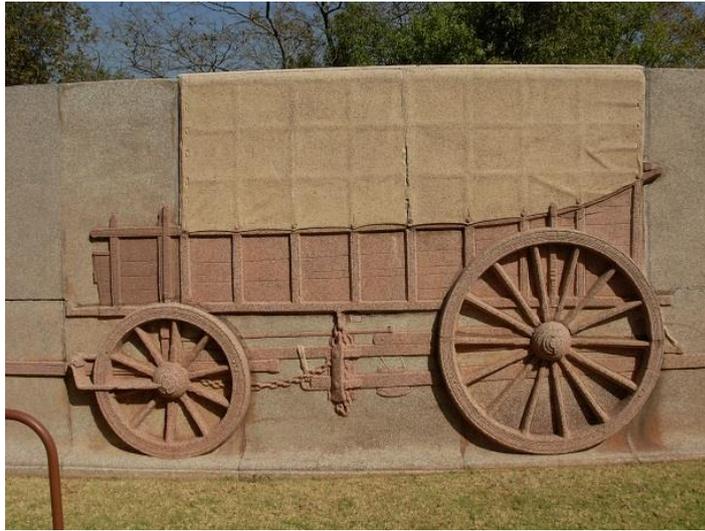
The sculptor, Frikkie Kruger, created a clay model of a *kakebeenwa* (jawbone wagon, so called as the wagon's body looked like a lower mandible) to cast a plaster of Paris mould. This mould formed the 'die' used to produce cement forms in Johannesburg. The Johannesburg-based Italian firm, Lupini, completed the terrazzo casting of the forms on-site at the Monument (see Figure 1).³

Figure 1: Example of typical terrazzo wagon.

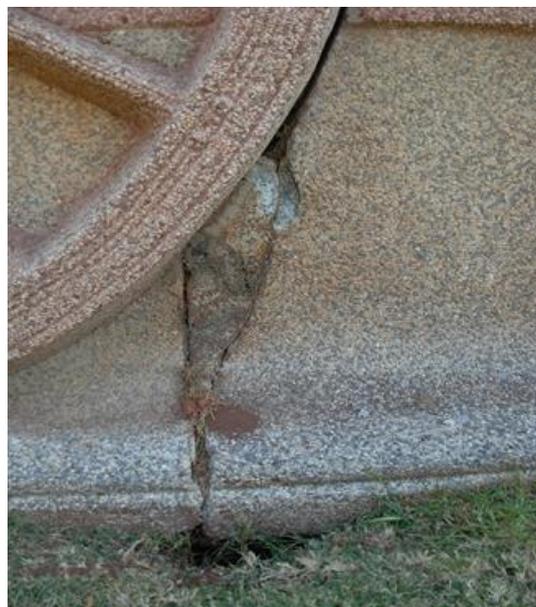
According to minutes held in the Voortrekker Monument archive, Lupini already needed to do repairs as early as 1959.⁴ Thereafter, repairs and maintenance frequently occurred over the past 60 years (see e.g. Figure 2). Naudé shows that these frequent repairs were, in part, necessitated due to inherent design faults in the original design of the wall and panels, and that continued deterioration is inevitable.⁵

Figure 2: Example of previous repair work.

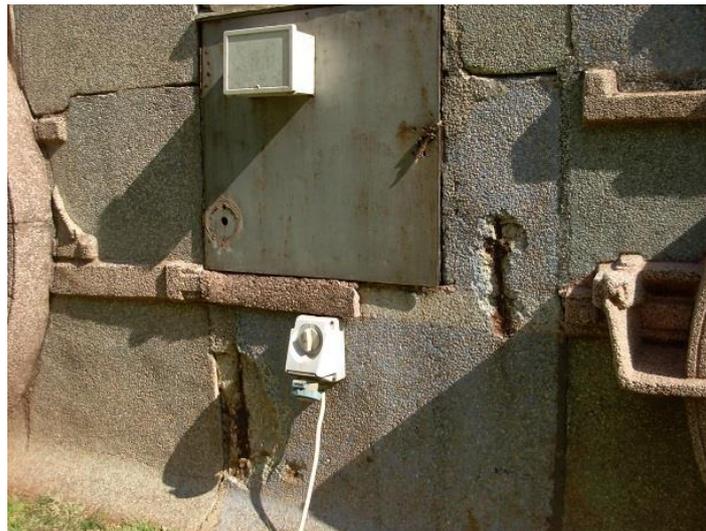
In 2016, the Voortrekker Monument realised that the wagon laager wall again required repairs and maintenance. The Monument completed a needs assessment that identified panels that require immediate maintenance to prevent significant damage to individual panels. The initial estimate was that the maintenance will be completed within six months. However, once preliminary work commenced various hidden defects became apparent that significantly contributed to the deterioration, such as corroded steel reinforcing, old electrical wiring and intruding tree roots, as well as natural expansion and contraction of the fabric (see Figure 3 and Figure 4).

Figure 3: Example of current maintenance challenges – corroding metal reinforcement

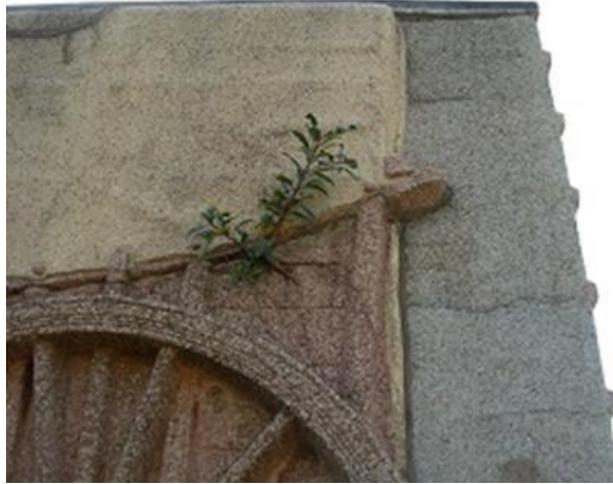
Figure 4: Example of current maintenance challenges – vegetation rooting in open joints

Pre-treatment further comprised manual removal and treatment of intruding vegetation and pruning low-hanging branches to approximately 500 mm from the wall to prevent moss growth on the walls.

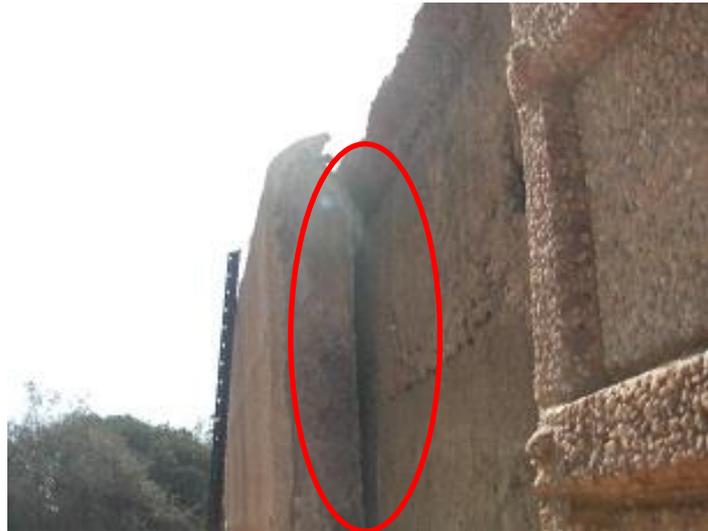
Resonance tests of all panels preceded maintenance work to determine which panels have pulled or are busy pulling away from the internal cement 'core' to prioritise panels in terms of highest future conservation risk. Closer inspection of high-risk panels showed that loosening occurs due to several factors. The quantity and quality of cement used, or the use of rubble and stones as infill instead of cement, during the 1949 construction notably contributes to loosening and overall deterioration.

Figure 5: Example of original internal concrete cast behind a removed panel. Note the space between the panel and cast.

Cuts made at panel joints and on top of the panels enabled the pouring of a fluid cement mixture between the panels and original internal concrete cast. Where necessary, inserted copper rods provide additional reinforcing and better adherence for the panels to the concrete cast, such as on top of the wagons and in larger panels (see Figure 5 and Figure 6).

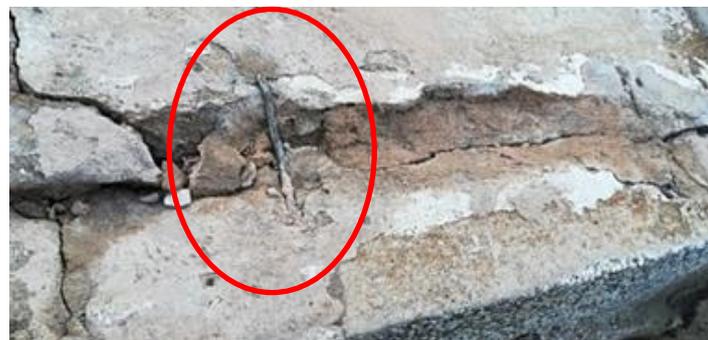
Figure 6: Example of copper staple inserted to join the panel to the concrete cast

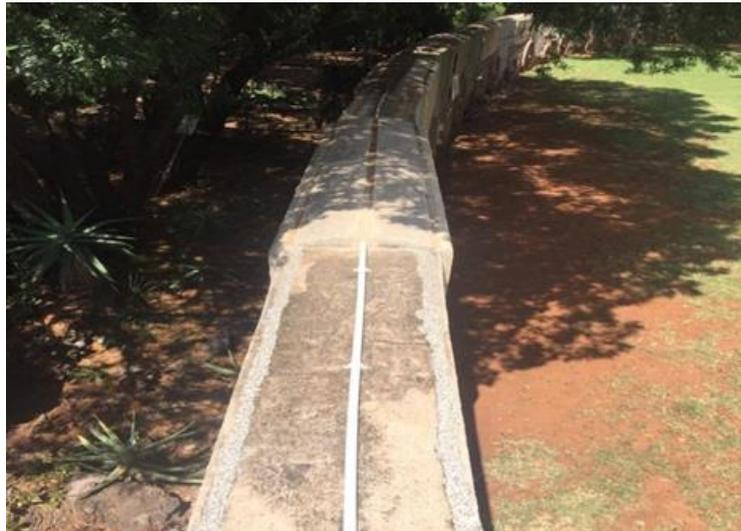
Figure 7: View of top part of wall after filling cavity and sealing of joints. White conduit contains electrical wiring.

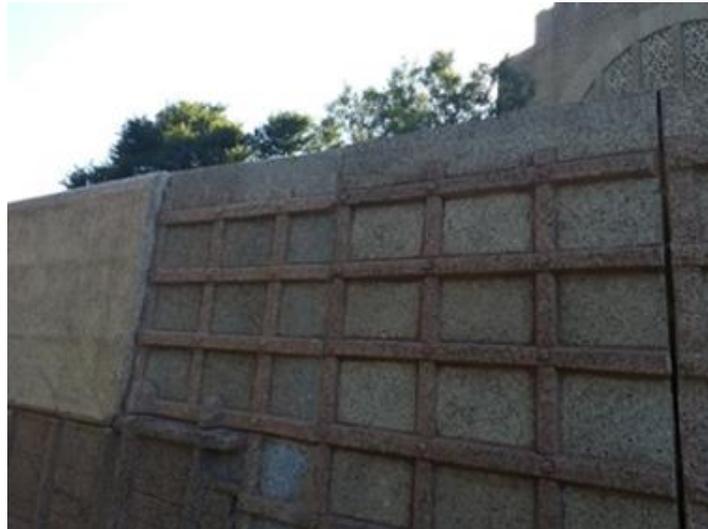
Figure 8: Step 1 – Opening of old joints around panels.

1. Opening of existing joints between and on top of panels to remove old, deteriorating material.
2. After opening the existing joints and removing as much old material as possible, wet newspaper inserted into the joints acts as a temporary seal to contain the cement mixture poured in behind the panels.

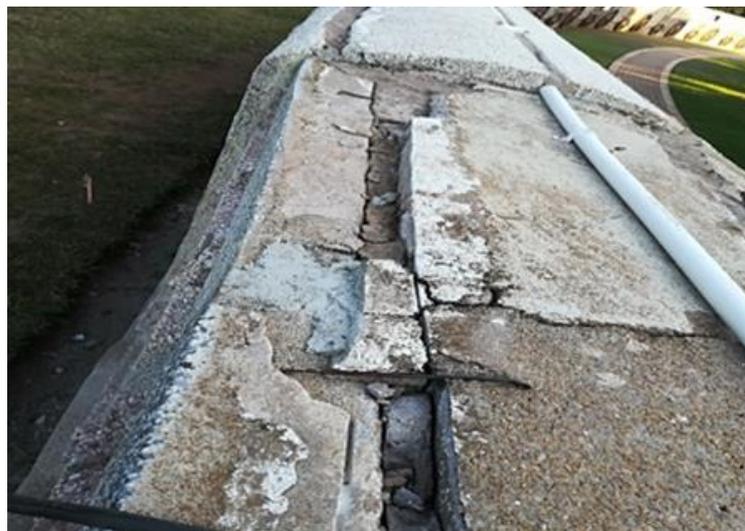
Figure 9: Step 1 – Opening cavity between panel and internal concrete cast.

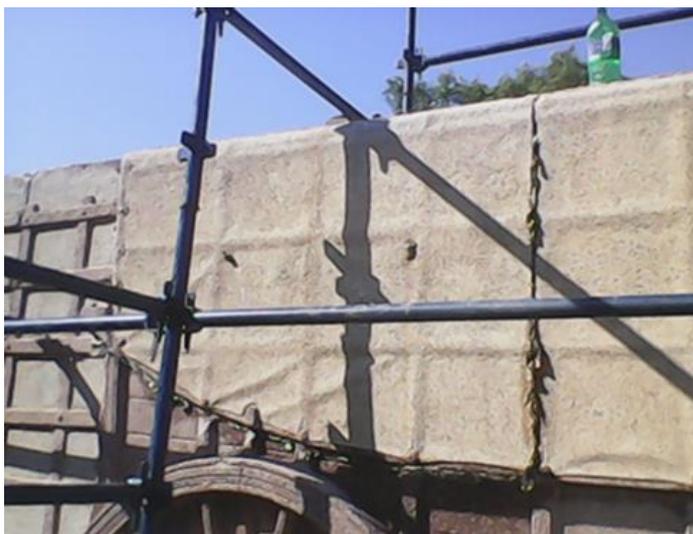
Figure 10: Step 2 – Wet newspaper inserted into joints as temporary seals.

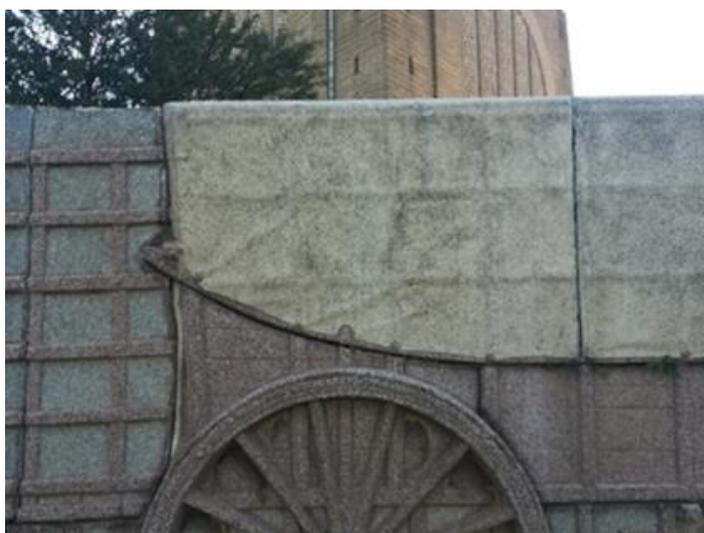
Figure 11: Seals removed after curing and before grouting and pointing.

4. After sufficient curing, the temporary seals are removed curing and the joints are ready for grouting and final pointing.
5. Grouting then commences using a mixture of building sand and cement and left to cure, after which the grouted joints are pointed to an even finish.

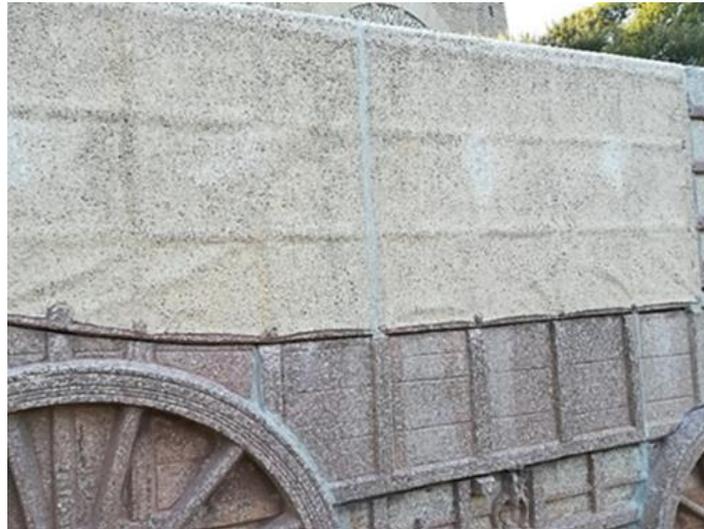
Figure 12: Example of final grouted and pointed joints.

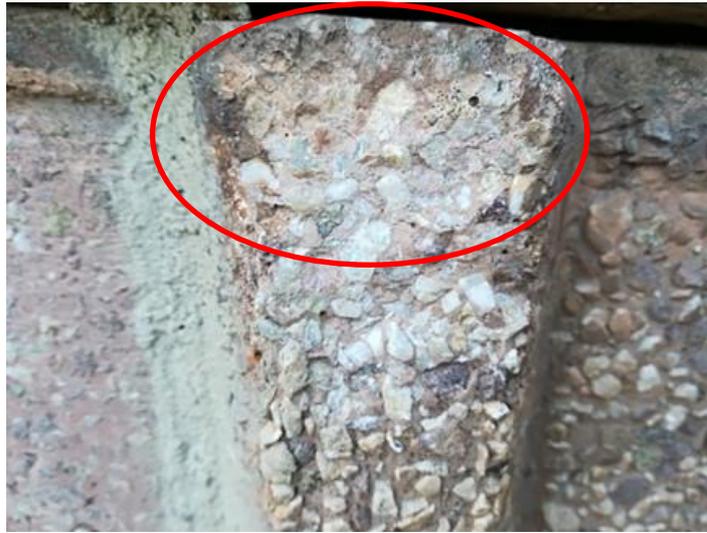
Patchwork is applied directly to the terrazzo panels where, for instance, corroding steel reinforcing caused surface damage or to conceal joints after final pointing is completed. The steps followed in patching included the following and illustrated in Figure 13 and Figure 14 –

Figure 13: Example of superficial damage to a panel element.

1. Cleaning of panels and pre-treatment where necessary.
2. Damaged panel elements are built up to the same dimensions using a sand-and-cement mixture that is cured over at least two days.
3. The final layer applied over the cement base comprises a mixture of building sand, river sand, oxides and cement blended to a similar colour as the original terrazzo. The oxide mixture consists of two or more colours to obtain the desired colour to match the panel.

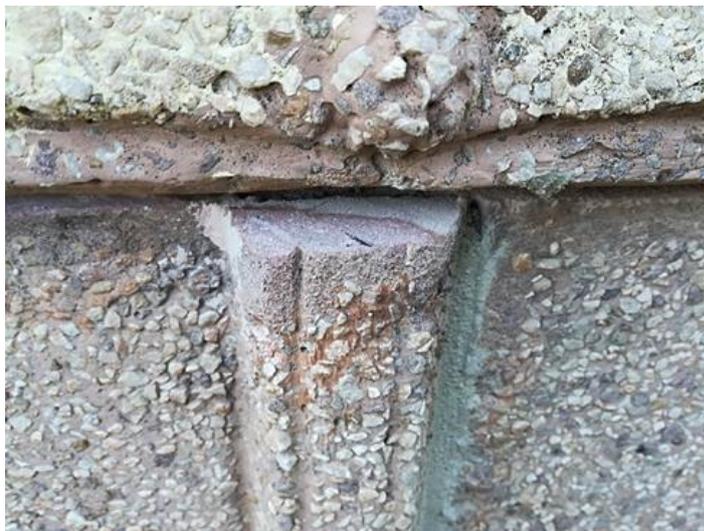
Figure 14: Patchwork on damaged area to obtain a uniform appearance of the panel element
