PROGRESS REPORT

Project Name:	Heritage Resources Management Process for the Exxaro Matla Coal Mining Right Area
Project Number:	EXX4731
Date:	August 2017

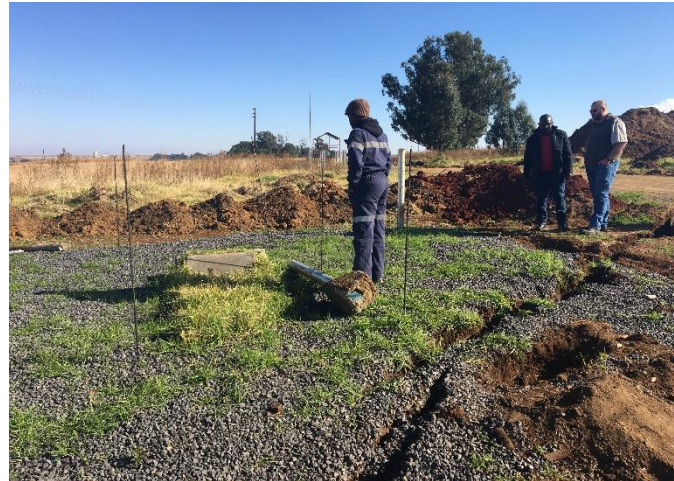
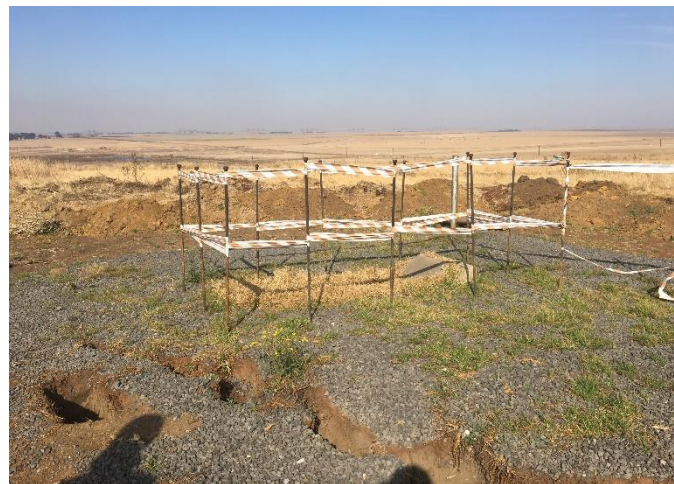
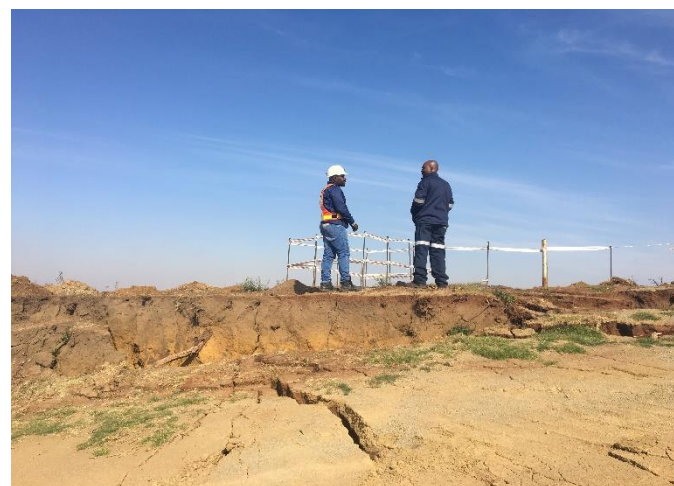
Pre-remediation

Subsidence occurred along Panel 20 resulting in the manifestation of surface cracking in proximity to the heritage site. As a result, reactive management measures as detailed in Table 1-1 were employed. Commensurate to the conditions of the HSMP and recommendations made by the heritage specialist, the SAHRA BGG Unit required Exxaro to mitigate the resultant cracks to promote the *in situ* conservation of the heritage site. As a result, Exxaro appointed a qualified and accredited archaeologist to complete a Watching Brief during rehabilitation activities.

Rehabilitation activities avoided any physical damage to the surface dressing of the heritage site. No mortal remains were exposed through the exposure of the sub-surface during remediation of the surface cracks. The heritage site was conserved *in situ*.

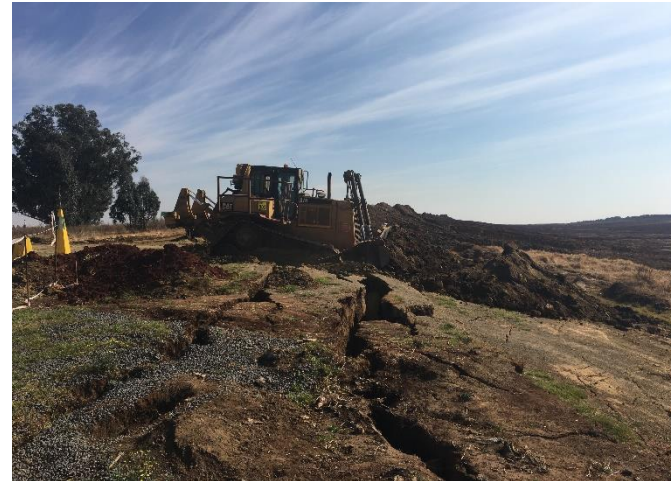
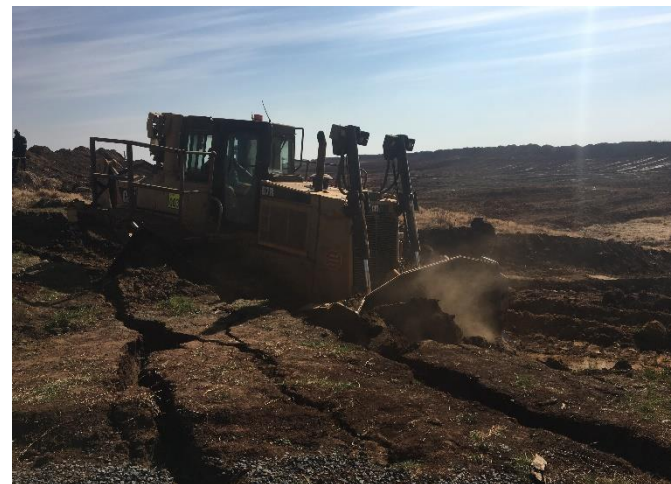
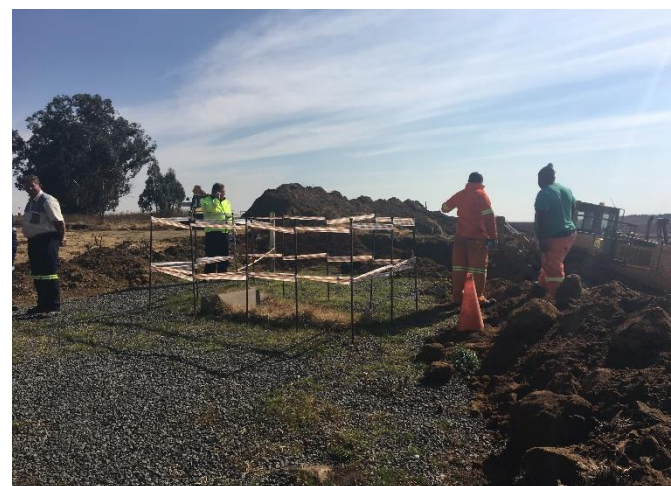
The area subjected to soil ripping via the Dozer underwent a final process of soils shaping to create the “desired” topography that would reinforce and support the elevated heritage site, and reduce the likelihood of erosion over time. The smaller, shallower cracks subject to remediation via the TLB and manual labour was infilled with a combination of soils and concrete pebbles to promote stabilisation of the soil and reduce further collapse over time. Once sufficiently infilled, the rehabilitated cracks were compacted as far as possible.
