Department of Public Works

MOTOR LICENCING BUREAU (MLB BUILDING)

ELECTRICAL CONDITIONAL ASSESSMENT REPORT

MAY 2022

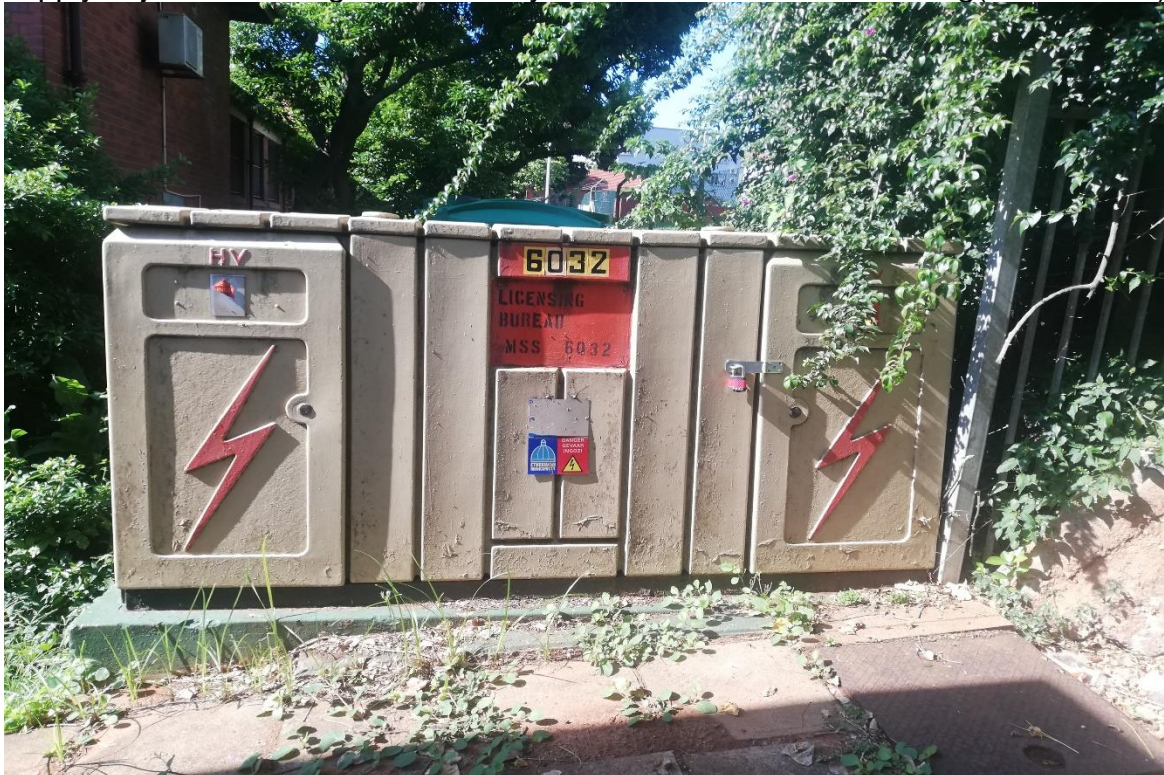
PICTURE A

The facility is currently fed from the local municipality via an existing mini sub (PICTURE A) located in proximity of the MLB Building and from the site inspection deems to have a 400 Amp, 400 V, three phase supply. The mini sub appears to supply adjacent buildings and not only dedicated to the MLB building (PICTURE B).

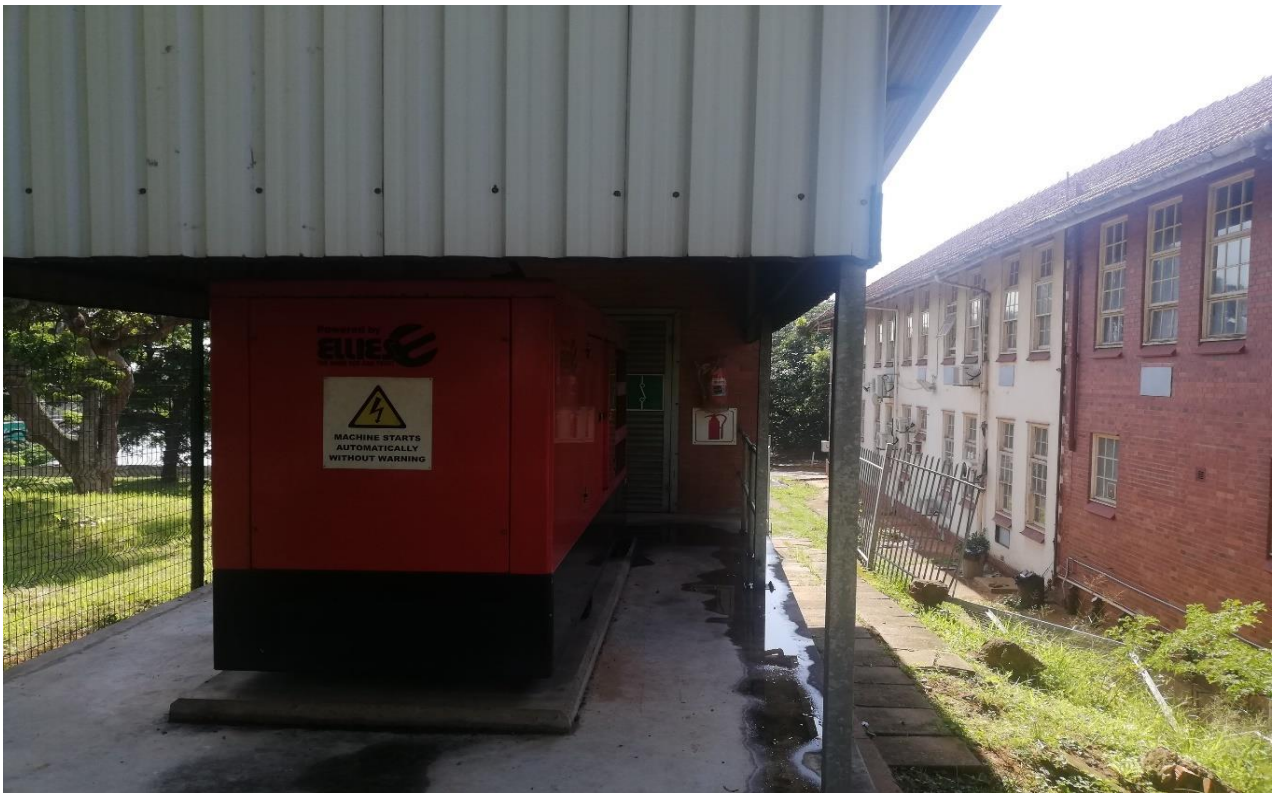
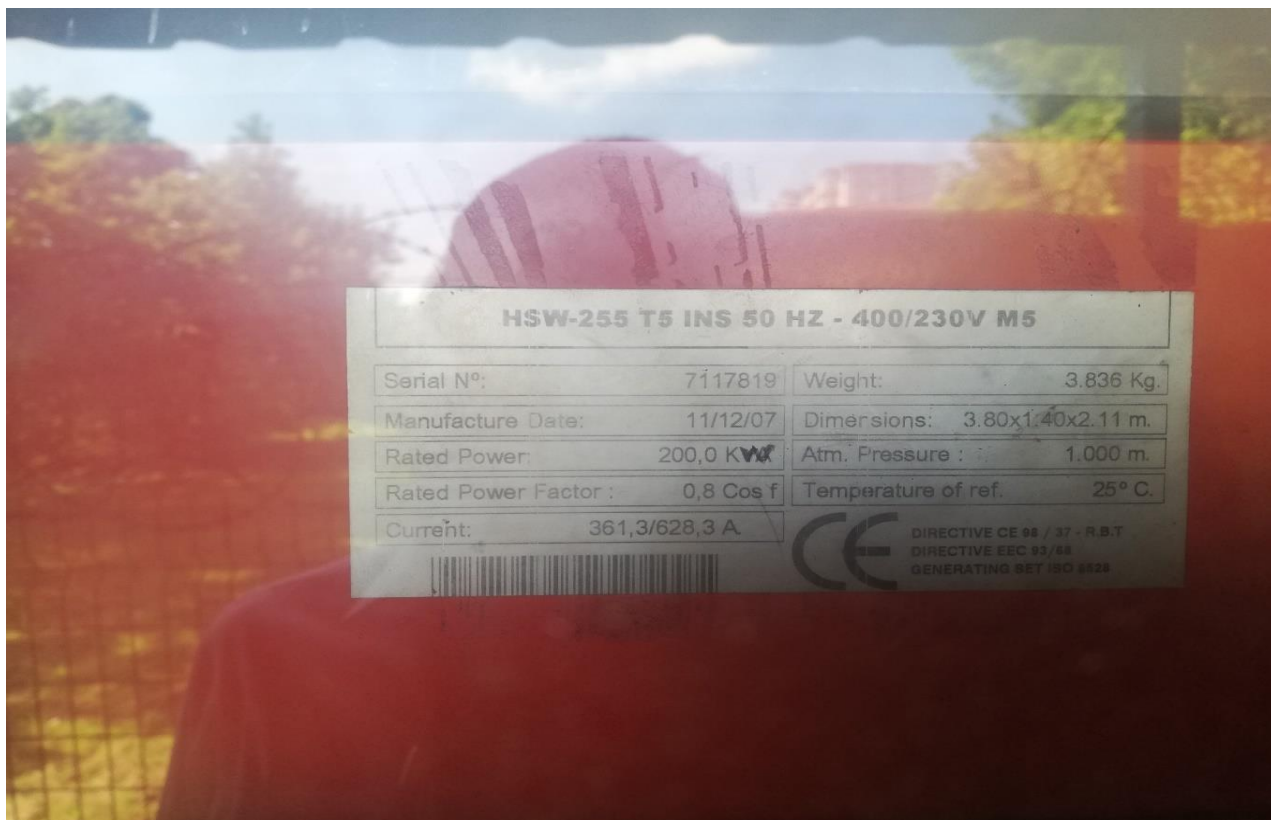
Important to note that there is an outdoor existing generator on site and the assumption is that the entire facility is currently on back-up power with no differentiation between normal power and emergency power. The generator has been serviced regularly.

The main cable from the generator change-over switch enters the main dB located on the ground floor thereafter the main board supplies various sub-boards. The boards are currently in a dilapidated state. The mains cable would need to be tested to ensure that it is in satisfactory working condition.

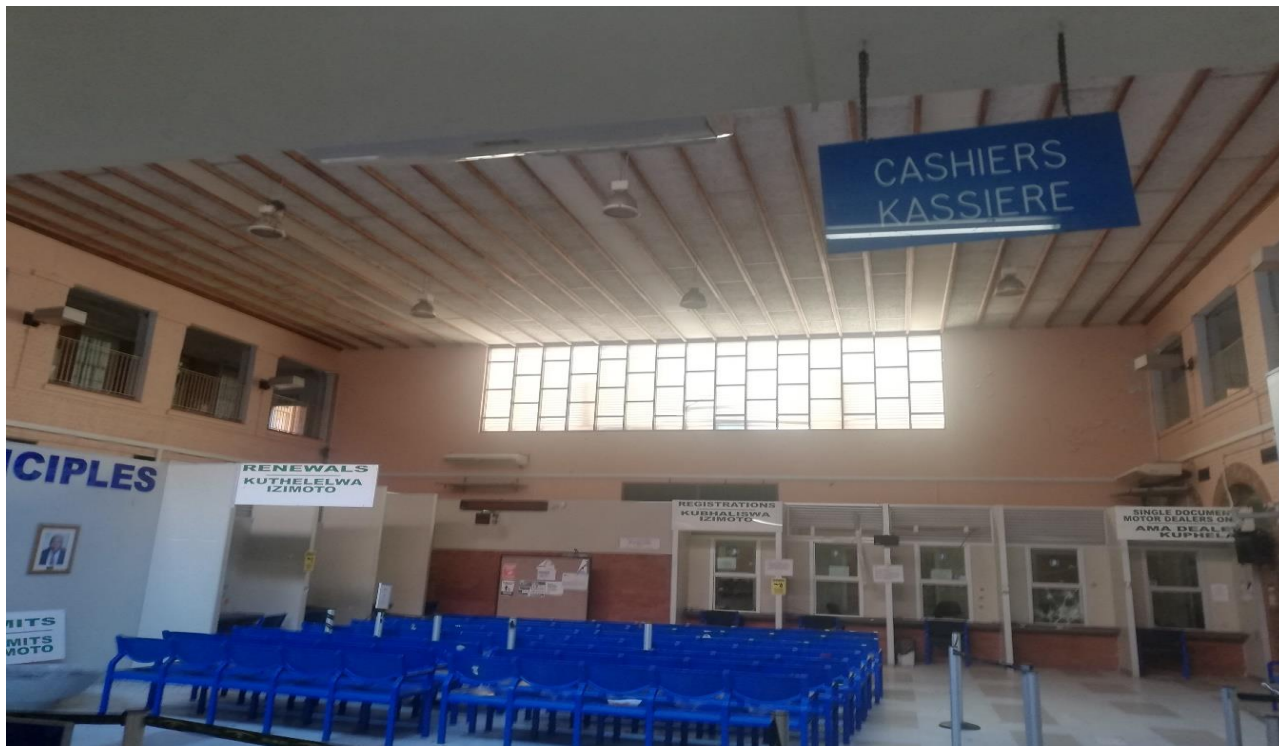
There are no luminaires present for emergency escape lighting in the case of fires or total loss of power.

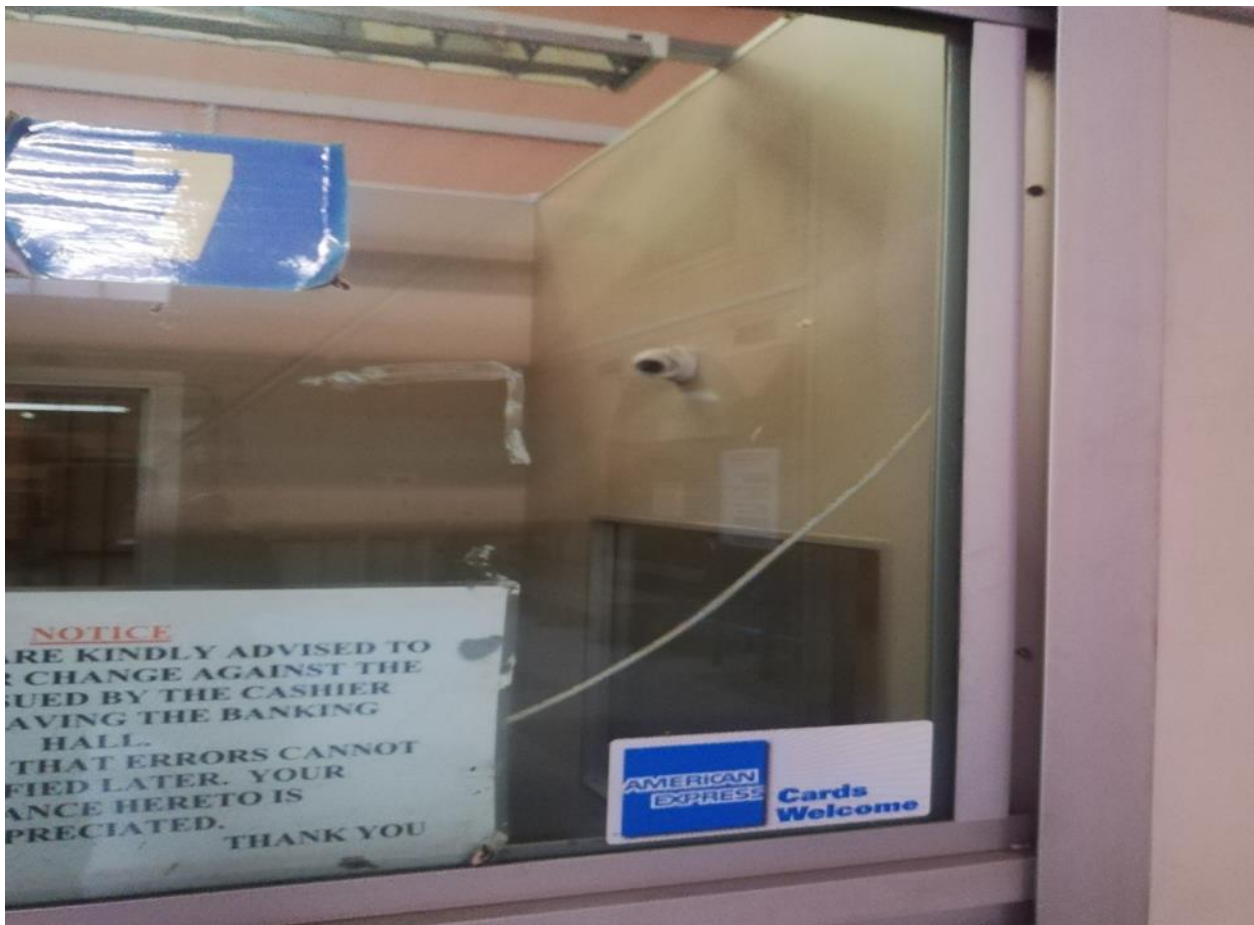
There is evidence of an CCTV installation however the system is non-operational. The monitors and equipment could not be located.

PICTURE INDICATING CCTV CAMERA
