SAH CONSULTING ENGINEERS

28 August 2023

INSPECTION REPORT AT 120 KENNETH KAUNDA ROAD , NORTHWAY , DURBAN NORTH

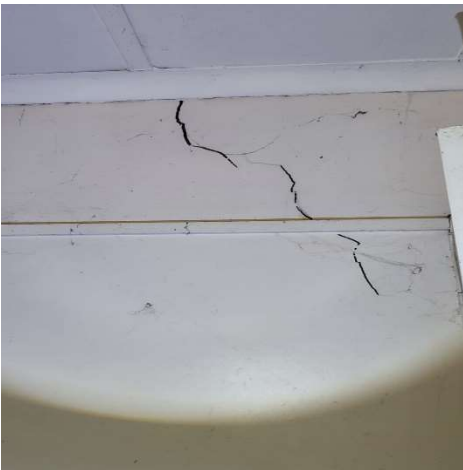
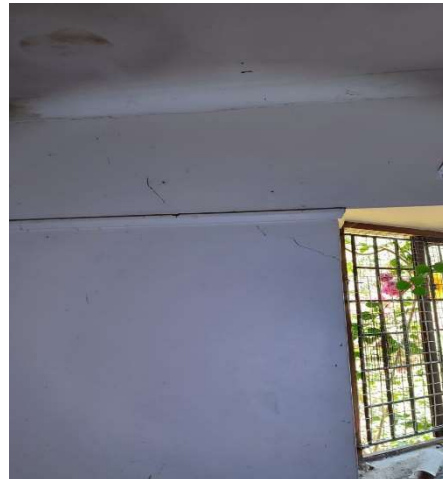
Front Far Right Room :

In this room three structural cracks were noticed. As this is a corner room with two external walls, two of the cracks were noticed on external walls and one on an internal wall. These cracks are severe with a width of 2 mm to 5 mm and running the length of 500 mm to 1000 mm. The locations of these cracks led me to believe that they are not purely simple settlement cracks.

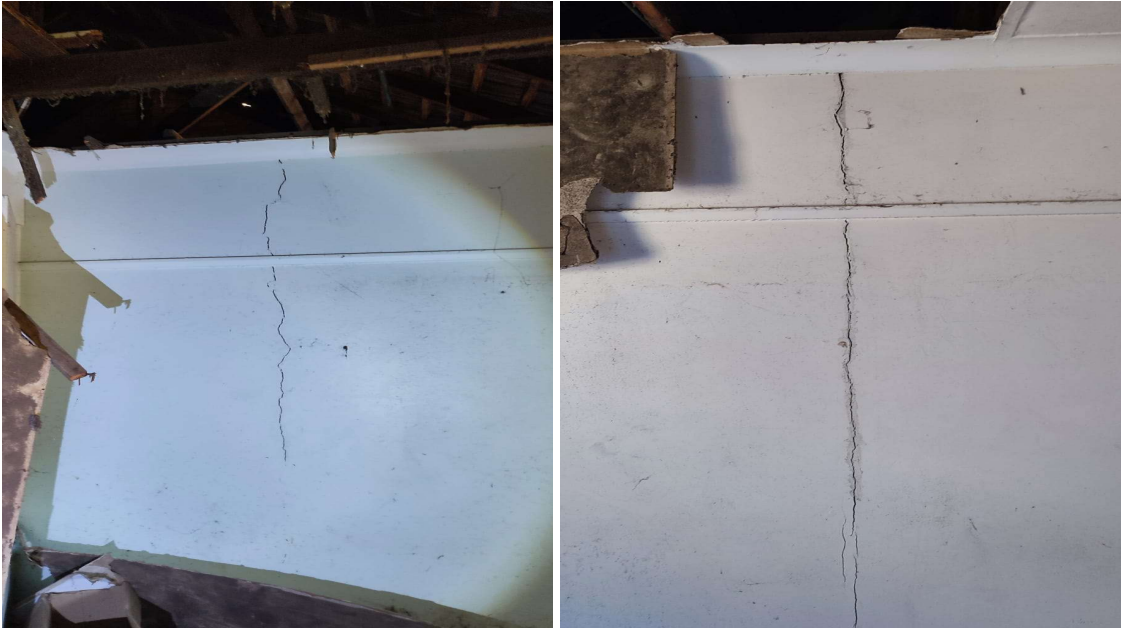
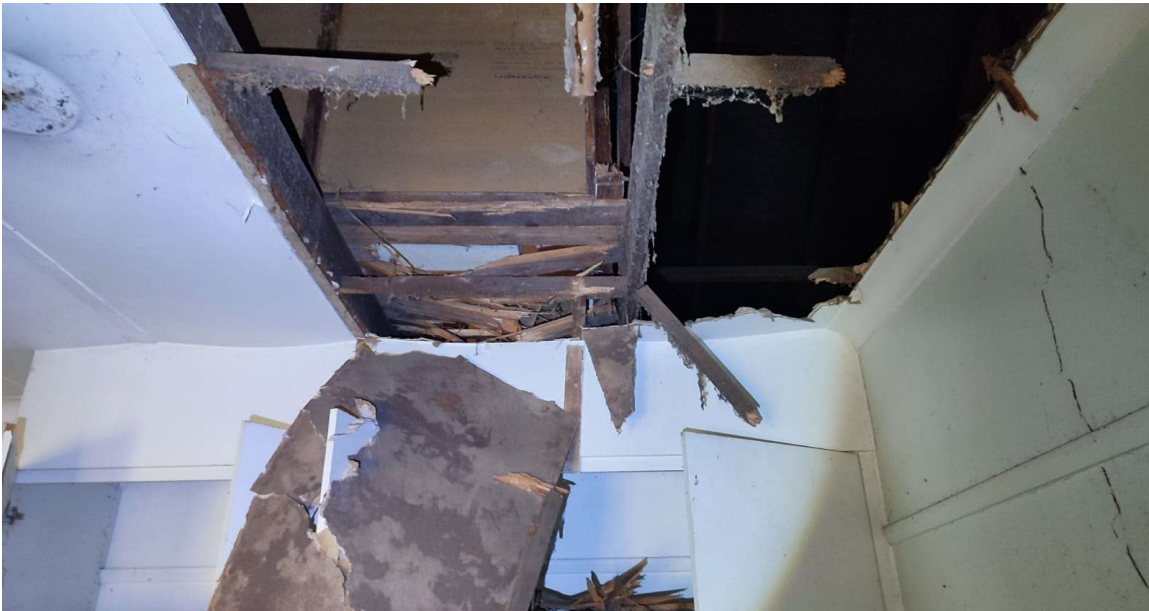
Front Middle Room :

This is the room that partially supports the first floor. Within this room another two cracks were noticed. This ranged from 2 mm to 4 mm wide and runs the length of 500 mm to 1500 mm. The greatest concern of this is that these walls partially

support the first floor and seeing them compromised explains some of the reasoning behind the first floor being compromised.

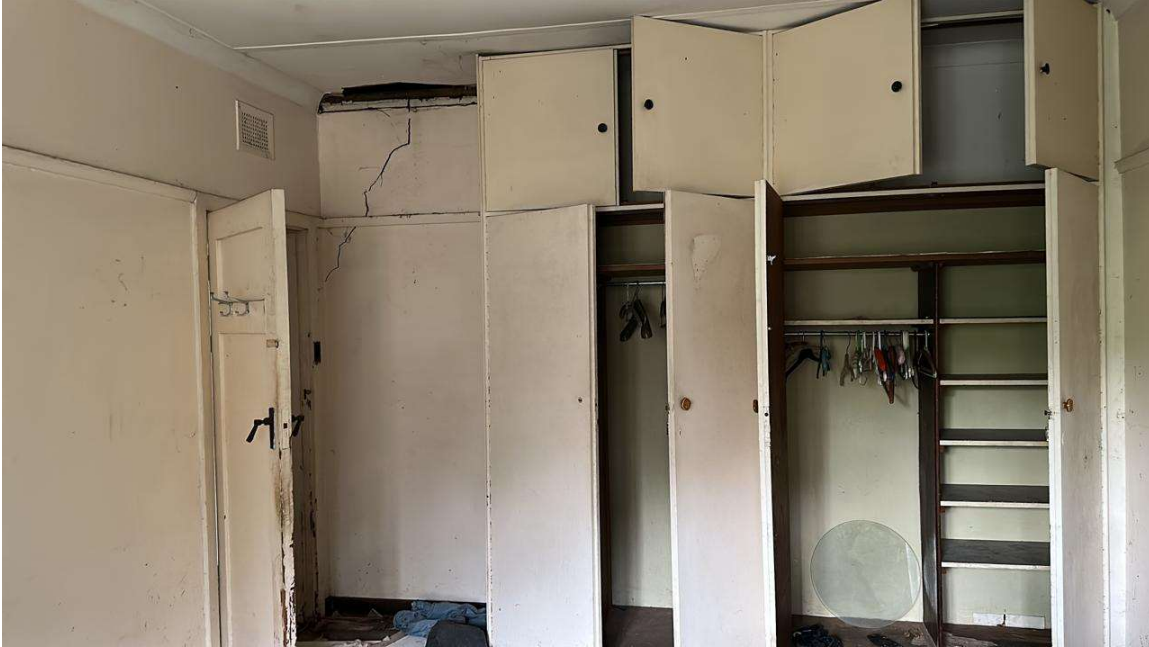
Rear Far Right Room :

In this room another structural cracks was noticed. The location of this is an internal wall. This is the staircase adjoining wall. This crack has a width of 3 mm and runs the length of 600 mm .

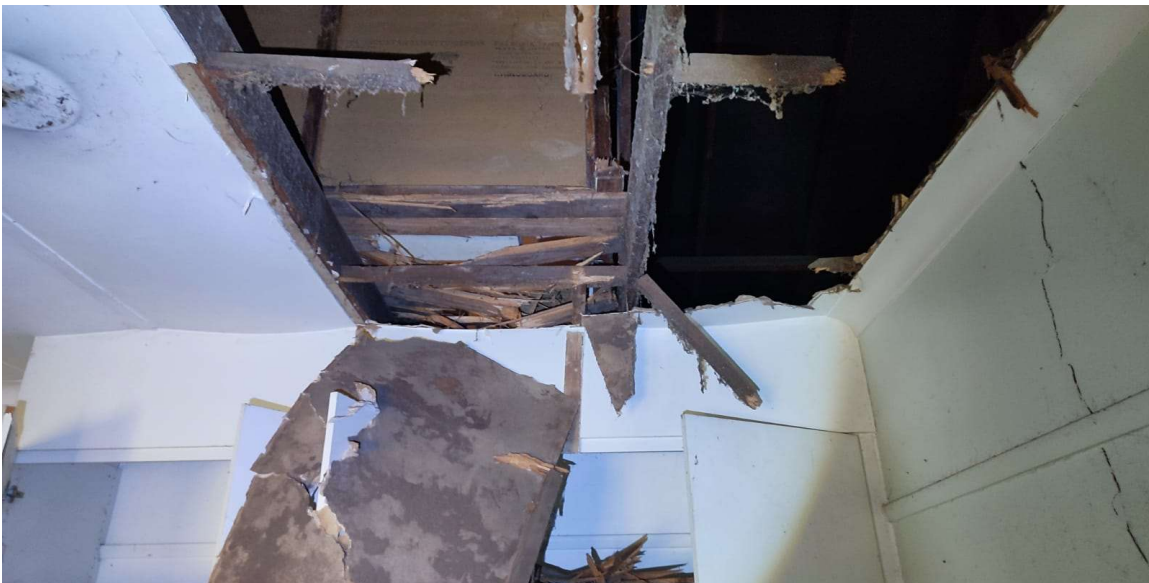
First Floor

The supports to the first floor have been severely damaged. The current floor is unstable and will need to be removed before any loading or occupation can occur. This is a hazard as many of the support beams and rafters have been damaged.

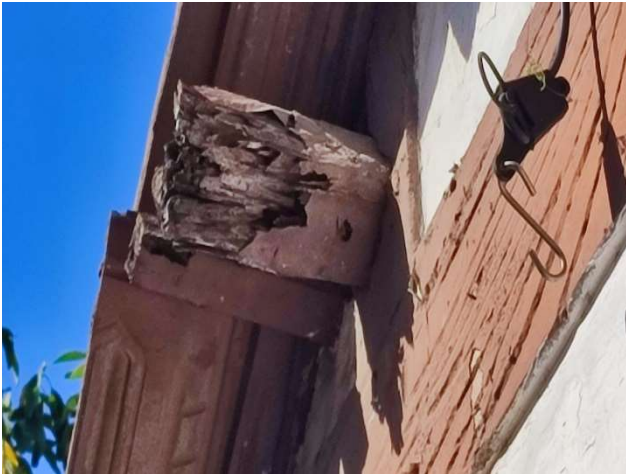
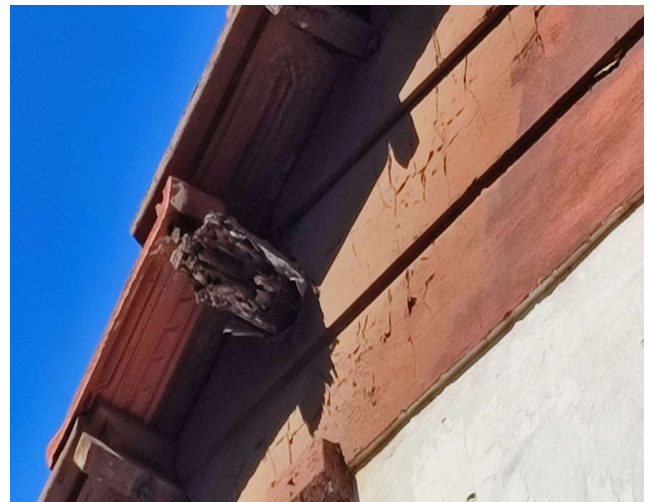
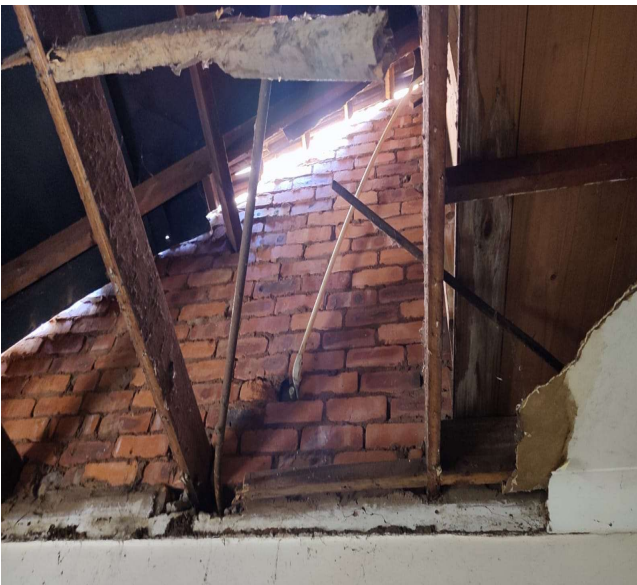
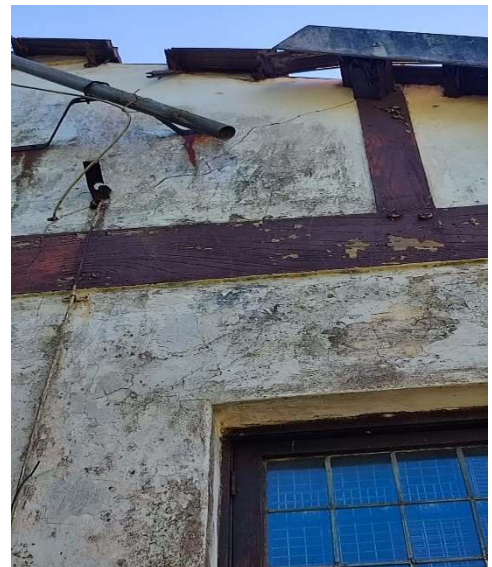
Roof

The roof has been severely compromised from rot and damage. The current structure is un salvageable. There are cracks running up the gable and at points the roof has pulled away from the brickwork. This has led to water damage. The rafters also shows signs of deflection and torsional movement. The roof appears to have been repaired at some time however this is not an option anymore due to the severe damage and rot it has sustained.

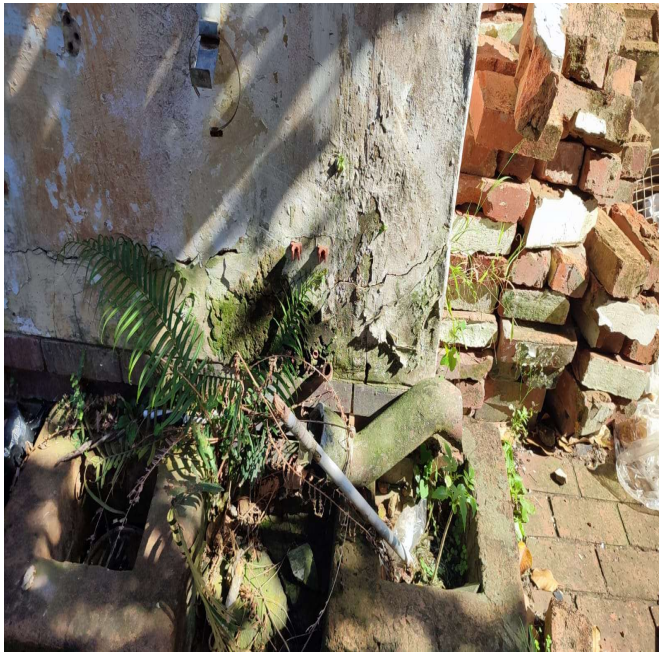
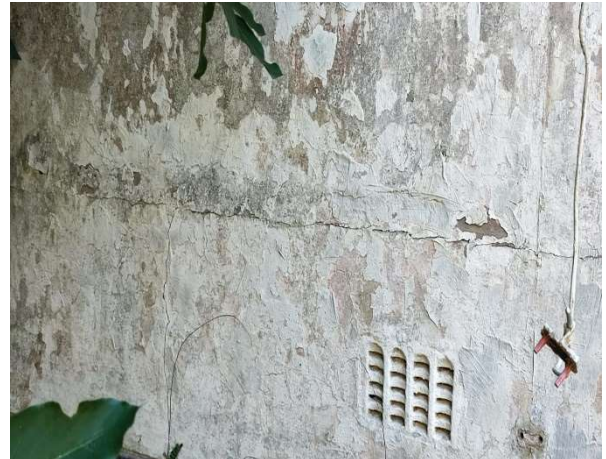
Ground Floor Slab

Movement and settlement cracks were also noticed around the perimeter of the entire building. These cracks, however not an issue now may pose a problem in the future .
