Alterations to
Existing Buildings on Erf 1319. Barkly East

HERITAGE REPORT

Vicente Property Holding (PTY) Ltd

RiBox

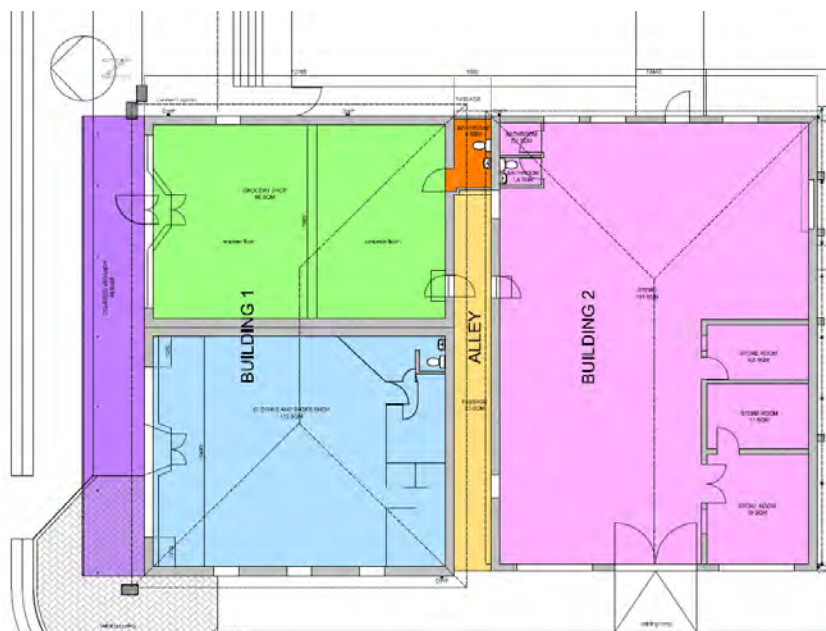
Figure 2

- Original veranda (indicated in purple on the figure 2 to the left)
- Existing Alley (indicated in yellow on the figure 2 to the left)

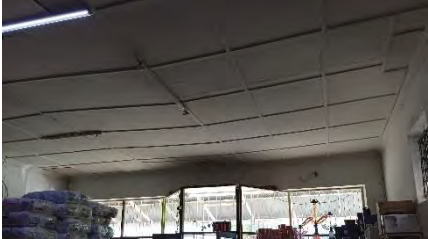
Building 1				
Level	Element		Observations and recommendations	Photos
Grocery & Miscellaneous shop	Roof Structure	→ Ceilings	<ul style="list-style-type: none"> → Existing ceiling is a modern gypsum ceiling board with a wooden strip with poor quality installation. → We propose replacing the existing ceiling and installing a non-combustible material ceiling. → Install new insulation: 135mm isotherm

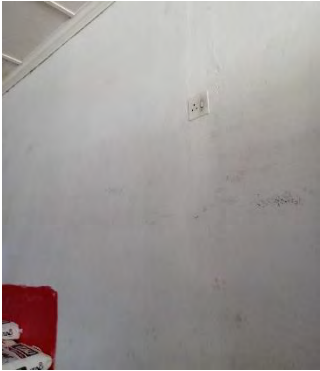
Walls	<ul style="list-style-type: none"> → Interior → Existing bathroom 	<ul style="list-style-type: none"> → The structure and wall plaster are in good condition. → Demolish existing bathroom walls in the alley. → Demolish internal walls and install steel structure as shown on drawings.

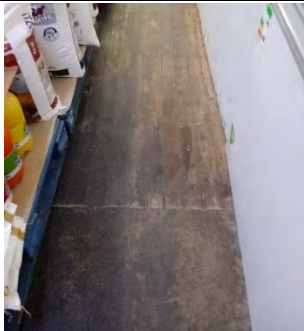
Floors	<ul style="list-style-type: none"> → Shop → Bathroom → Alley 	<ul style="list-style-type: none"> → Remove existing wooden floor, cast new concrete floor → Remove existing vinyl sheeting → Remove existing paving

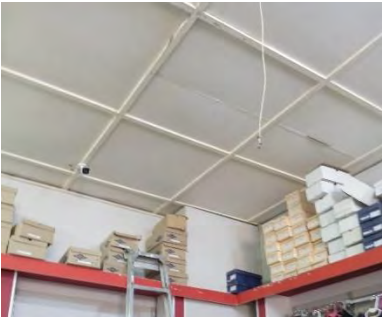
Gainde Fatma House (Clothes & shoe store)	Roof Structure	<ul style="list-style-type: none"> → Ceiling 	<ul style="list-style-type: none"> → Existing ceiling is a modern gypsum ceiling board with wooden strip, poor installation quality. → We propose replacing existing ceiling and installing non-combustible material ceiling. → Install new insulation: 135mm isotherm

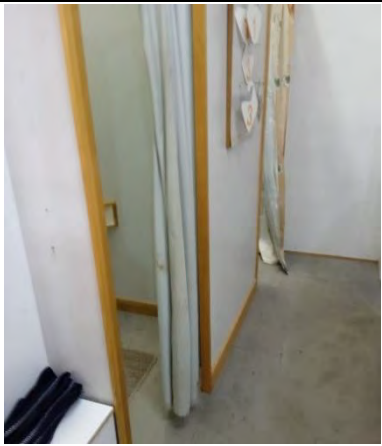
Wall	<ul style="list-style-type: none"> → Inside 	<ul style="list-style-type: none"> → Demolish existing bathroom brick walls → Remove dry walls → Demolish internal wall as shown on proposed ground floor plan

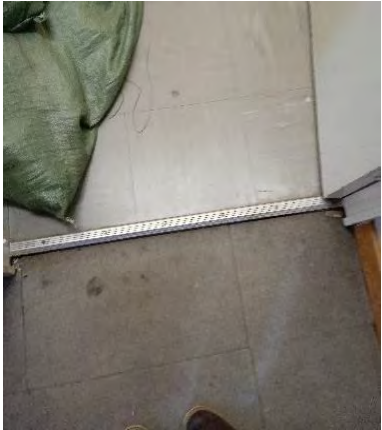
Floor	→ Shop	→ Remove existing carpet in the shop and existing vinyl tile in bathroom,

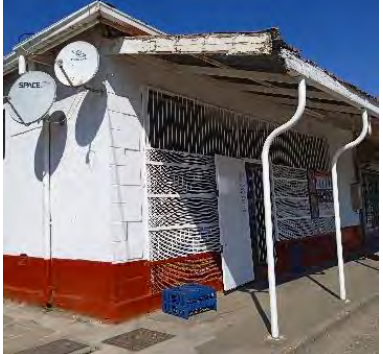
Exterior	Veranda Roof Structure	→ Sheeting → Purlins → Fascia/gutter/Rainwater pipe	→ Replacement of sheeting required. → Replace where required. → Install fascia, gutter, and down water pipe.

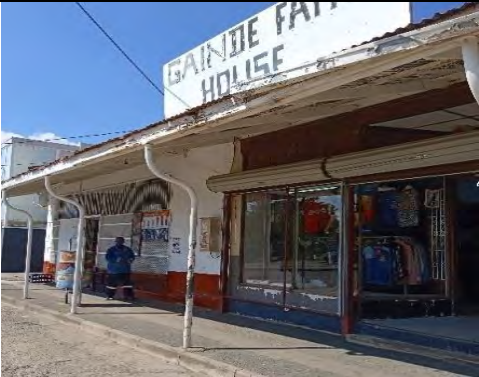
Veranda	→ Front shop	<ul style="list-style-type: none"> → Remove steel burglar bar and steel door → Remove roller shutter and steel frame → Remove wooden door & windows

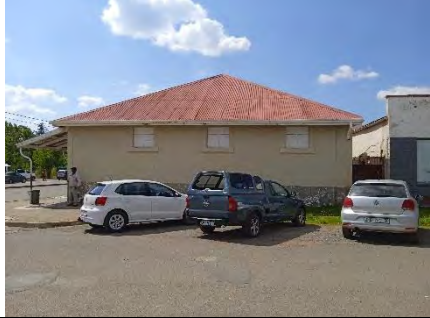
Wall	→ Plaster	<ul style="list-style-type: none"> → Re-paint walls → Remove steel windows and brick up exterior opening (the interior is already bricked up)

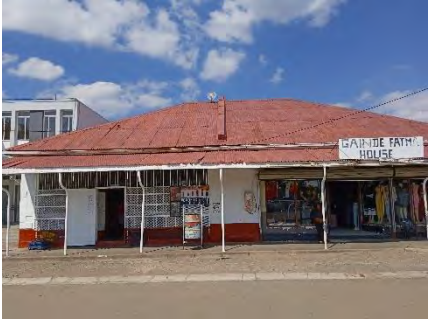
Roof structure	<ul style="list-style-type: none"> → Sheeting → Purlins → Fascia/gutter/Rainwater pipe 	<ul style="list-style-type: none"> → Seal, sand & paint roof sheets. → Remove & replace damaged roof sheets. → Replace existing trusses and purlins where required. → Replace existing fascia, gutter, and down water pipes

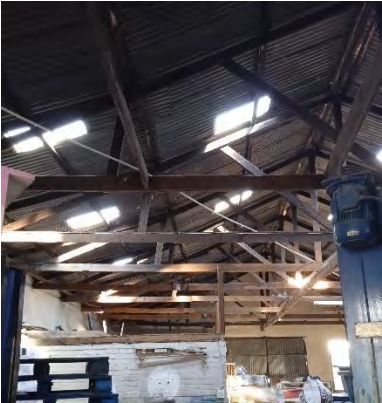
Building 2				
Level	Element		Observations and recommendations	Photos
Vacant	Roof Structure	<ul style="list-style-type: none"> → Sheeting → Purlins → Trusses → Rainwater goods → Ceiling 	<ul style="list-style-type: none"> → Replacement of sheeting required. → Replace. → To be replaced according to Architect and engineer's design. → Asbestos gutter to be replaced according to architect's specifications and engineer's design. → Remove existing ceiling at store

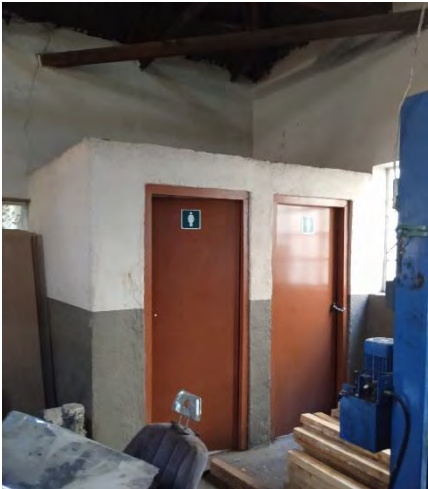
Walls	<ul style="list-style-type: none"> → Interior → Exterior 	<ul style="list-style-type: none"> → Minor cracks visible, re-plaster and repaint. → Demolish bathroom walls and storeroom walls. → Minor cracks and major chips visible, re-plaster and repaint on exterior walls.

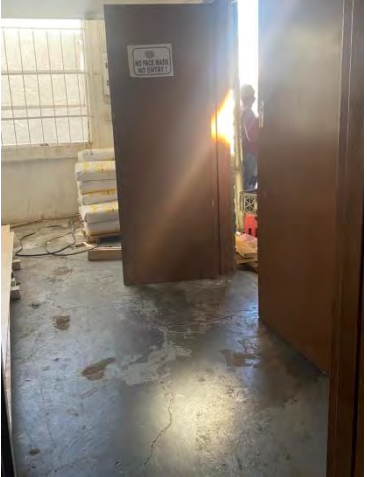
<p>Floors</p>	<p>→ Interior</p>	<p>→ Demolish existing concrete floor and cast new concrete floor at the same level of the building 1.</p>

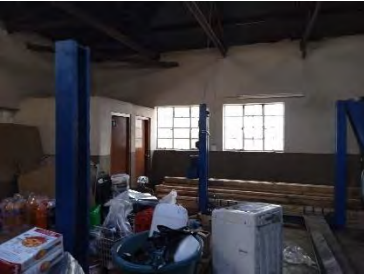
<p>Windows and doors</p>	<p>→ Interior/exterior</p>	<p>→ Remove windows and doors. Brick up opening according proposed ground floor plan.</p>
