**Cultural Heritage Investigation of Historical Steel-Framed Building
on the Property of PPC Slurry Operation, near Mafikeng, North
West Province**

**Pretoria Portland Cement Co. Ltd.
Slurry Operation
Mafikeng
North West Province**

**Graham Reeks & Francois Coetzee
Department of Anthropology & Archaeology
University of South Africa
PO Box 392
Pretoria 0003**

December 2012

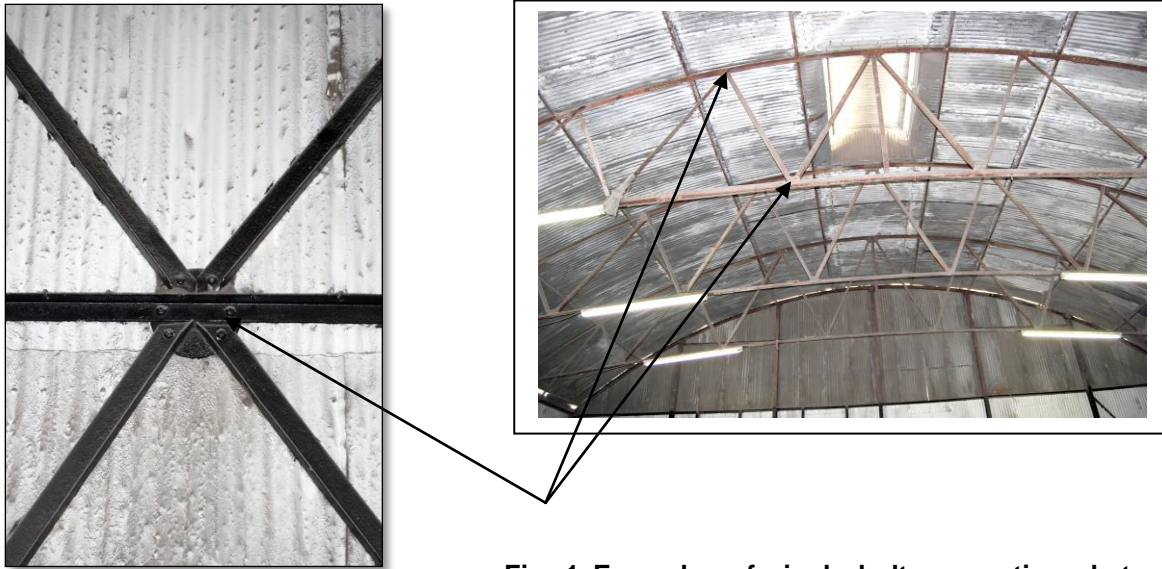
One outstanding feature of the design to any structural or mechanical engineer is the fact that virtually all of the connections are made with a single bolt point whereas modern structures would have anywhere from 3-6 bolts per attachment point. This design feature is part of the evidence that the structure is much older than was thought. What is clear is that the original bolted structural steel framework was designed in an age when building codes, if they existed at all, were less restrictive. This point is taken up again when the possible age of the structure is debated.

Fig. 1 Examples of single bolt connections between steelwork

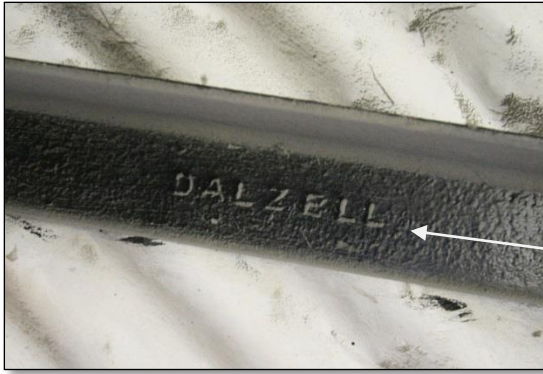
During the internal survey two of the pieces of structural steel were found to have the name of DALZELL in raised letters. It was formed during the hot rolling process of the steel angle section. No other names or identification marks were found. A search of the name Dalzell produced several sites which identified the name as that of a well known Scottish steel maker. They are still in existence in Motherwell Scotland but now form part of the TATA steel group. What is of significance is that they were in existence from around 1881 and were one of the largest steel makers in Scotland, eventually becoming part of the British Steel Corporation in 1967 (see 8.1.1).

Fig. 2 Rolled raised letters showing the name DALZELL

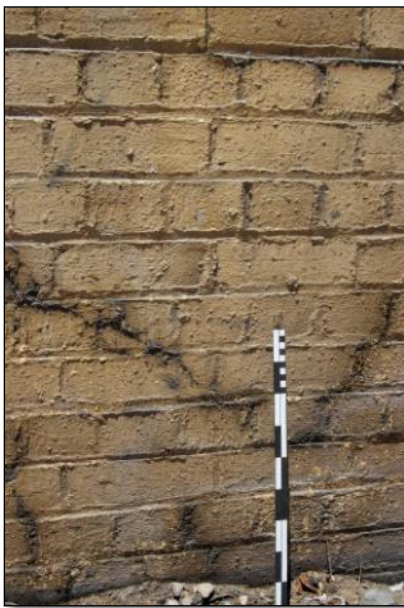
The steel structure is built on a raised foundation consisting of a brick foundation with buttresses aligned with the steel columns of the structure. The base of the columns is covered by brickwork in a low bund wall of 3-8 courses above the internal floor level. The external wall varies from 1.0 - 1.7 m above the hard standing area profile surrounding the building. Of interest is the brickwork which has been laid to an English bond configuration rather than the more modern stretcher bond (Fig 3).

Fig. 3 External wall showing brickwork in English bond.

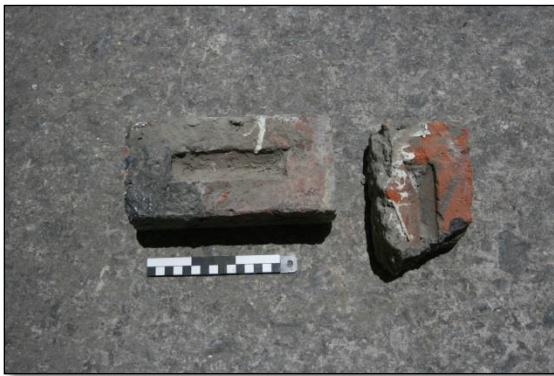
During the meeting with Frank Whitley the cracks in the foundation wall brickwork were discussed. The cracks display a typical lateral movement on the brickwork by following a general 45-degree line upwards from a point most commonly around 3-4 courses above the current ground or tarmac surface level. It was agreed that they are:

- Very old- the staining and dirt within the crack lines displayed this fact. It can be assumed therefore that the structure is now stable.
- Most probably has minimal impact upon the integrity of the foundation, but it could be strengthened if necessary.

Fig. 4 Handmade bricks used in the foundation walling.

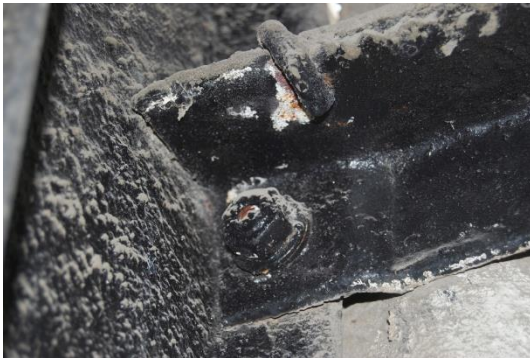
Fig. 5 Single bolt connection of a girt.

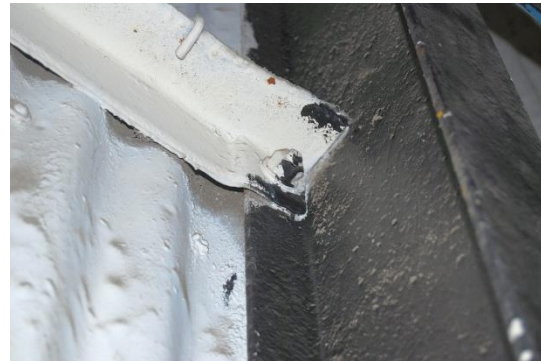
Fig. 6 Single bolt connection of a girt.

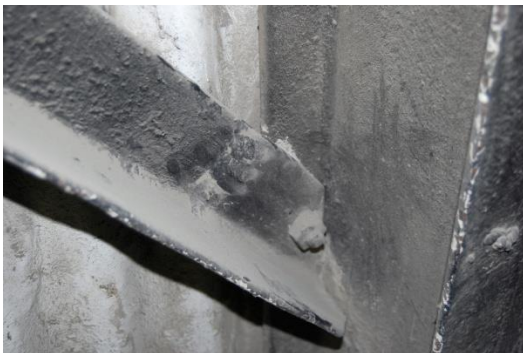
Fig. 7 Single bolt connection of a cross-brace.

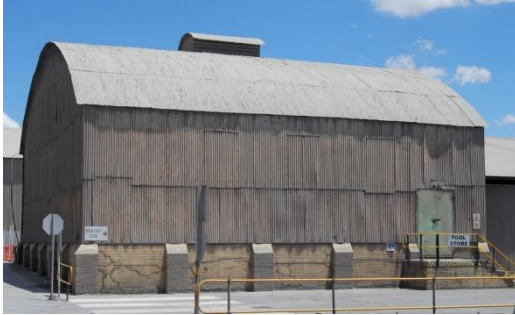
Fig. 8 View of the north-facing façade with inside the air vent on the top of the roof.

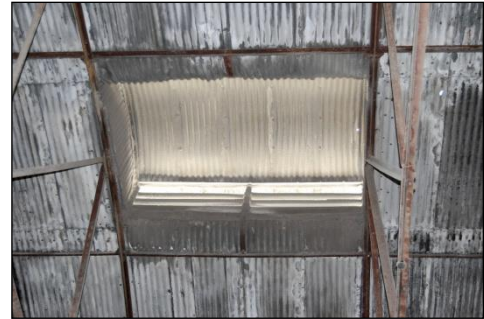
Fig. 9 View of the air vent from the building.

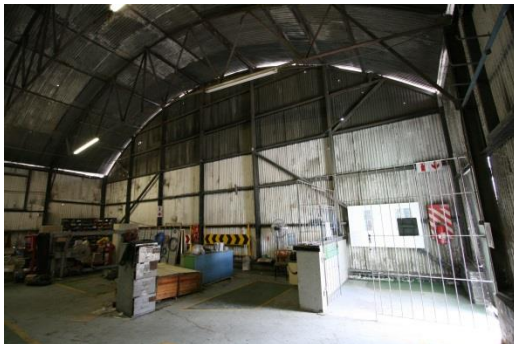
modification though. From the photographs below one can see that the 18m width of the building was designed as a clear-span structure. Many modern factory buildings have adopted this type of structure but it comes at a substantial cost because of the need for a stronger roof structure. Such a span was probably very much ahead of its time if the 1890s is accepted as the date of the building.

Fig. 10 View of the clear-span structure of the building looking towards the West gable.

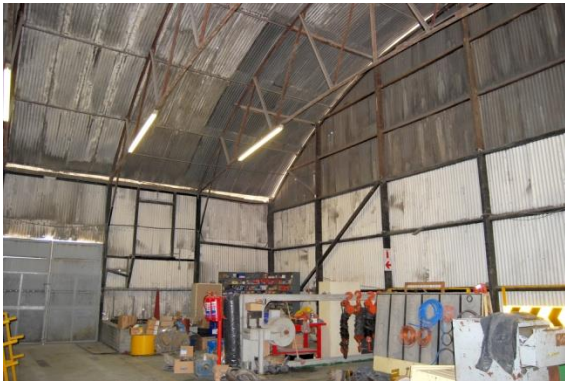
attachment of the timber members to each other or a mechanism of holding the timber columns to the base timber plate. One would assume that bolts are used but none are visible. Some of the timbers show evidence of cracking/ageing and hence the integrity of the timber is questionable

What defies logic is the lack of suitable cross bracing, especially above the point at which the diagonal braces meet the columns. There are two shorter diagonal braces, but they are only effective to the quadrant of the frame in which they are attached. The top three levels of panelling have no diagonal cross bracing and so most probably rely on the integral strength of the attached corrugate sheeting for lateral strength and wind resistance.

Fig. 11 View of the timber structure gable end looking south-west.

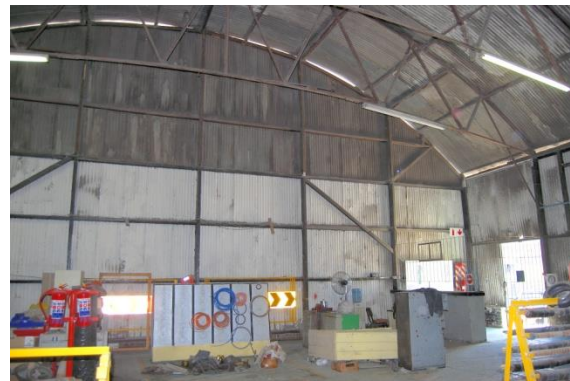
Fig. 12 View of the timber structure gable end looking north-west.

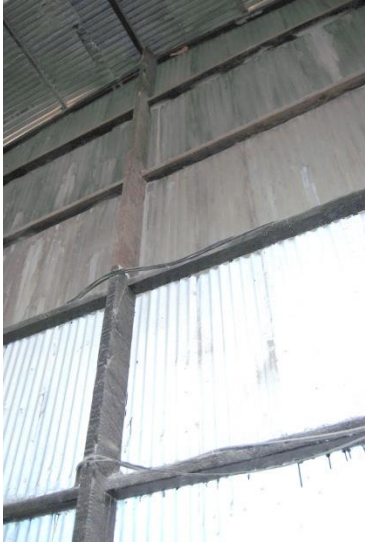
Fig. 13 One of the main timber columns with timber girts.

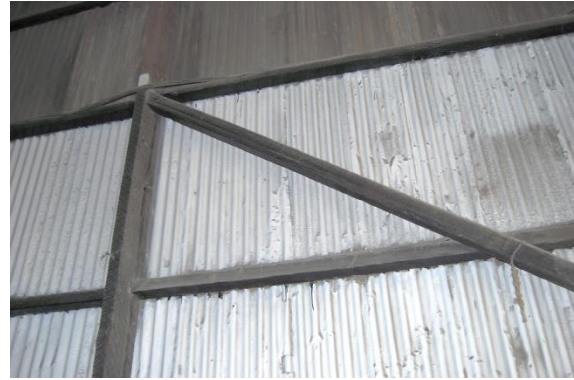
Fig. 14 A column with a diagonal timber brace. There was no obvious means of mechanical connection between the timbers.

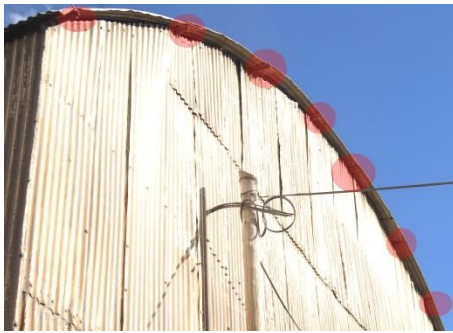
Fig. 15. Irregular cutting of the roof sections support the hypothesis that the structure was cut and shortened

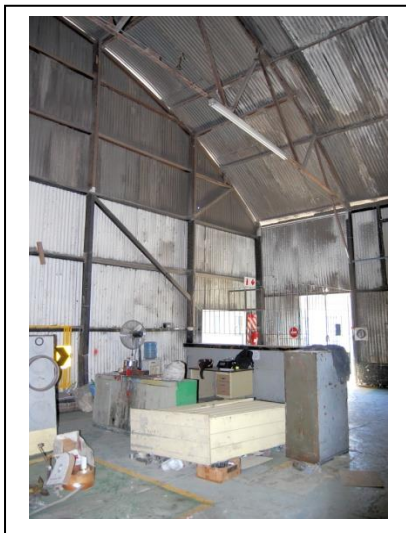
Fig. 18 North-west corner, note the lack of cross bracing on the north wall. The same is visible in Fig 14.

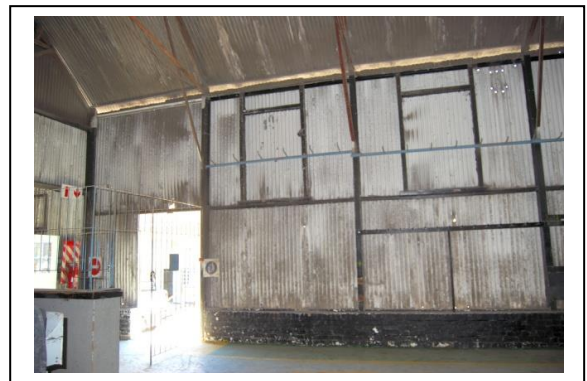
Fig. 19 North wall by doorway. The rectangles on the wall are timber frames of earlier windows.

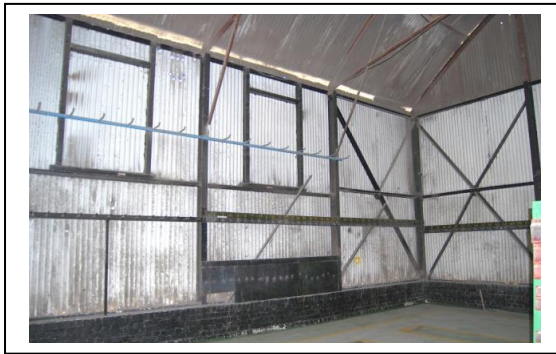
Fig. 20 North-east corner, note the bund wall.

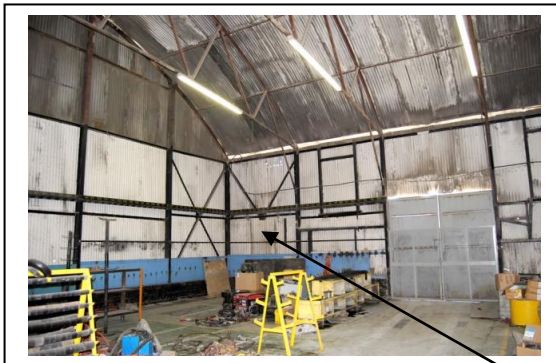
Fig. 22 South-east corner with double door. Note the missing lower cross braces.

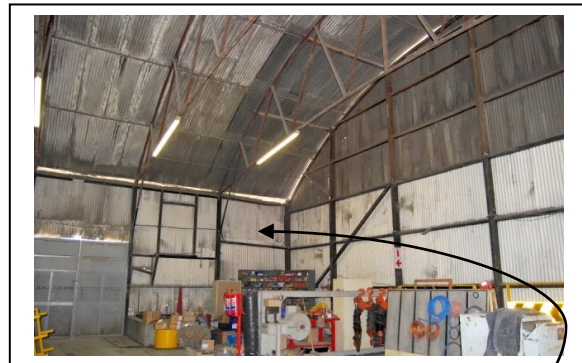
Fig. 23 South-west corner which ties in with Fig 16. Note the lack of cross bracing

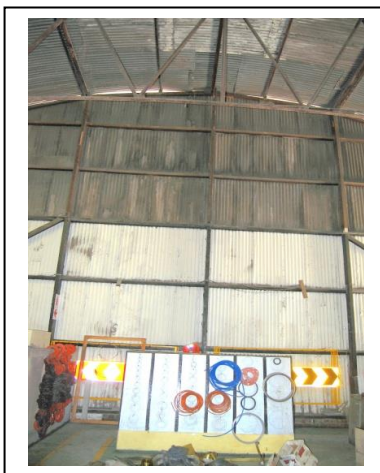
Fig. 24 West gable end with timber structural frame.

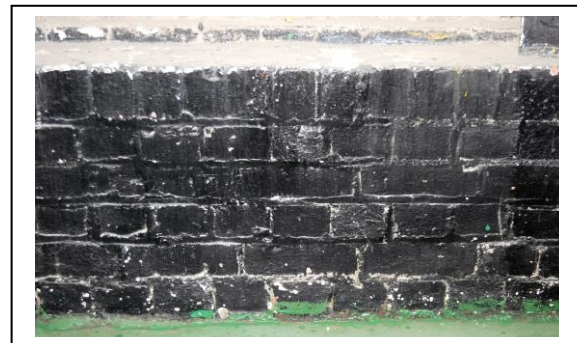
Fig. 25 English bond brickwork on the internal bund wall.

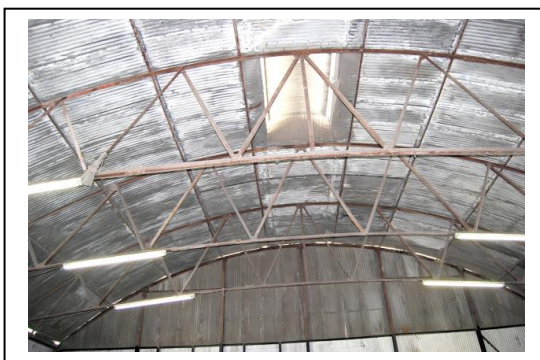
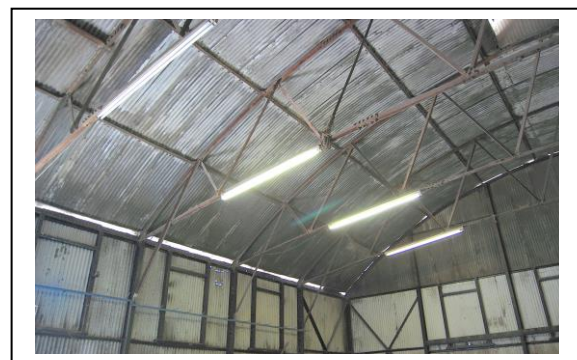
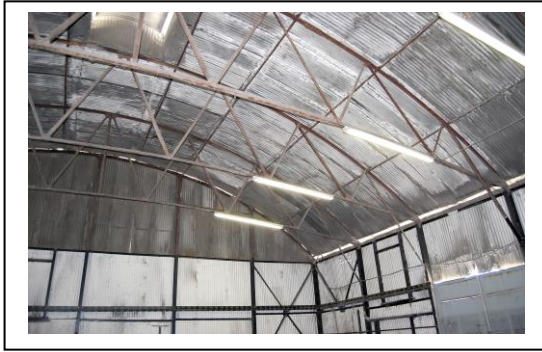
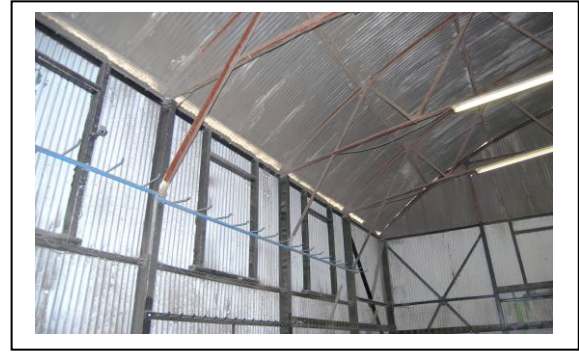
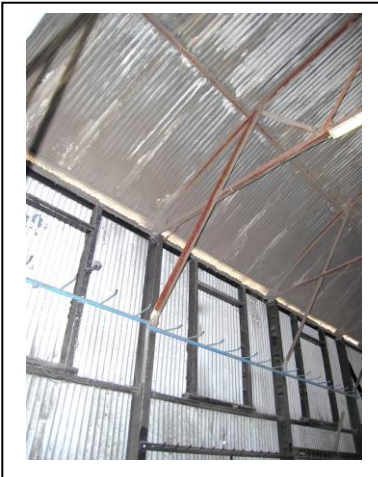
Figs 26 – 30 show the detail of the roof truss steelwork. What can be seen is the complete lack of any cross bracing for windage and the roof sheeting appears to be a structural unit between the trusses and purlins.

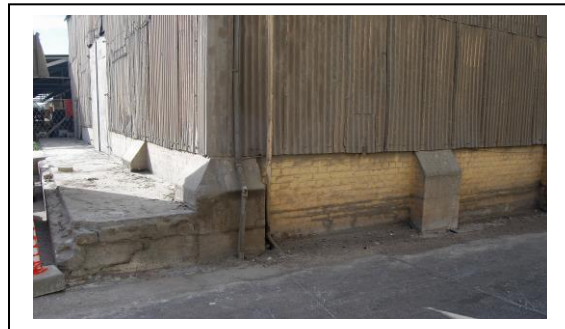
Fig. 38 buttresses on south-east corner

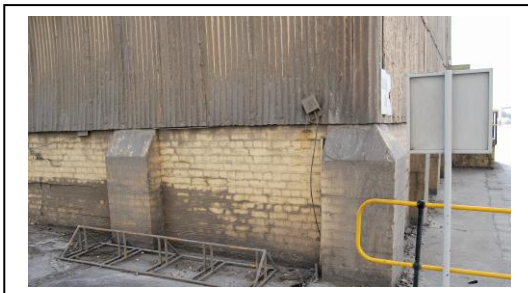
Fig. 39 Buttresses on the north-east corner.

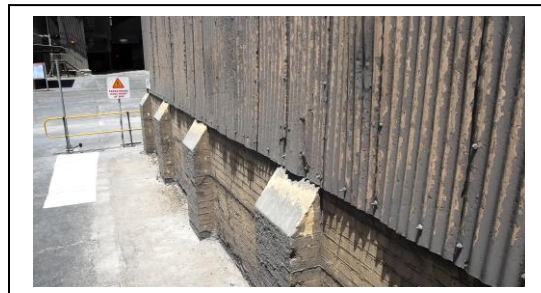
Fig. 40 Buttresses on the north wall.
