FINAL HIA REPORT FOR PROPOSED TOWNSHIP DEVELOPMENTS (BOKSBURG WEST EXT.7 & LILIANTION EXT.7) LOCATED ON PORTIONS 410 & 411 OF THE FARM DRIEFONTEIN 85IR, BOKSBURG, GAUTENG FOR APPLICATION FOR ALTERATIONS AND DEMOLITIONS

REPORT: APAC015/39

August 2015

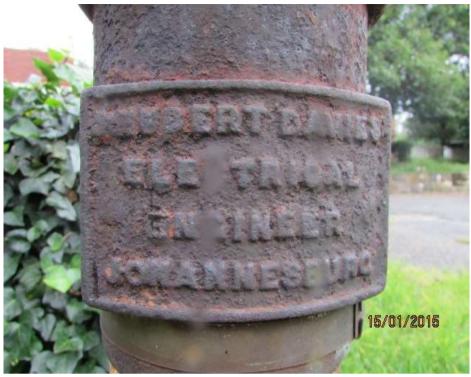
Figure 12: Plaque on lamp pole. Hubert Davies Electrical Engineer Johannesburg. Dating to between the late 19th and early 20th centuries.

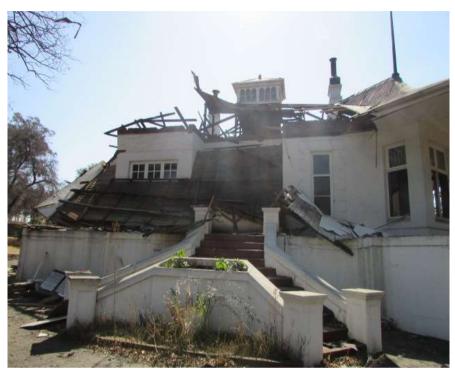
What is however clear (**See Photos to follow**), is that the damage to the house has been extensive, making renovation and or preservation virtually impossible. Furthermore, it is evident that although the original structure and some light fittings and other features dating to the late 19th tot early 20th centuries had remained intact until recently, that many modern changes, alterations and additions had taken place over recent years. This includes the bathrooms, kitchen and other internal changes. Based on the August 2015 assessment the following is therefore recommended:

Figure 13: Front view of house in August 2015 (see Figure 9 for comparison).

1. That the demolition of the structure be allowed. A permit will have to be applied for at the Gauteng-PHRA for this purpose

- 2. It is furthermore recommended that any remaining fixtures such as the flooring boards, fireplaces and original wooden (built-in) cabinets and wall features be salvaged and utilized in the renovation and alteration of the house on Portion 410 (it dates to the same time-period)
- 3. That a plaque be erected on the site that will provide information on the house and history of the area that will commemorate the historical house and mining history of the area

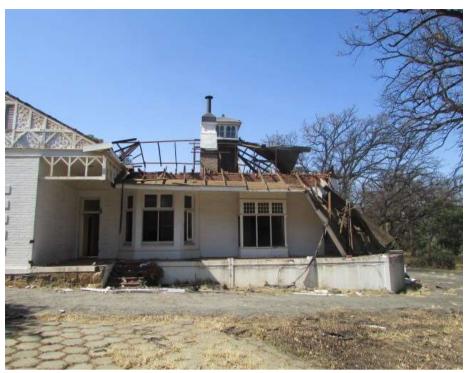
Figure 14: Another view of the damage done (see Figure 10 for comparison).

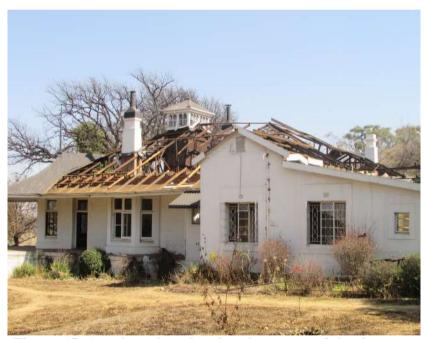
Figure 15: Another view showing the extent of the damage.

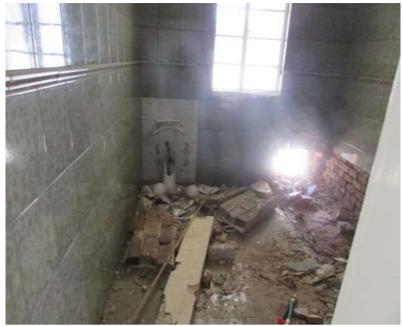
Figure 16: Damage to one of the bathrooms.

The basins, toilets and other features & fittings have been ripped out & destroyed.

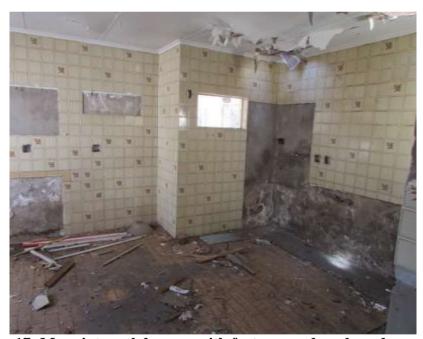
Figure 17: More internal damage with features and cupboards removed.

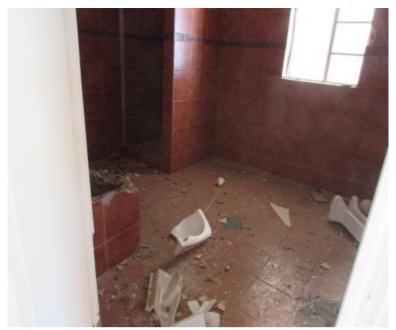
Figure 18: Bathroom fittings broken and lying around.

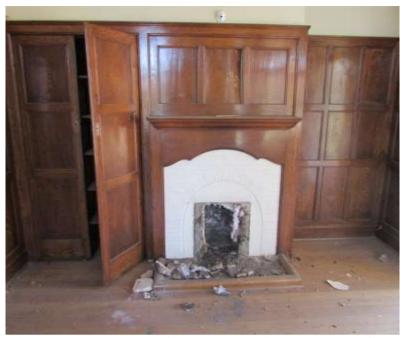
Figure 20: The second fireplace showing also some of the Built-in wooden features that can be salvaged.

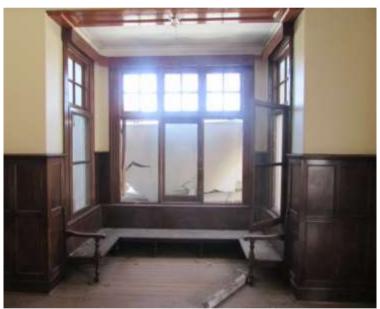
Figure 23: Wooden feature, including benches.

This feature needs to be salvaged and is possibly part of the original house (dating to the late 19th/early 20th century).

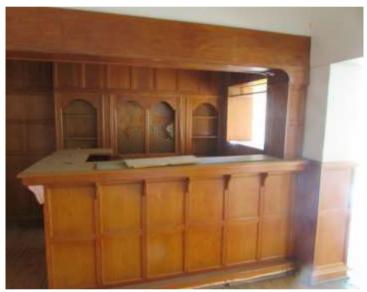
Figure 25: Recent bar feature in the house. This can also be salvaged. A similar feature is also situated in the house on Portion 410.

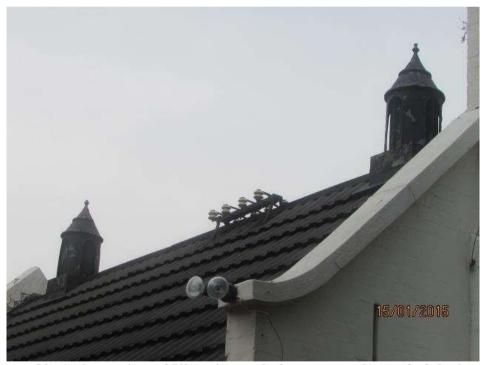
Figure 32: A closer view of Victorian-style features on the roof of the house.

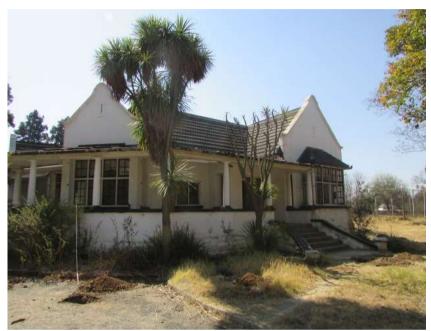
What is clear however (See Photos to follow), is that although damage to the house has been extensive, renovation and preservation (alteration) would be possible. Furthermore, it is evident that although the original structure and some light fittings and other features dating to the late 19th tot early 20th centuries had remained intact until recently, that many modern changes, alterations and additions had taken place over recent years. This includes the bathrooms, kitchen and other internal changes. Based on the August 2015 assessment the following is therefore recommended:

Figure 34: View of house in August 2015 (for comparison see Figure 28).

- 1. That Alterations to and renovation of the structure be allowed. A permit will have to be applied for at the Gauteng-PHRA for this purpose
- 2. It is furthermore recommended that any remaining fixtures such as the flooring boards, fireplaces and original wooden (built-in) cabinets and wall features be retained and utilized in the renovation and alteration of the house on Portion 410. Salvaged features from the house to be demolished on Portion 411 can be re-used here as well (it dates to the same time-period). Detailed architectural plans for the alterations/renovations will have to be drafted and submitted as part of the application

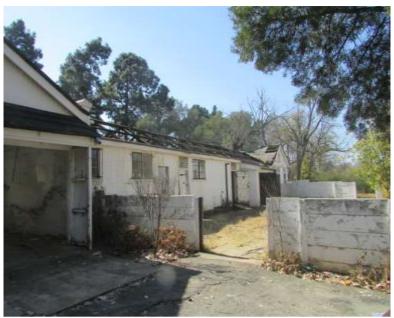
Figure 36: Damage to associated features (labourer's houses).

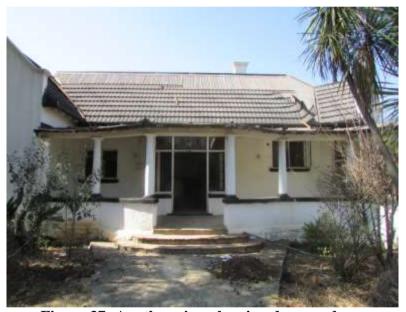
Figure 37: Another view showing damage done.

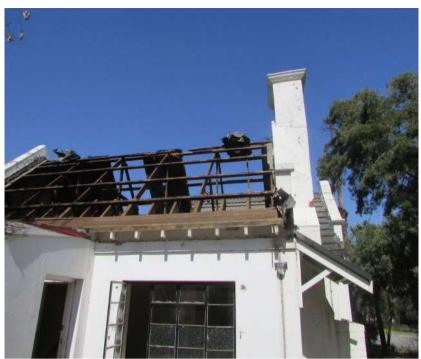
Figure 38: A view showing damage to roof and indicating removal of Victorian features (see Figure 32 for comparison).

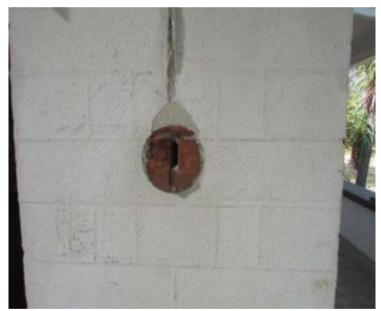
Figure 39: All light fittings and other movable wall features have been removed.

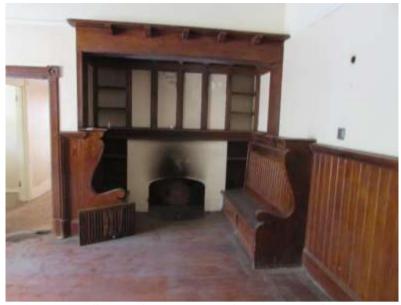
Figure 40: Some of the wooden features and flooring is still intact. This is similar to one in the house on Portion 411 & need to be retained.

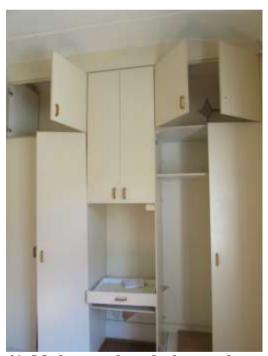
Figure 41: Modern cupboards that can be removed.

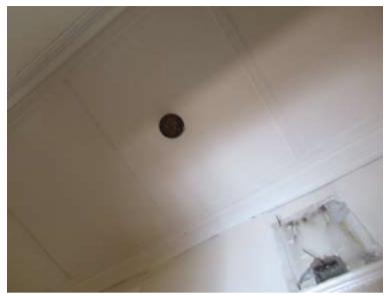
Figure 42: All lights have been removed as well.

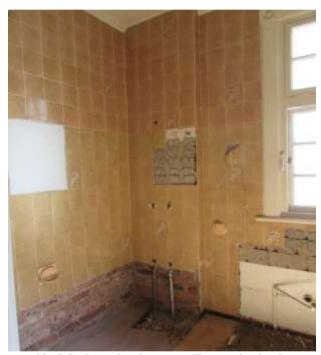
Figure 43: Modern bathroom. Extensively damaged.

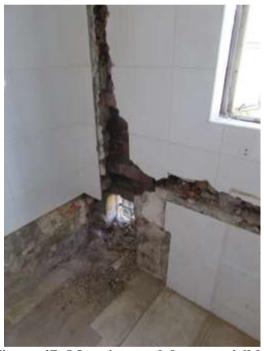
Figure 47: More internal damage visible.

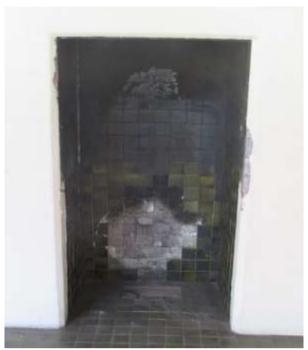
Figure 50: Damage visible to one of the fireplaces.

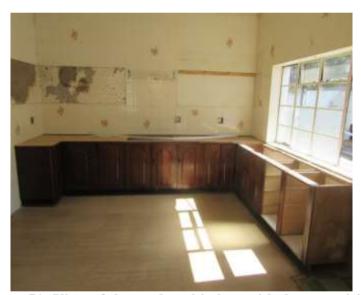
Figure 51: View of the modern kitchen with damage visible.

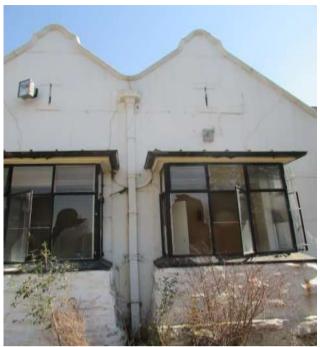
Figure 52: View of a back section of the house showing some damage.
