**FINAL REPORT
PHASE ONE AIA 13 – 27 OCTOBER 2009
REMAINDER FARM 1511
(FORMERLY PORTION OF PLATTEKLOOF FARM 394)**

**HWC REF No. HM/CAPE TOWN/PLATTEKLOOF/FARM 1511 BARONETCY
PERMIT No. 2009/10/001**

26 February 2010

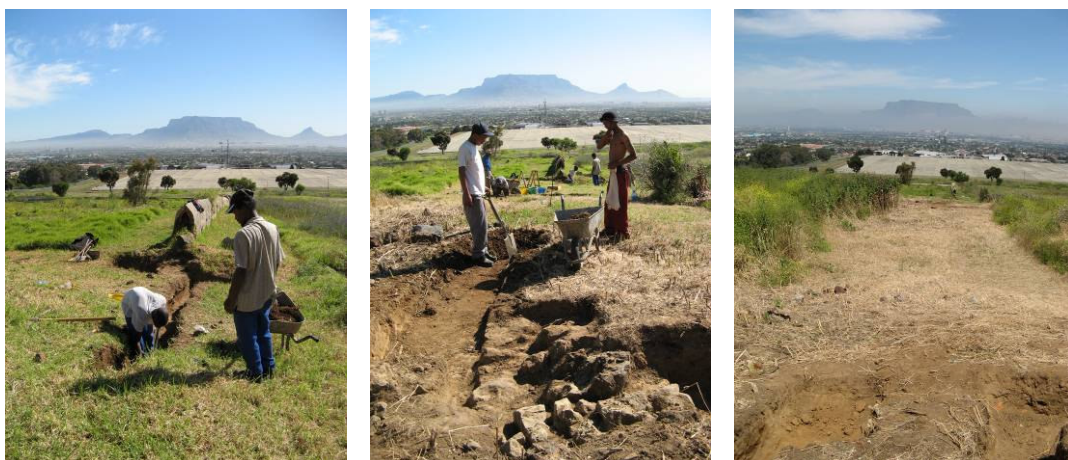
area to try and pick up traces of the buildings. Only the two tests closest to the werf wall had conclusive results. The two tests higher on the hill, were less fruitful: the ground being extremely hard (possibly owing to inclusion of decomposed clay brick), no clear evidence of stone foundations could be found, although a couple of 19th century refined earthenware fragments and a few fragments of dark green glass were uncovered.

Figure 6: View of the trenches in the location of the 'Slave lodge'. The image in the middle shows shallow remains of outer wall. The image on the right shows a suggestion of a foundation, but is not conclusive. The yellow soil of decomposed brick is clearly visible.

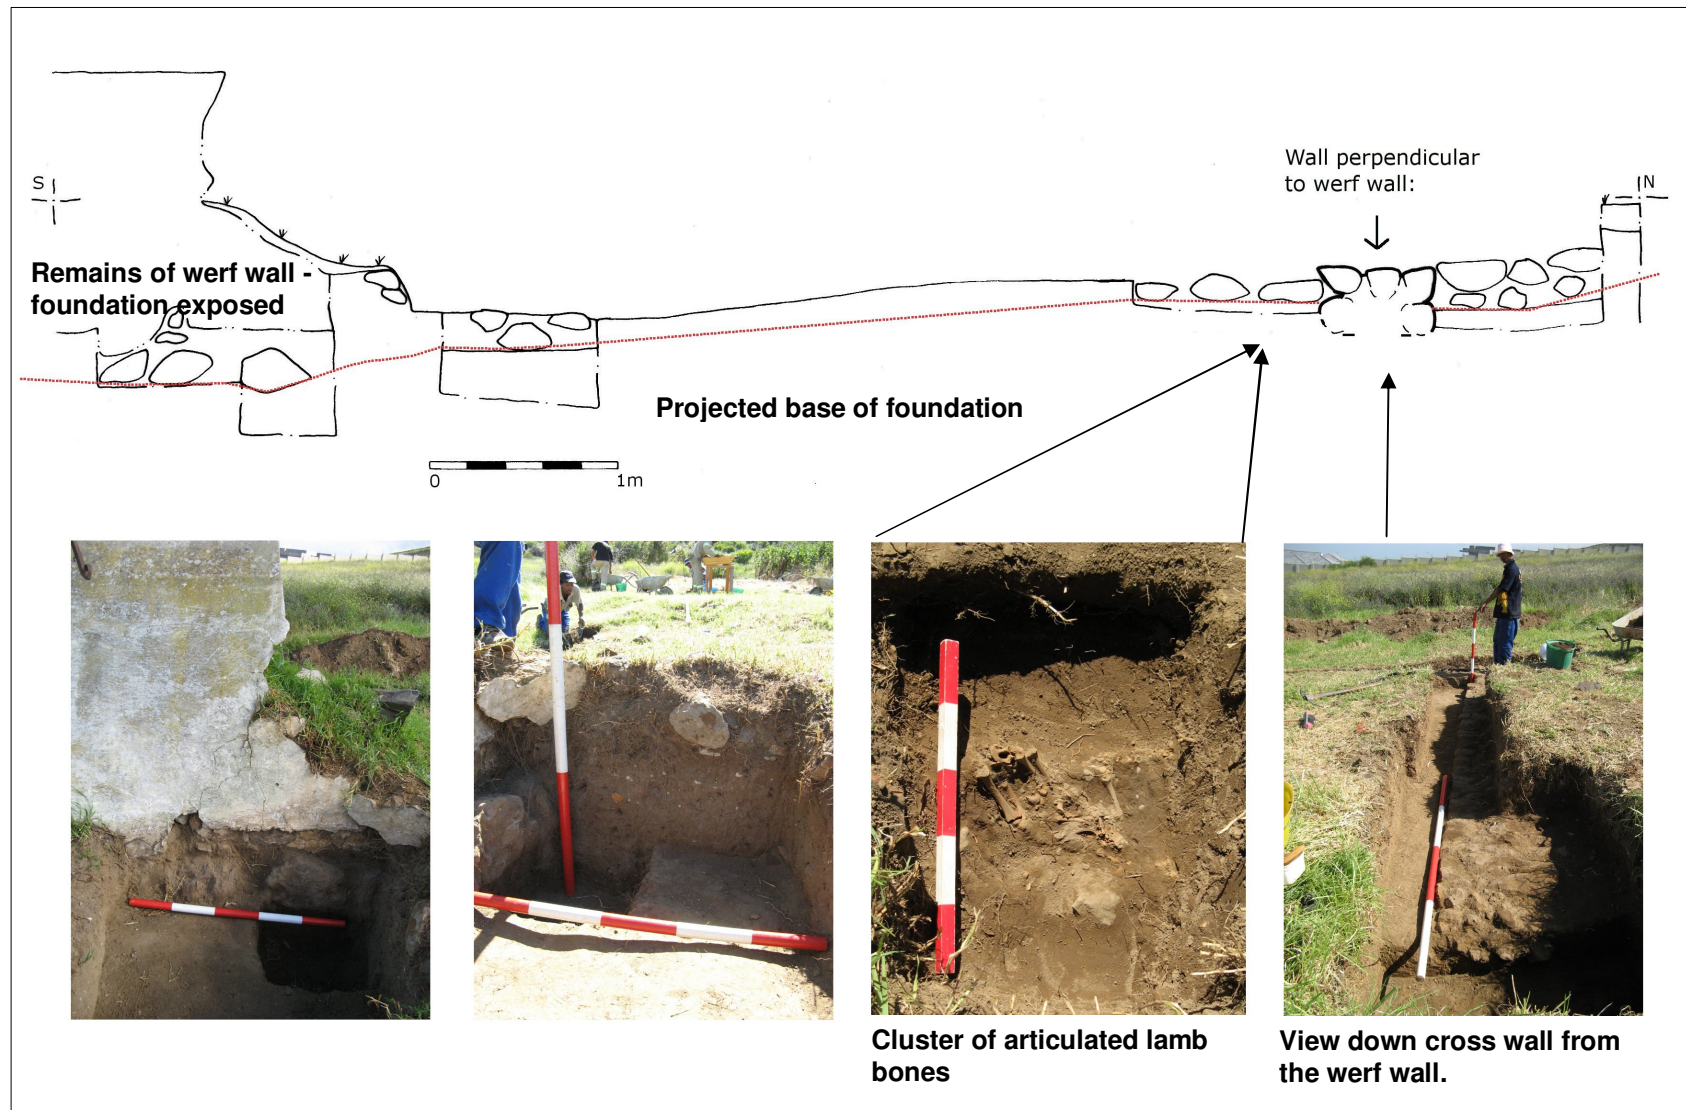
Figure 8: Section of Test area Pt 6.2 closest to the remains of the werf wall. The would correspond to the location of the first of the three buildings in Figure 4.

The presence of at least 1 articulated juvenile small bovid, and the post cranial remains of another 4, had been uncovered in what would have been the corner formed between the werf wall and the wall of the structure (Figure 8). This is unusual, and according to Smith (pers comm. 2009) is reminiscent of a similar finding at Kasteelberg of a small lamb being buried (possibly wrapped in leather) the bones stained with ochre. Some ochre was uncovered in the excavation, but it is naturally occurring in the area, and may be incidental.

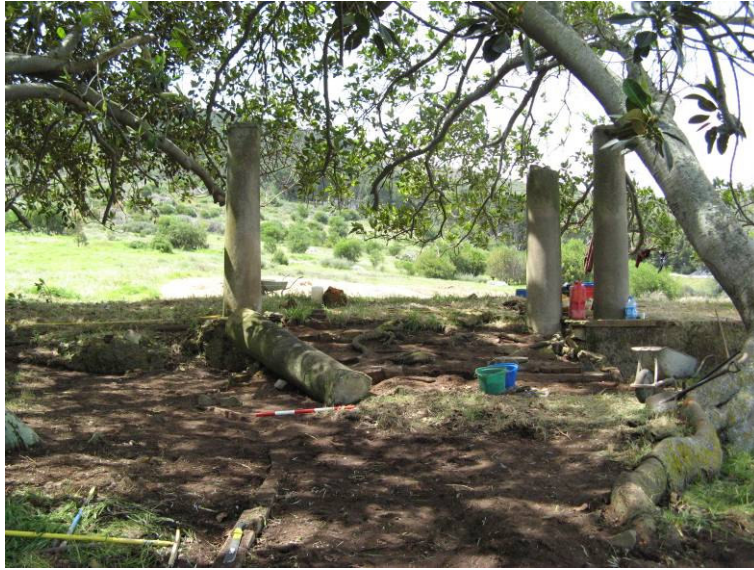
Figure 12: View of the ruins of the dwelling house. The roots of the wild fig to the left of the photograph has invaded most of the foundations on the western end of the ruins.

The ruins of the main house can be incorporated into the present design as a folly. The roots of the fig trees have entwined with the remaining foundations and any attempts to remove the trees would undermine the remaining foundations particularly of the stoep wall. In some cases the roots are the only indication of features that have disappeared eg the wall enclosing the front of the house. The trees themselves are a significant feature, given their size.

- The incorporation of the ruins of the main house in the recreation open area is acceptable. Care should be taken to prevent disturbance of the sub-surface deposits.

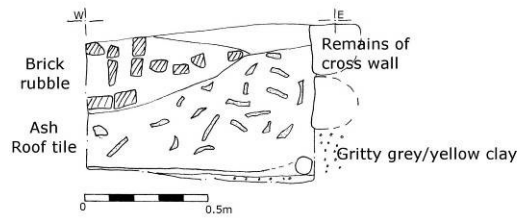
A dense layer of ash and fragmented Marseille roof tiles¹ was found throughout the areas tested, and in some cases underneath brick rubble, suggesting that the roof collapsed in the fire and some time after, the walls caved in. It is likely that the tiles are contemporary with the c1920s remodelling of the house which Neethling (2003) associates with the stoep pillars.

Figure 15: SW section of Test A, clearly showing the a thick layer of ash and roof tile abutting the remains of the foundation (to the right of the photo).

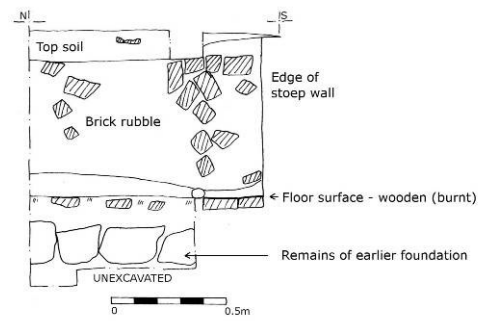
Figure 16: SE section of Test B. Once again a thick layer of brick rubble is visible. At the base of the test is the remains of a foundation perpendicular to the stoep wall.

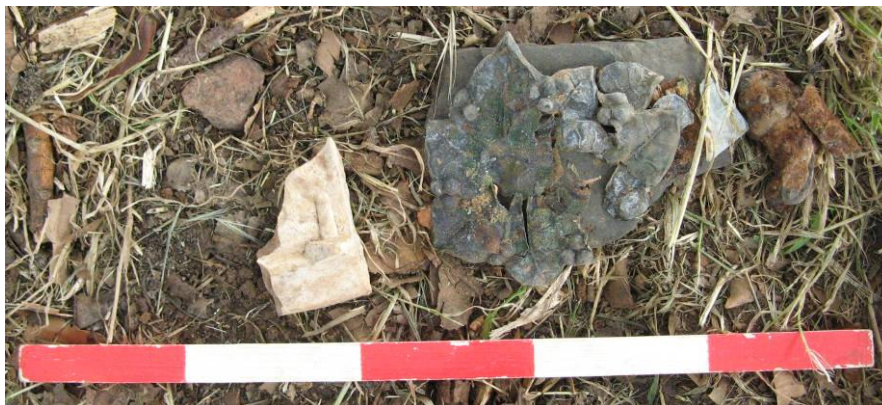
Figure 17: Remains of decorative stone moulding and metal work. Melted metal was also found in the same test, confirming fire damage to the structure.

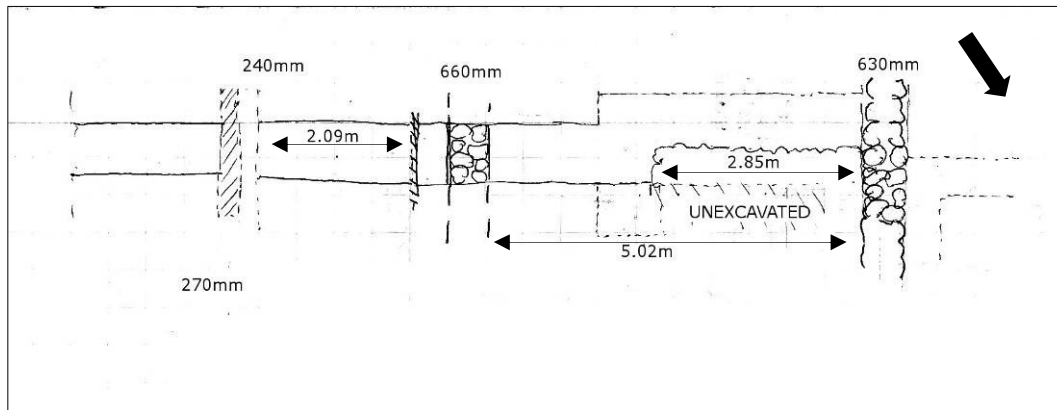
The wall foundations vary between 630-660mm thick. The interior span is 5.02m, which is consistent with 18th century buildings. Based on the Deacon survey (1992) the granary was about 20m long. As with the other outbuildings, these foundations are relatively shallow, suggesting that mechanical means were used to assist their removal.

Figure 20: Sketch plan of the 'Granary' trench showing the wall thicknesses (Not to scale).

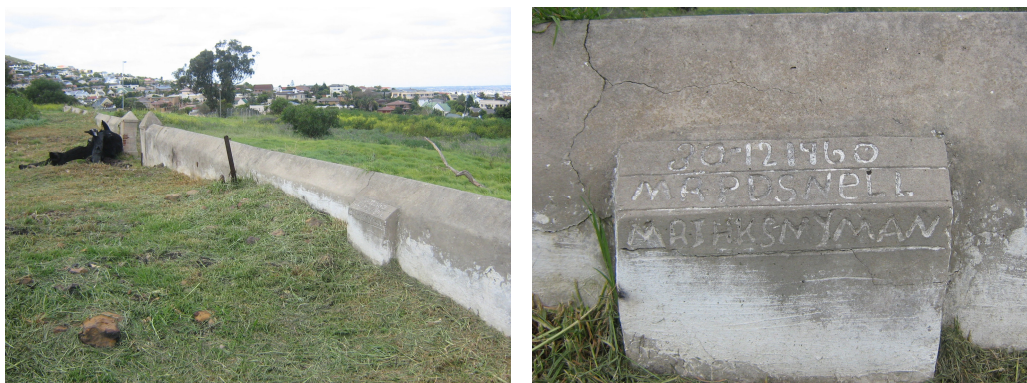
The werf wall is the only remaining feature of the historical werf which is more or less intact. The wall shows evidence of much maintenance and repair over the years – the most recent repair having been undertaken in the 1960s and included a coat of cement along the whole extent of the wall (Figure 22). There has been much build up of soil on the interior of the werf wall and this is putting pressure on the structure of the wall, which has fairly shallow foundations.

Figure 22. Most recent layer of cement plaster added in 1960, associated with the use of the property as a cattle kraal by the De Villiers Graafs.

- The werf wall needs to be stabilised and repaired. Specialist advice (engineer) needs to be sought to ensure that the wall is not destabilised during the construction period. A number of products are available that are more compatible with the soft brick used in older structures, and specialist advice (architect/builder familiar with old structures) should be sought as to how best to maintain this structure.

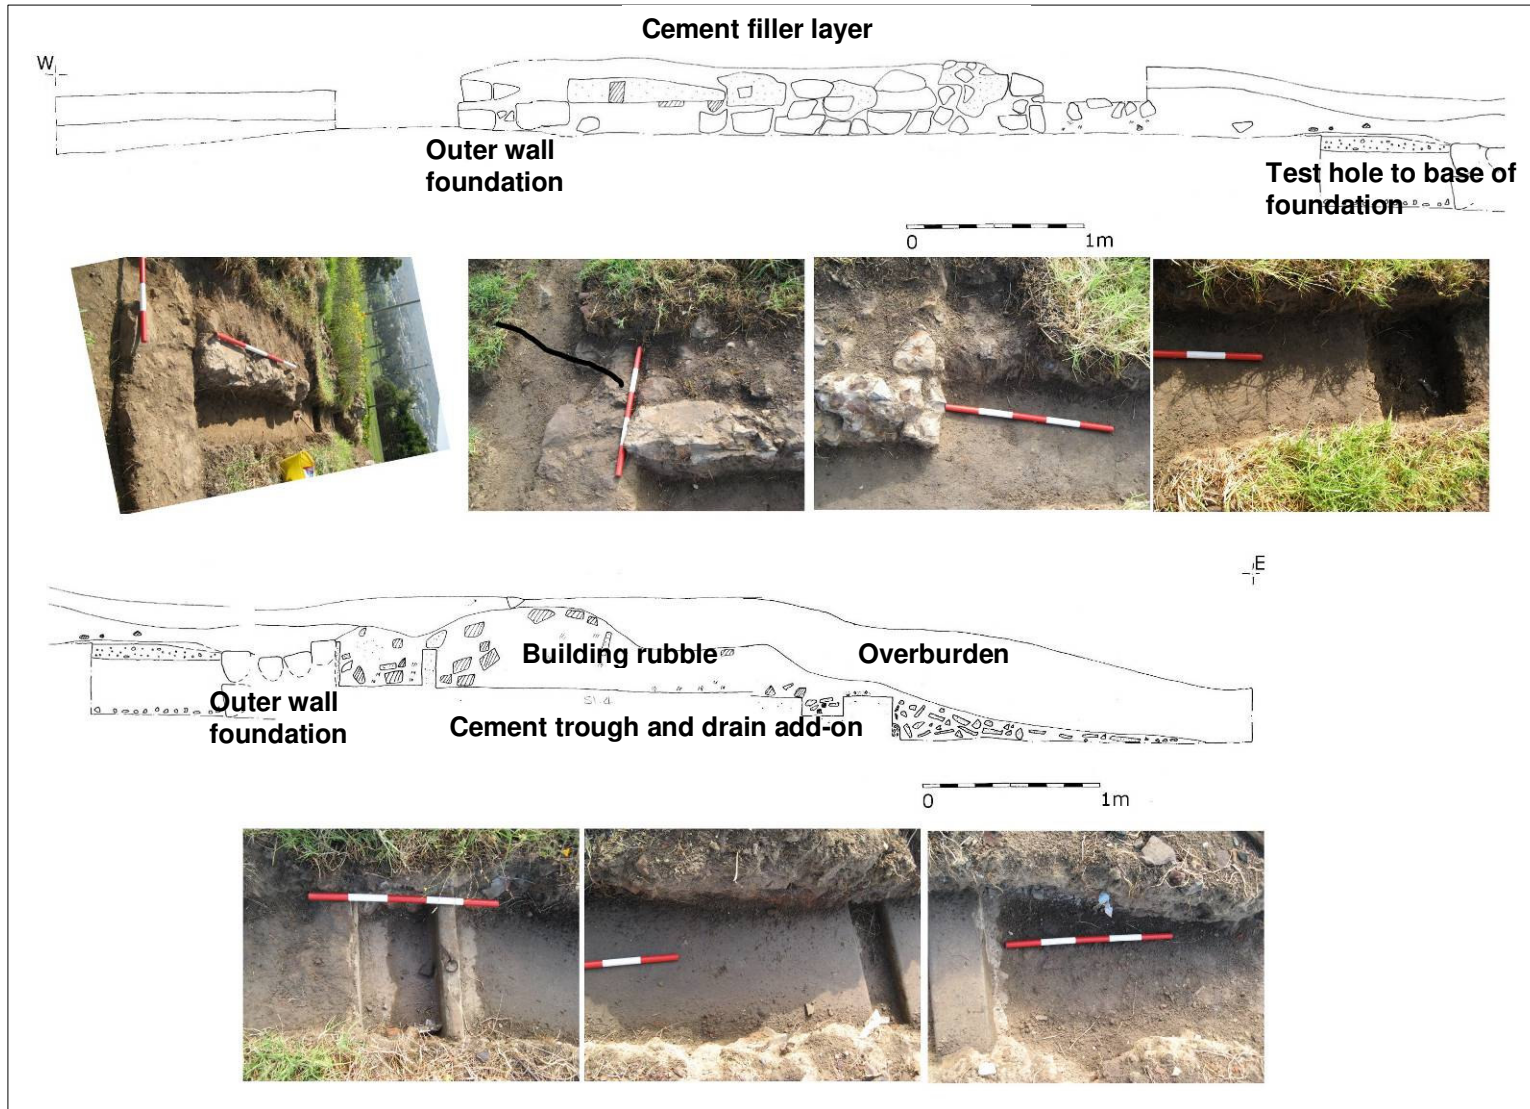
Figure 21: Section of the excavation trench. The two parts of the section overlap at the test hole to the W of the eastern outer wall.

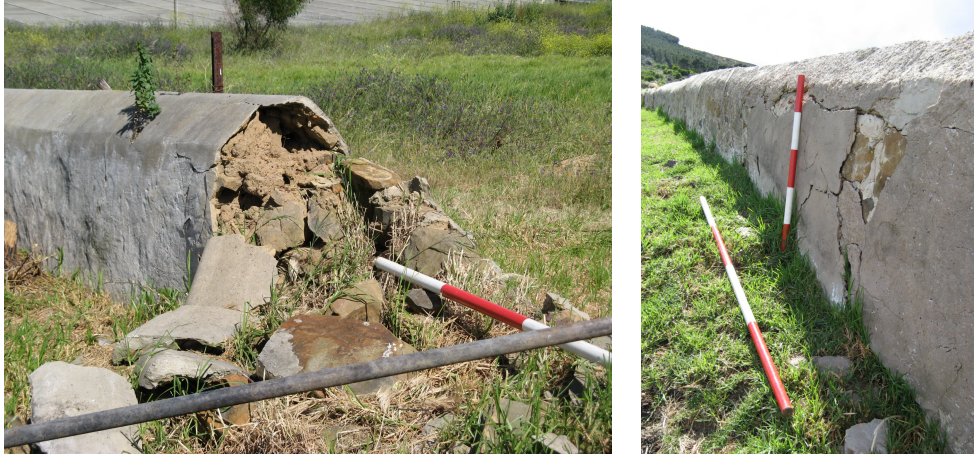
The oldest portion of the wall is constructed with a stone base, with an unbaked clay bricks coping. The construction method is particularly evident along the western portion of the wall where the wall has been knocked over (Figure 23).

Figure 23: Western portion of the werf wall is the oldest remaining portion of the wall, being stone build with an unbaked brick coping. Shell lime plaster is visible on the exterior part of the wall.

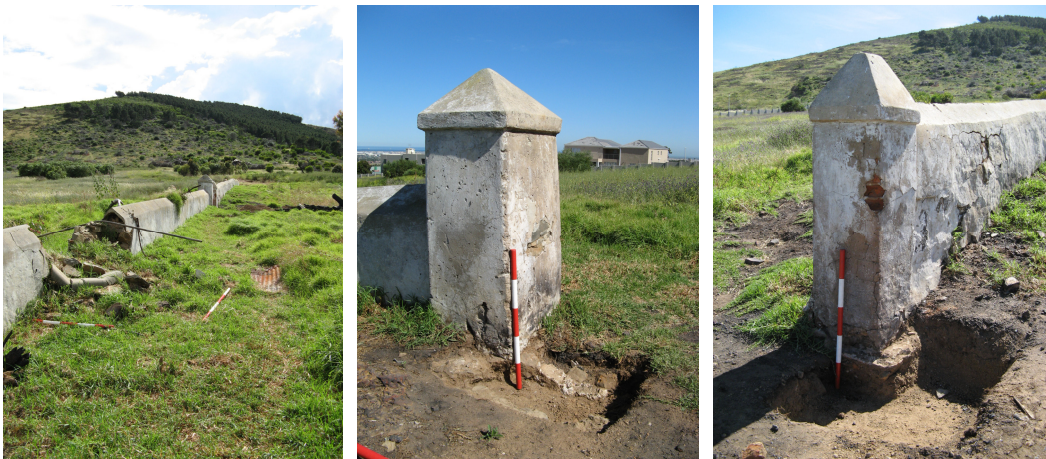
Figure 24: View of the western portion of the werf wall and details of the gate posts. It appears as if the southernmost gate post (central image) had been shifted, to make the opening wider. This may have been the original access/link route to de Grendel.

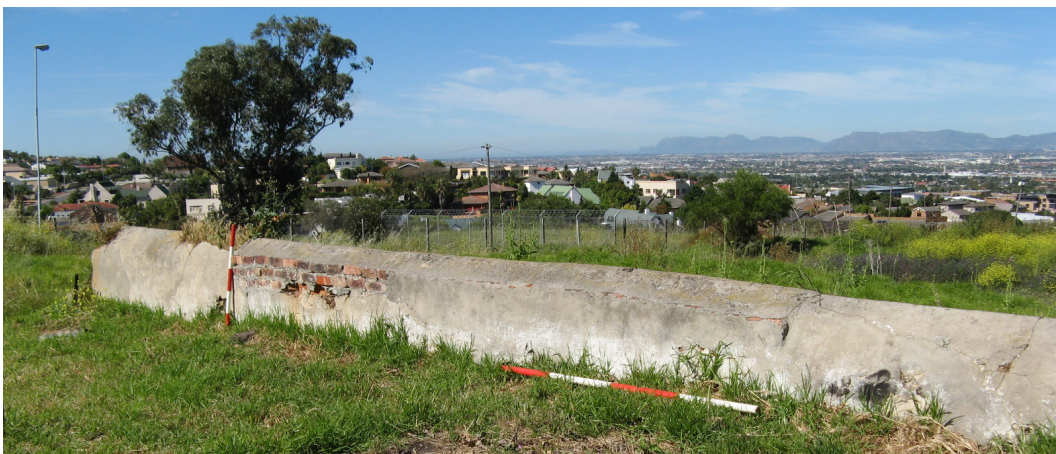
Figure 25: Evidence of modern repair to the werf wall. The werf wall stops just beyond the metre stick, possibly having been demolished when the ruins of the granary/kraal complex were flattened. Along this wall are a number of shallow buttresses.

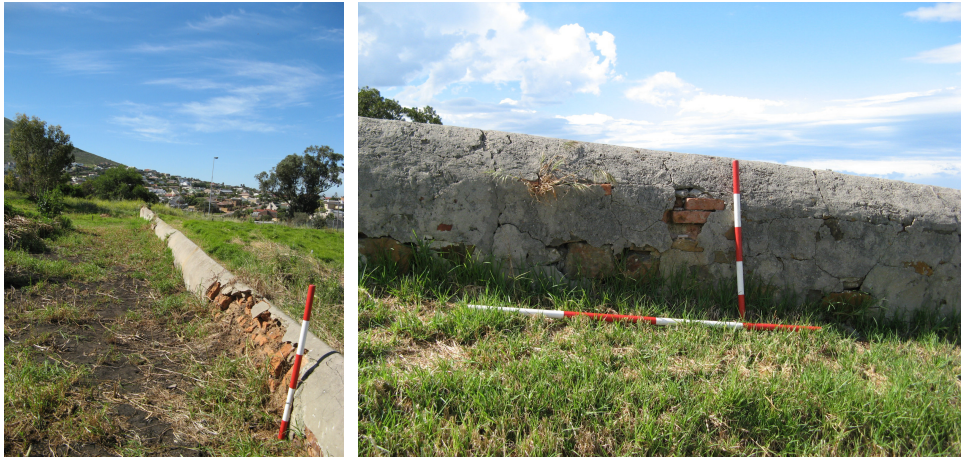
Figure 26: Two repair episodes to the southern section of the wall, both dating to the 19th century. The image on the right shows typical early 19th century baked brick, identified by the thinness of the brick.
