HERITAGE IMPACT ASSESSMENT PROPOSED DR02481 BRIDGE REFURBISHMENT

EASTERN CAPE PROVINCIAL DEPARTMENT OF ROADS

DECEMBER 2019

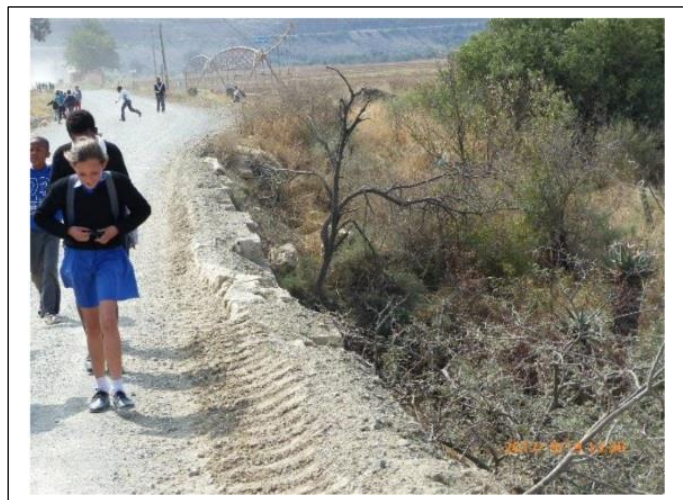
- Other pedestrians also use the bridge.
- Without side safety walls and due to its narrowness the bridge is unsafe for pedestrians and vehicles.

Figure 3: School pupils crossing the bridge. (Source: Afrisa Consulting.)

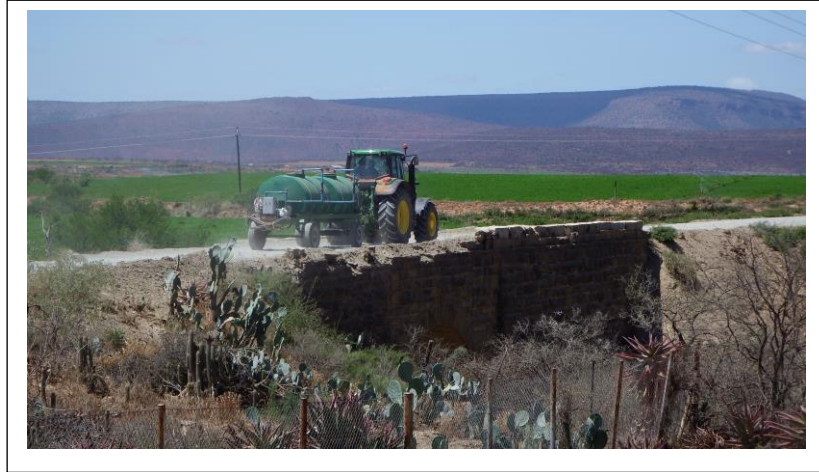
- The bridge carriageway is slightly narrower than the roadway making it difficult for modern traffic.
- Some of the large agricultural vehicles that need to regularly cross the bridge are of such a size that they take up the full width of the bridge and they may be in danger of falling off.

Figure 4: Tractor crossing the bridge. (Photo: The Author)

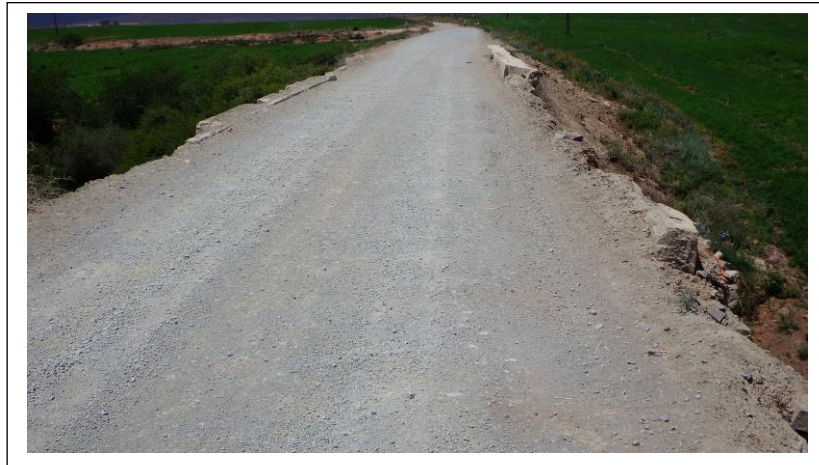
Figure 5: The bridge carriageway. Note the missing safety walls. (Photo: The Author)

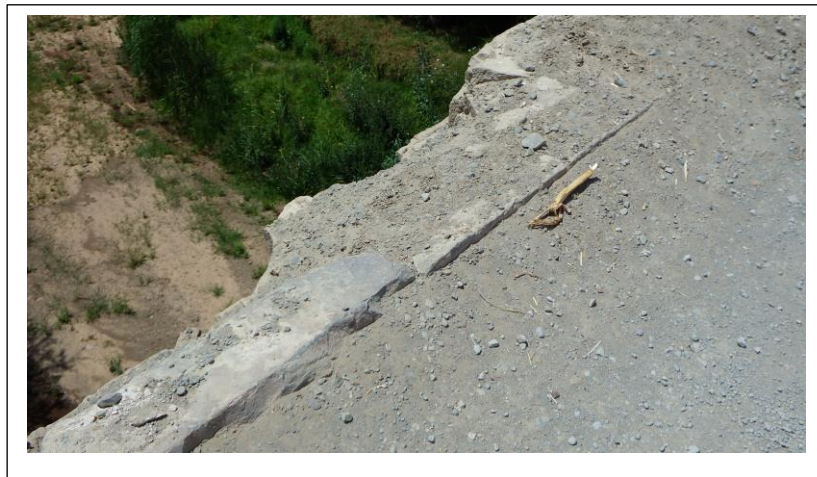
Figure 6: Missing side safety wall. (Photo: The Author)

- The bridge at the carriageway level has sustained some damage (no side safety walls).
- The original rail lines have been removed and the carriageway covered in compressed layers of gravel as a contemporary continuation of the DR02481.

- 5.3. Clear the gravel from the bridge carriageway and effect what repairs may be necessary to the bridge and its stonework and foundations with the aim of making sure that the old structure is sound. Then construct a new wider carriageway in reinforced concrete with safety balustrades on both sides and that has space for a pedestrian walkway. This approach is the most acceptable as it resolves current functional and safety issues and preserves what is left of the old bridge while honestly revealing the new work to be contemporary. Architecturally historically this is the most acceptable approach. However, this approach is the acceptable one provided that:

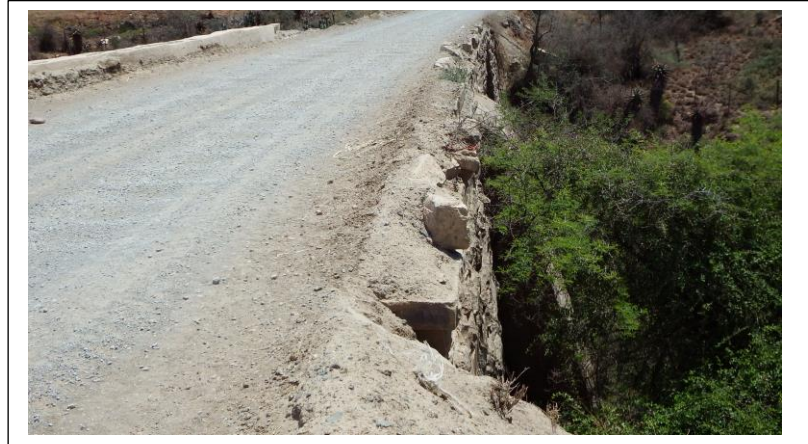
Figure 7: The bridge carriageway showing missing side safety walls. (Photo: The Author)

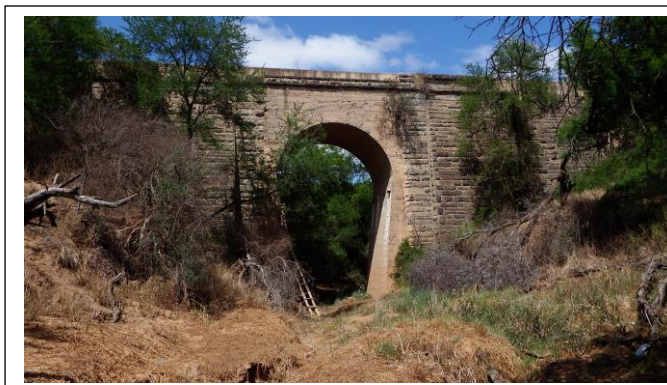
- About 12 kilometres south along the DR02481 is another similar stone bridge which must have also been a part of the old railway alignment. It is also a little narrower than the road and somewhat damaged above carriageway level. It appears to be structurally sound below and has been repaired with concrete at some stage. This bridge, which differs in that the side ramps are stone clad, but the central arch is concrete, has heritage value.
- About a kilometre north along the DR02481 is the old Klipfontein station building and platform no longer used as a railway station. Currently the building complex is used as a family house and is in poor condition. This complex, despite its poor condition and change of use, is an important part of the heritage of this area.

Figures 24 & 25: The other old bridge and the old Klipfontein station. (Photos: The Author)

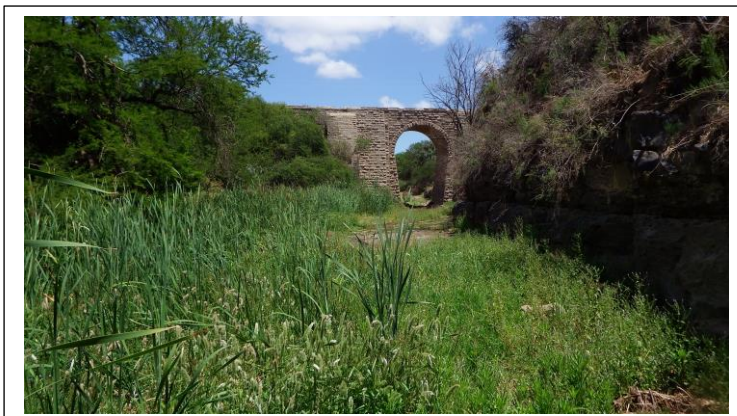
Figure 27: Bridge DR02481
(Photo: The Author)

On the negative side the bridge has the following deficiencies:

In the light of the above, as a heritage structure it is judged to be of Local or General importance and to comply with the requirements of category 3B.

It is recommended that alternative 5.3 is the acceptable alternative. This alternative resolves the current functional and safety issues and is architecturally historically the most honest approach. It will result in a heritage structure that can be clearly read in terms of authenticity of original and new work. The nature of this alternative is such that the following are recommended:

- 6.1.1. The engineering consultants must undertake a thorough structural examination of the old bridge and effect any repairs necessary to ensure the structural integrity of the old bridge.
- 6.1.2. Once the detail design of any repairs to the old bridge are complete, they must be subject to approval of a suitable heritage specialist.
- 6.1.3. Once the detail design of the new reinforced concrete carriageway and pedestrian walkways is complete, they must be subject to the approval of a suitable heritage specialist.
- 6.1.4. Once construction is underway the works must be inspected at least twice by a suitable heritage specialist to ensure that the new work is being executed in such a manner that it does not damage the old.
